# VEHICLE INSPECTION REPORT

YC19LBN

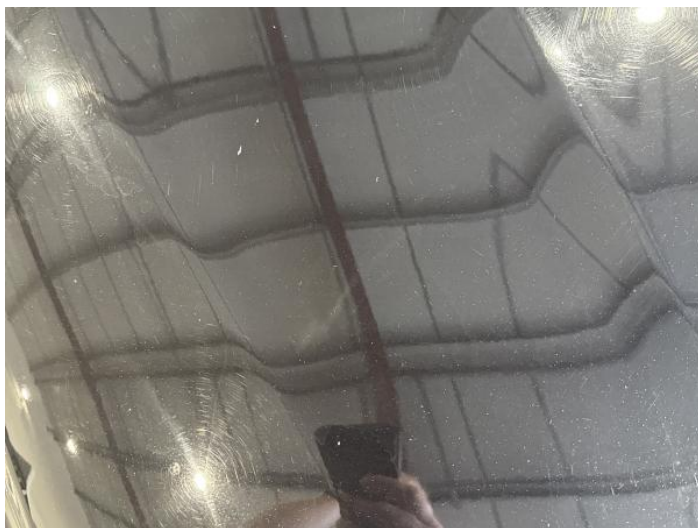
1: Bonnet  
Chipped  
Multiple Chips

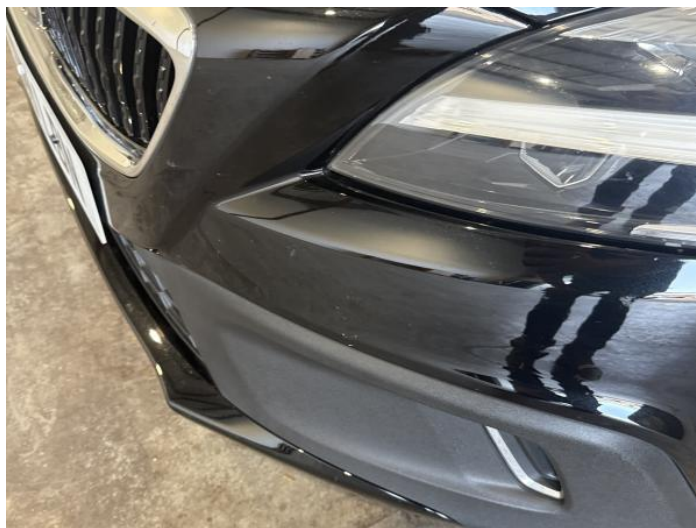
2: Bumper Front  
Chipped  
Multiple Chips

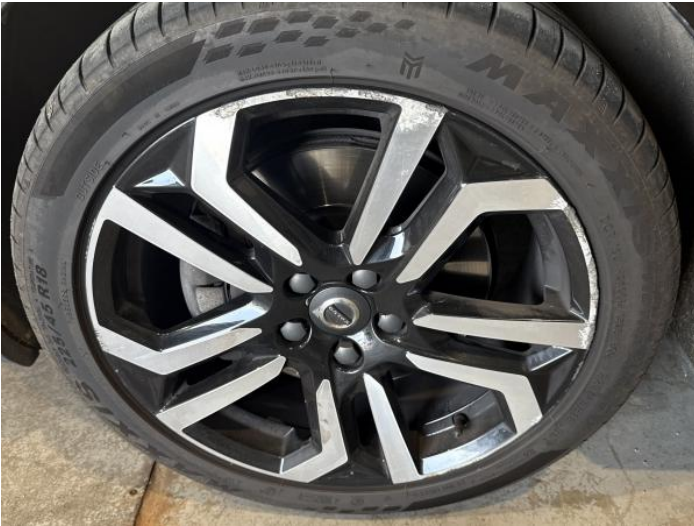
3: Wheel nsf  
Scratched  
Over 50mm

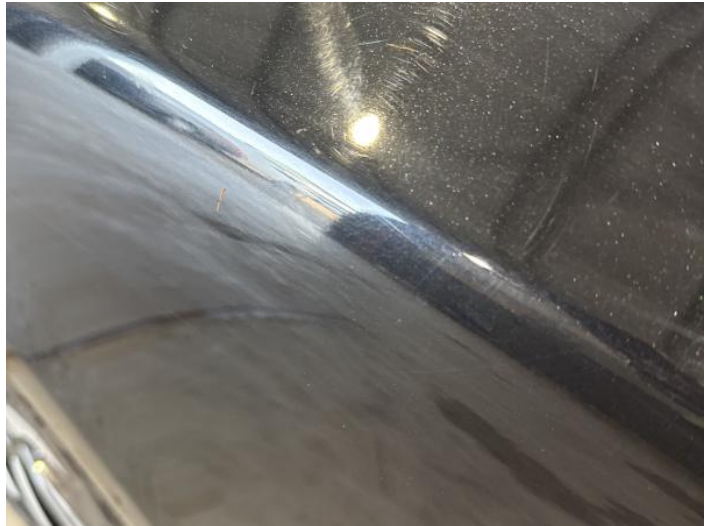
4: Wing nsf  
Scratched  
UpTo 25mm Thru Paint

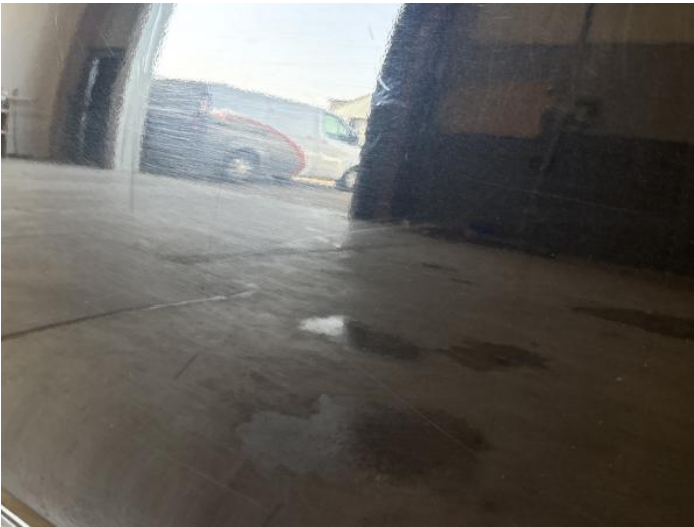
5: Door nsf  
Scratched  
Over 25mm Thru Paint

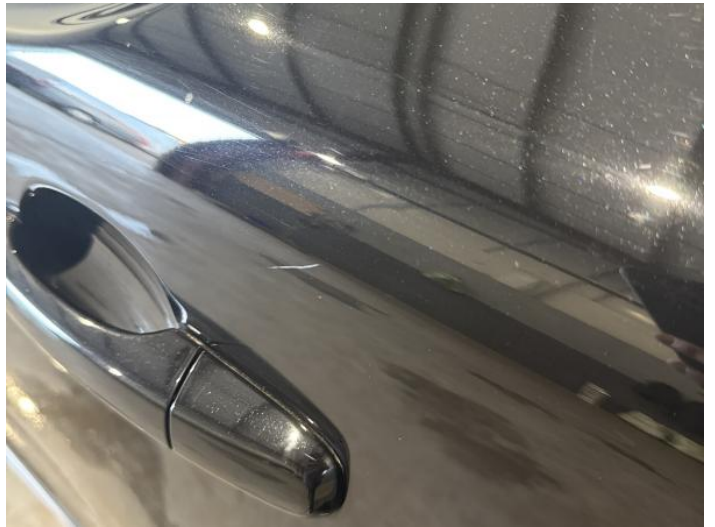
6: Door nsr  
Scratched  
UpTo 25mm Thru Paint

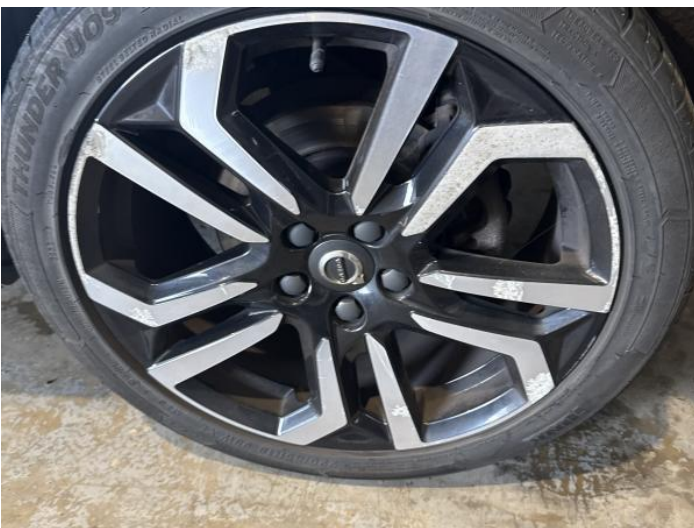
7: Wheel nsr  
Scratched  
Over 50mm

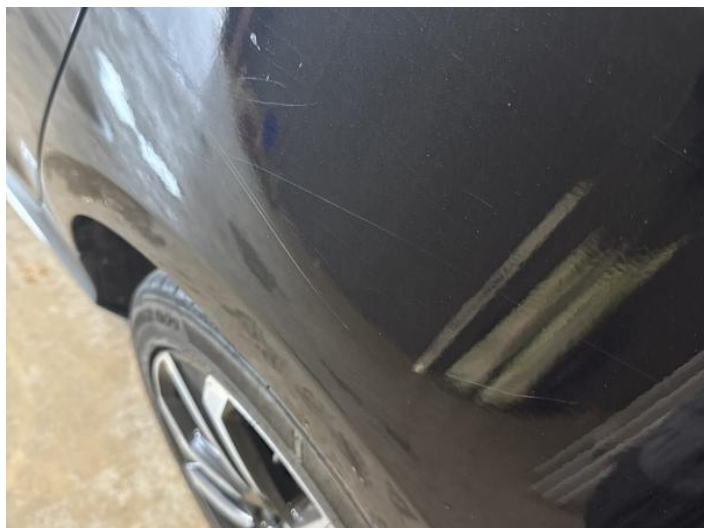
8: Qtr Panel nsr  
Scratched  
Over 25mm Thru Paint

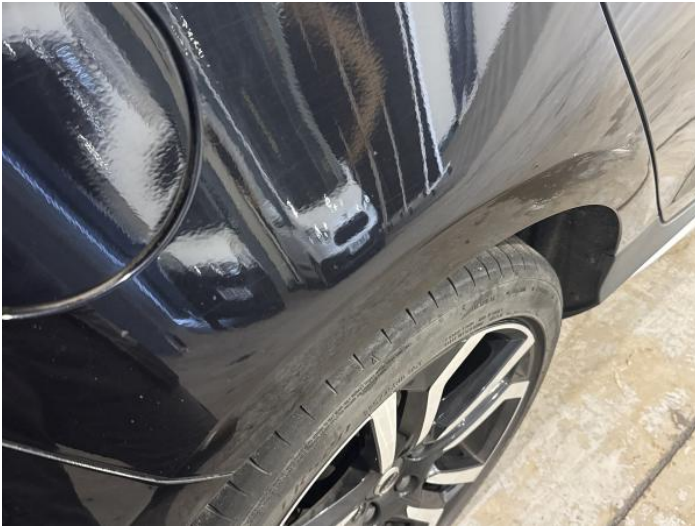
9: Qtr Panel osr  
Chipped  
Multiple Chips

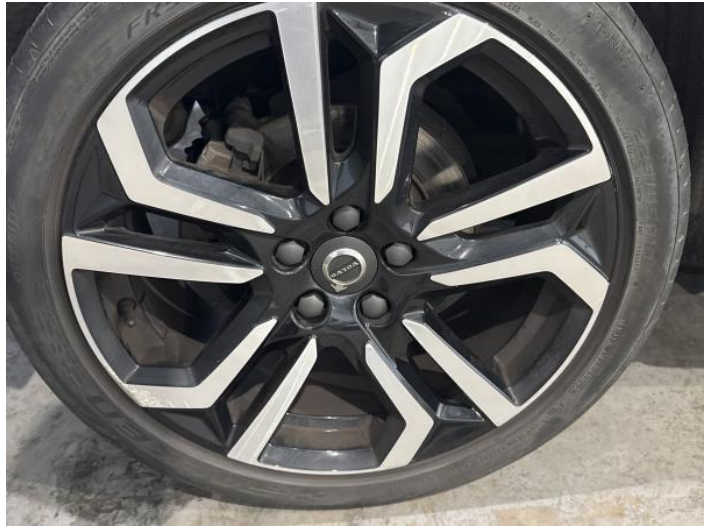
10: Wheel osr  
Scratched  
Over 50mm

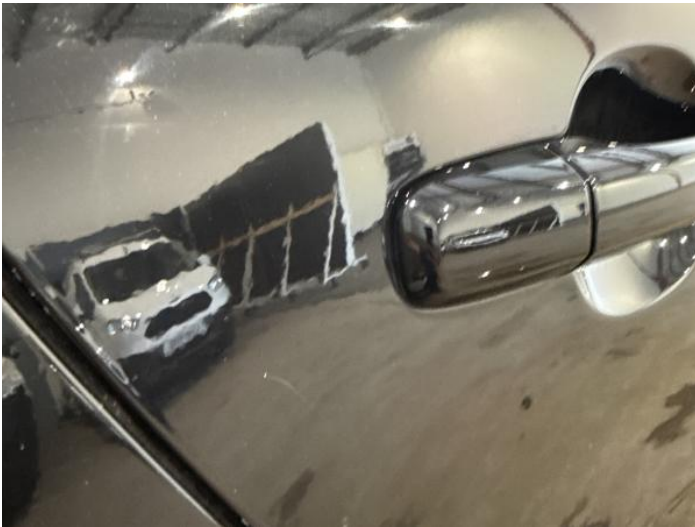
11: Door osr  
Scratched  
Over 25mm Thru Paint

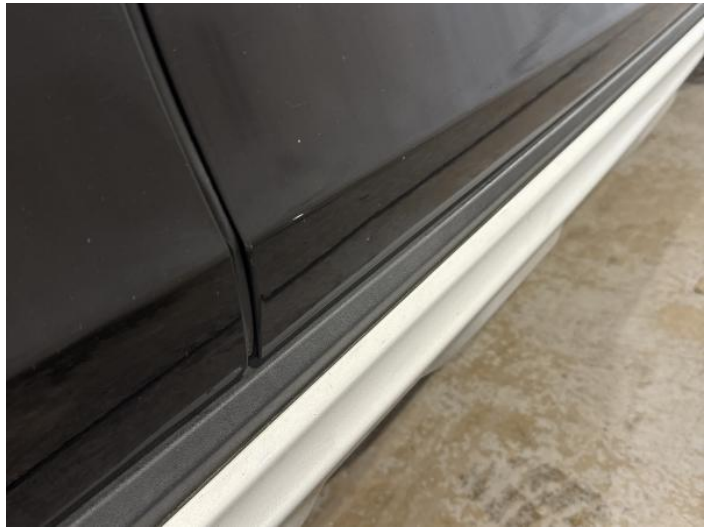
12: Door osf  
Dented  
Between 10mm + 30mm

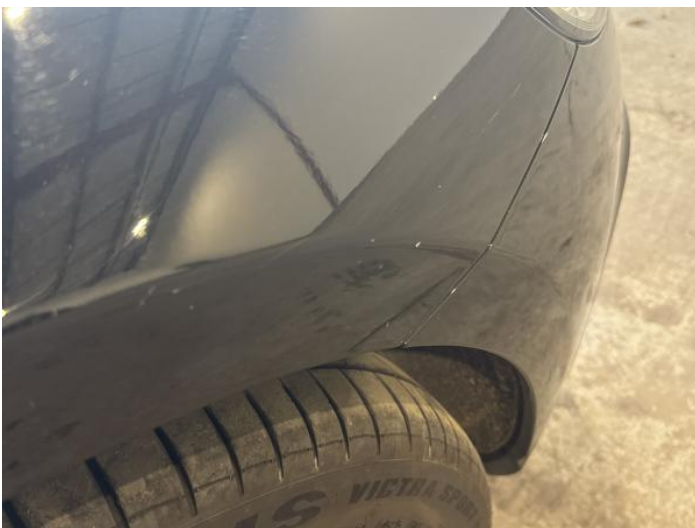
13: Wing osf  
Scratched  
Over 25mm Thru Paint

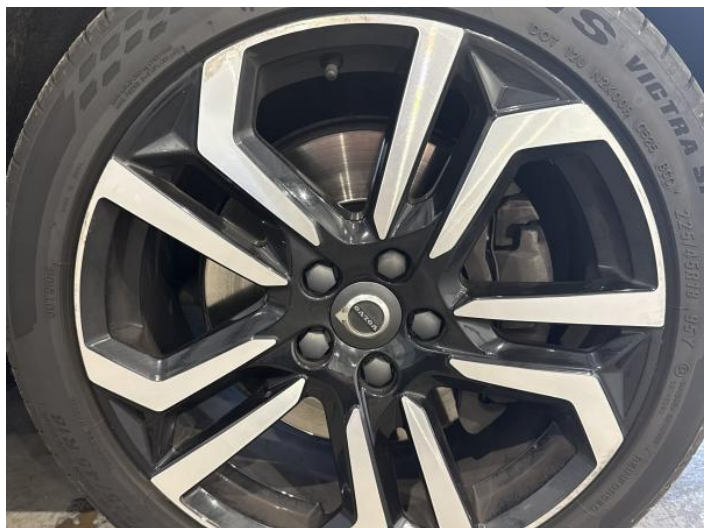
14: Wheel osf  
Scratched  
Up To 50mm
