VEHICLE INSPECTION REPORT

SD68KKJ

Renault Captur 0.9 TCE 90 GT Line 5dr

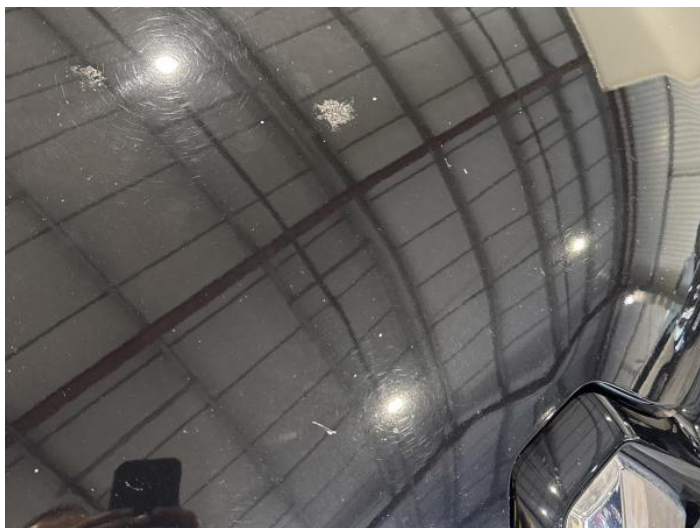
1: Bonnet
Chipped
Multiple Chips

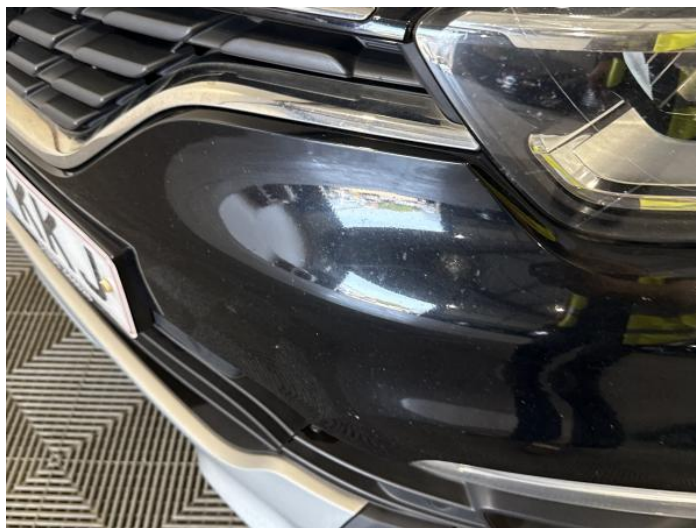
2: Bumper Front
Chipped
Multiple Chips

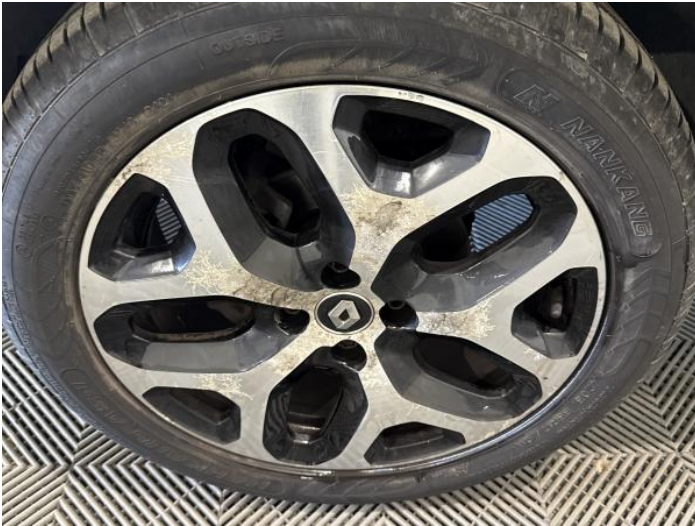
3: Wheel osf
Scratched
Over 50mm

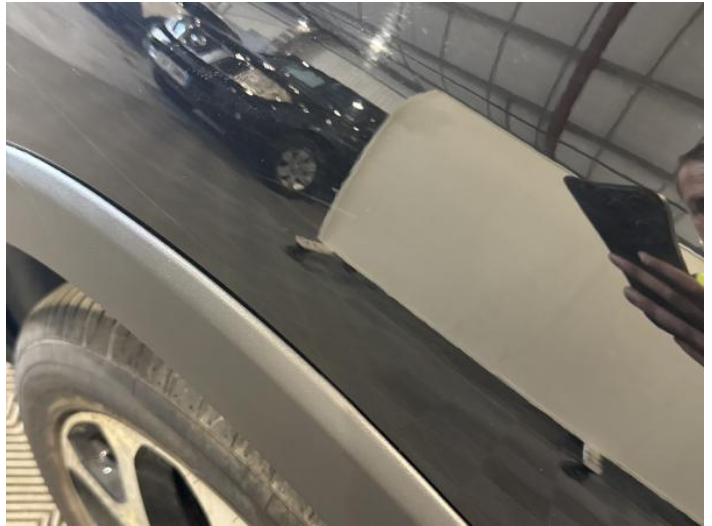
4: Wing nsf
Scratched
UpTo 25mm Thru Paint

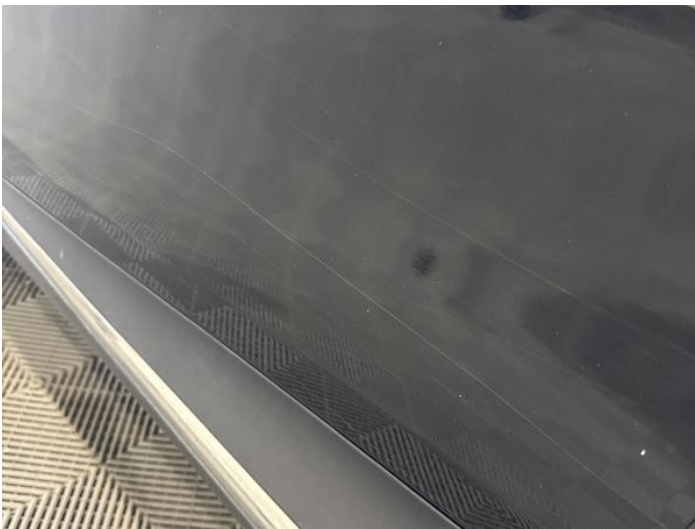
5: Door nsf
Scratched
Over 25mm Thru Paint

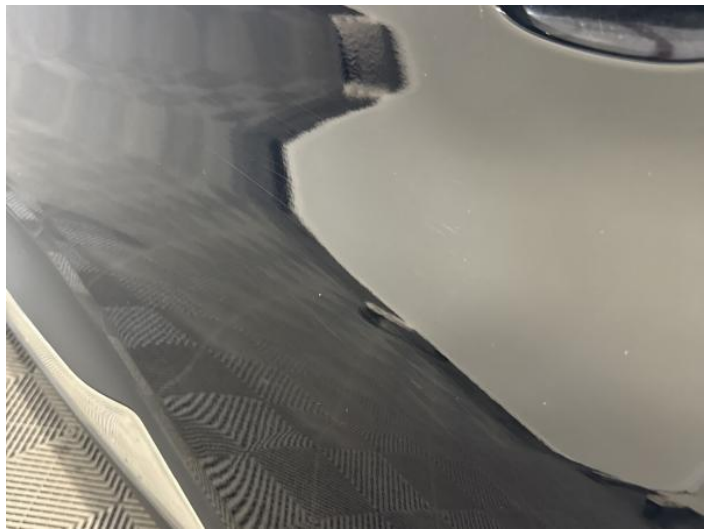
6: Door nsr
Scratched
Over 25mm Thru Paint

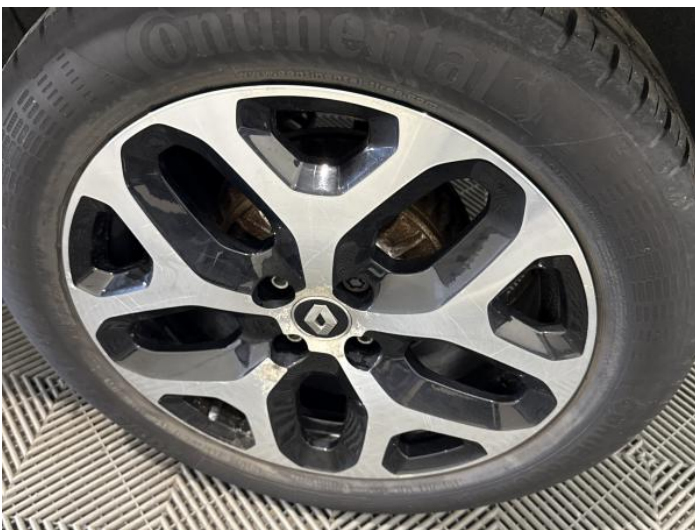
7: Wheel nsr
Scratched
Over 50mm

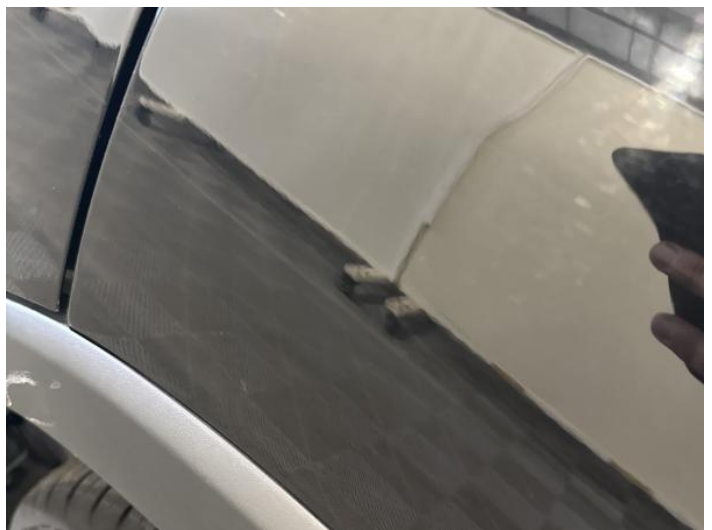
8: Qtr Panel nsr
Scratched
Over 25mm Thru Paint

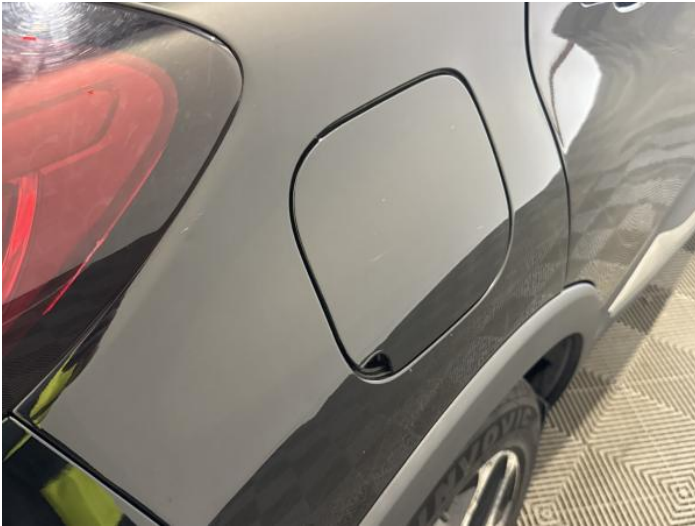
9: Qtr Panel osr
Dented
Between 10mm + 30mm

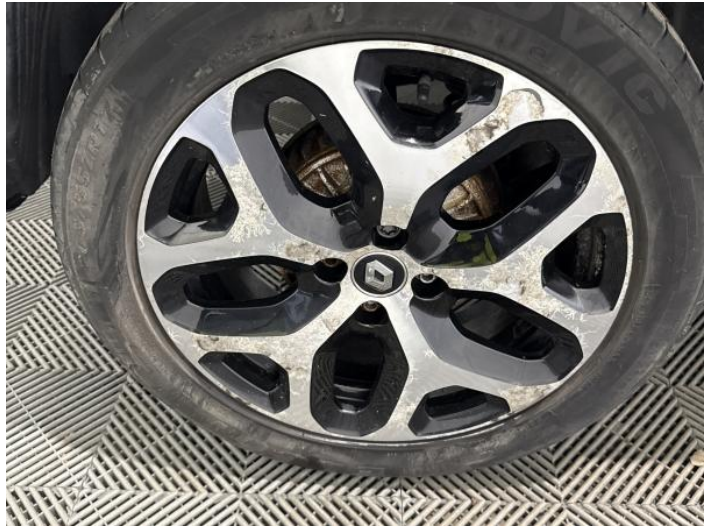
10: Wheel osr
Scratched
Over 50mm

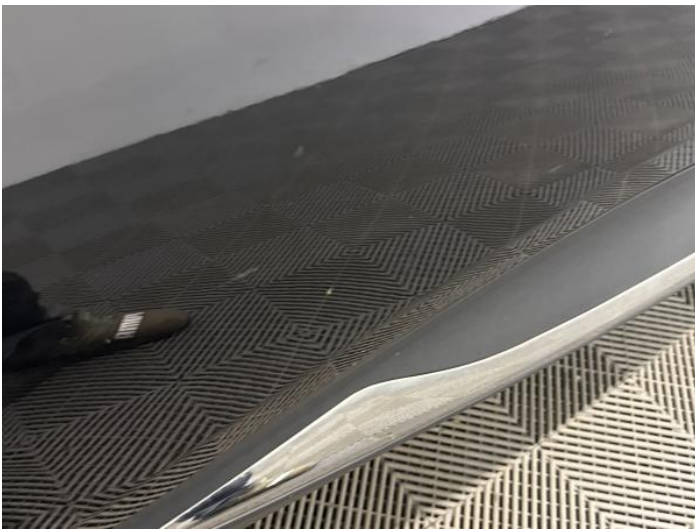
11: Door osr
Scratched
UpTo 25mm Thru Paint

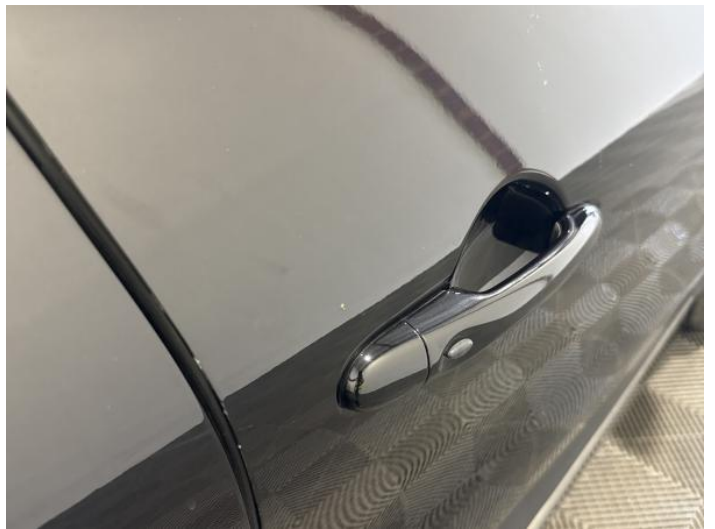
12: Door osf
Dented
Between 10mm + 30mm

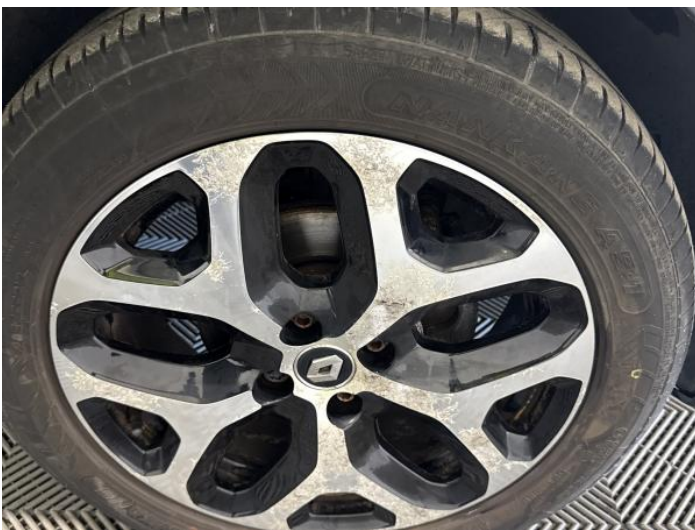
13: Wheel osf
Scratched
Over 50mm

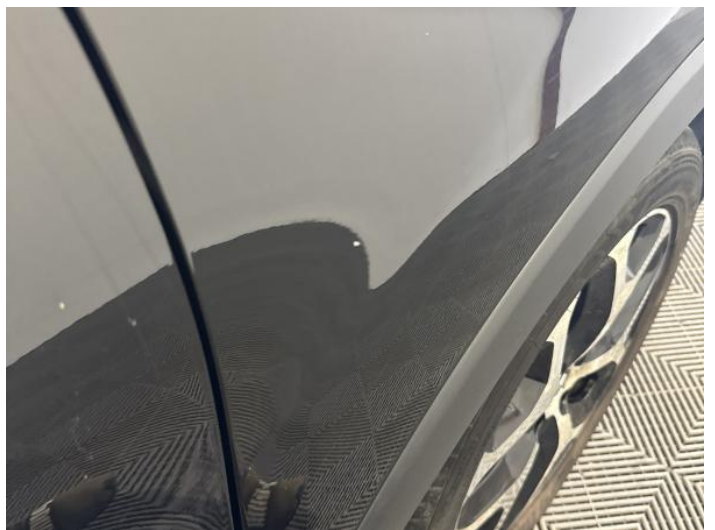
14: Wing osf
Chipped
1 To 5
