# VEHICLE INSPECTION REPORT

**GU66LXT**

## Honda Civic 1.4 i-VTEC SE Plus 5dr [Nav]

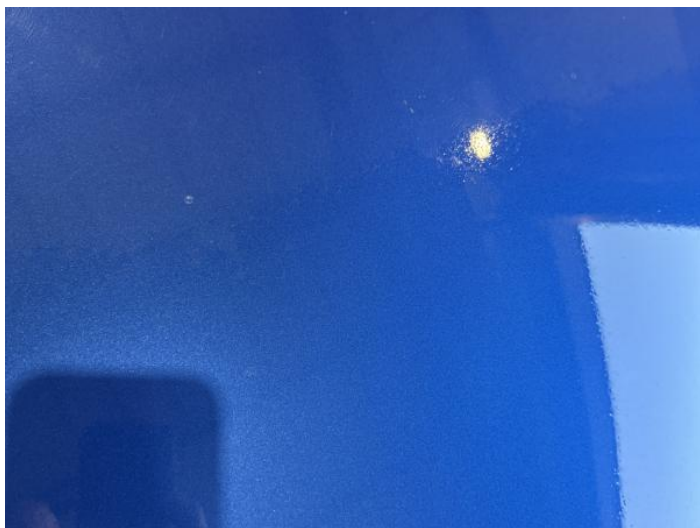
1: Bonnet  
Chipped  
Multiple Chips

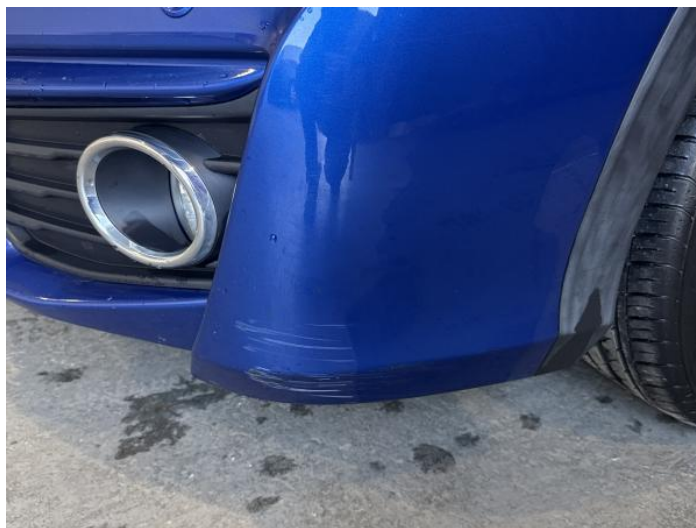
2: Bumper Front  
Scratched  
Over 100mm Thru Paint

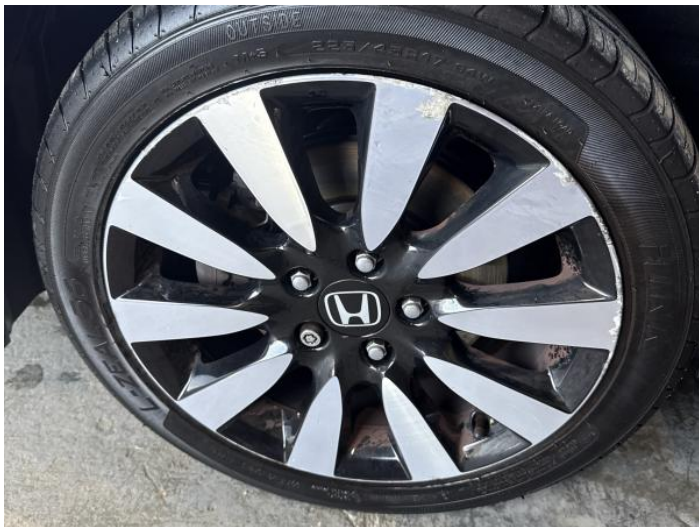
3: Wheel nsf  
Scratched  
Over 50mm

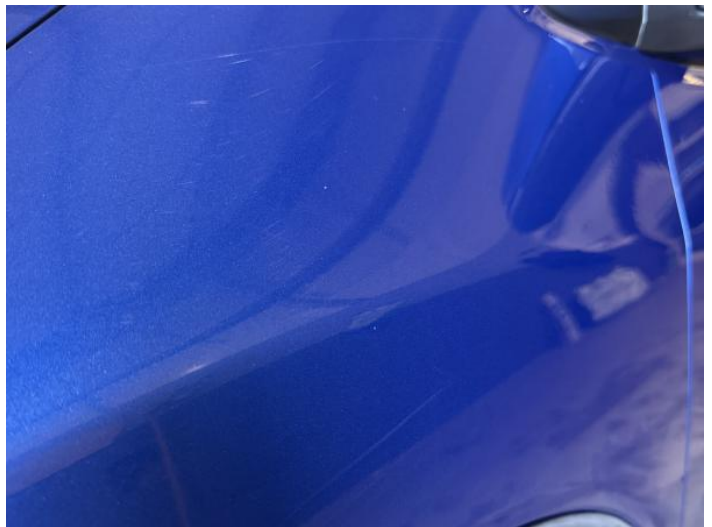
4: Wing nsf  
Chipped  
1 To 5

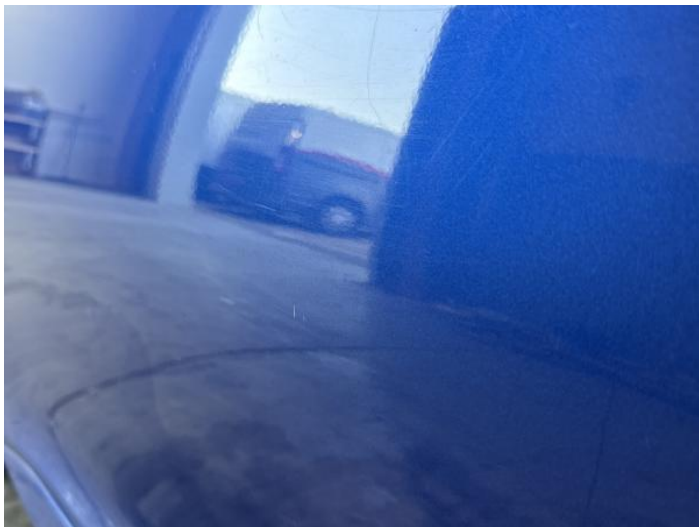
5: Door nsf  
Scratched  
Over 25mm Thru Paint

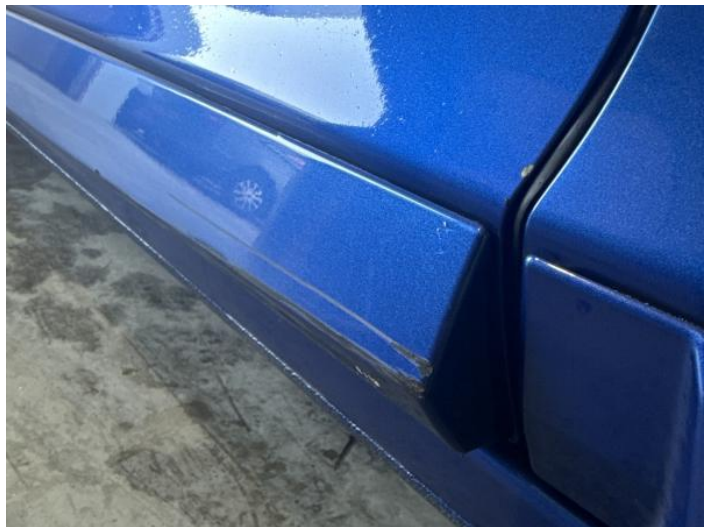
6: Door Moulding nsf  
Scratched (Painted)  
Over 25mm Thru Paint

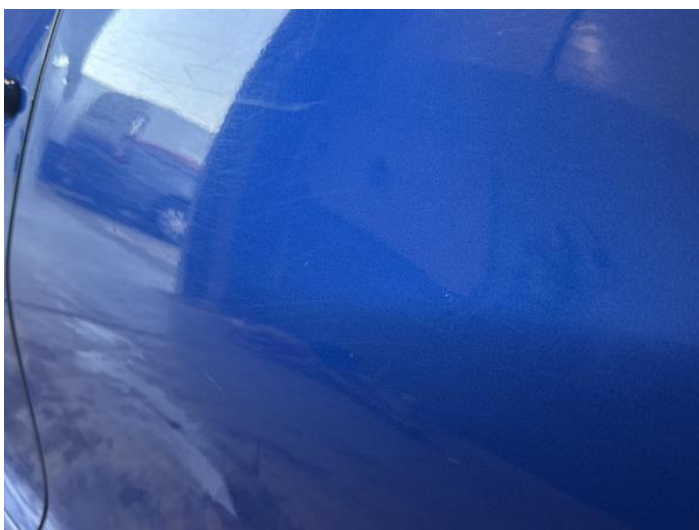
7: Door nsr  
Scratched  
Over 25mm Thru Paint

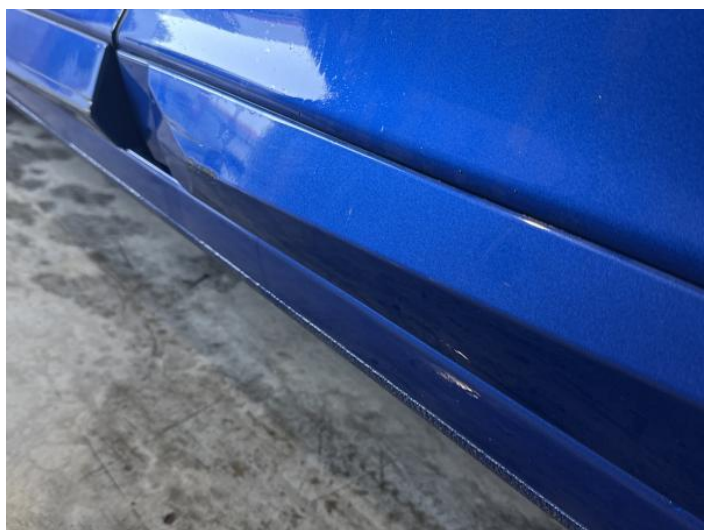
8: Door Moulding nsr  
Scratched (Painted)  
Over 25mm Thru Paint

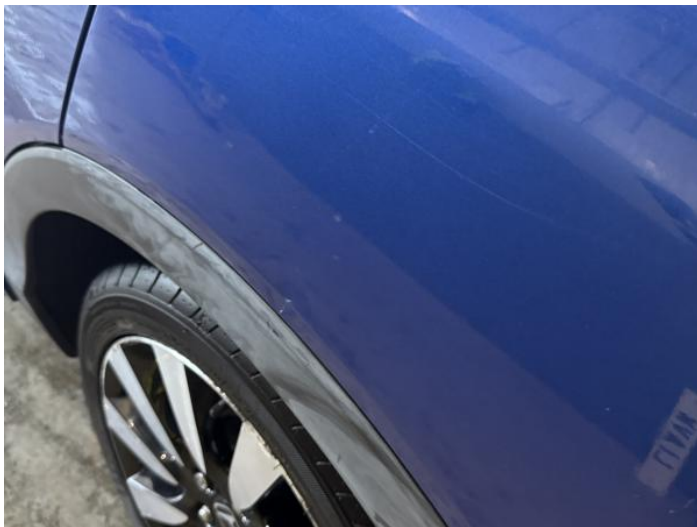
9: Qtr Panel nsr  
Dented  
Between 10mm + 30mm

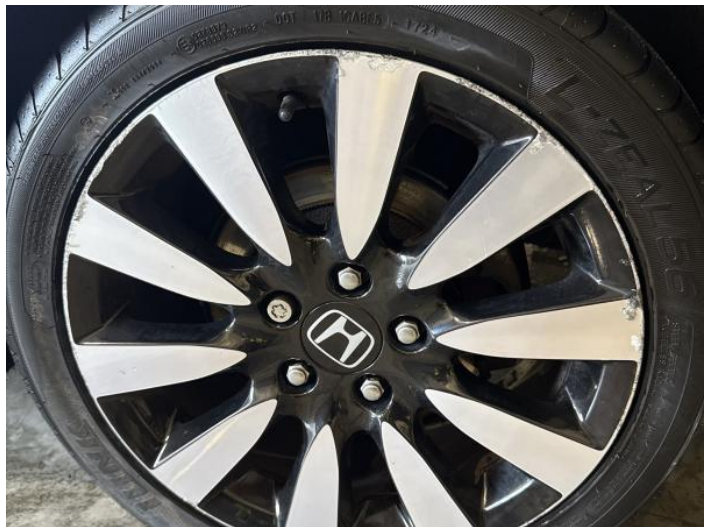
10: Wheel nsr  
Scratched  
Over 50mm

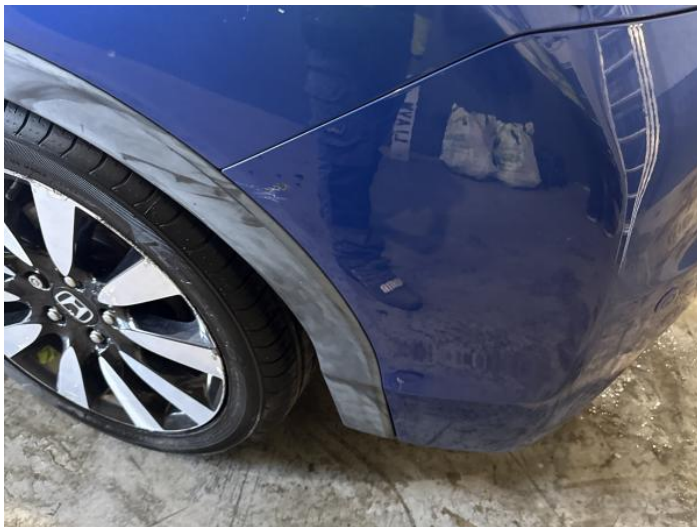
11: Bumper Rear  
Scratched  
Over 100mm Thru Paint

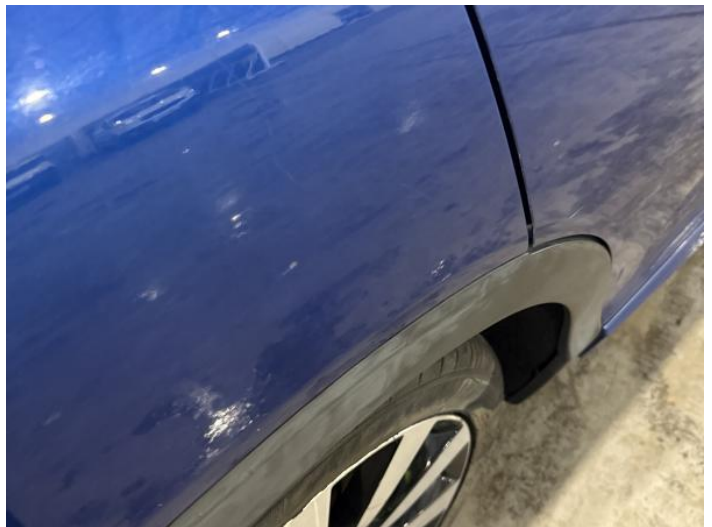
12: Qtr Panel osr  
Scratched  
UpTo 25mm Thru Paint

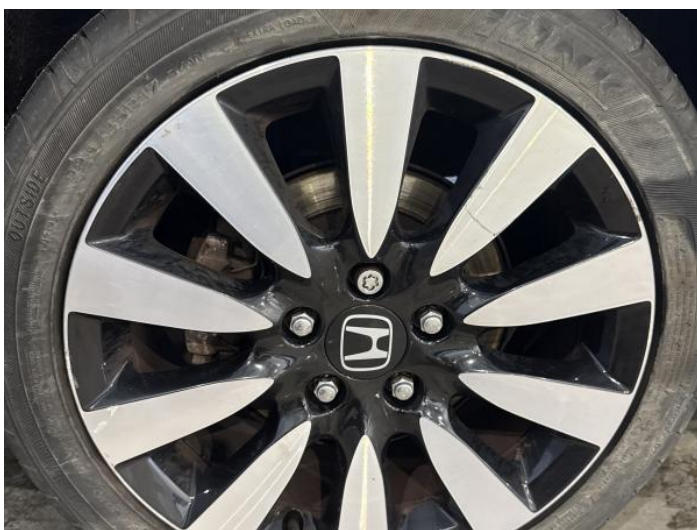
13: Wheel osr  
Scratched  
Over 50mm

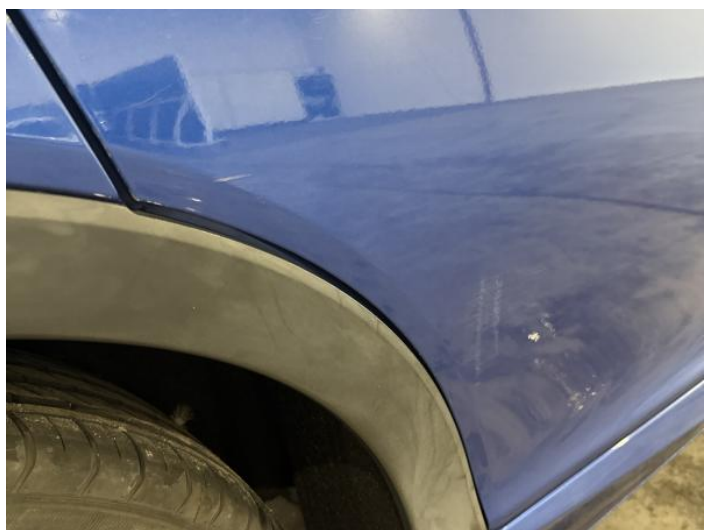
14: Door osr  
Dented  
With Paint Damage

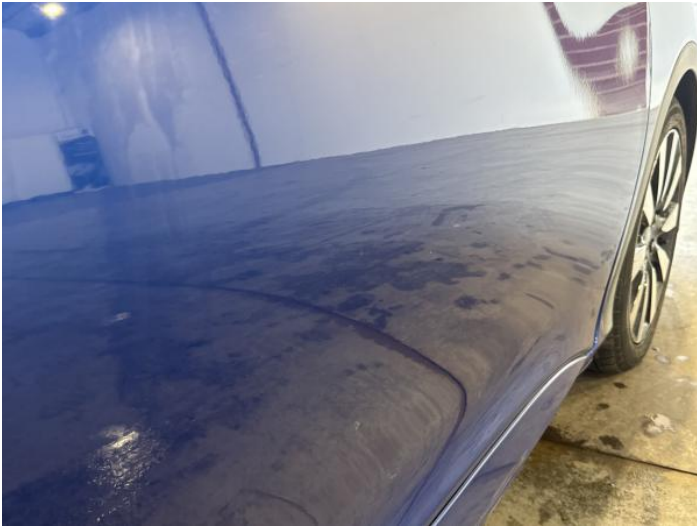
15: Door osf  
Dented  
Over 30mm

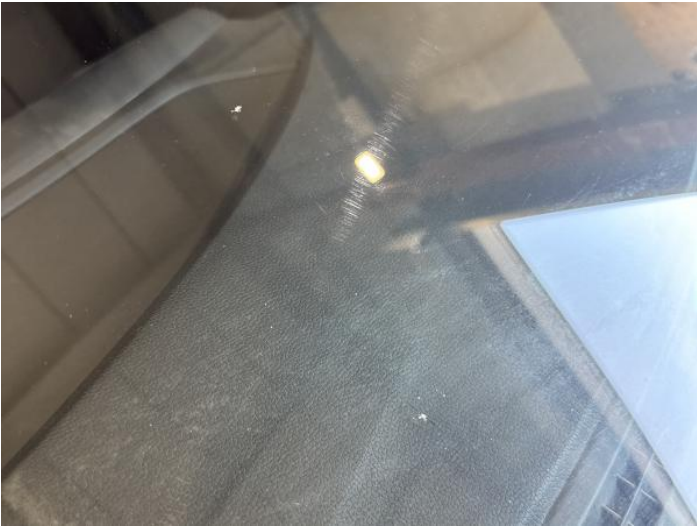
16: Screen Front  
Chipped  
Over 10mm

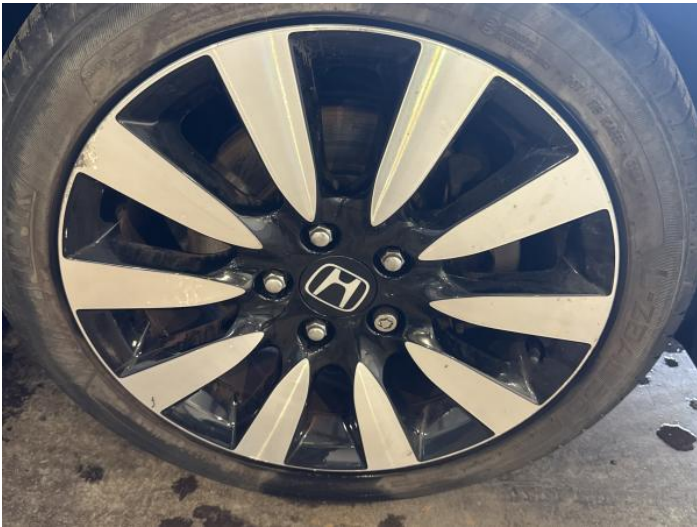
17: Wheel osf  
Scratched  
Over 50mm

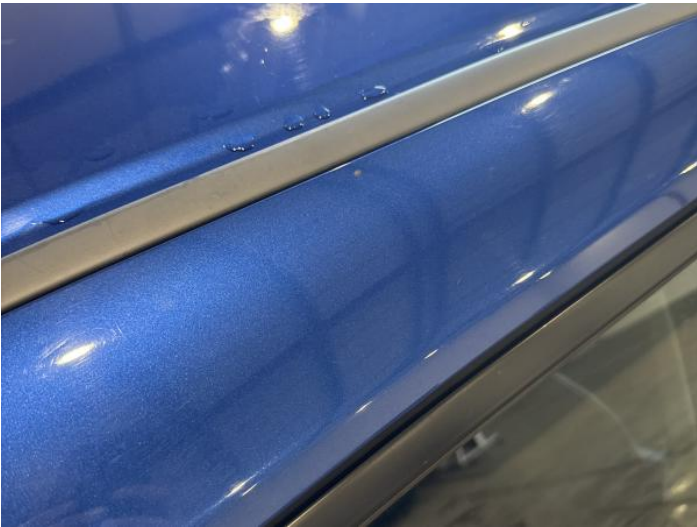
18: Roof  
Chipped  
1 To 5
