# VEHICLE INSPECTION REPORT

**GY65BTZ**

## Hyundai I20 1.4 Premium 5dr

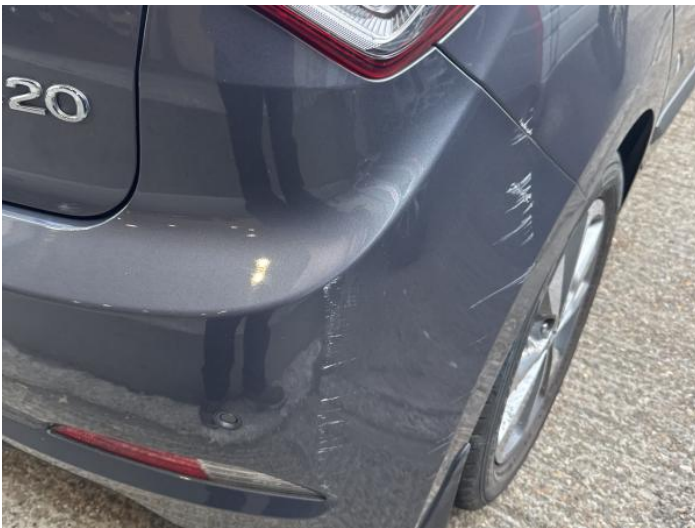
1: Bumper Rear  
Scratched  
Over 100mm Thru Paint

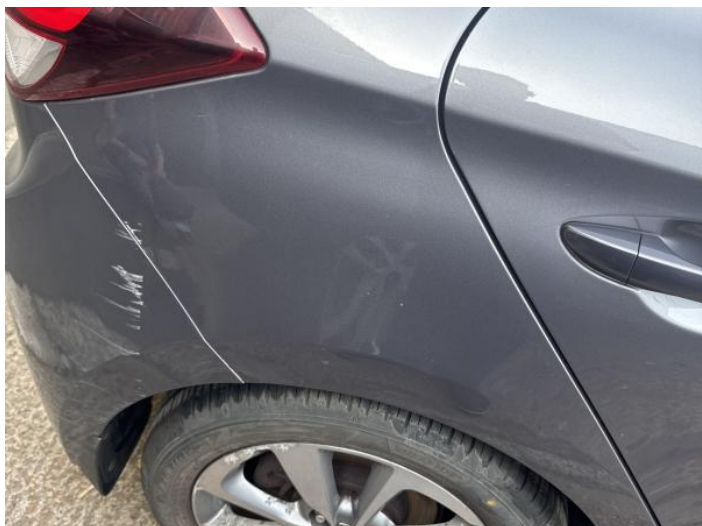
3: Qtr Panel osr  
Dented  
With Paint Damage

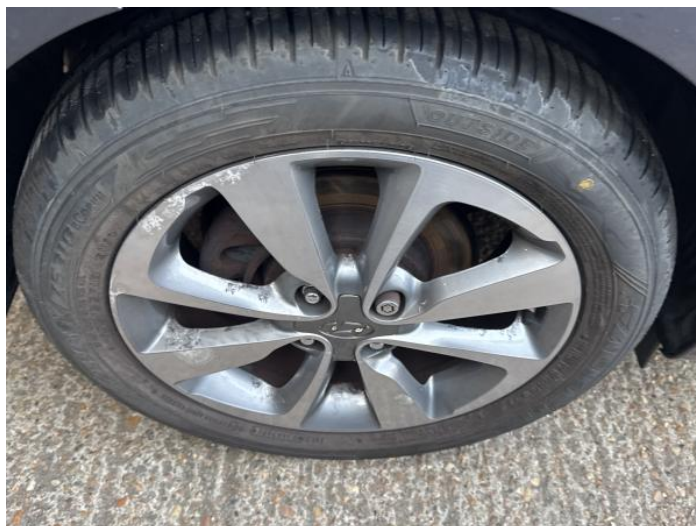
4: Wheel osr  
Scratched  
Over 50mm

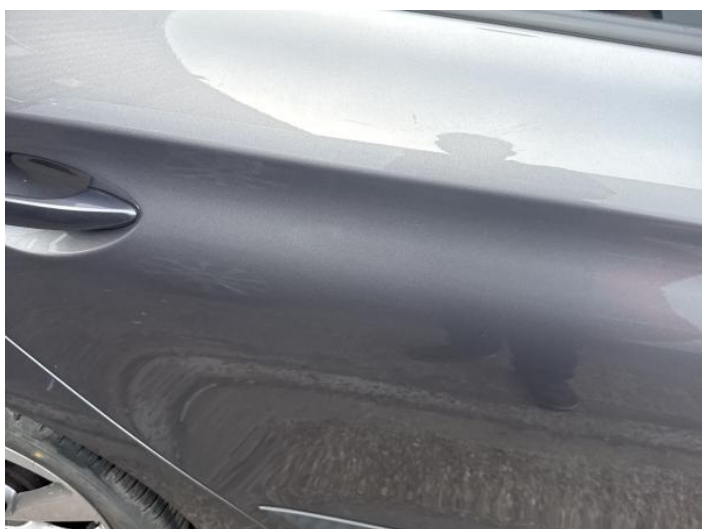
5: Door osr  
Dented  
Over 2 UpTo 10mm

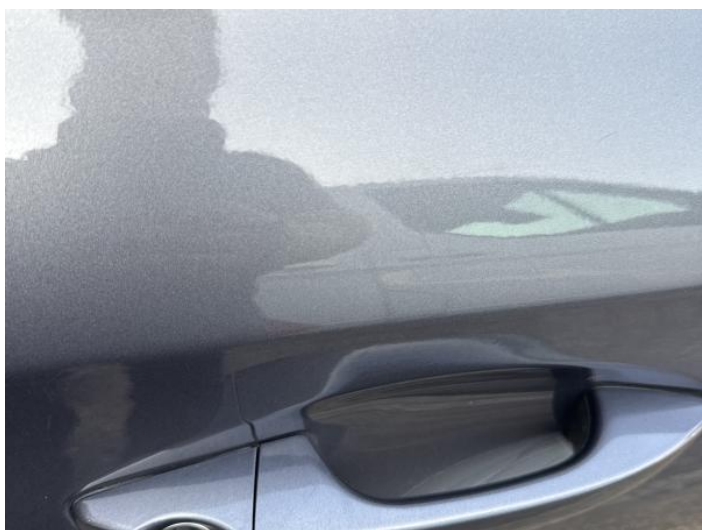
7: Door osf  
Chipped  
1 To 5

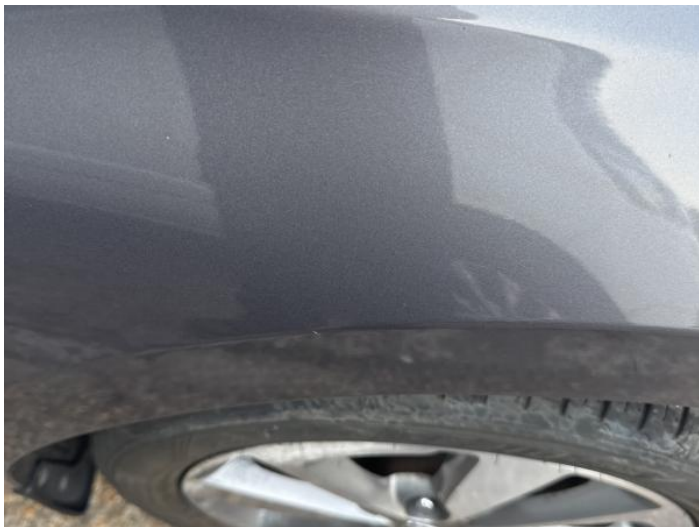
9: Wing osf  
Chipped  
1 To 5

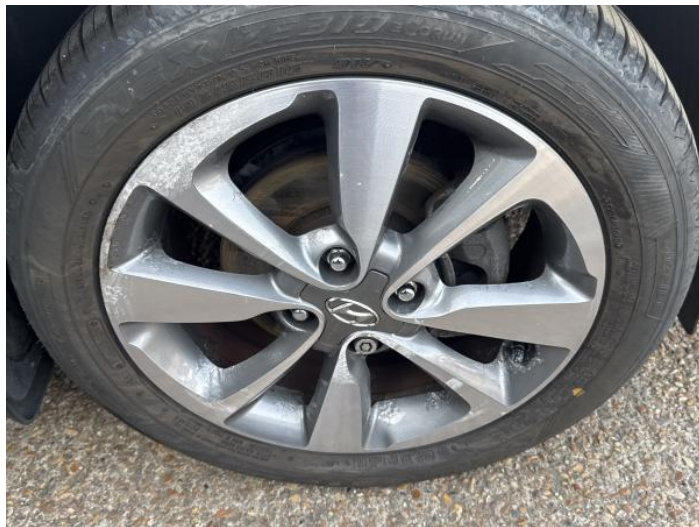
10: Wheel osf  
Scratched  
Over 50mm

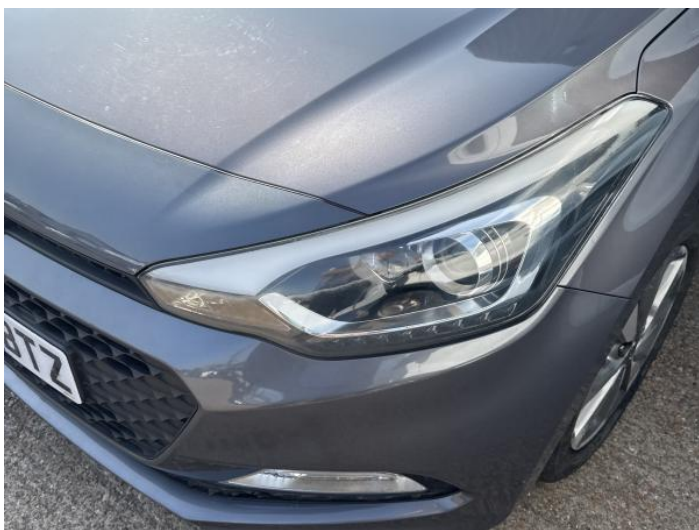
11: Bumper Front  
Scratched  
25 to 100mm Thru Paint

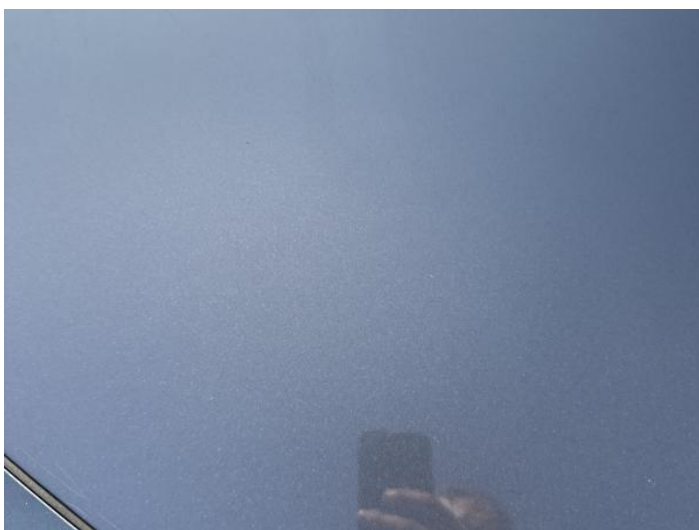
13: Bonnet  
Chipped  
1 To 5

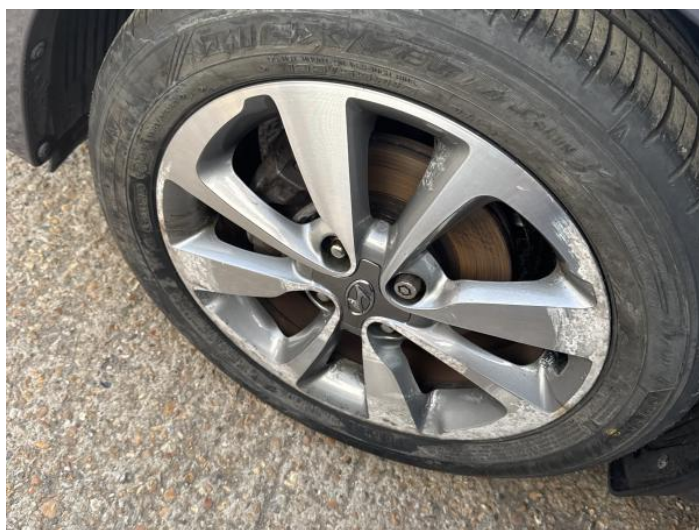
14: Wheel nsf  
Scratched  
Over 50mm

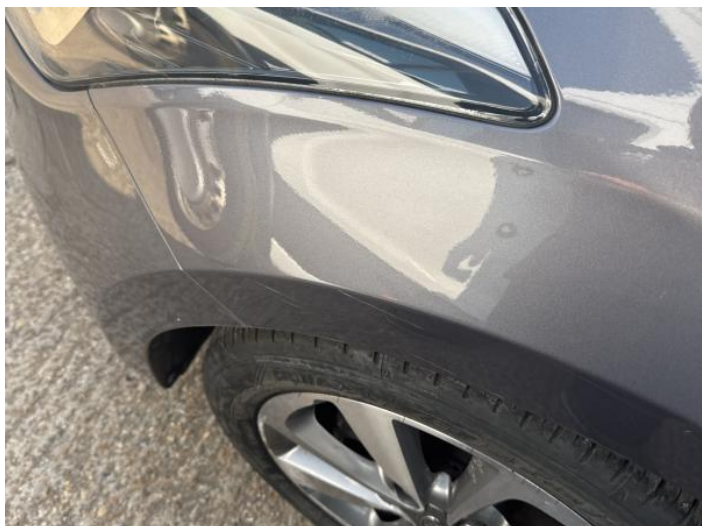
15: Wing nsf  
Scratched  
Over 25mm Thru Paint

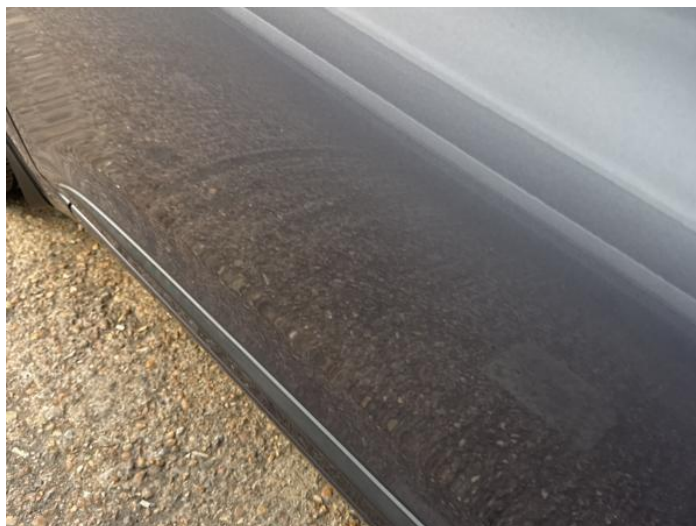
16: Door nsf  
Chipped  
1 To 5

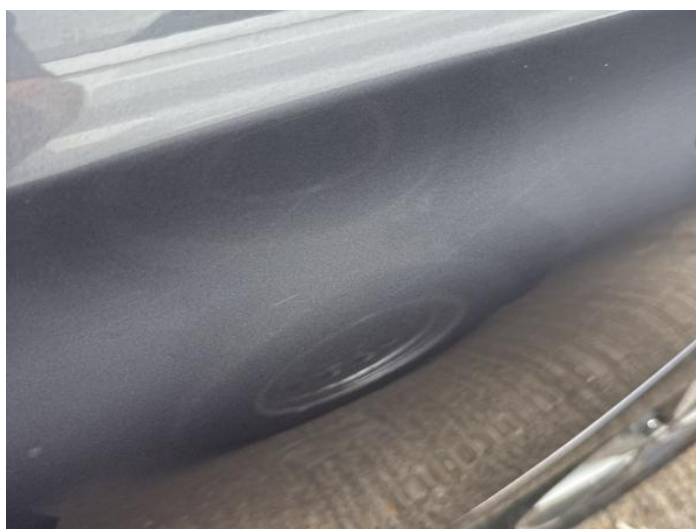
18: Door nsr  
Chipped  
1 To 5

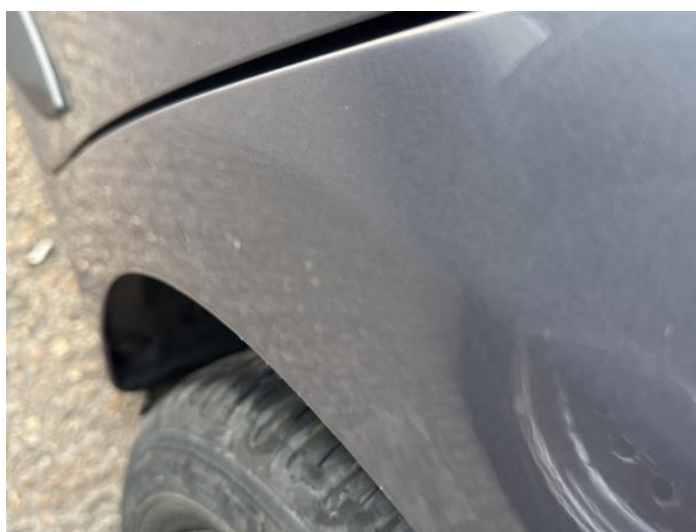
20: Qtr Panel nsr  
Dented  
Over 2 UpTo 10mm

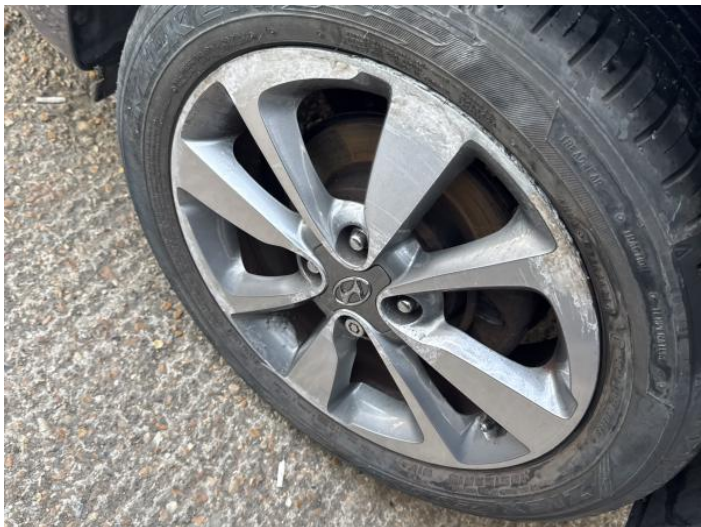
21: Wheel nsr  
Scratched  
Over 50mm
