VEHICLE INSPECTION REPORT

LY05XAB

Mercedes-Benz CLK CLK350 ELEGANCE

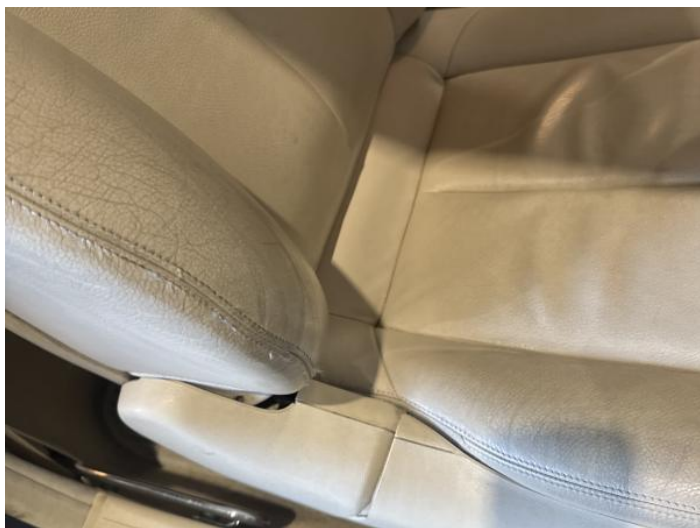
1: Seat Base Cover osf
Torn
UpTo 3mm

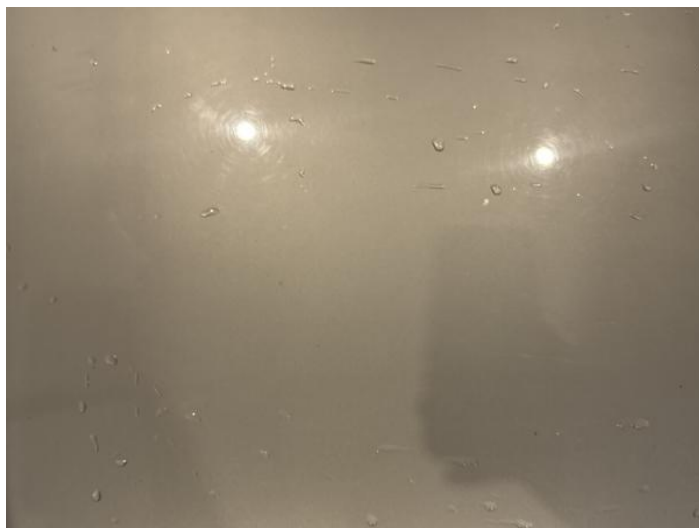
2: Bonnet
Chipped
1 To 5

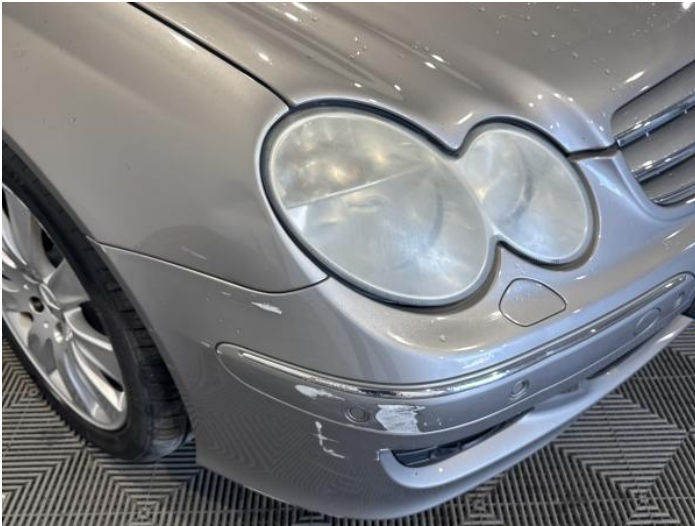
3: Bumper Front
Scratched
Over 100mm Thru Paint

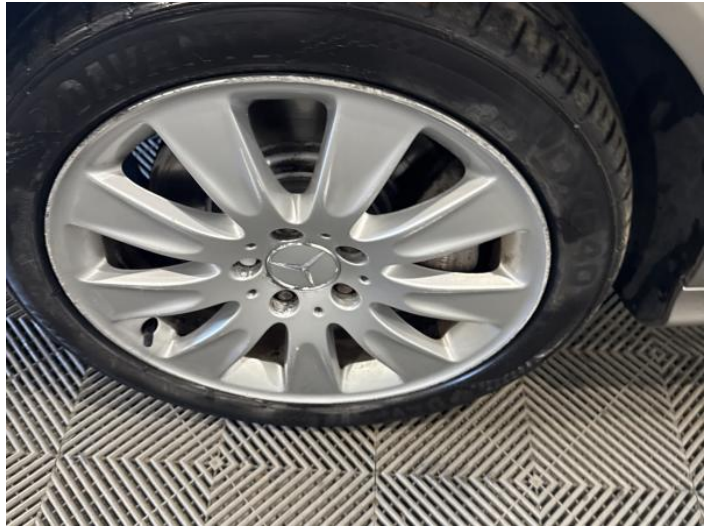
4: Wheel nsf
Scratched
Over 50mm

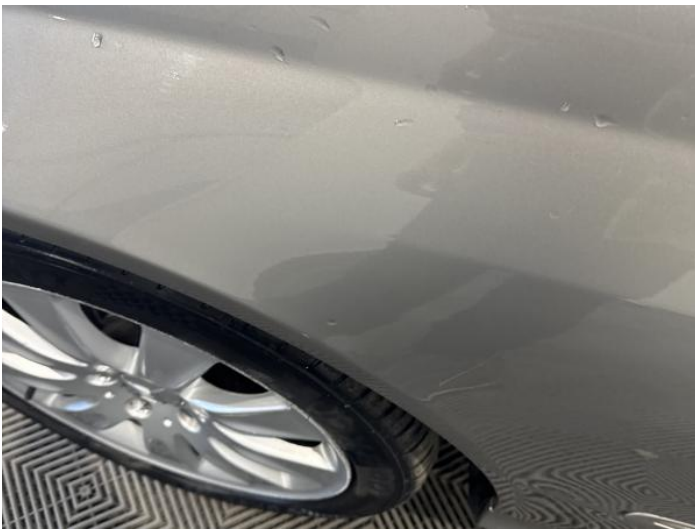
5: Wing nsf
Dented
Over 2 UpTo 10mm

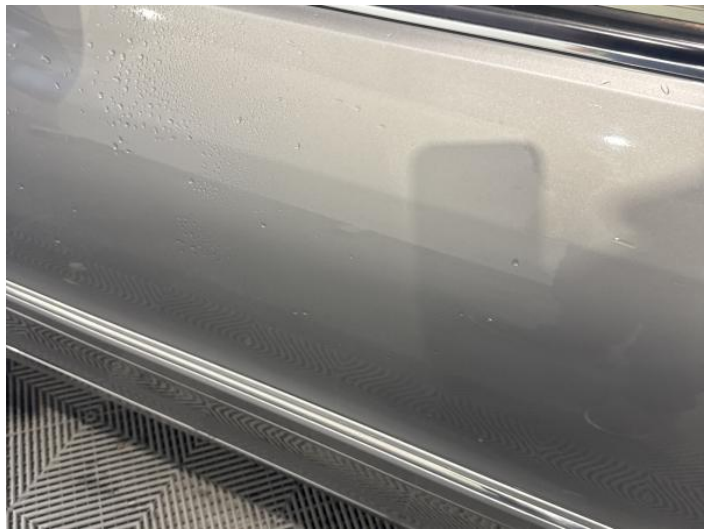
6: Door nsf
Chipped
1 To 5

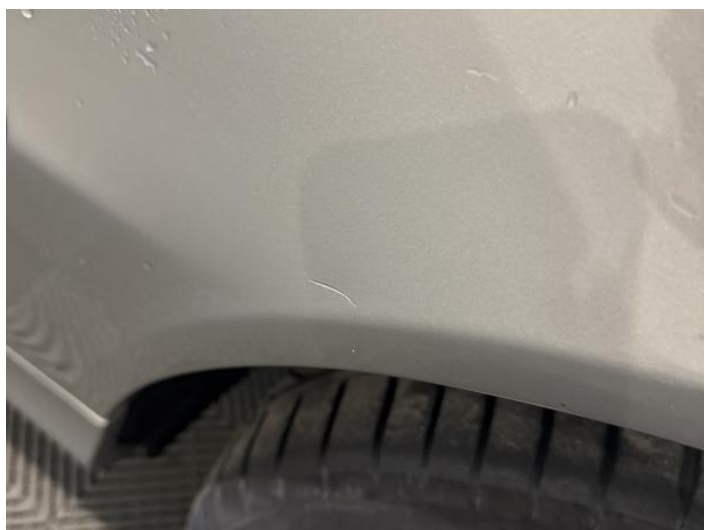
8: Qtr Panel nsr
Scratched
UpTo 25mm Thru Paint

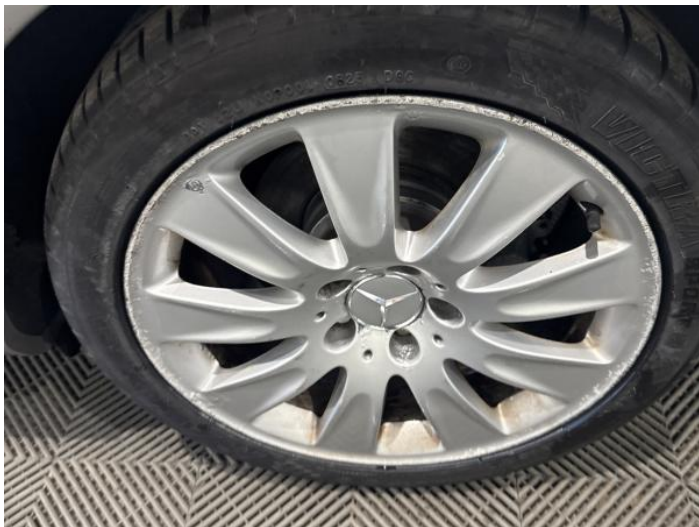
9: Wheel nsr
Scratched
Over 50mm

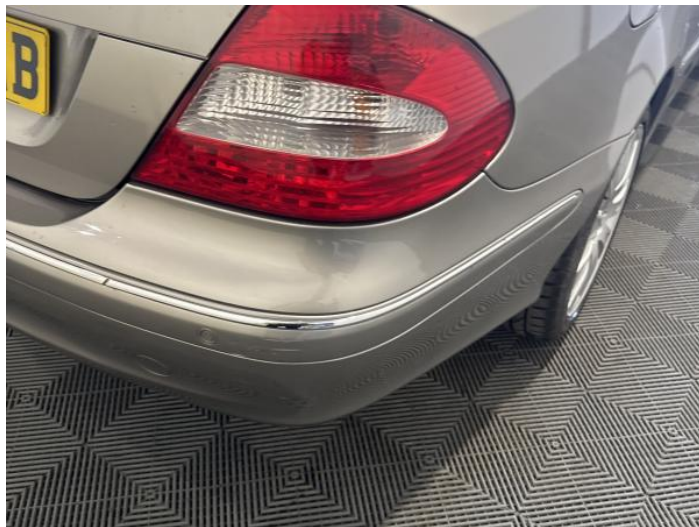
10: Bumper Rear
Scratched
Over 100mm Thru Paint

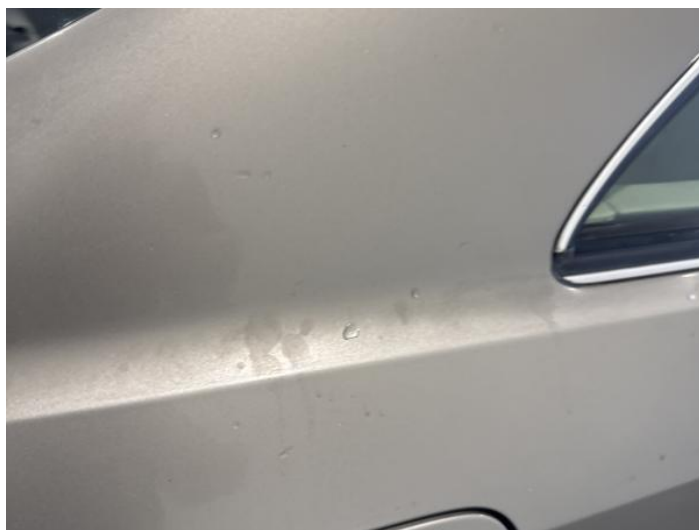
12: Qtr Panel osr
Poor Previous Repair
Poor Paint

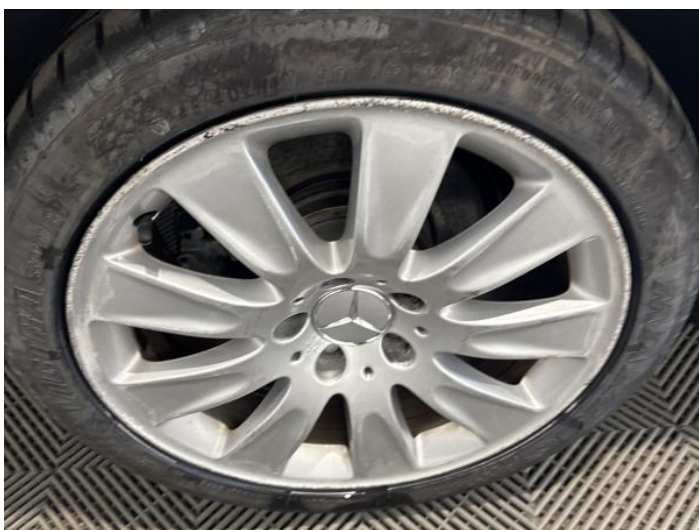
13: Wheel osr
Scratched
Over 50mm

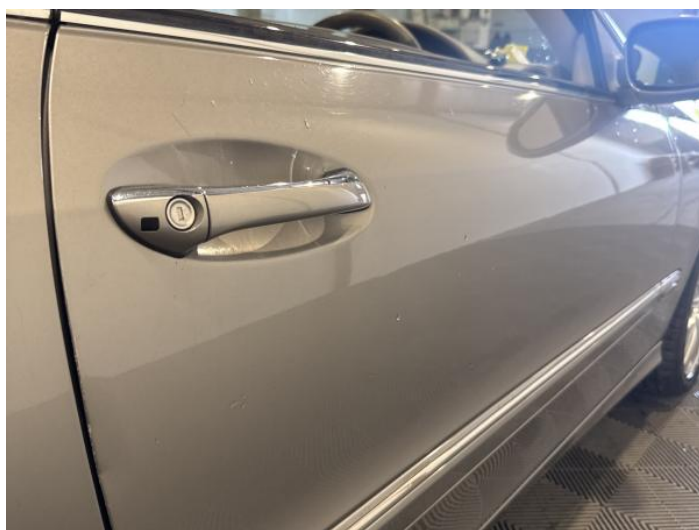
14: Door osf
Dented
Over 30mm

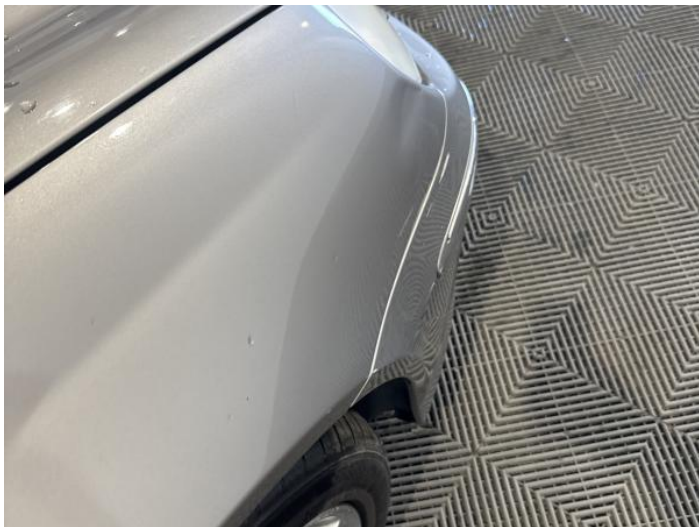
15: Wing of
Dented
With Paint Damage

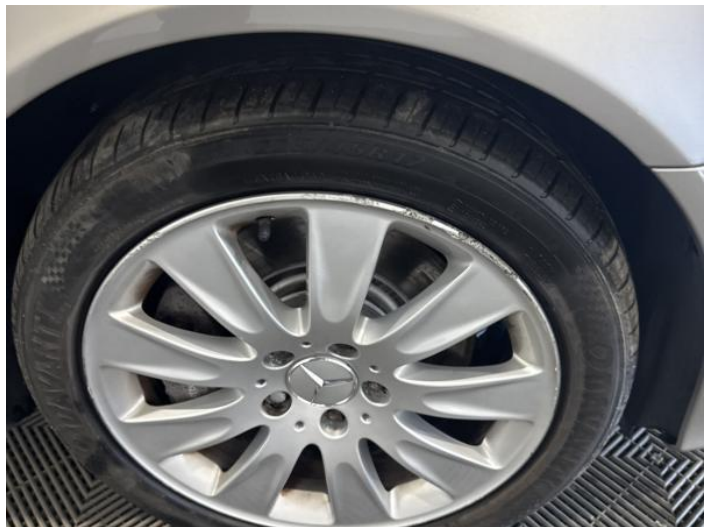
16: Wheel of
Scratched
Over 50mm
