VEHICLE INSPECTION REPORT

BD09OSE

Ford C-Max 1.6 Zetec 5dr

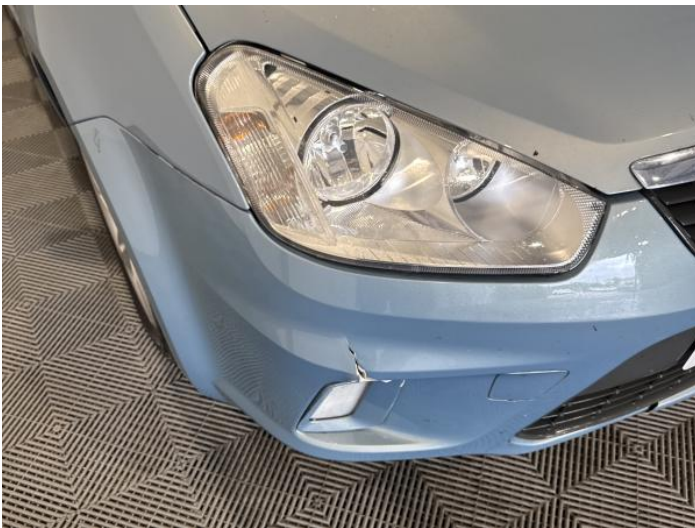
1: Bumper Front
Cracked
Over 25mm

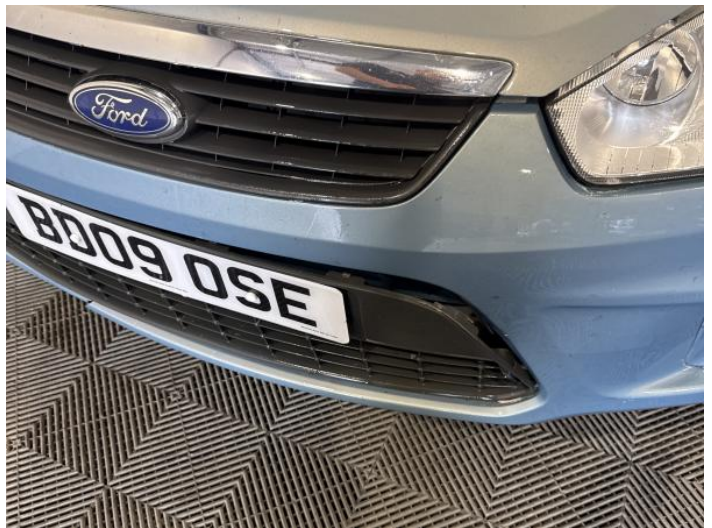
2: Bumper Front Grill
Broken
Replace

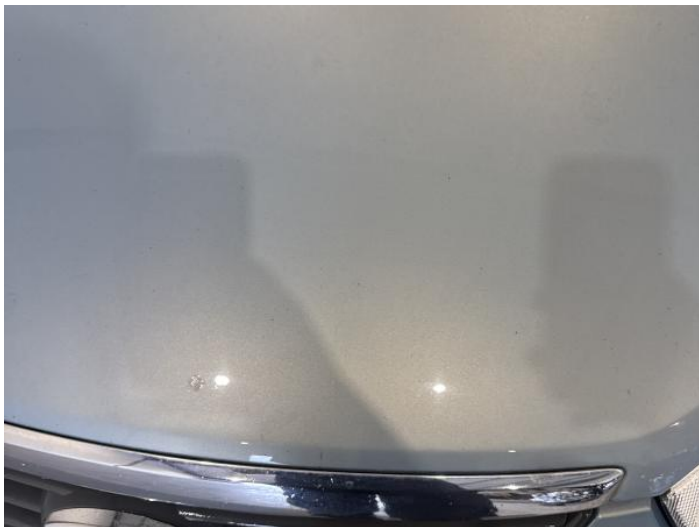
3: Bonnet
Chipped
1 To 5

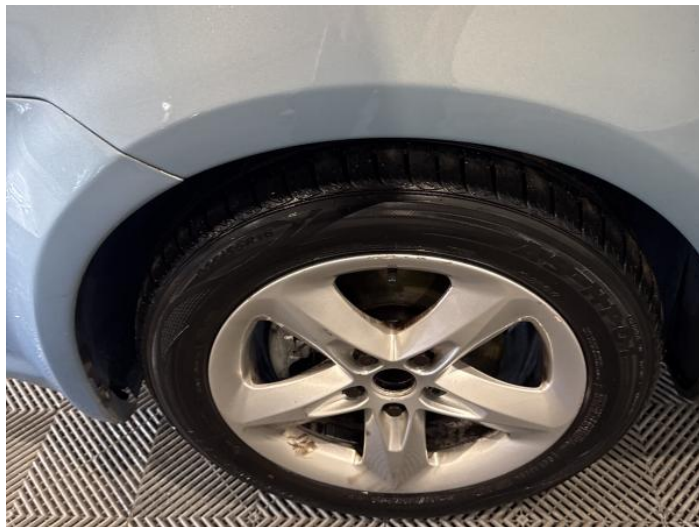
4: Wheel nsf
Scratched
Over 50mm

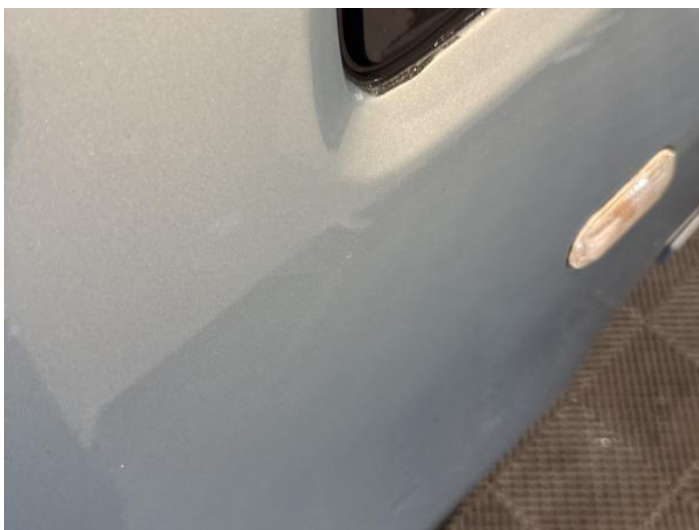
5: Wing nsf
Chipped
1 To 5

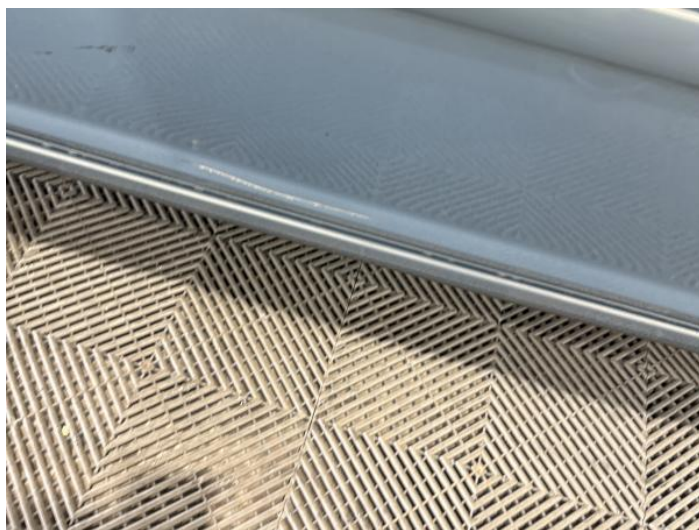
6: Door nsf
Dented
With Paint Damage

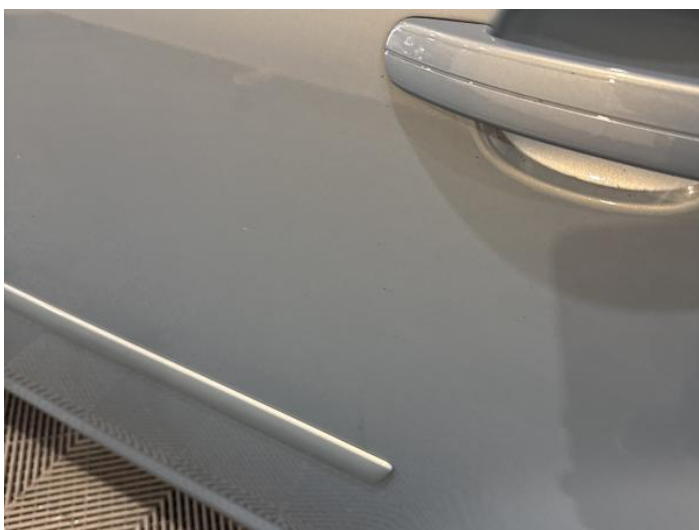
7: Door nsr
Dented
2 Or Less UpTo 10mm

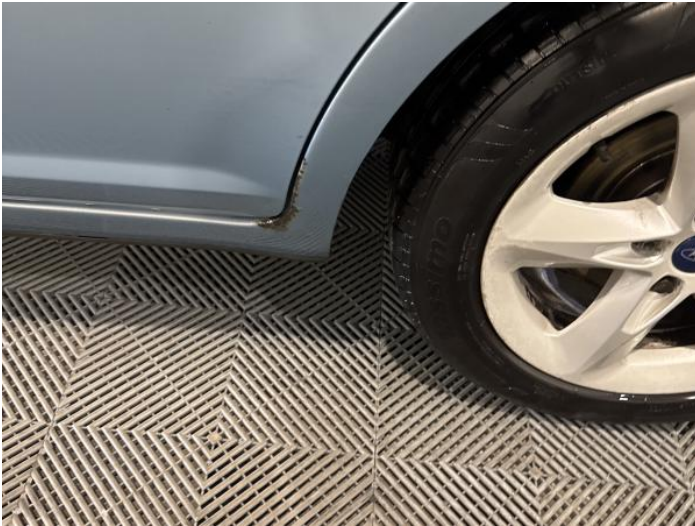
9: Qtr Panel nsr
Rusted
Over 5mm

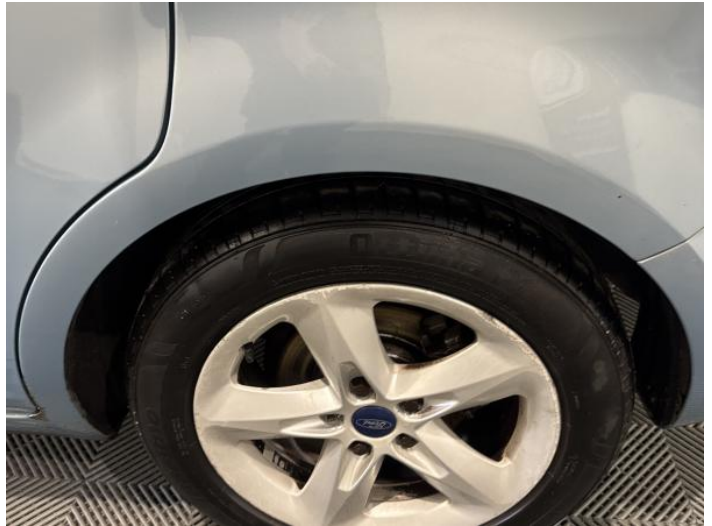
10: Wheel nsr
Scratched
Over 50mm

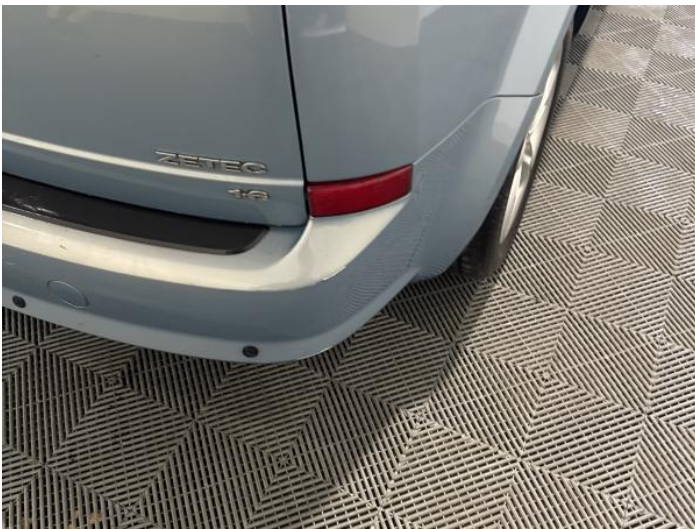
11: Bumper Rear
Scratched
Over 100mm Thru Paint

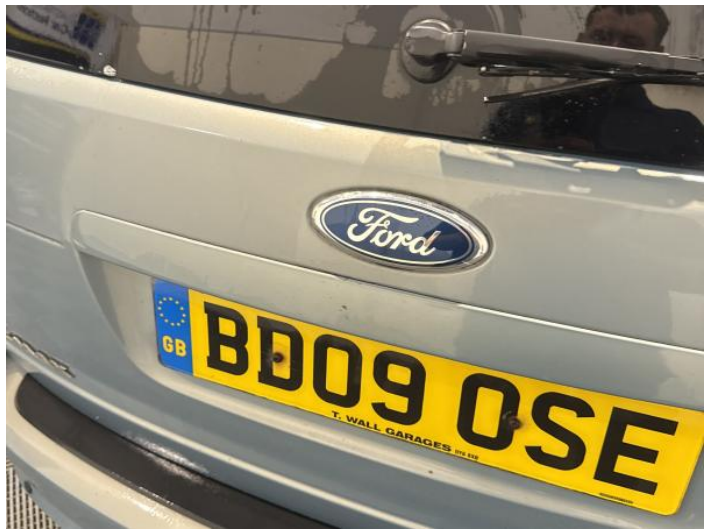
12: Boot Lid
Dented
Over 2 UpTo 10mm

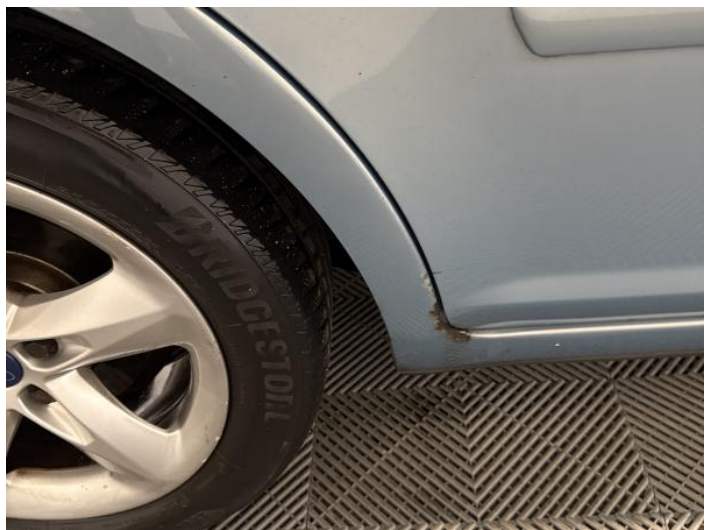
14: Qtr Panel osr
Rusted
Over 5mm

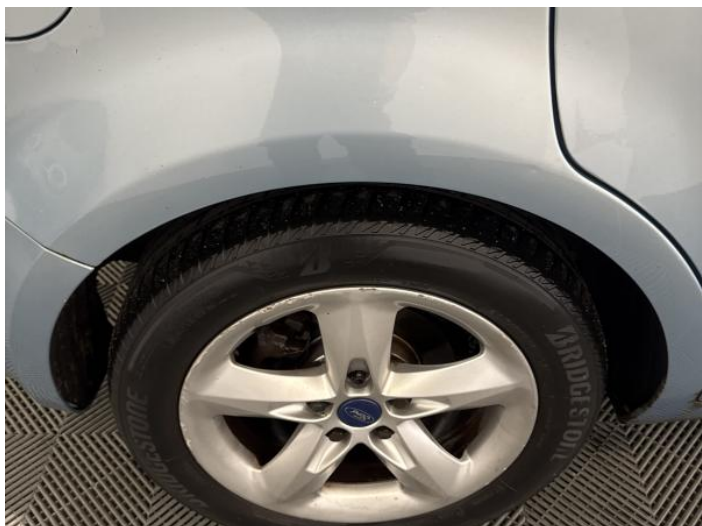
15: Wheel osr
Scratched
Over 50mm

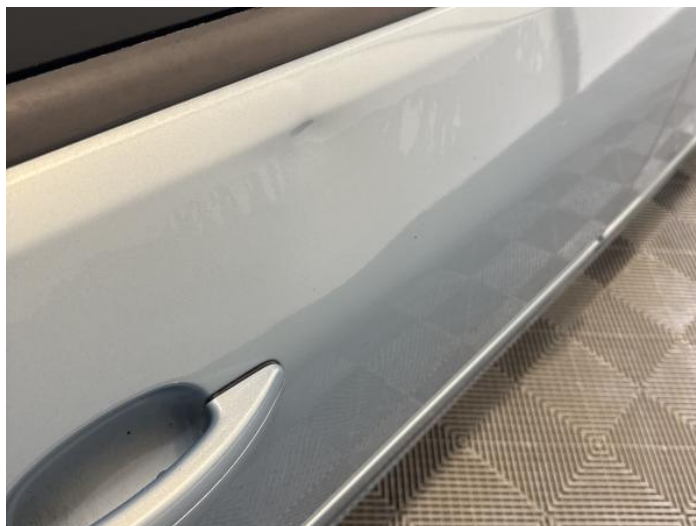
16: Door osr
Dented
Between 10mm + 30mm

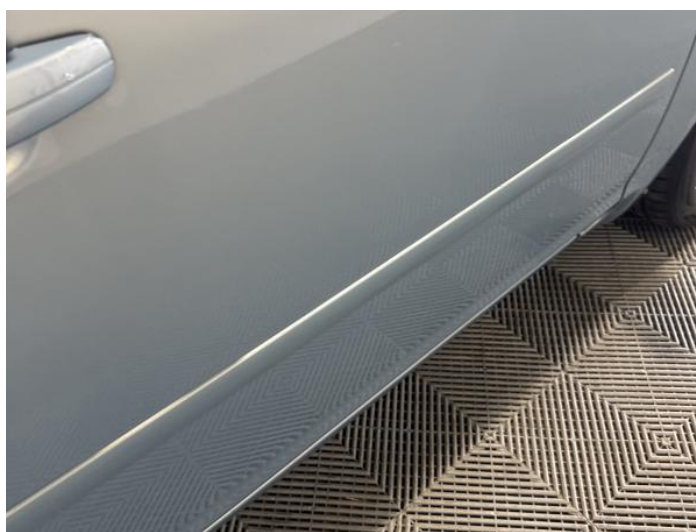
18: Door osf
Chipped
1 To 5
