## VEHICLE INSPECTION REPORT

**LX06YML**

### Vauxhall Corsa 1.2i 16V Design [80] 5dr

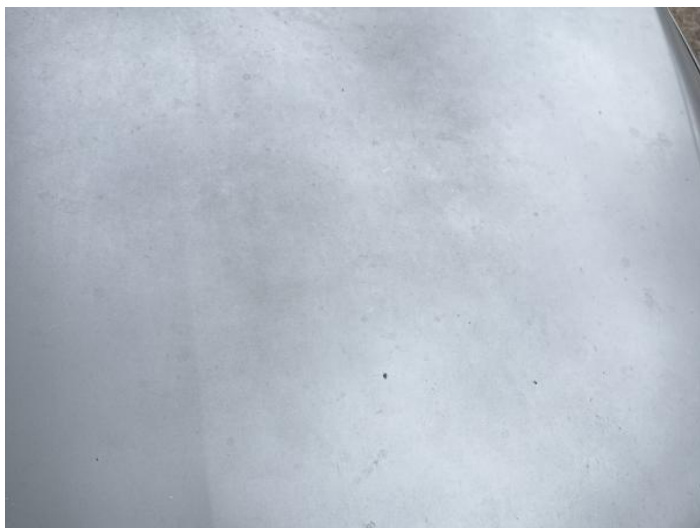
1: Bonnet  
Poor Previous Repair  
Poor Paint

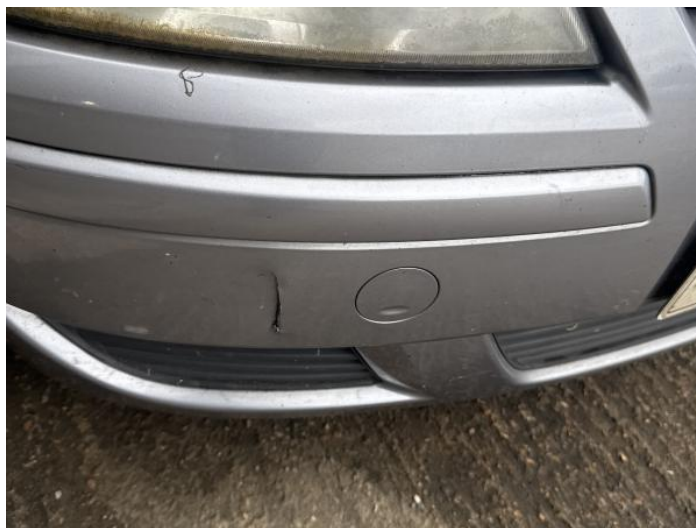
2: Bumper Front  
Cracked  
Over 25mm

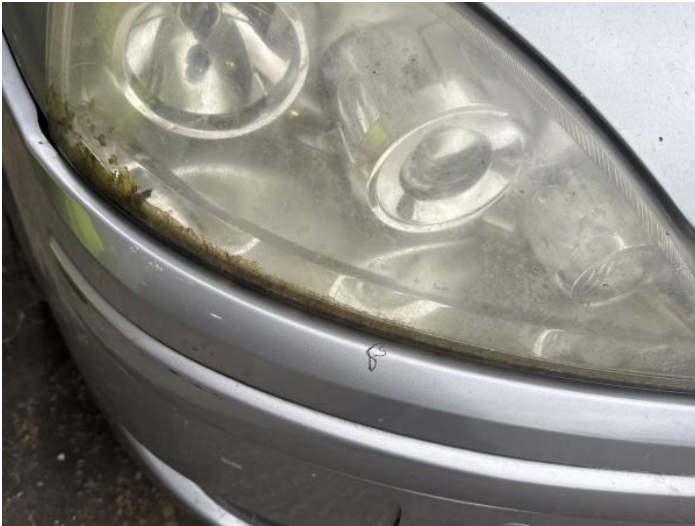
3: Headlamp os  
Broken  
Replace

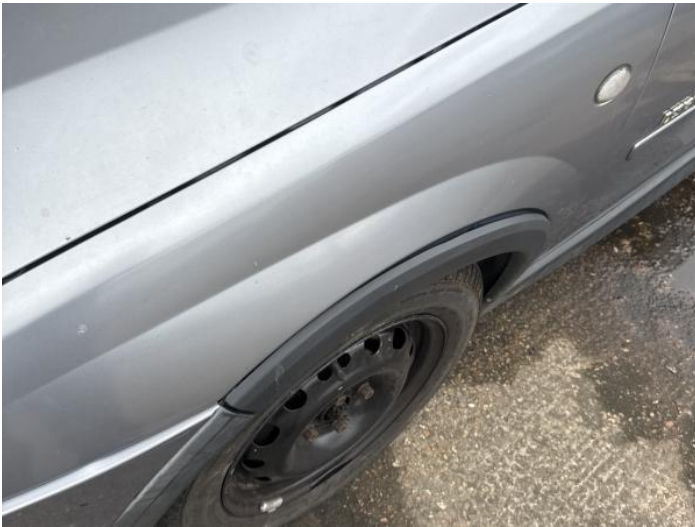
5: Wing nsf  
Poor Previous Repair  
Poor Paint

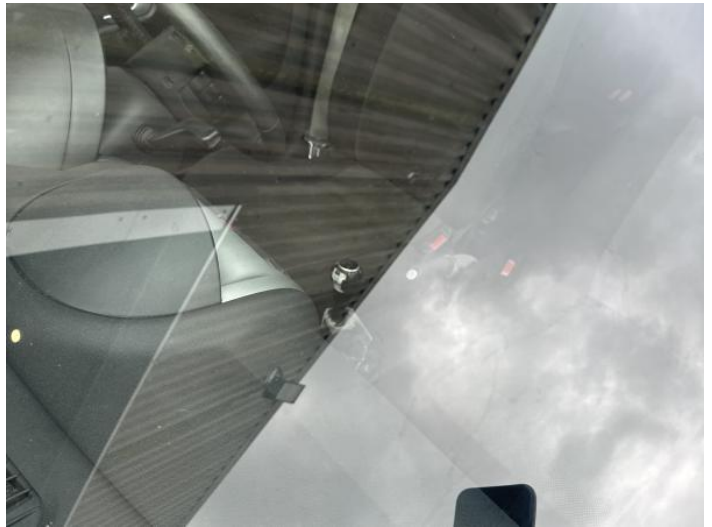
6: Screen Front  
Chipped  
UpTo 10mm

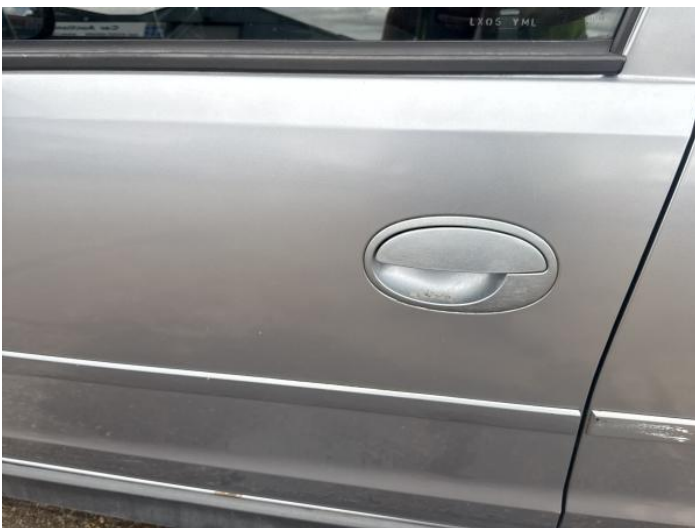
7: Door nsf  
Chipped  
1 To 5

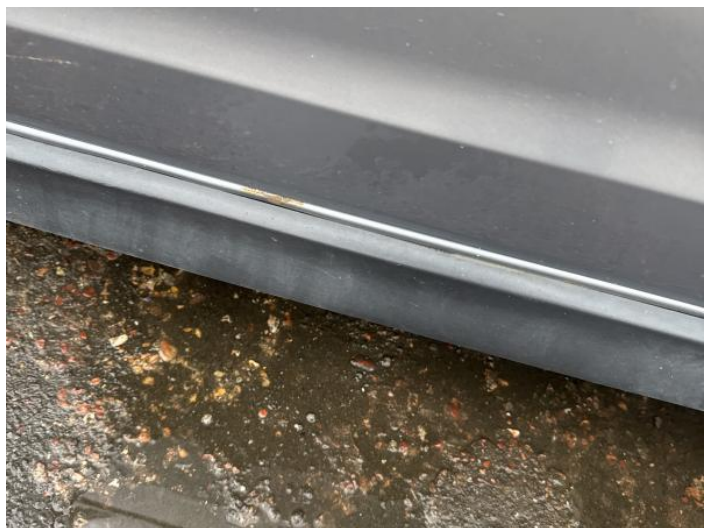
8: Sill ns  
Rusted  
Over 5mm

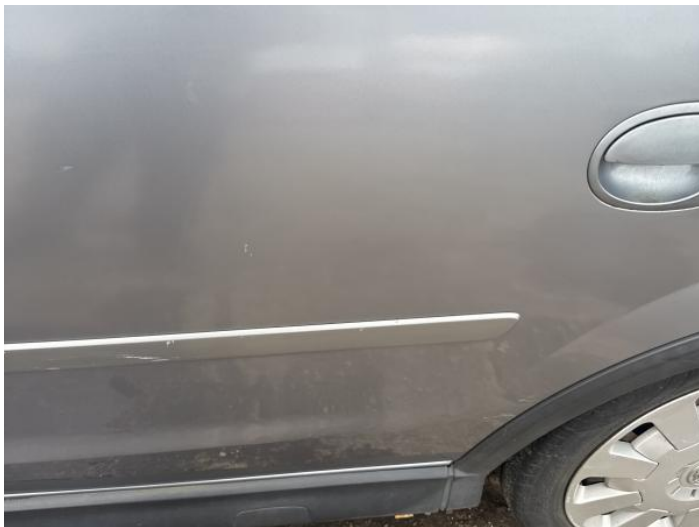
9: Door nsr  
Chipped  
Multiple Chips

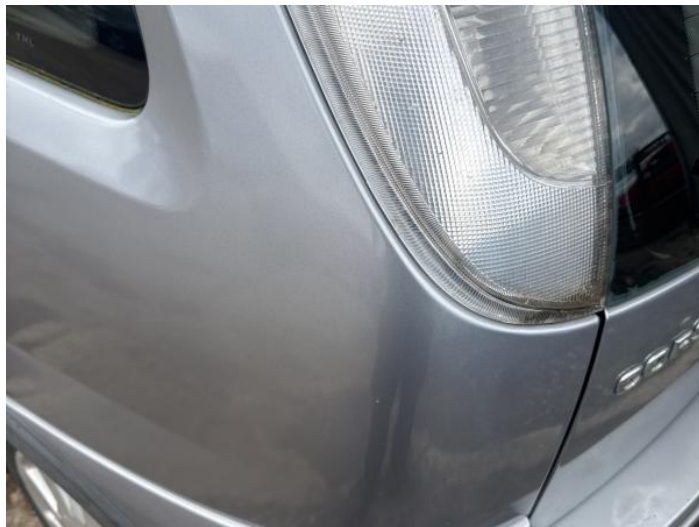
10: Qtr Panel nsr  
Chipped  
1 To 5

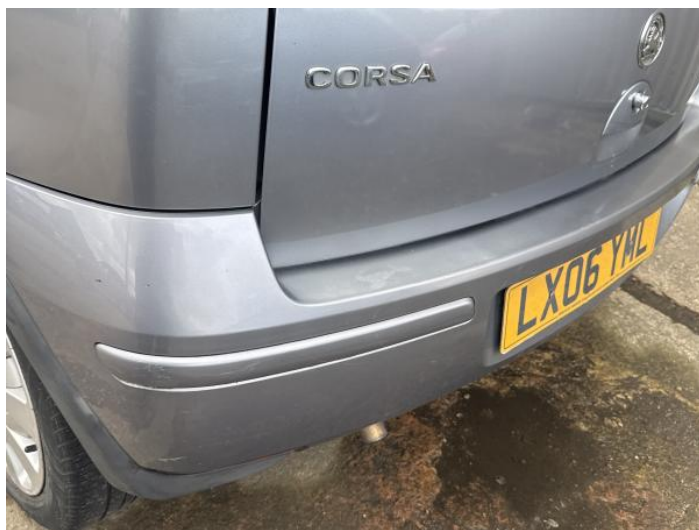
12: Bumper Rear  
Poor Previous Repair  
Paint Flake

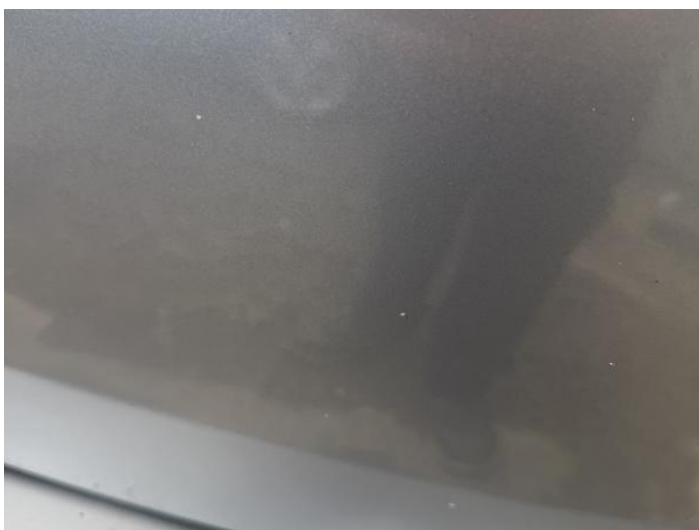
13: Boot Lid  
Chipped  
1 To 5

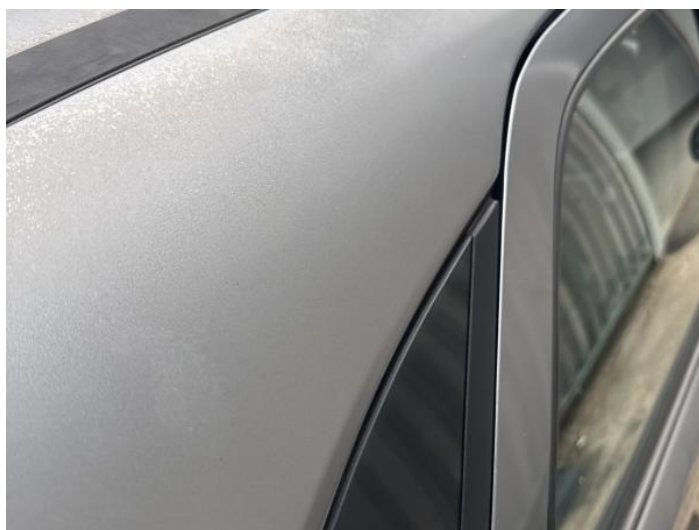
14: D Post os  
Poor Previous Repair  
Poor Paint

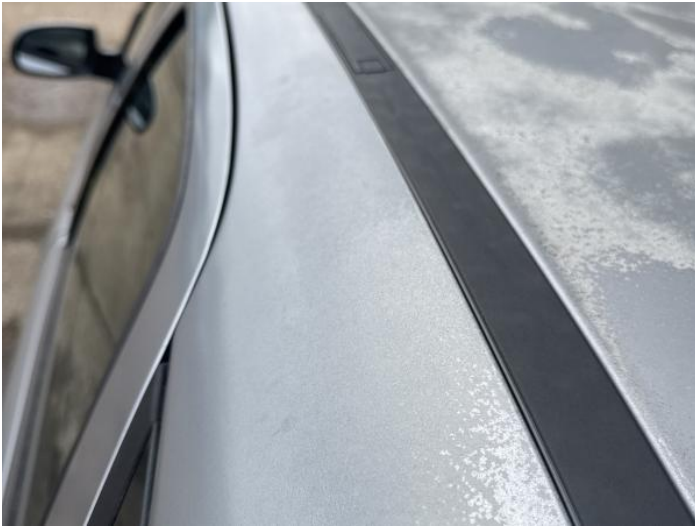
15: D Post ns  
Poor Previous Repair  
Poor Paint

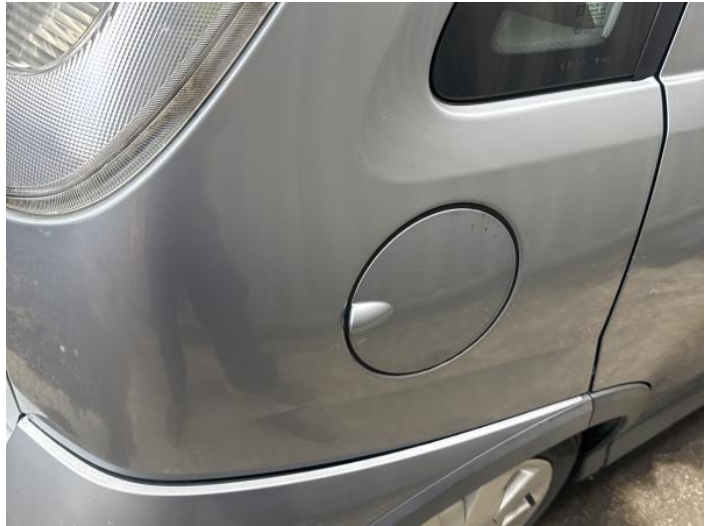
16: Qtr Panel osr  
Chipped  
1 To 5

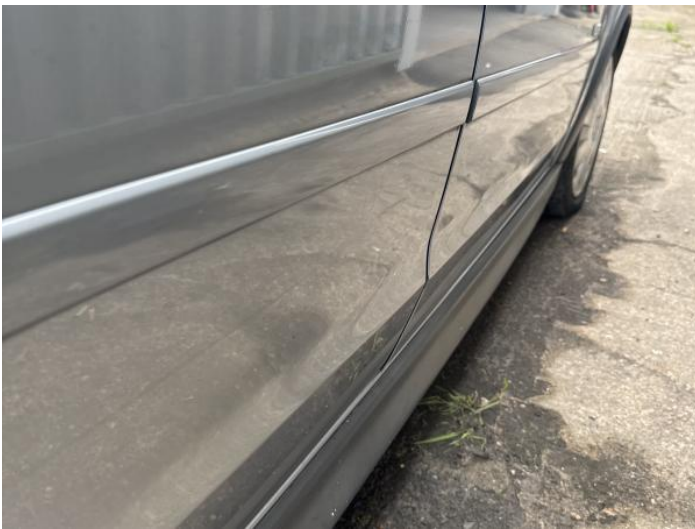
17: Door osr  
Dented  
Over 30mm

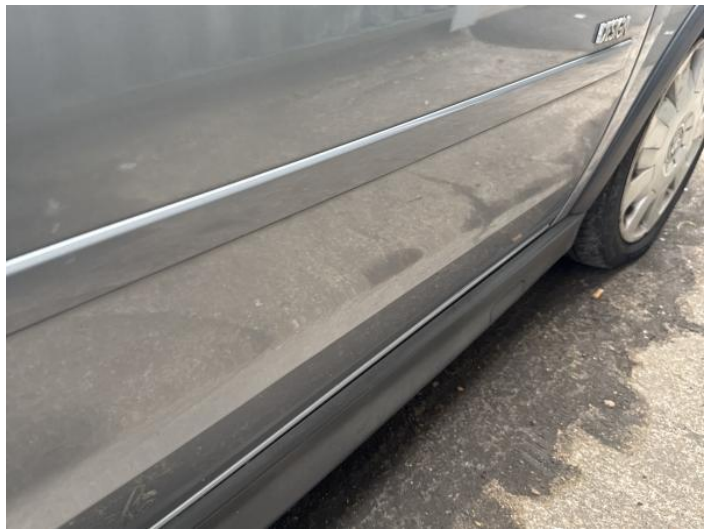
18: Door osf  
Chipped  
1 To 5

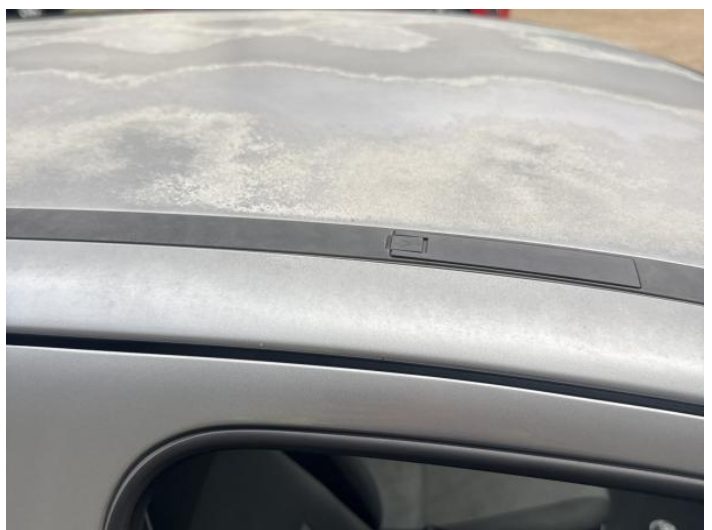
20: A Post os  
Poor Previous Repair  
Poor Paint

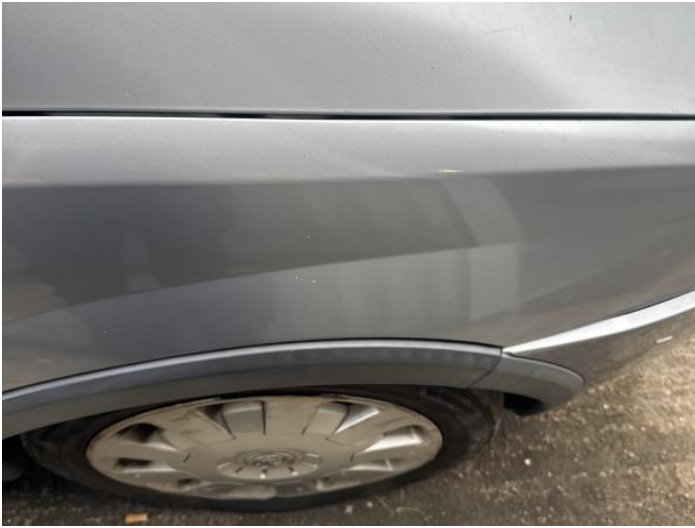
21: Wing osf  
Chipped  
1 To 5

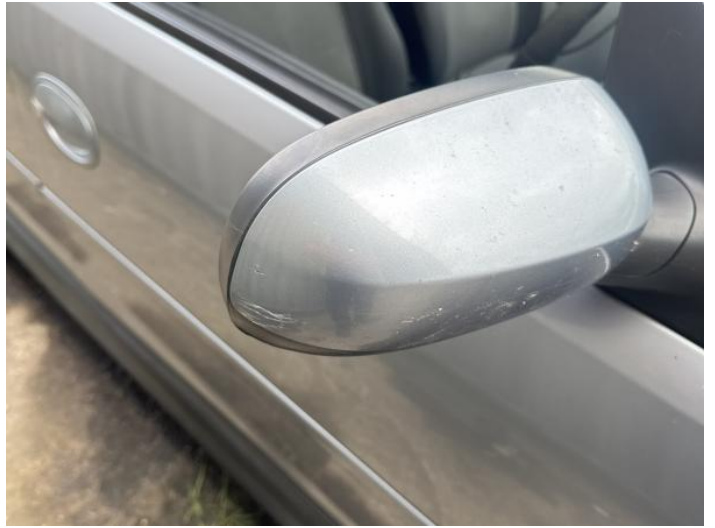
22: Door Mirror Assy osf  
Scratched (Painted)  
Over 25mm Thru Paint

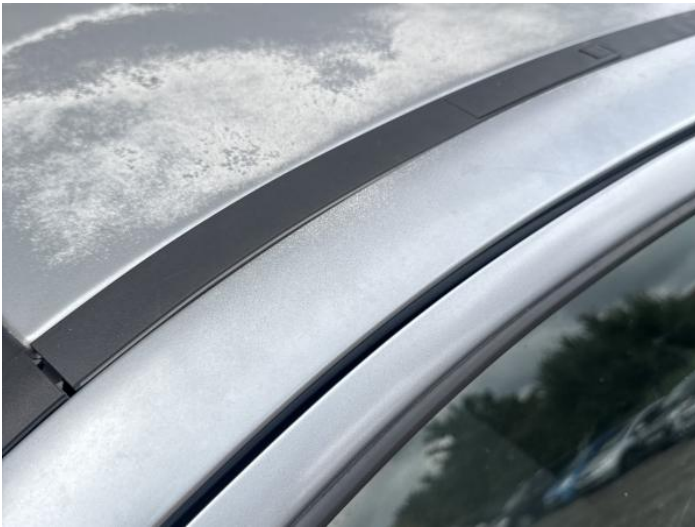
23: A Post ns  
Poor Previous Repair  
Poor Paint

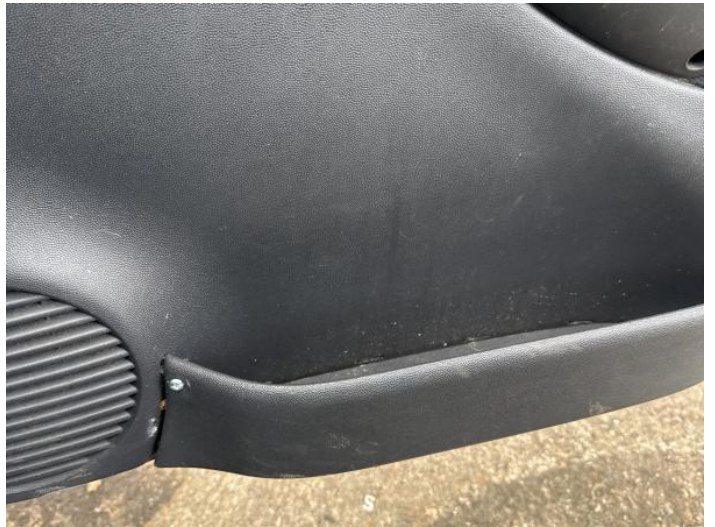
24: Door Pad osf  
Broken  
Replace

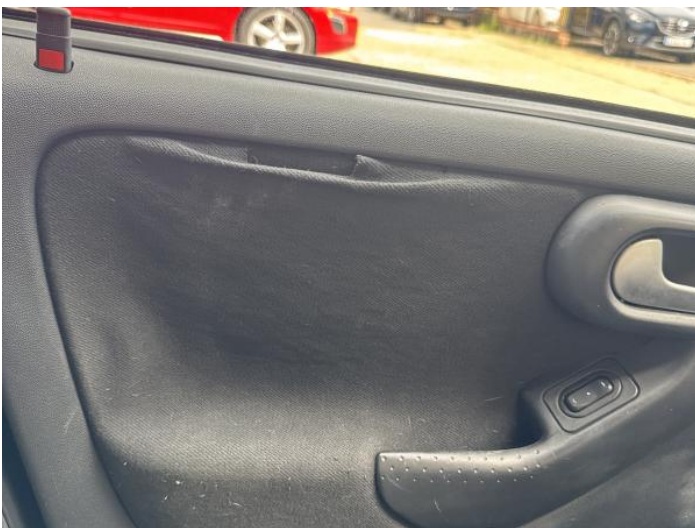
25: Door Pad nsf  
Torn  
Over 10mm

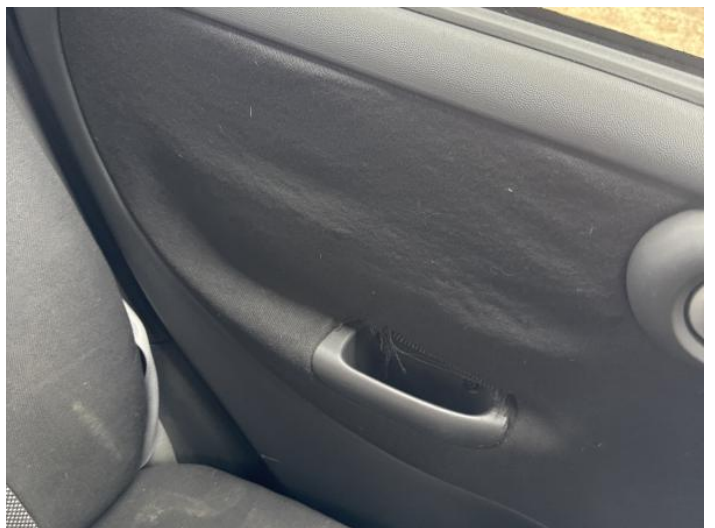
26: Door Pad nsr  
Torn  
Over 10mm

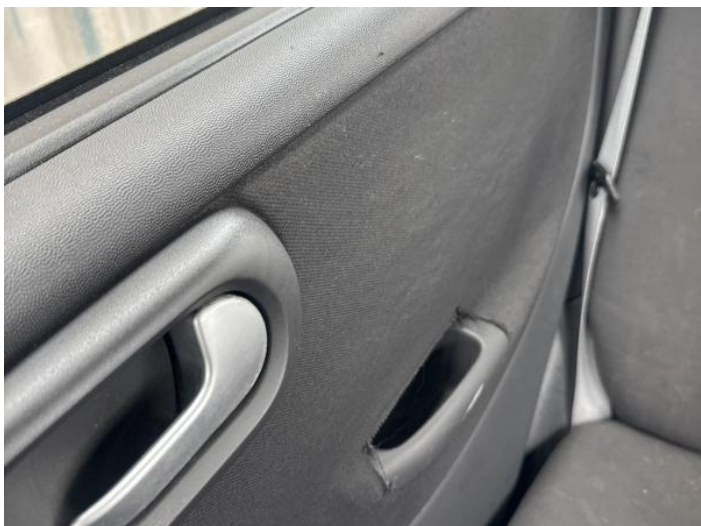
27: Door Pad osr  
Torn  
Over 10mm
