# VEHICLE INSPECTION REPORT

**DL60ORO**

## Vauxhall Meriva 1.4T 16V [140] Exclusiv 5dr

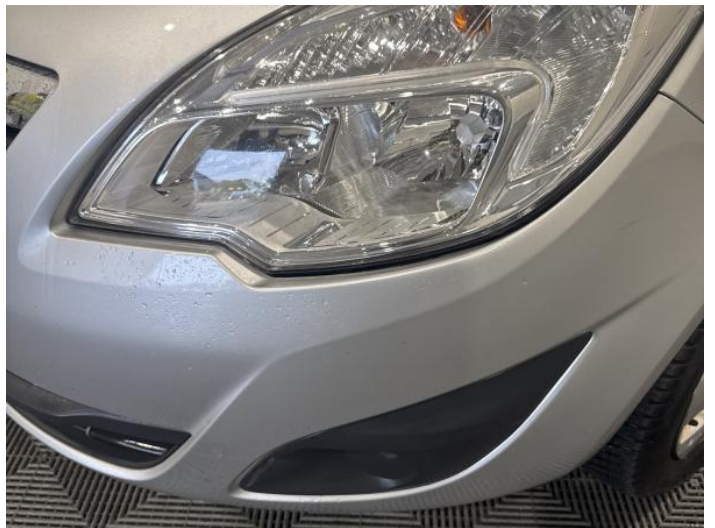
2: Bumper Front  
Poor Previous Repair  
Poor Paint

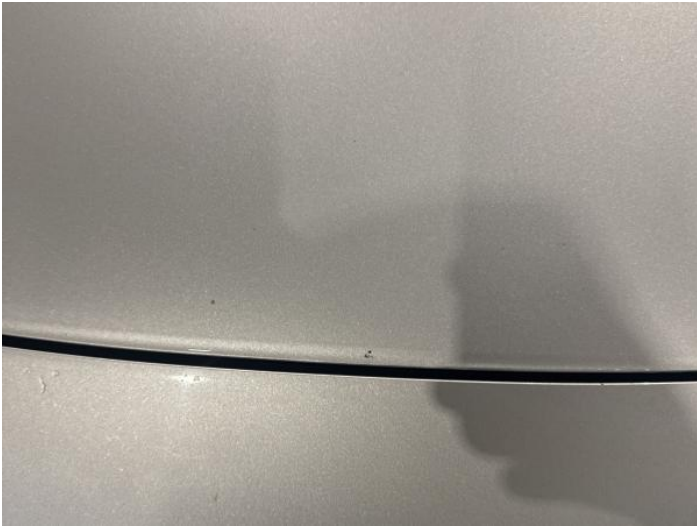
3: Bonnet  
Chipped  
1 To 5

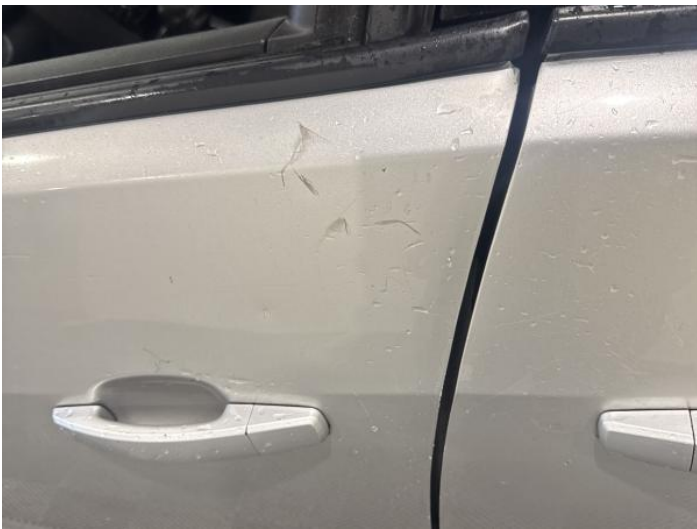
5: Door nsf  
Dented  
With Paint Damage

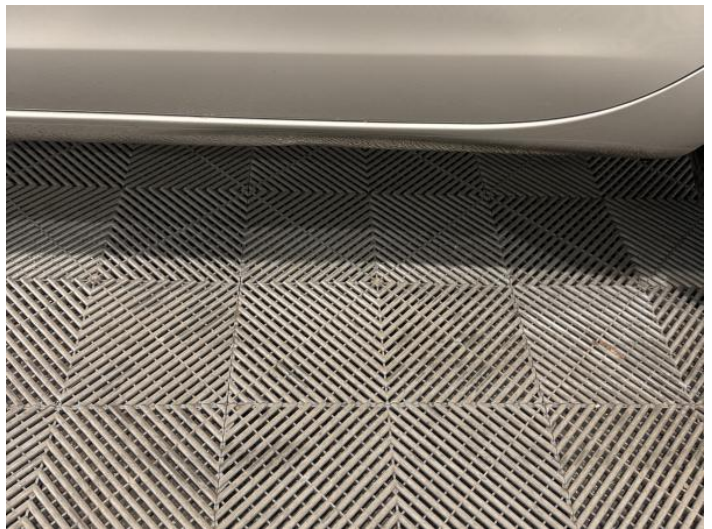
6: Sill ns  
Dented  
Over 30mm

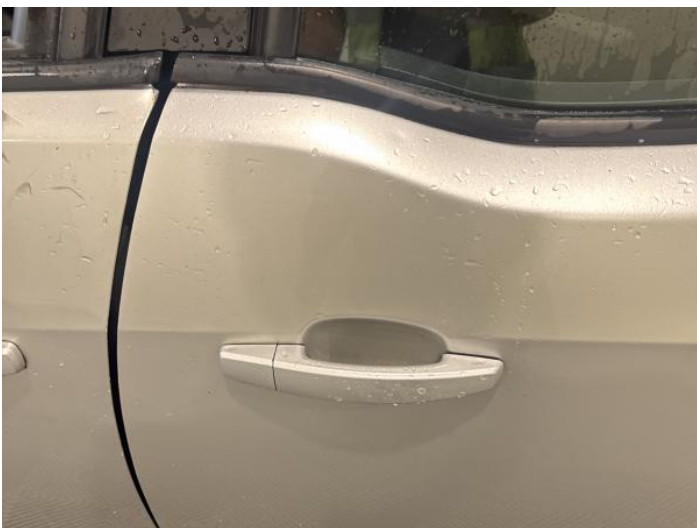
7: Sill ns  
Dented  
2 Or Less UpTo 10mm

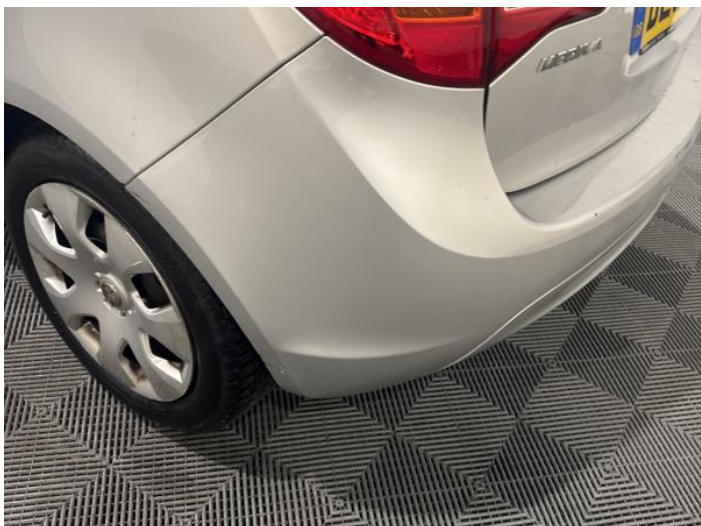
9: Bumper Rear  
Scratched  
Over 100mm Thru Paint

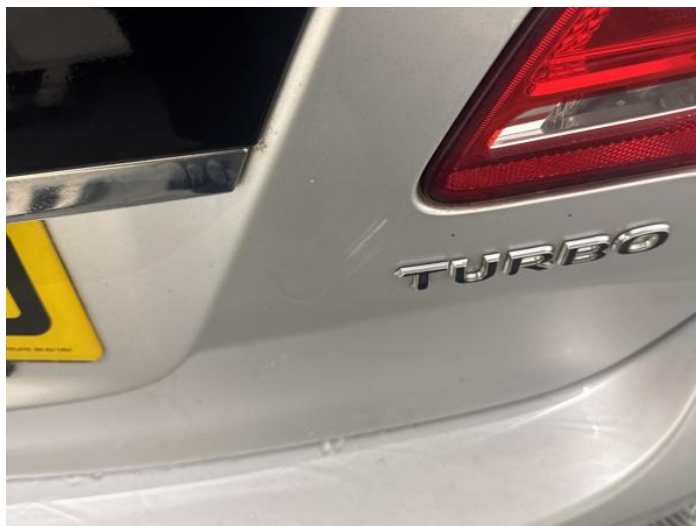
10: Boot Lid  
Dented  
Over 2 UpTo 10mm

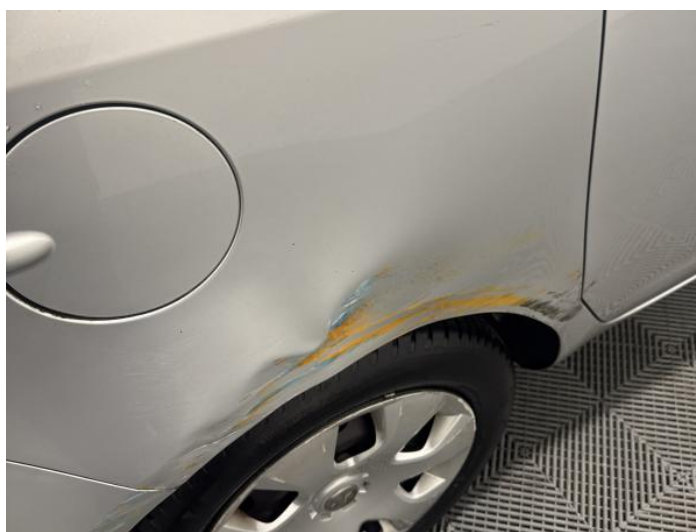
12: Qtr Panel osr  
Dented  
With Paint Damage

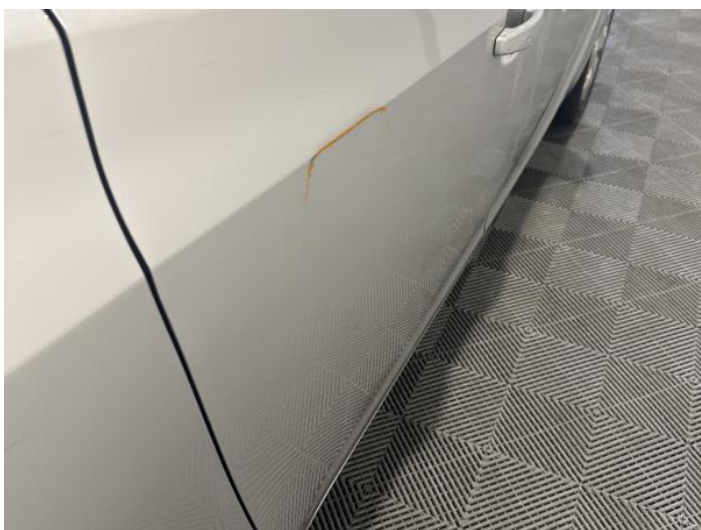
13: Door osr  
Dented  
With Paint Damage

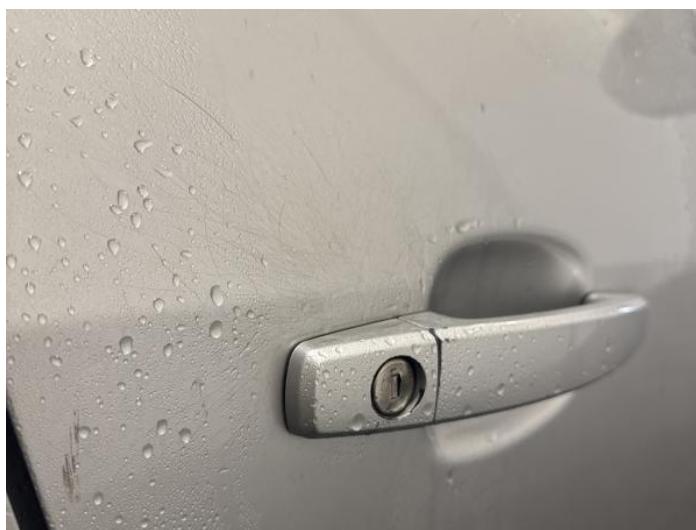
14: Door osf  
Poor Previous Repair  
Poor Paint

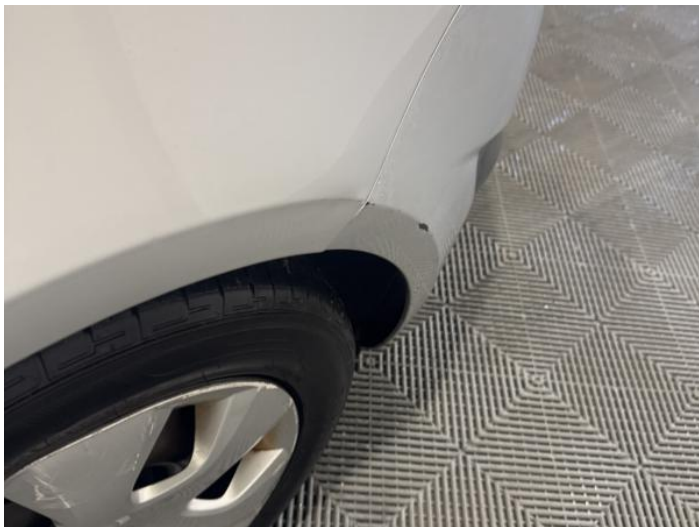
15: Wing osf  
Dented  
With Paint Damage
