VEHICLE INSPECTION REPORT

VE60FVZ

Renault Scenic 1.6 VVT Dynamique TomTom 5dr

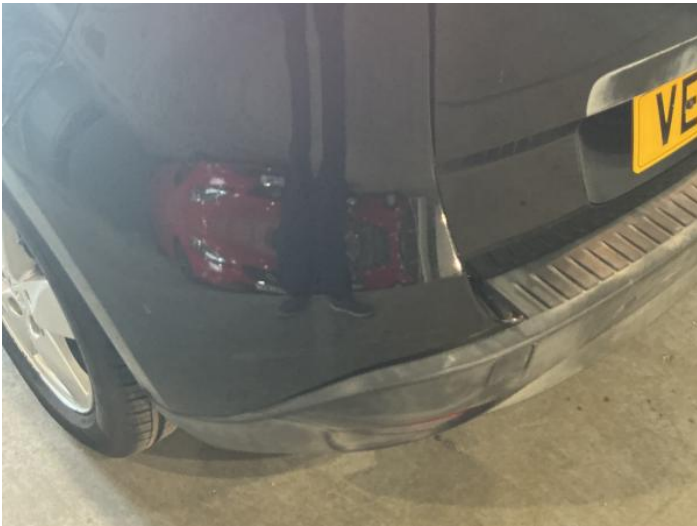
1: Bumper Rear
Poor Previous Repair
Poor Paint

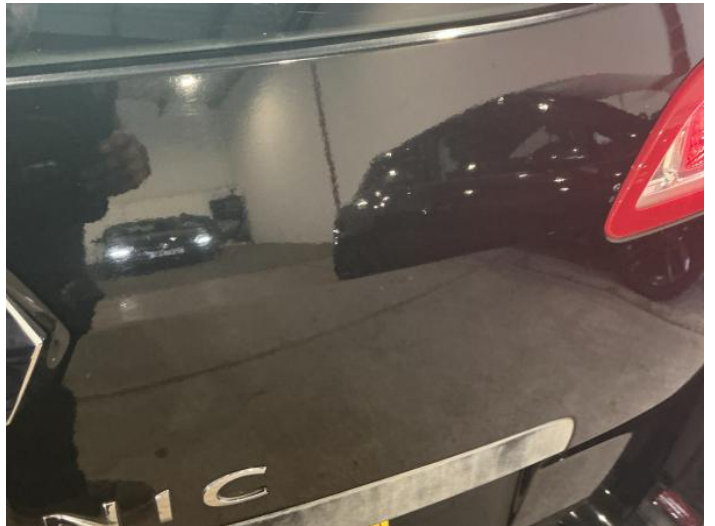
2: Boot Lid
Poor Previous Repair
Poor Paint

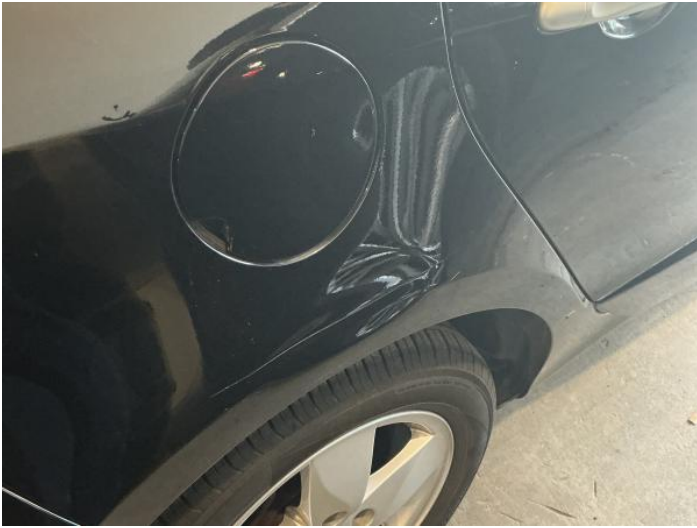
3: Qtr Panel osr
Dented
With Paint Damage

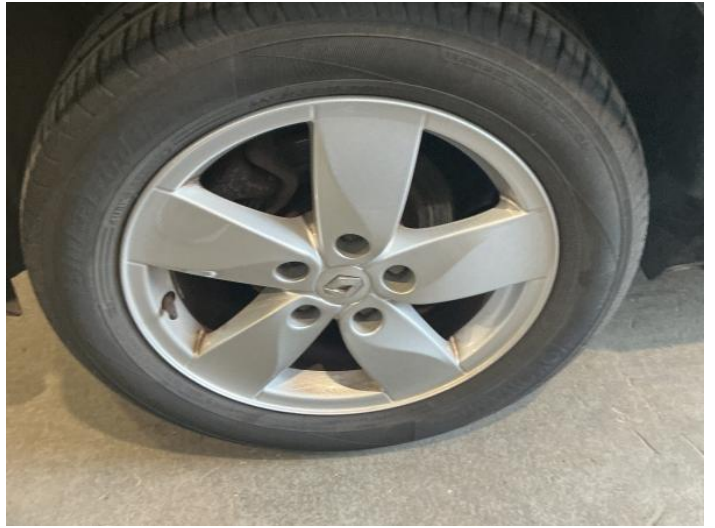
4: Wheel osr
Scratched
Up To 50mm

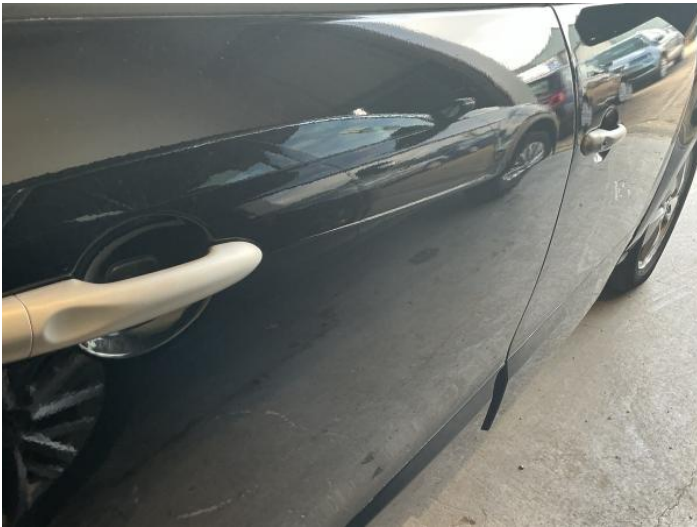
5: Door osr
Dented
Over 30mm

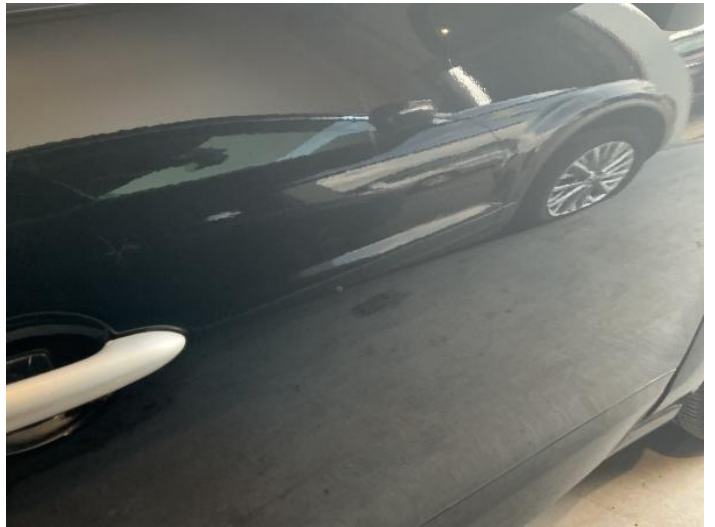
6: Door osf
Poor Previous Repair
Poor Paint

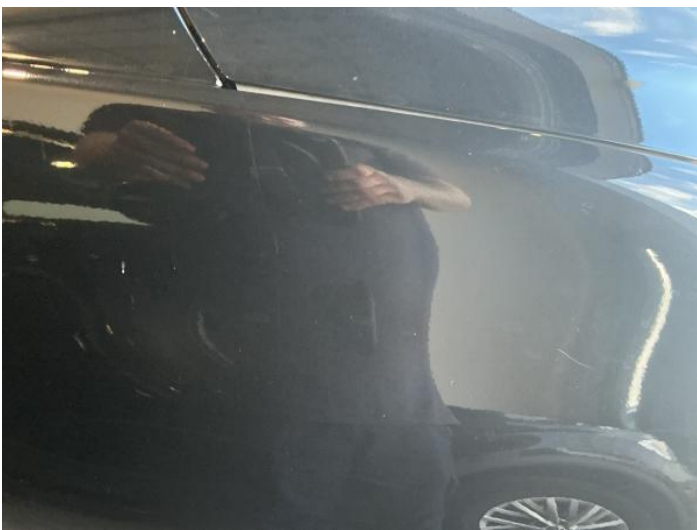
7: Wing osf
Chipped
1 To 5

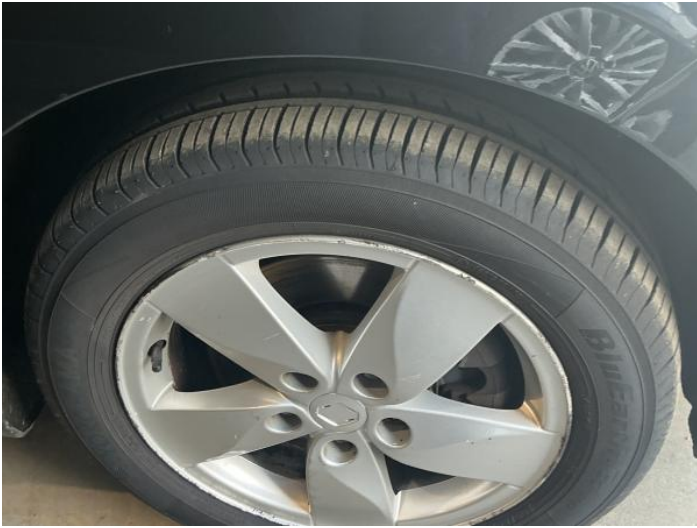
9: Wheel osf
Scratched
Over 50mm

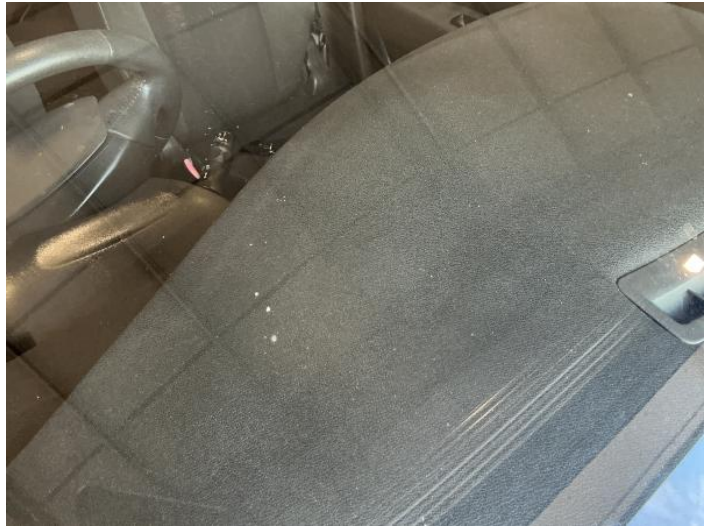
10: Screen Front
Chipped
UpTo 10mm

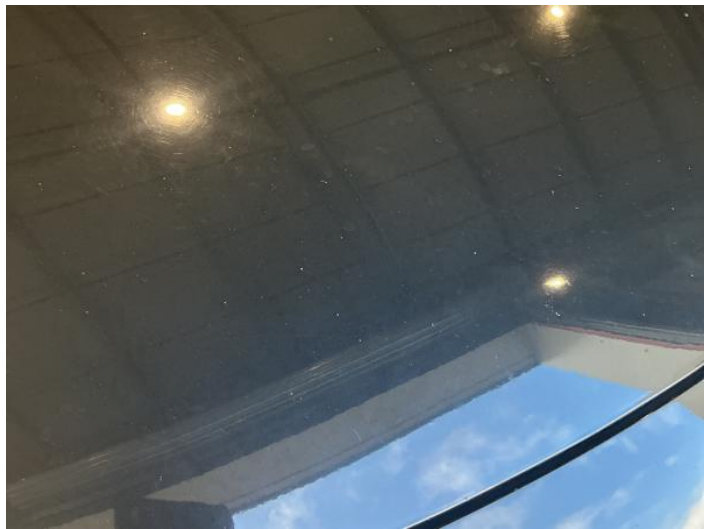
12: Bonnet
Chipped
Multiple Chips

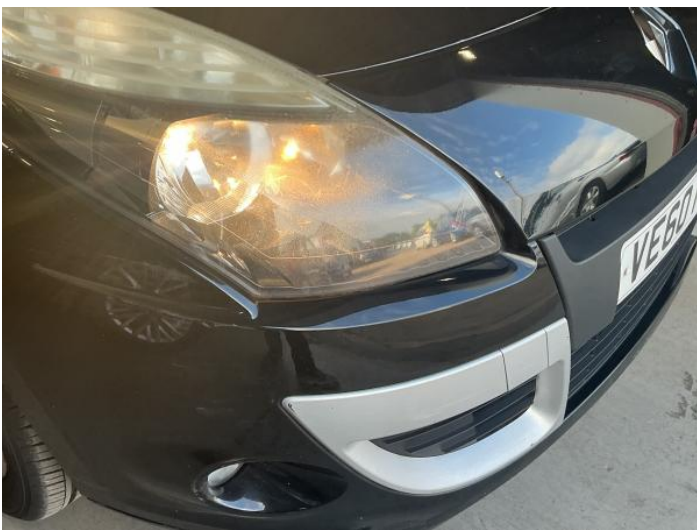
13: Bumper Front
Scratched
Over 100mm Thru Paint

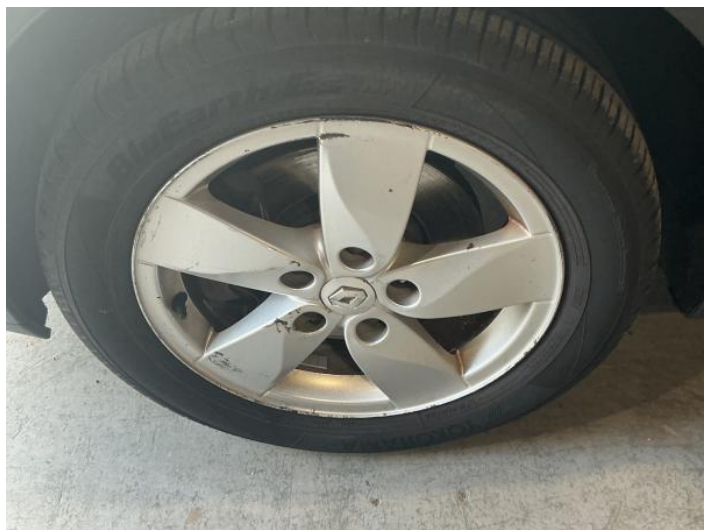
14: Wheel nsf
Scratched
Over 50mm

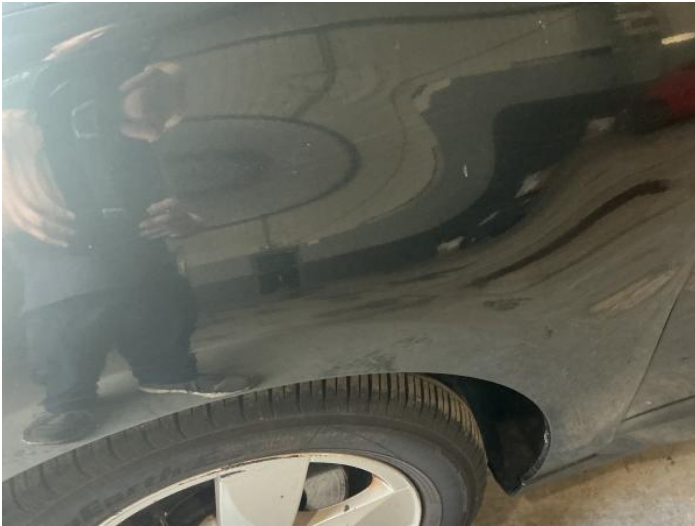
15: Wing nsf
Chipped
1 To 5

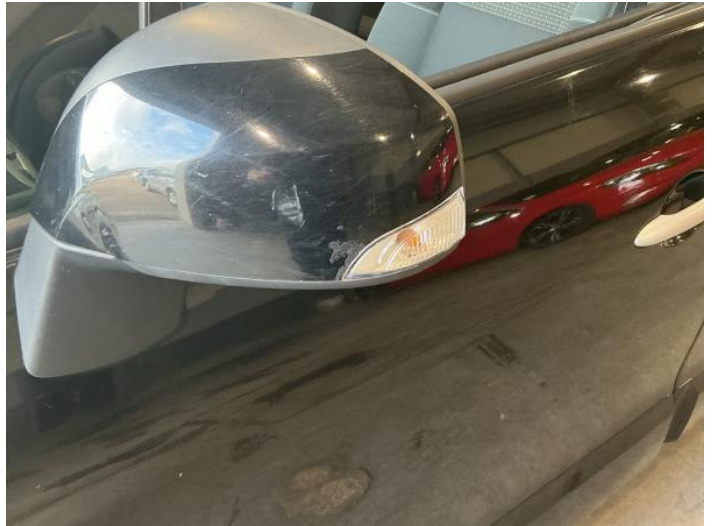
16: Door Mirror Assy nsf
Scratched (Painted)
Over 25mm Thru Paint

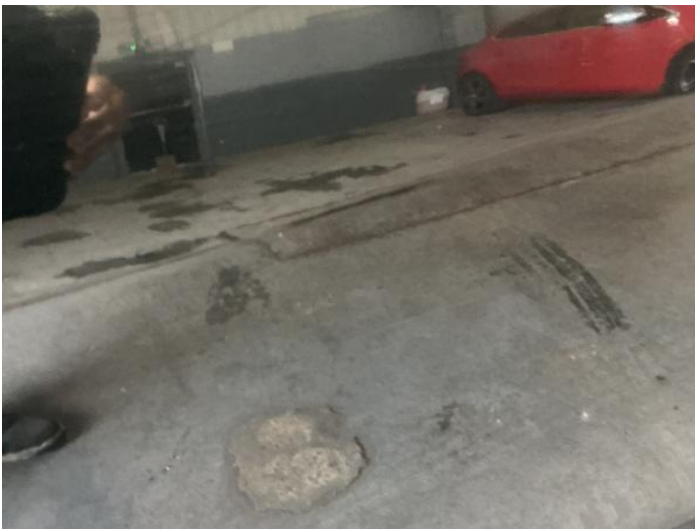
17: Door nsf
Scratched
Over 25mm Thru Paint

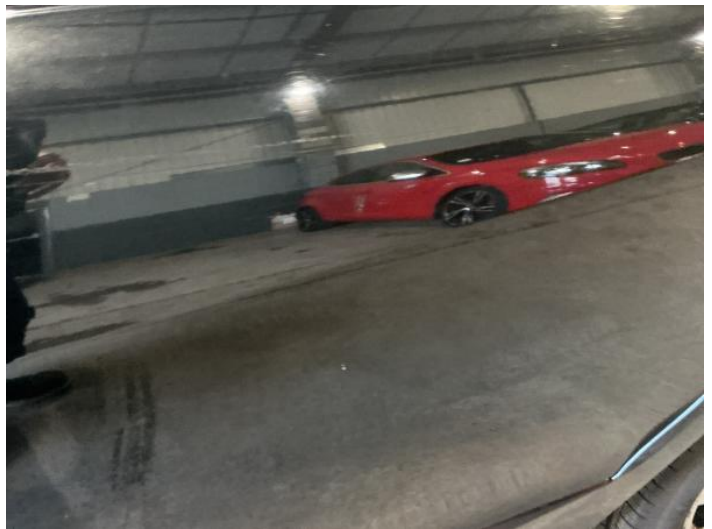
18: Door nsr
Chipped
1 To 5

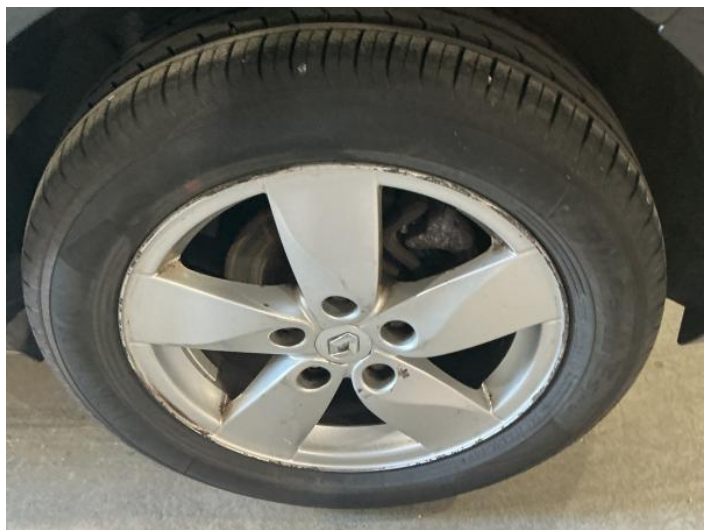
20: Wheel nsr
Scratched
Over 50mm

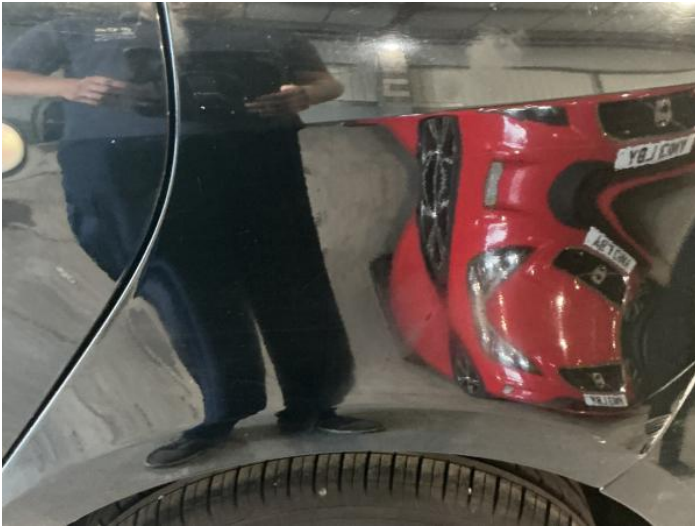
21: Qtr Panel nsr
Dented
With Paint Damage

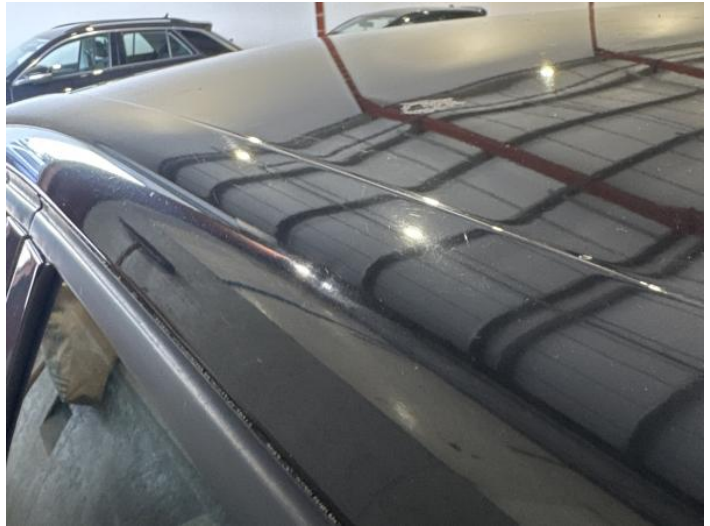
22: C Post ns
Dented
Over 30mm

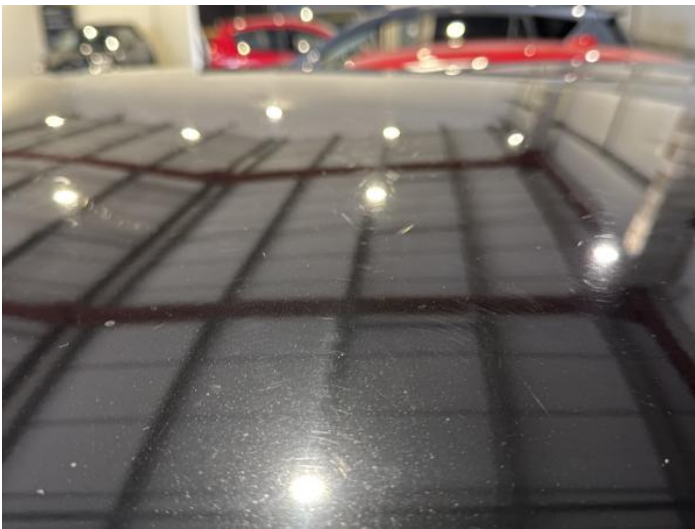
23: Roof
Dented
Over 30mm
