# VEHICLE INSPECTION REPORT

**BJ62FPV**

## Hyundai I10 1.2 Style 5dr

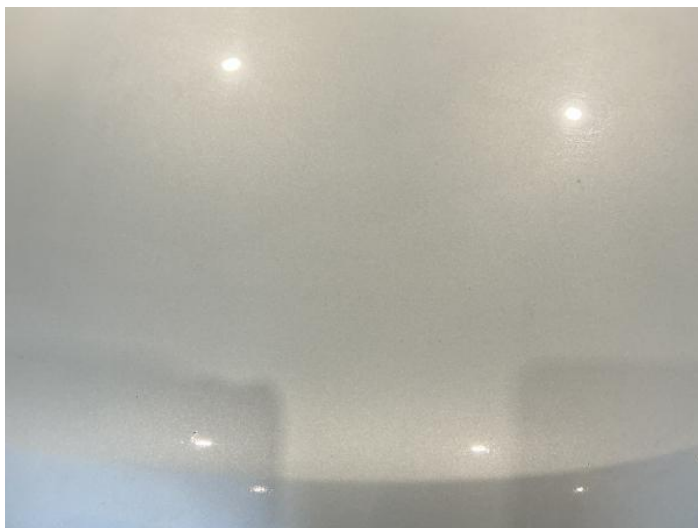
1: Bonnet  
Chipped  
1 To 5

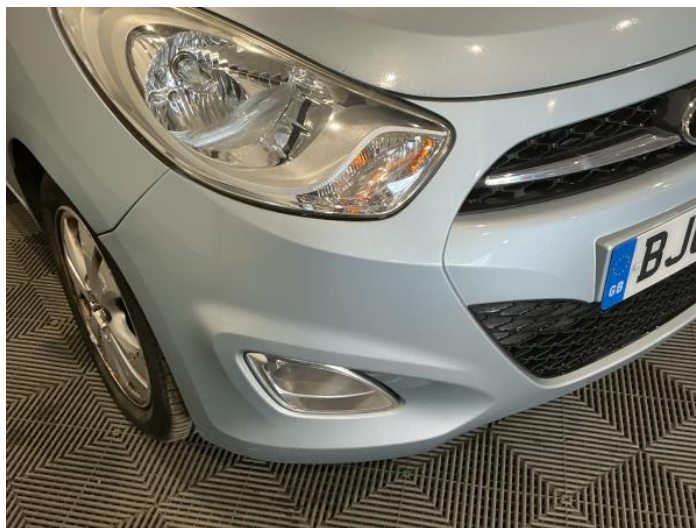
2: Bumper Front  
Scratched  
Over 100mm Thru Paint

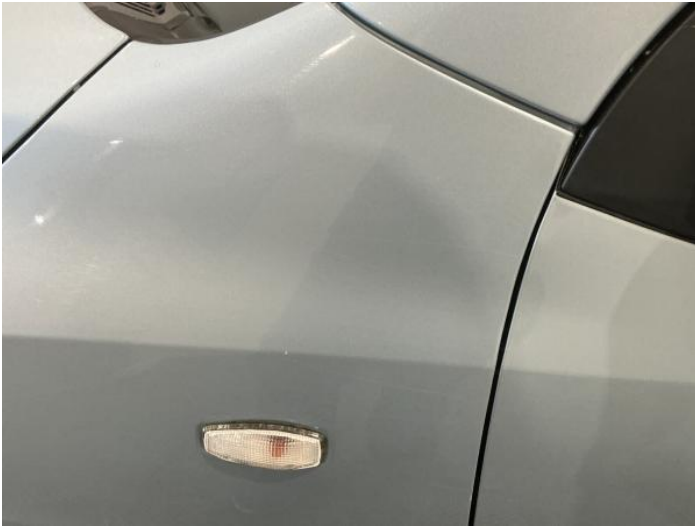
3: Wing nsf  
Chipped  
1 To 5

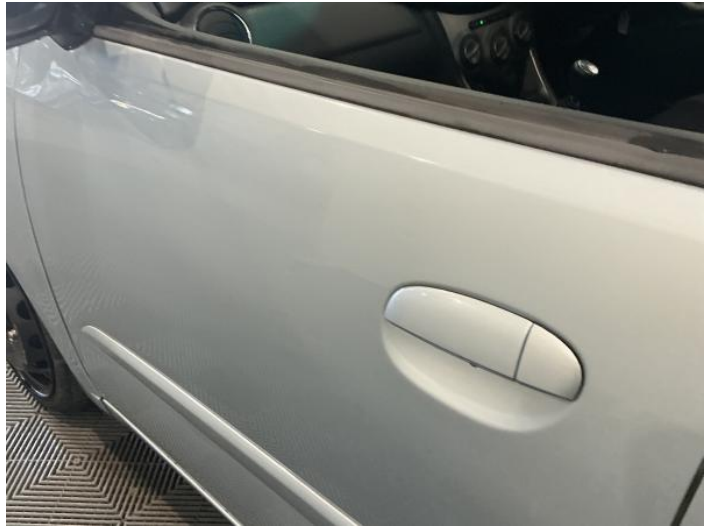
4: Door nsf  
Dented  
Over 2 UpTo 10mm

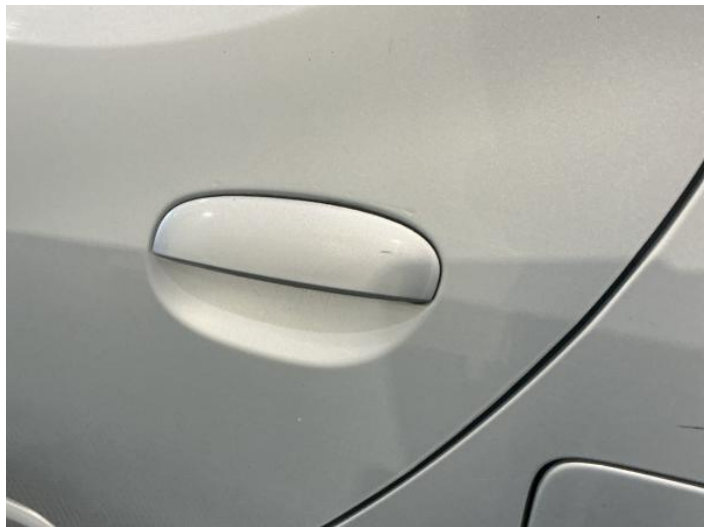
6: Door nsr  
Chipped  
1 To 5

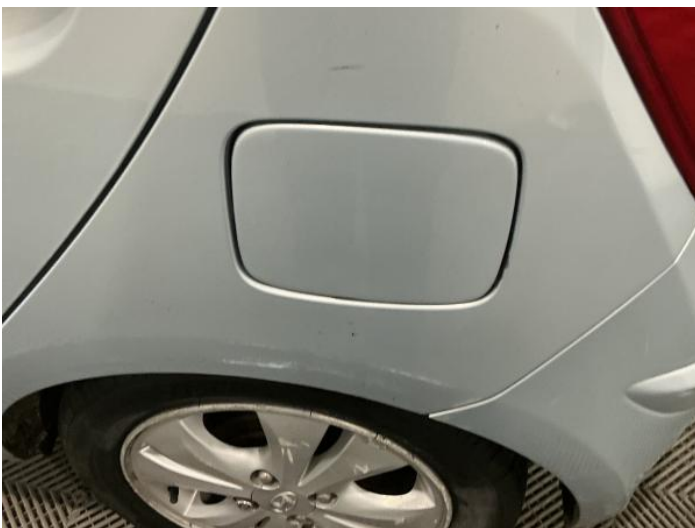
7: Qtr Panel nsr  
Dented  
With Paint Damage

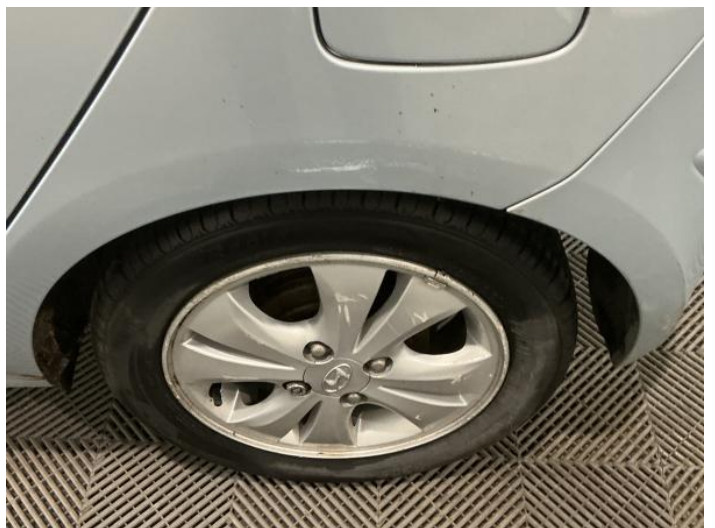
8: Wheel nsr  
Scratched  
Over 50mm

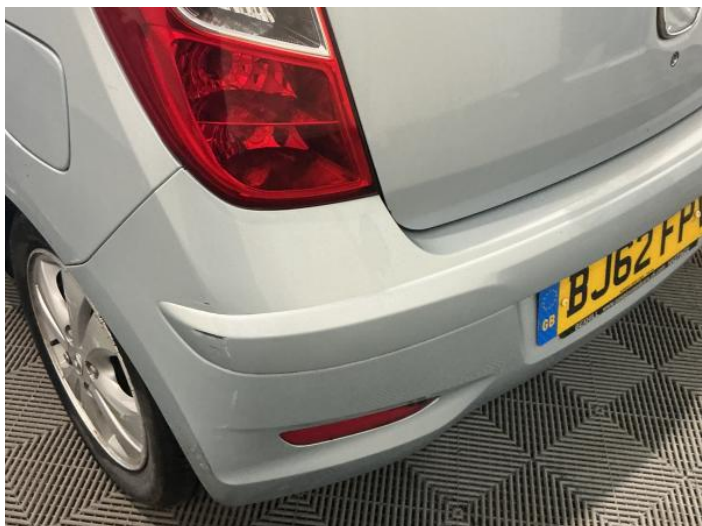
9: Bumper Rear  
Scratched  
Over 100mm Thru Paint

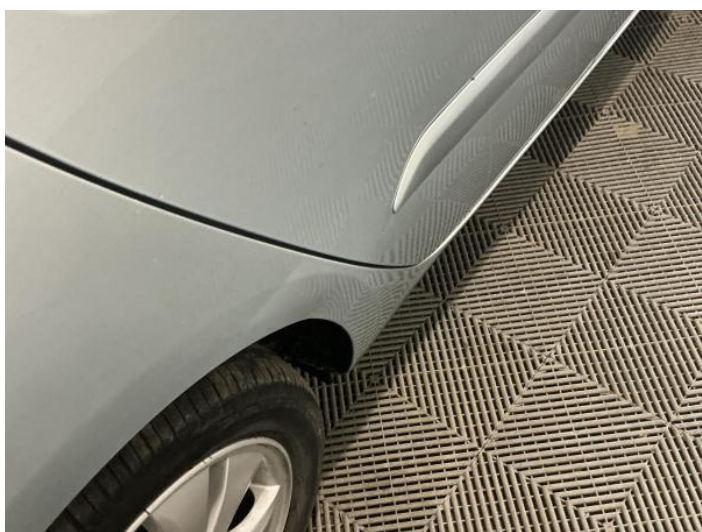
11: Qtr Panel osr  
Dented  
Over 30mm

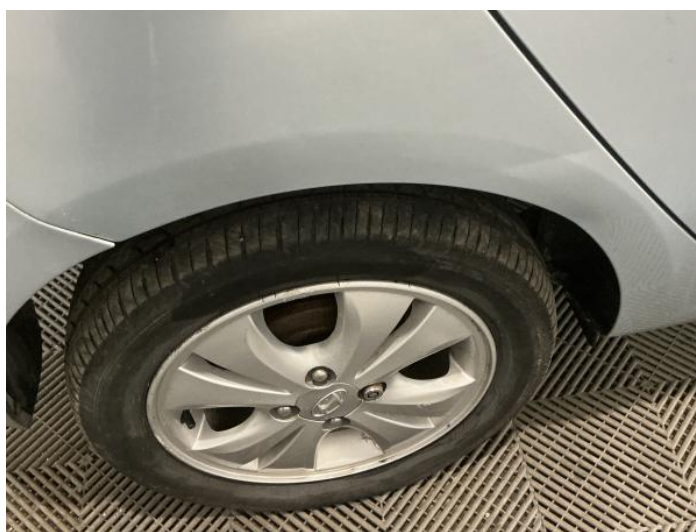
12: Wheel osr  
Scratched  
Over 50mm

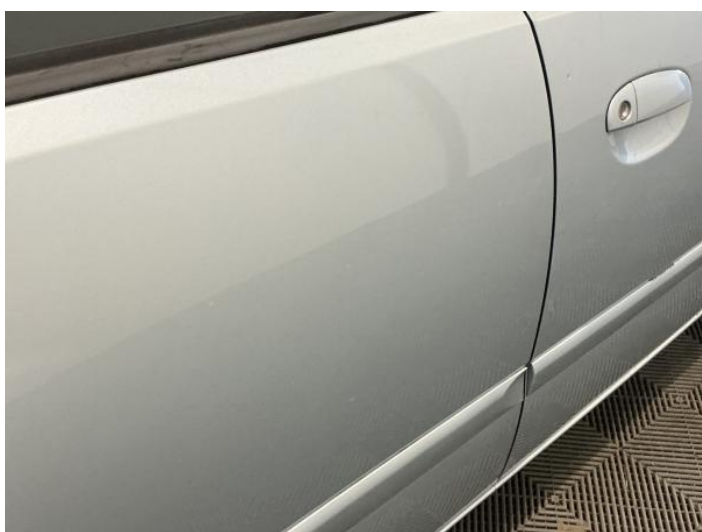
13: Door osr  
Chipped  
1 To 5

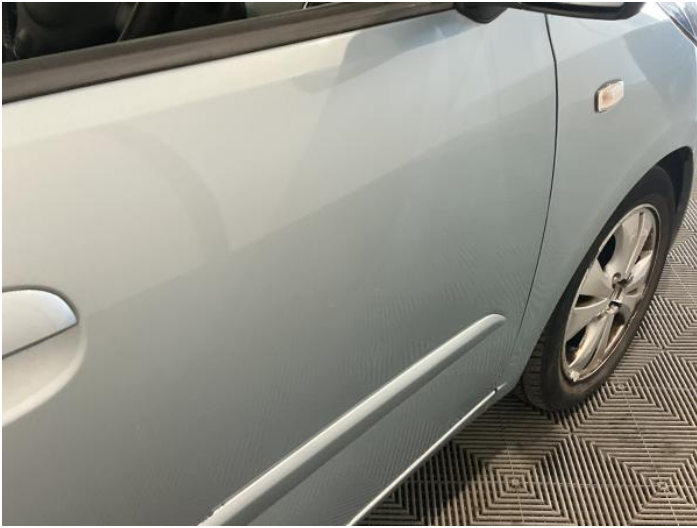
15: Door osf  
Chipped  
1 To 5

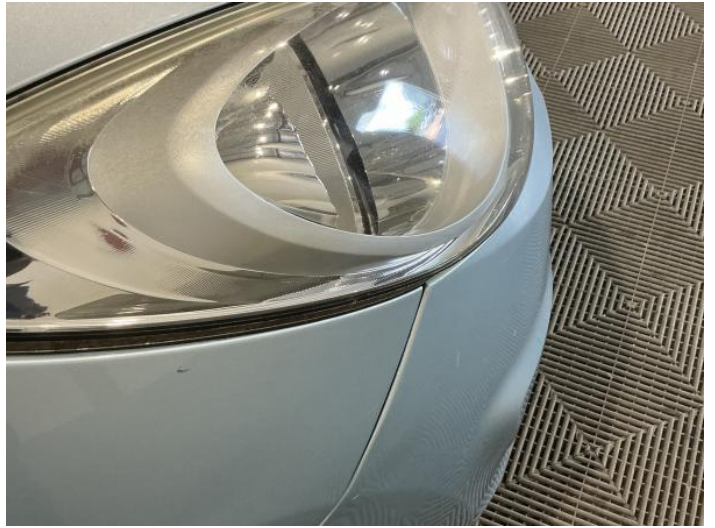
16: Wing osf  
Chipped  
1 To 5

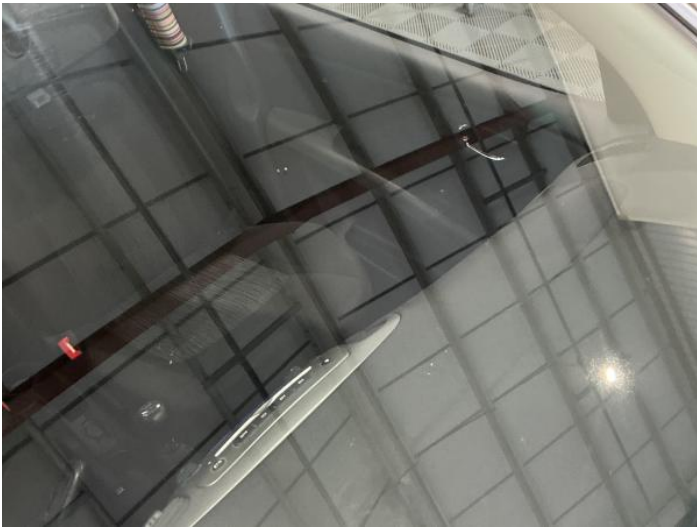
17: Screen Front  
Chipped  
UpTo 10mm

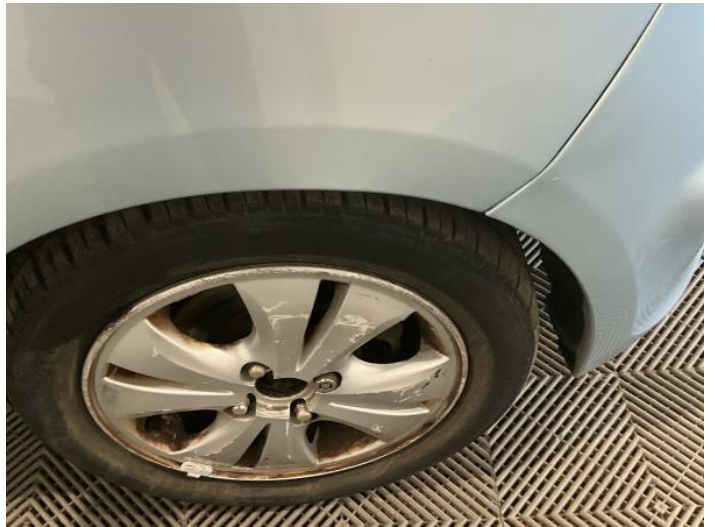
18: Wheel osf  
Scratched  
Over 50mm
