# VEHICLE INSPECTION REPORT

**BD64VYC**

## Peugeot 5008 1.6 HDi Active 5dr

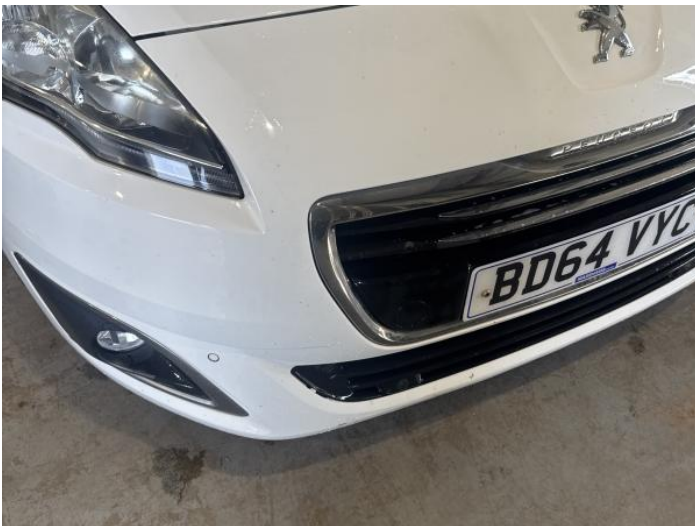
1: Bumper Front  
Scratched  
Over 100mm Thru Paint

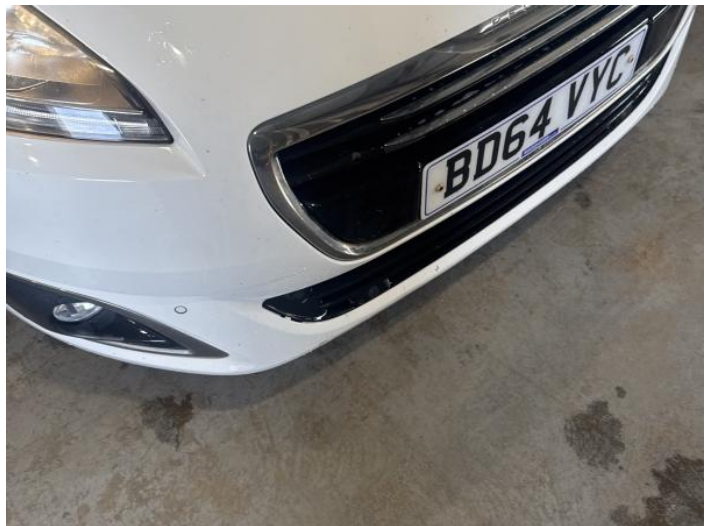
2: Bumper Front Grill  
Broken  
Replace

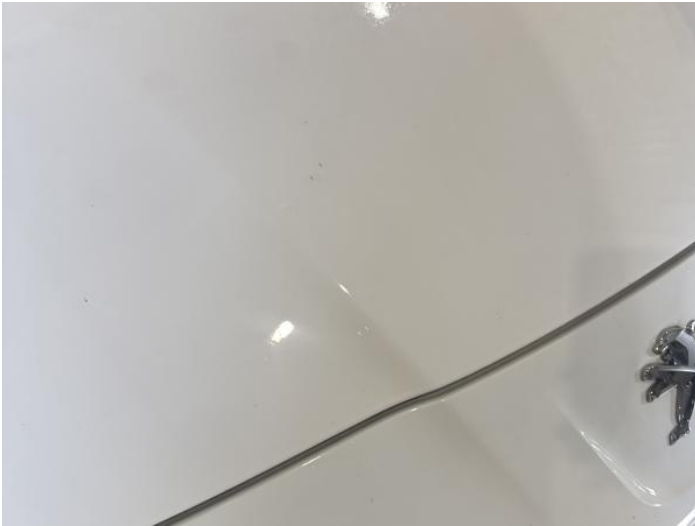
3: Bonnet  
Chipped  
1 To 5

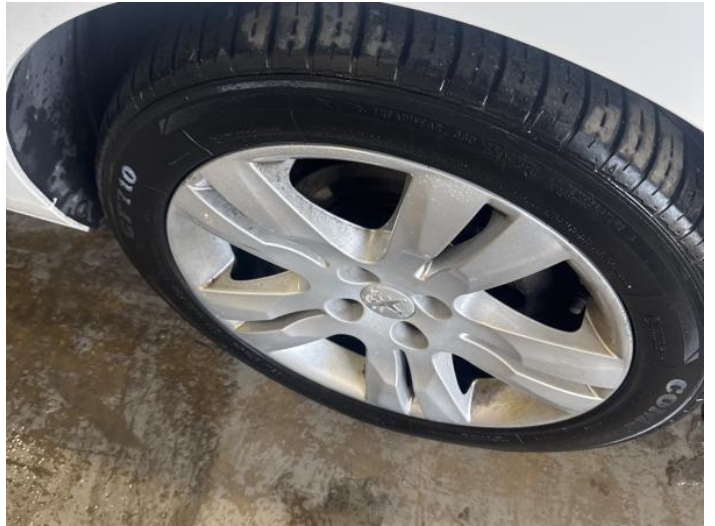
4: Wheel osf  
Scratched  
Up To 50mm

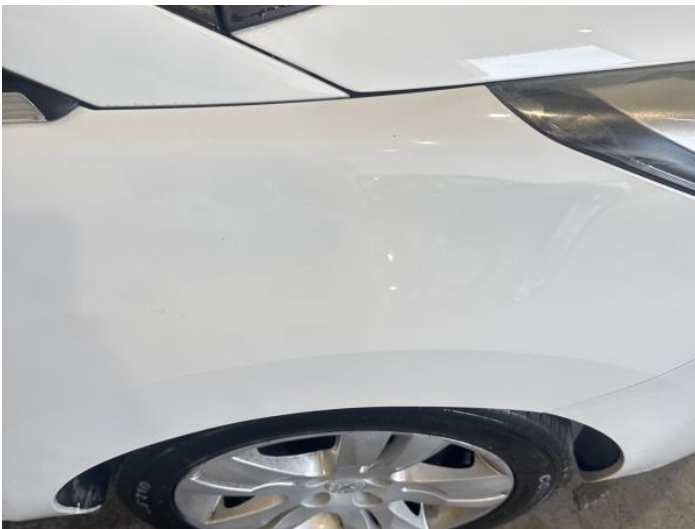
5: Wing osf  
Chipped  
1 To 5

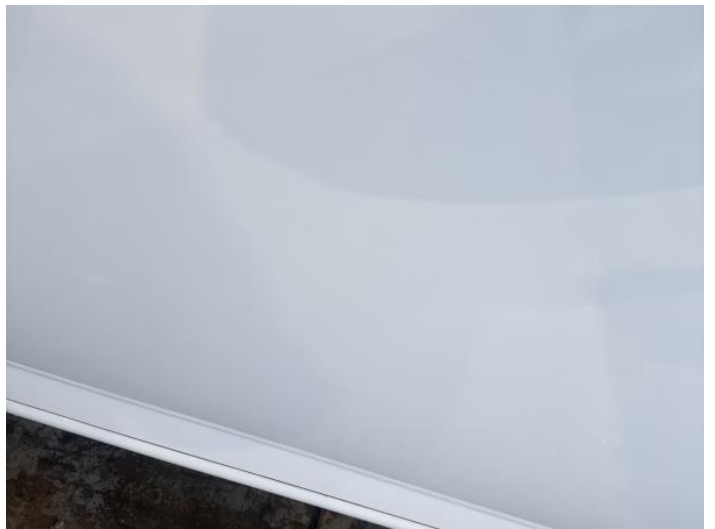
6: Door osf  
Chipped  
1 To 5

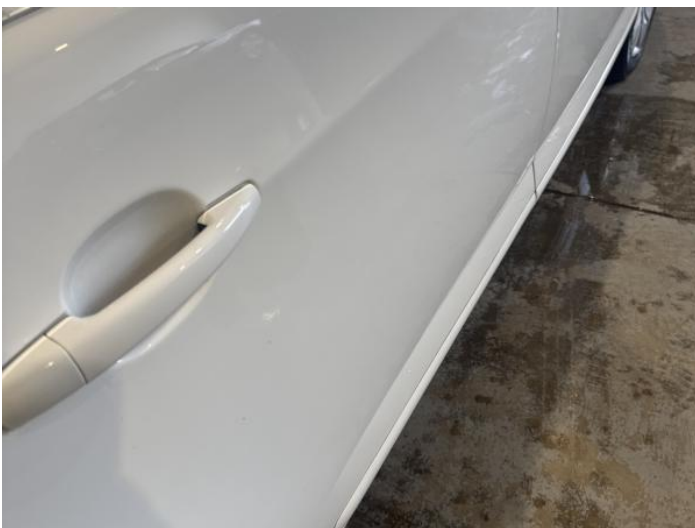
7: Door osr  
Dented  
2 Or Less UpTo 10mm

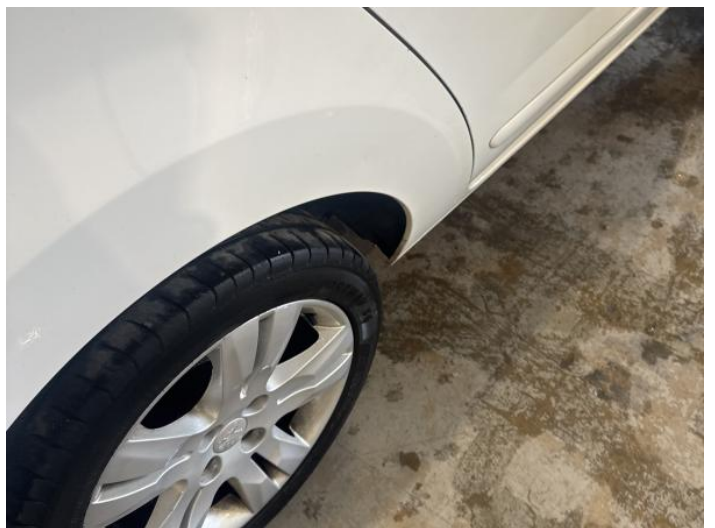
8: Qtr Panel osr  
Dented  
2 Or Less UpTo 10mm

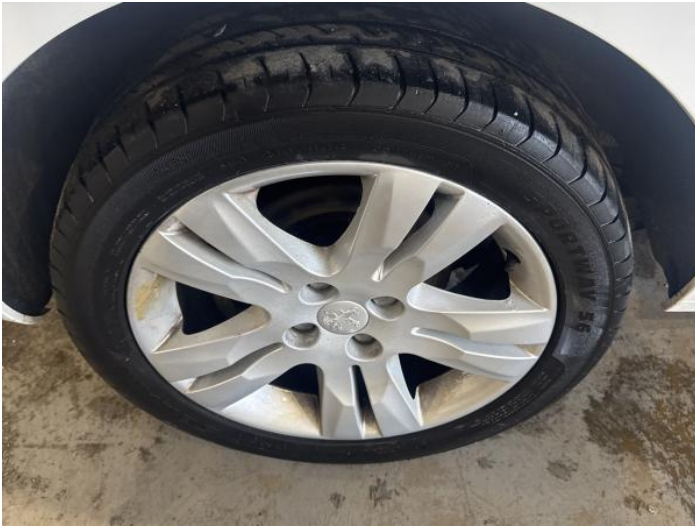
9: Wheel osr  
Scratched  
Over 50mm

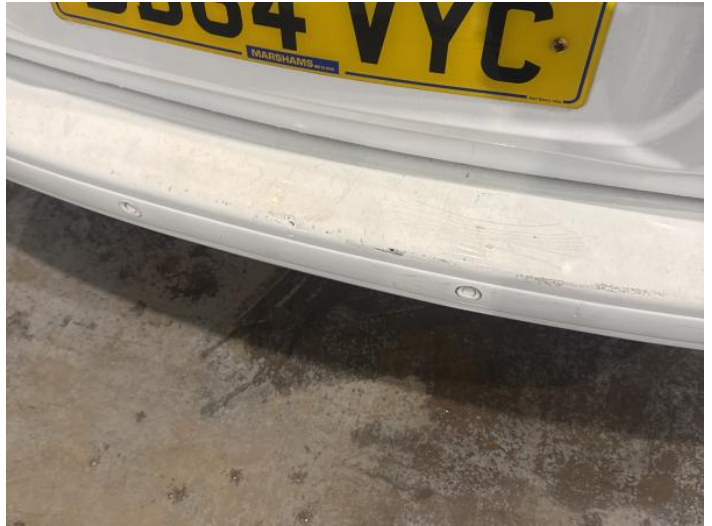
10: Bumper Rear  
Poor Previous Repair  
Rippled UpTo 30%

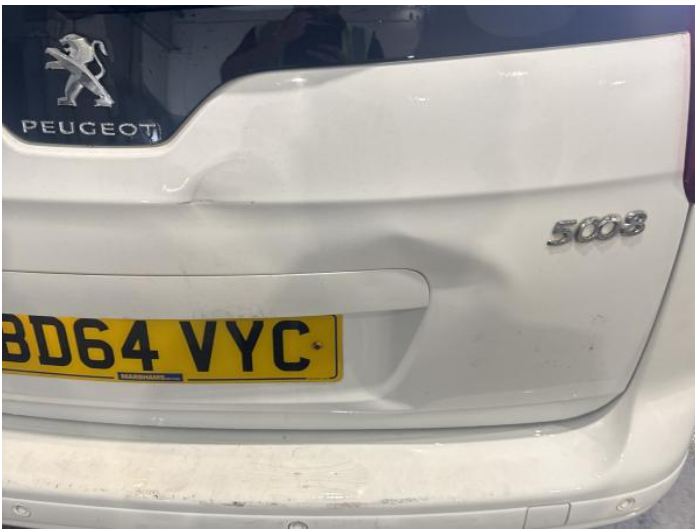
11: Boot Lid  
Dented  
Over 30mm

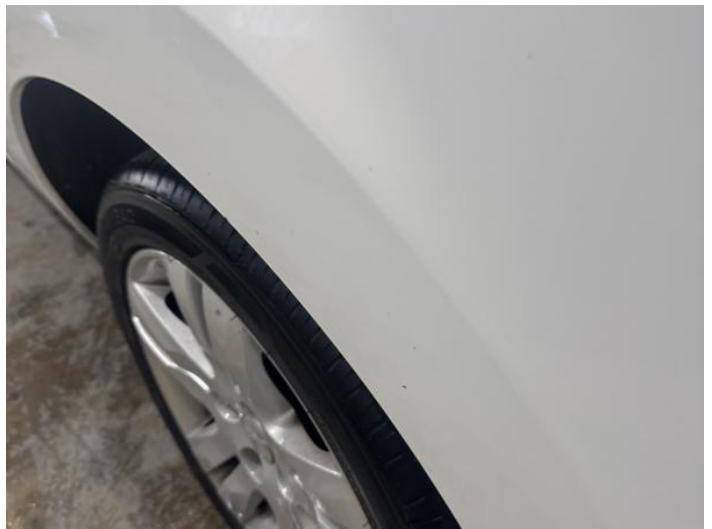
12: Qtr Panel nsr  
Chipped  
1 To 5

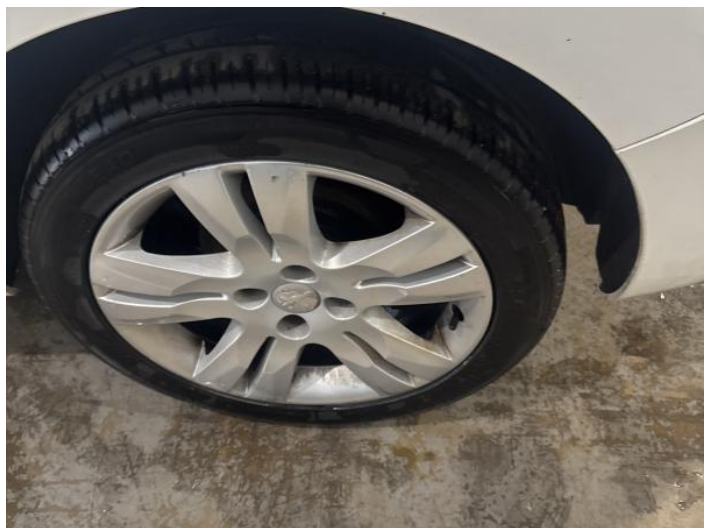
14: Wheel nsr  
Scratched  
Over 50mm

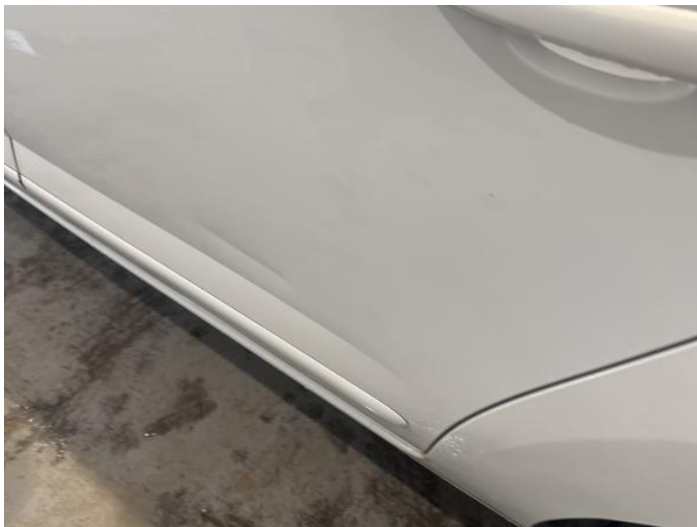
15: Door nsr  
Dented  
Over 30mm

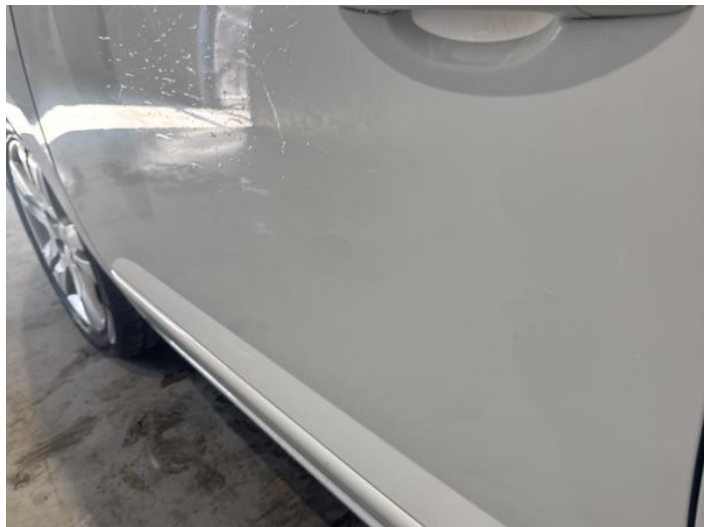
16: Door nsf  
Dented  
Over 2 UpTo 10mm

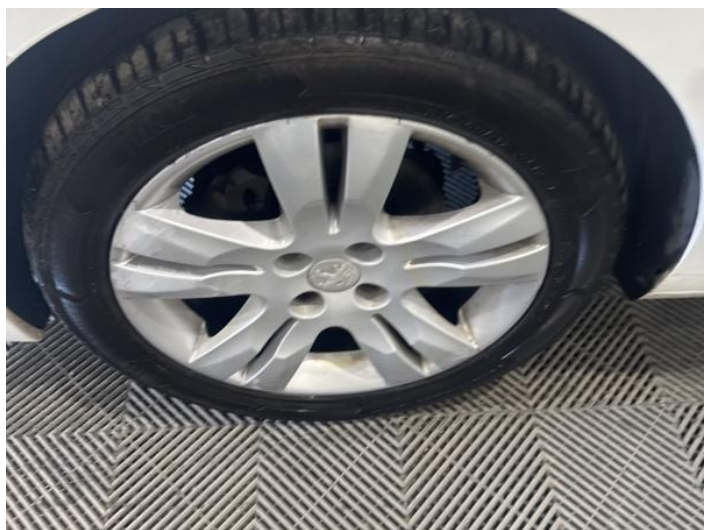
18: Wheel nsf  
Scratched  
Over 50mm

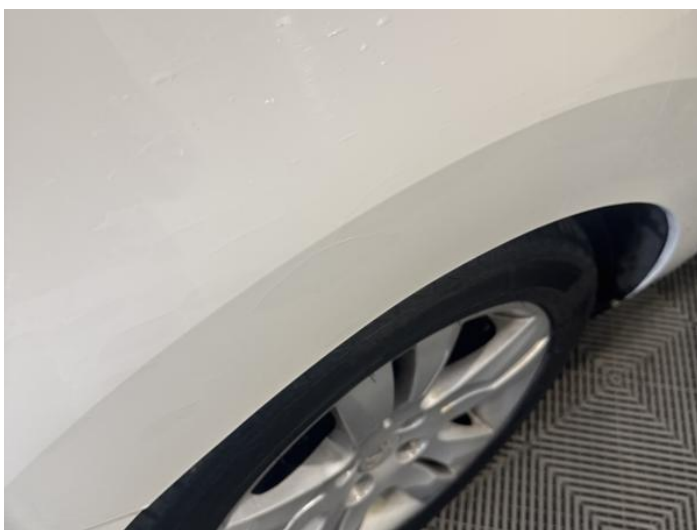
19: Wing nsf  
Scratched  
Over 25mm Not Thru Paint

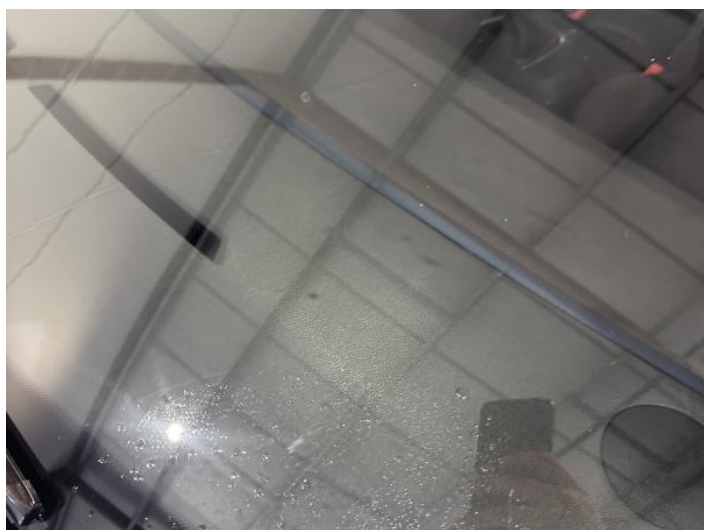
20: Screen Front  
Chipped  
UpTo 10mm
