VEHICLE INSPECTION REPORT

YT12PCZ

Nissan Qashqai 2.0 N-Tec 5dr CVT

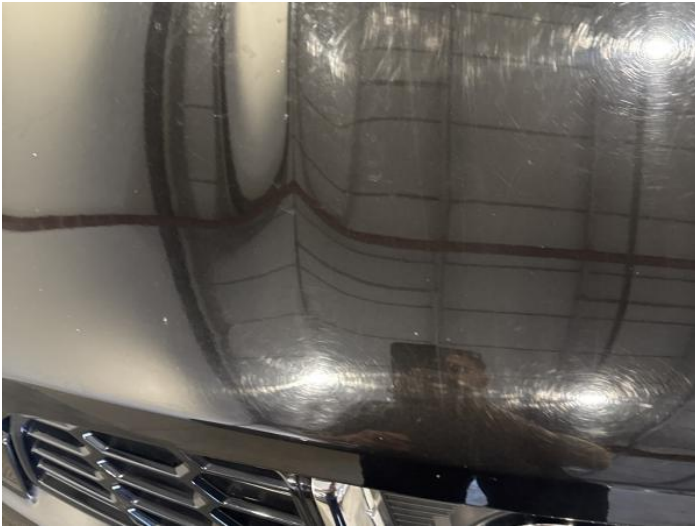
3: Bonnet
Dented
With Paint Damage

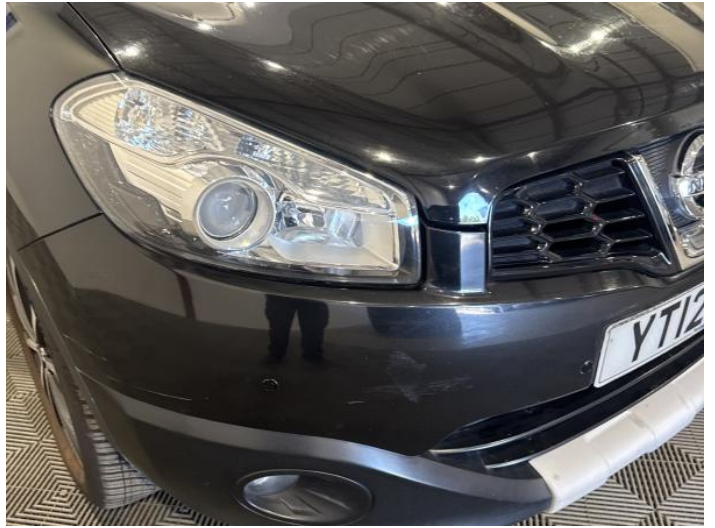
4: Bumper Front
Poor Previous Repair
Poor Paint

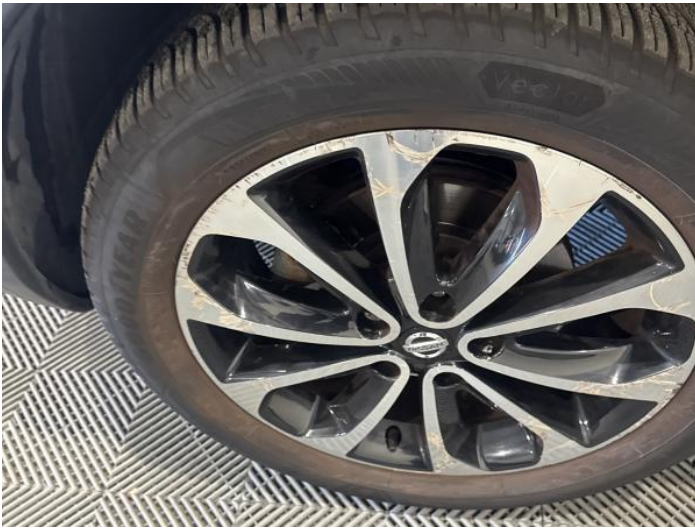
5: Wheel nsf
Scratched
Over 50mm

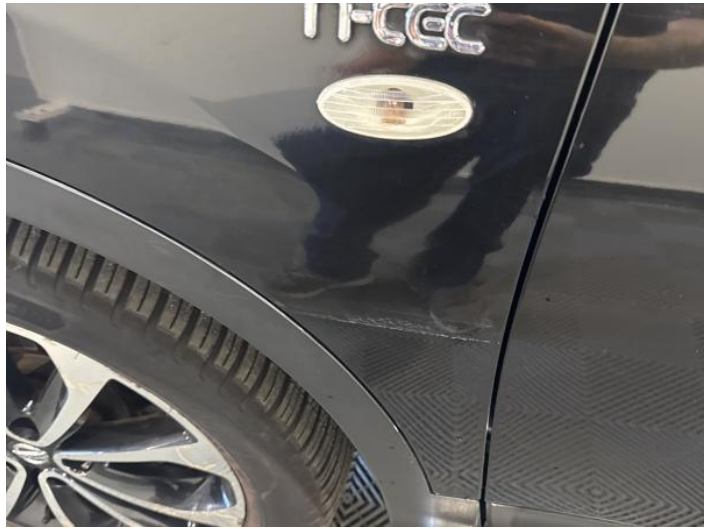
6: Wing nsf
Scratched
Over 25mm Thru Paint

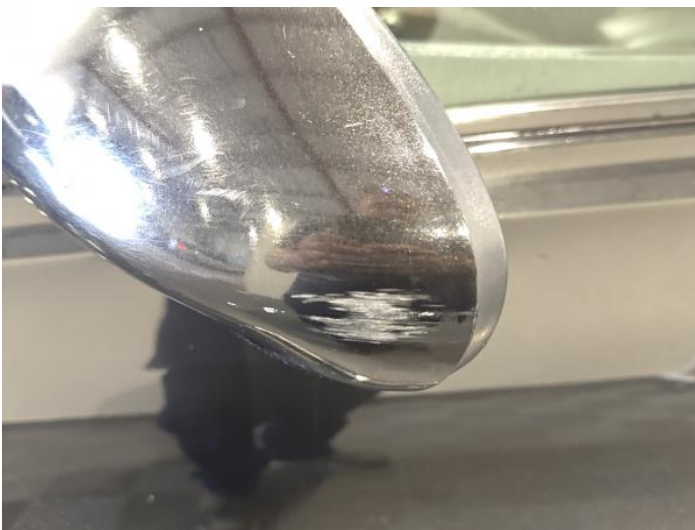
7: Door Mirror Assy nsf
Scratched (Painted)
Over 25mm Thru Paint

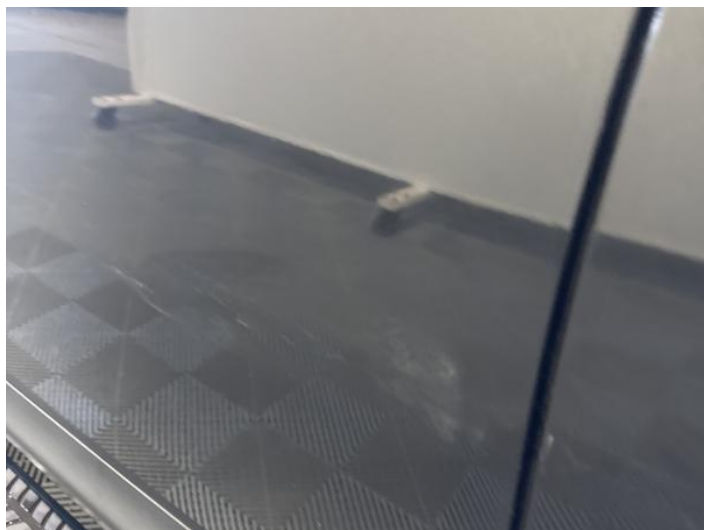
8: Door nsf
Scratched
Over 25mm Thru Paint

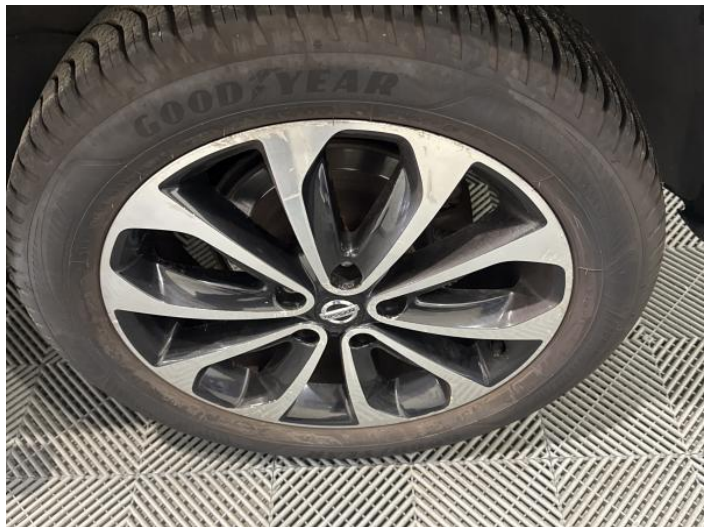
10: Wheel nsr
Scratched
Over 50mm

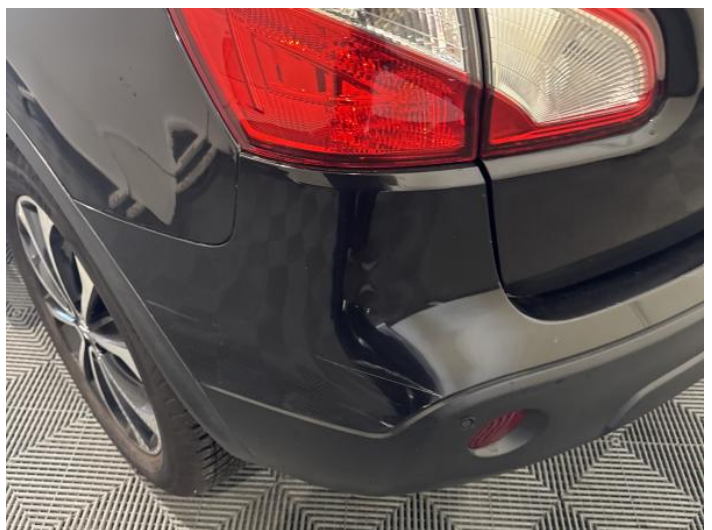
12: Bumper Rear
Scratched
Over 100mm Thru Paint

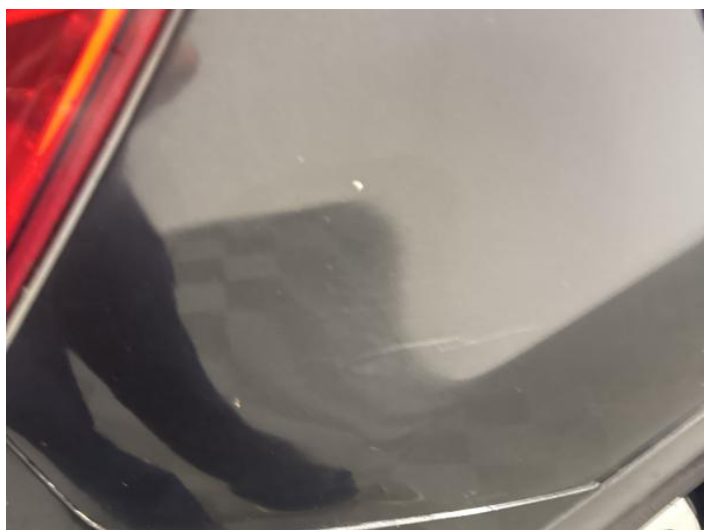
14: Qtr Panel osr
Scratched
Over 25mm Thru Paint

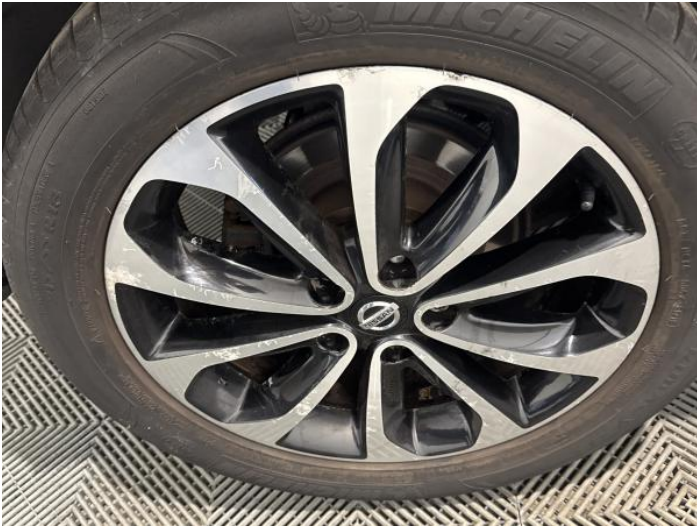
15: Wheel osr
Scratched
Over 50mm

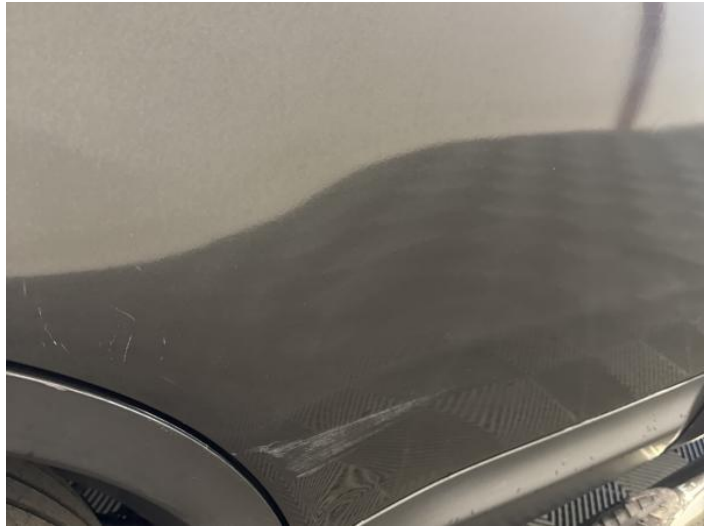
16: Door osr
Dented
With Paint Damage

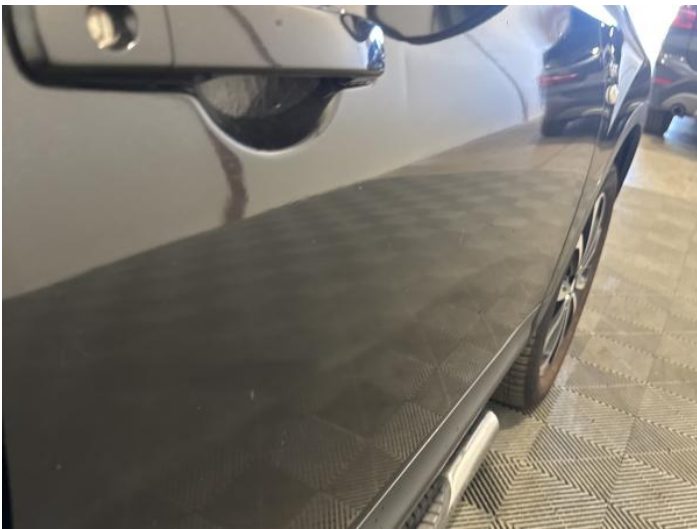
17: Door osf
Dented
With Paint Damage

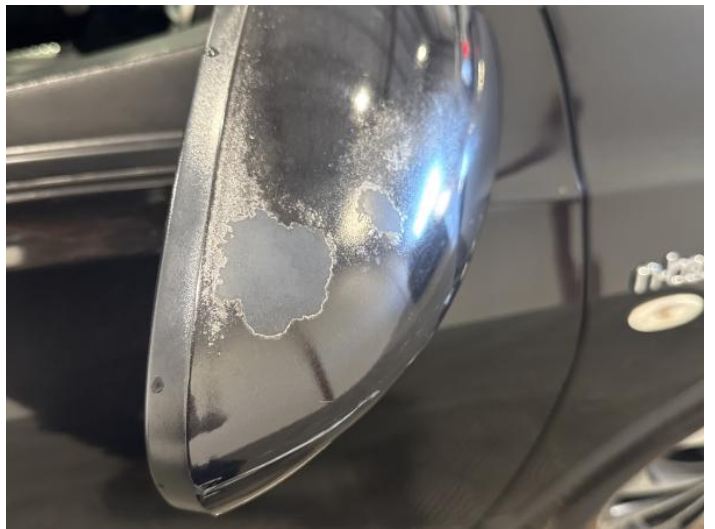
18: Door Mirror Assy osf
Scratched (Painted)
Over 25mm Thru Paint

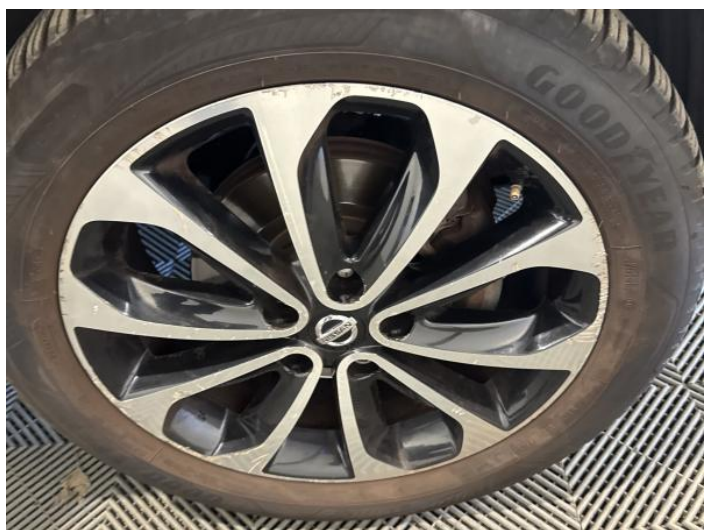
20: Wheel osf
Scratched
Over 50mm
