VEHICLE INSPECTION REPORT

GY63XNN

Peugeot 2008 1.6 e-HDi Allure 5dr

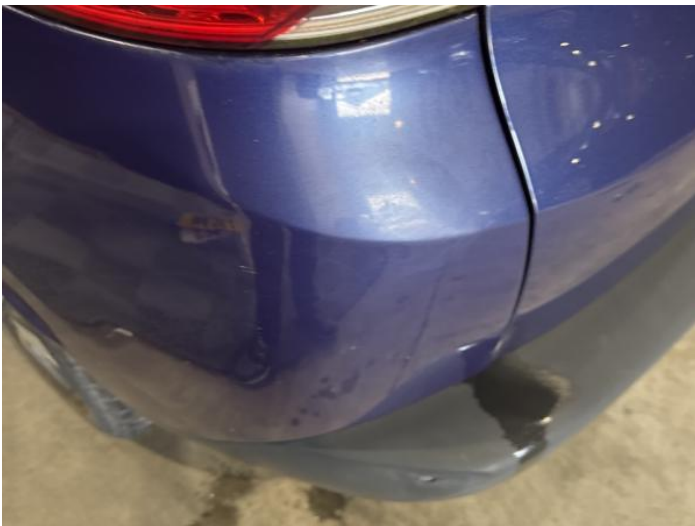
1: Bumper Rear
Poor Previous Repair
Poor Paint

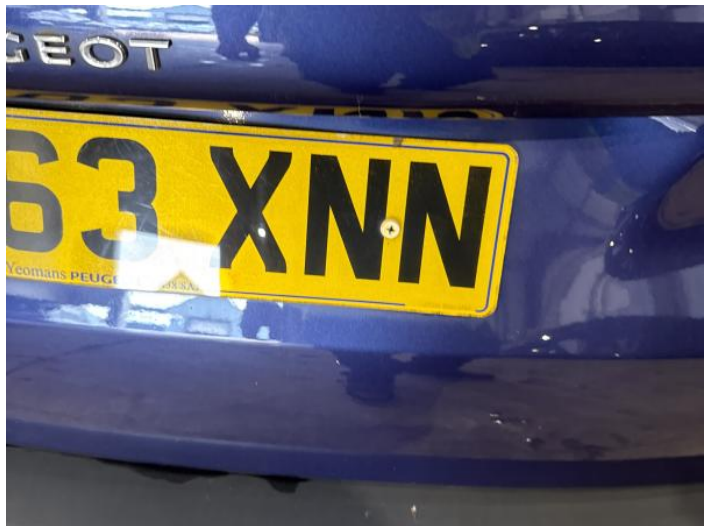
2: Boot Lid
Chipped
1 To 5

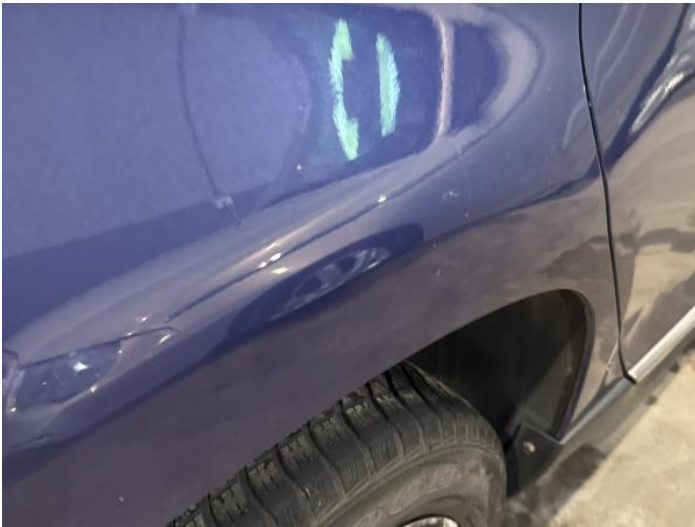
5: Qtr Panel osr
Dented
2 Or Less UpTo 10mm

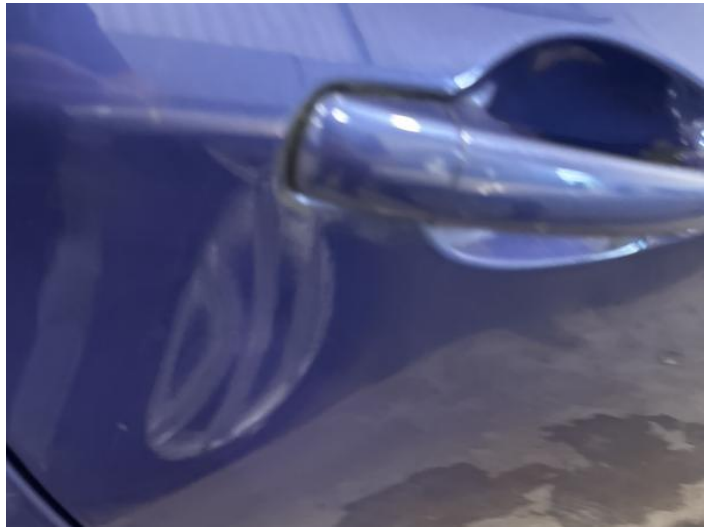
6: Door osr
Chipped
1 To 5

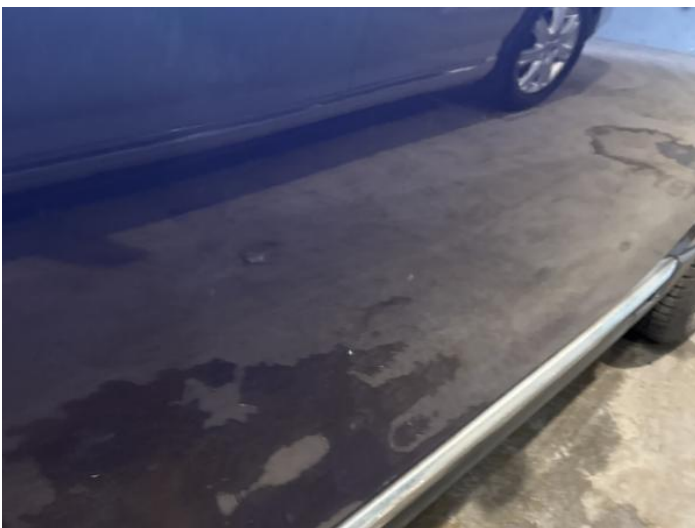
7: Door osf
Chipped
1 To 5

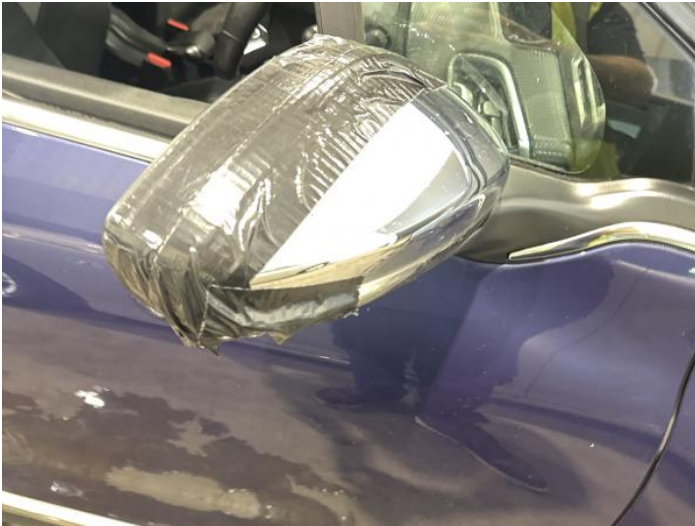
9: Door Mirror Assy osf
Broken
Replace

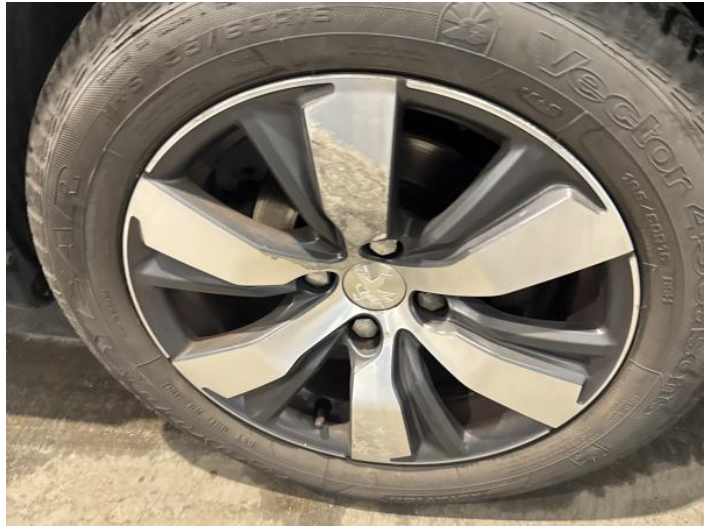
10: Wheel osf
Scratched
Over 50mm

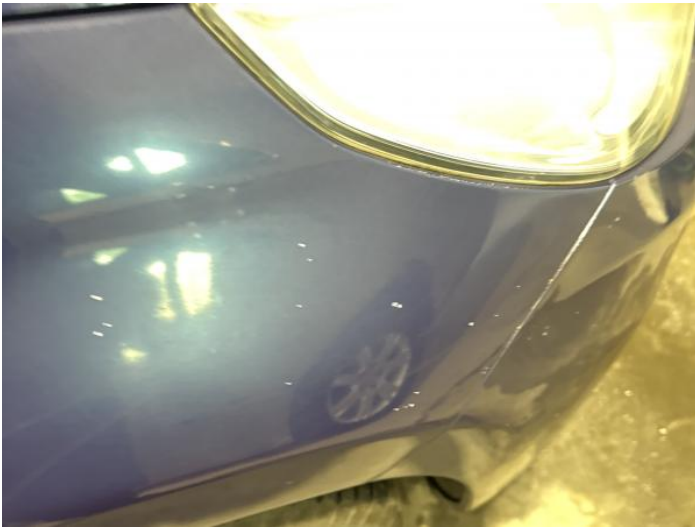
11: Wing osf
Chipped
Multiple Chips

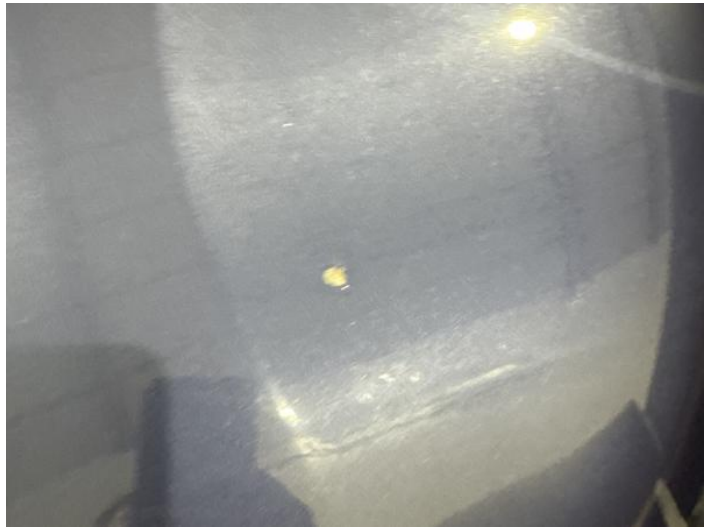
12: Bonnet
Chipped
Over 5mm

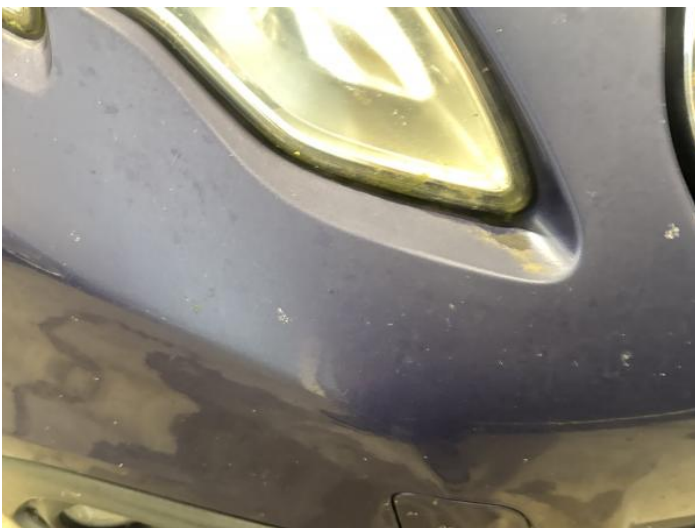
13: Bumper Front
Poor Previous Repair
Poor Paint

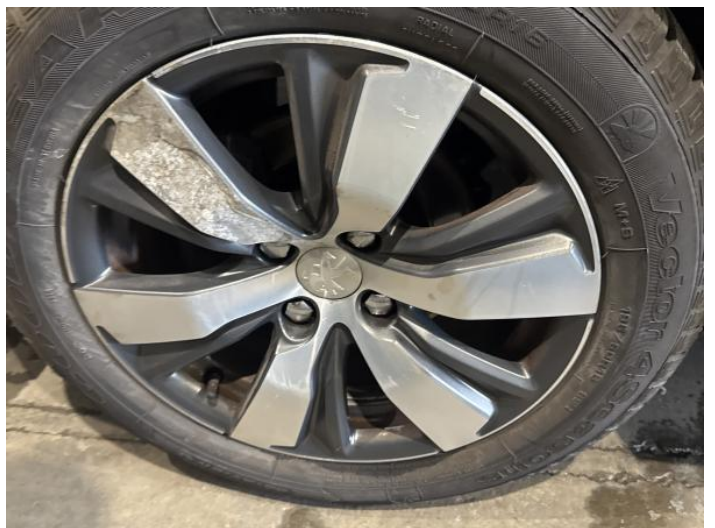
14: Wheel nsf
Scratched
Over 50mm

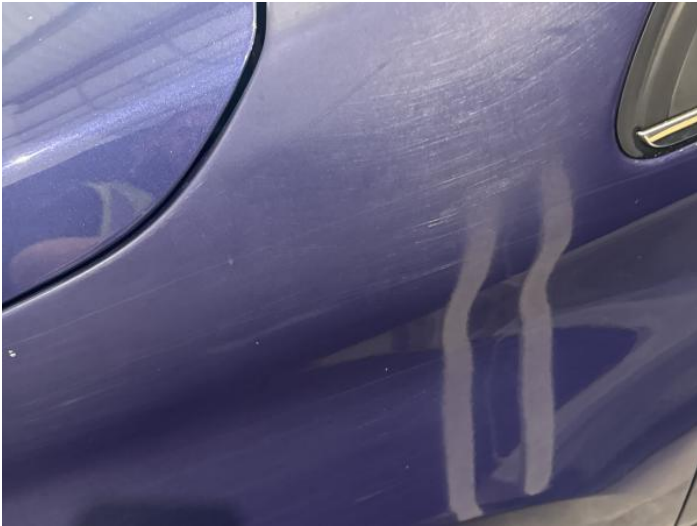
15: Wing nsf
Poor Previous Repair
Poor Paint

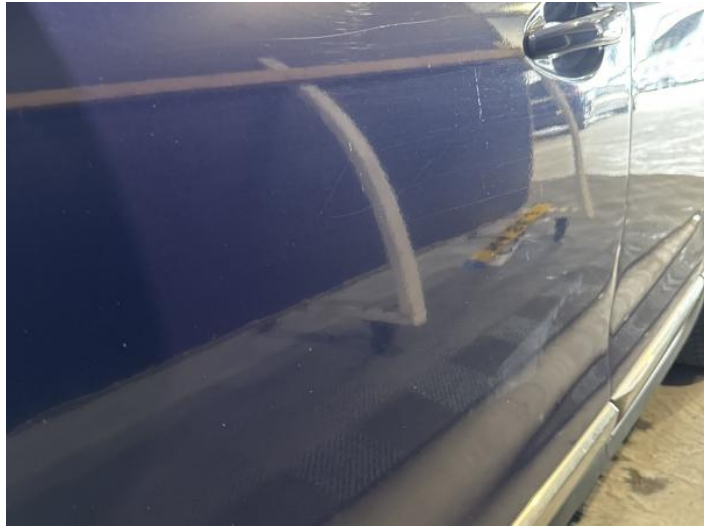
16: Door nsf
Poor Previous Repair
Poor Paint

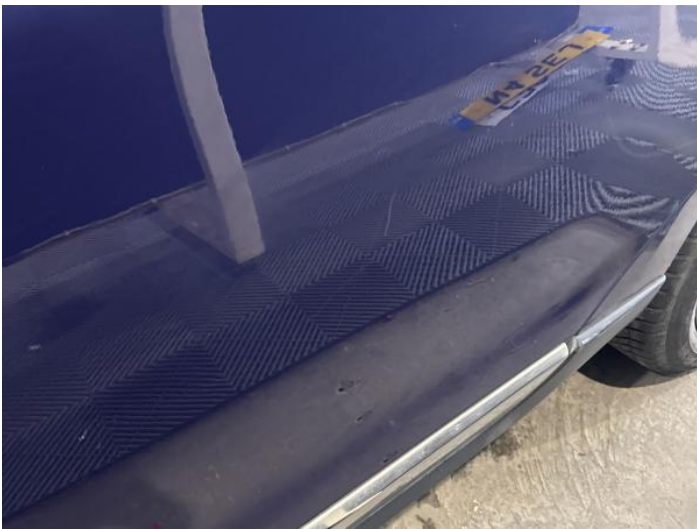
17: Door nsr
Chipped
1 To 5

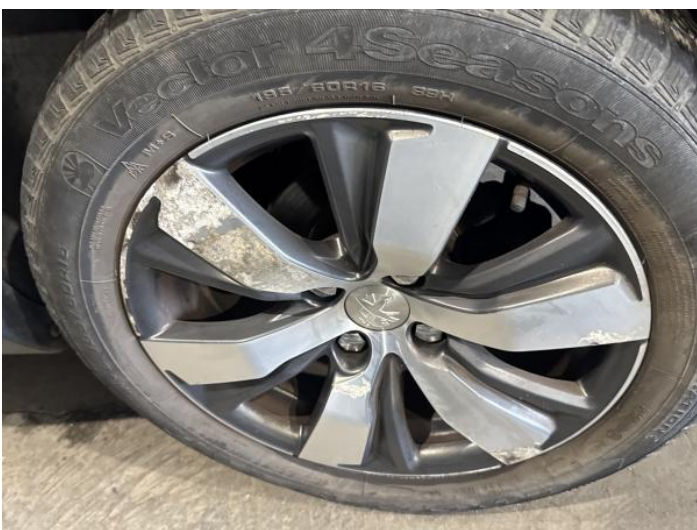
19: Wheel nsr
Scratched
Over 50mm

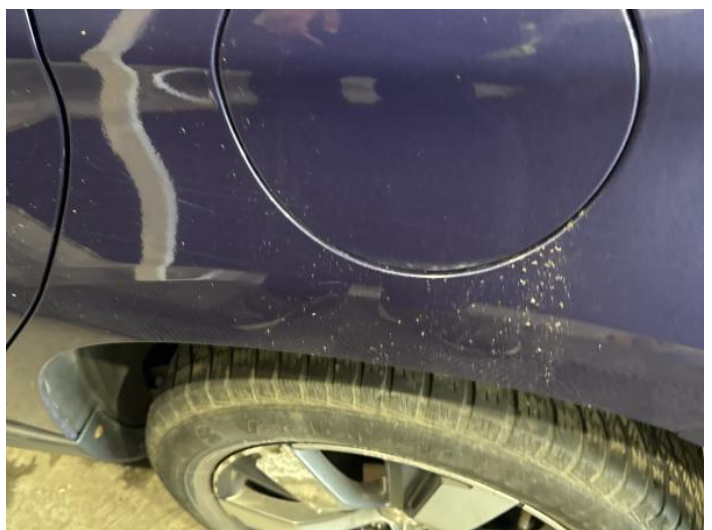
20: Qtr Panel nsr
Dented
Over 2 UpTo 10mm
