VEHICLE INSPECTION REPORT

YF58KZD

BMW X5 3.0sd M Sport 5dr Auto

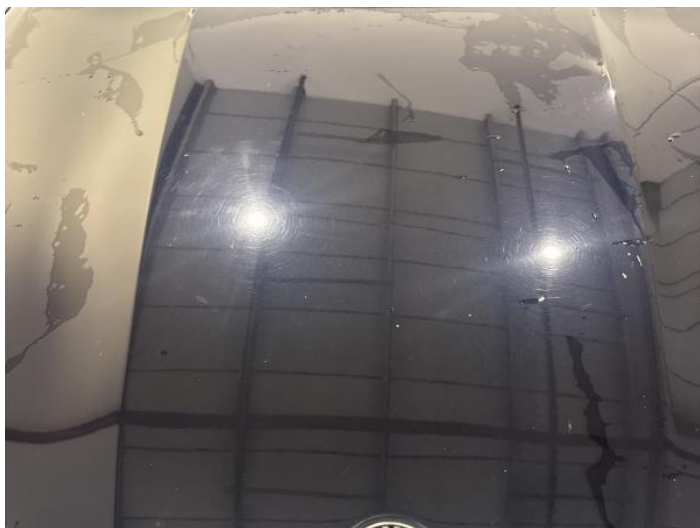
1: Bonnet
Chipped
Multiple Chips

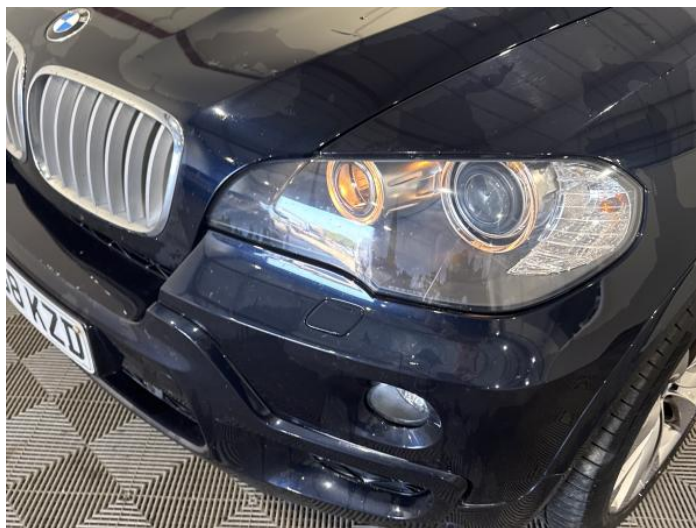
2: Bumper Front
Chipped
Multiple Chips

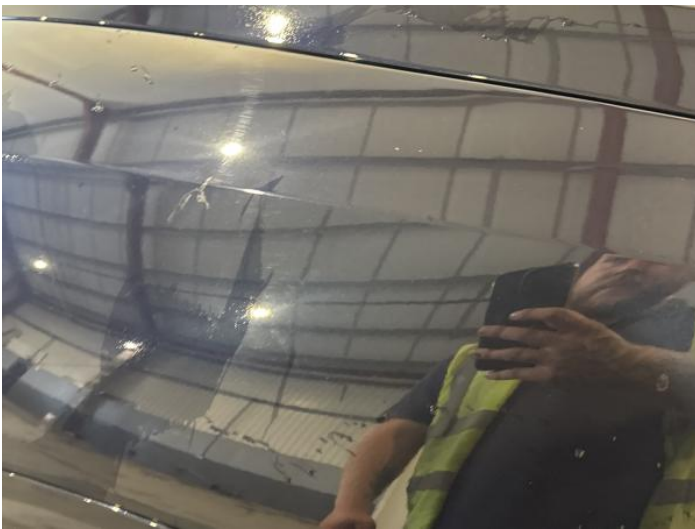
5: Wing nsf
Chipped
1 To 5

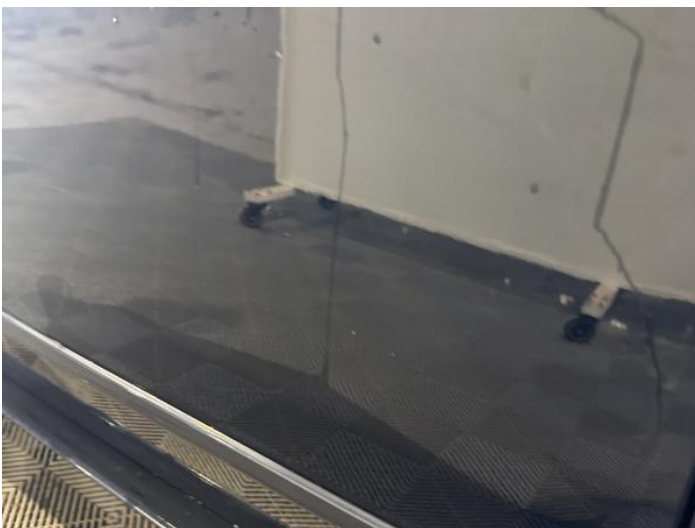
7: Door nsf
Poor Previous Repair
Poor Paint

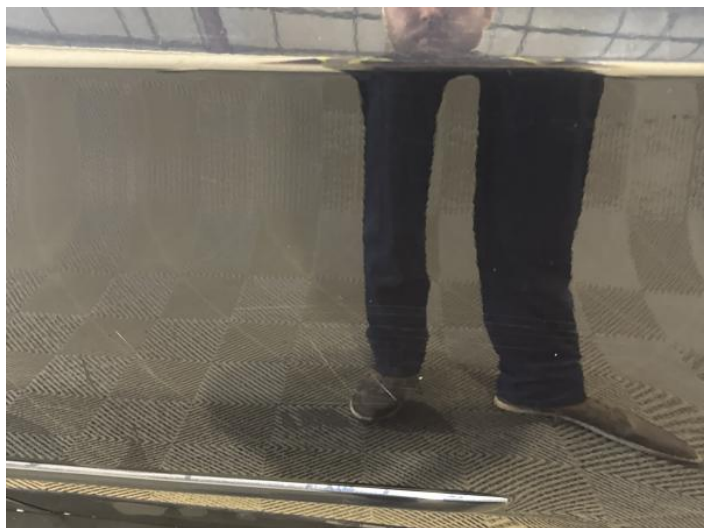
8: Door nsr
Chipped
1 To 5

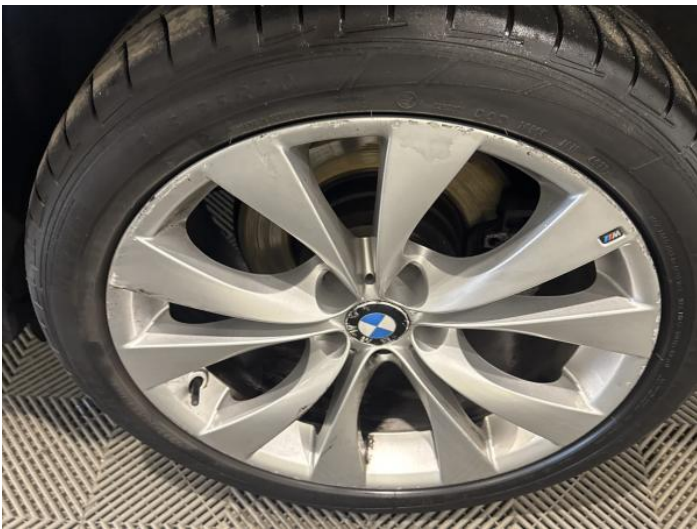
11: Wheel nsr
Scratched
Over 50mm

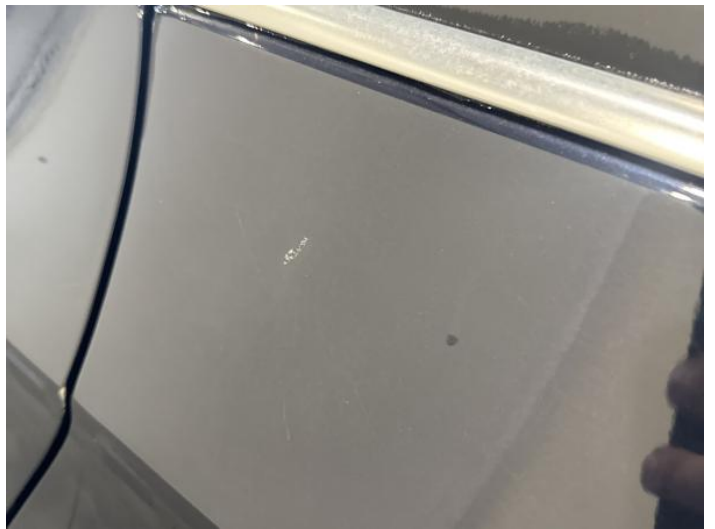
12: Qtr Panel nsr
Chipped
1 To 5

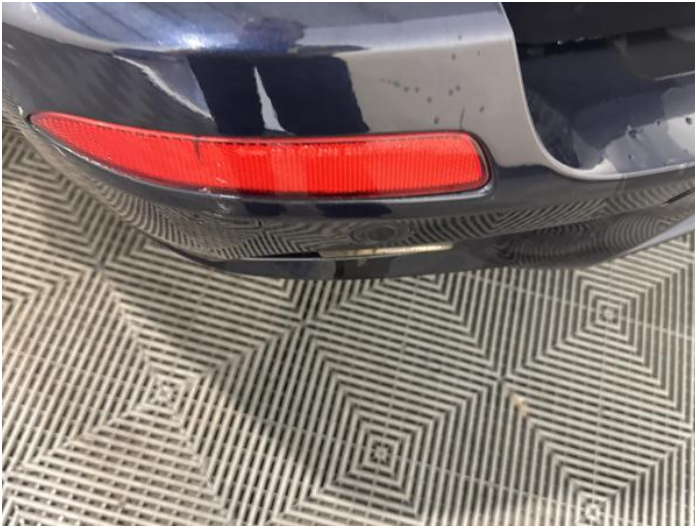
15: Bumper Reflector nsr
Broken
Replace

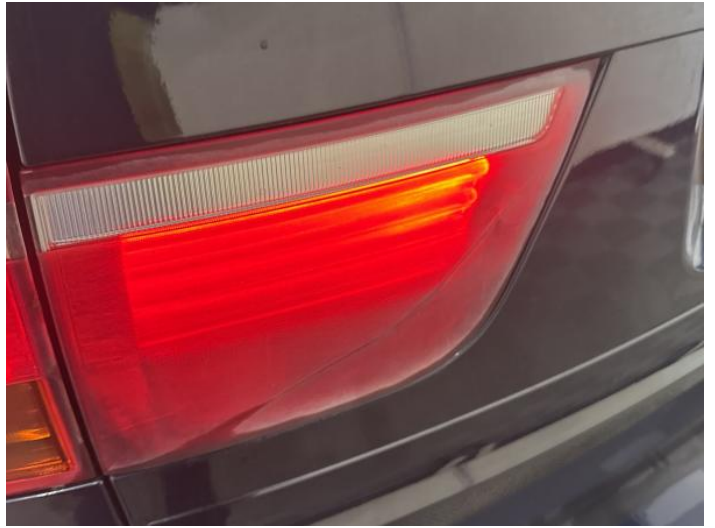
16: Lamp nsr
Broken
Replace

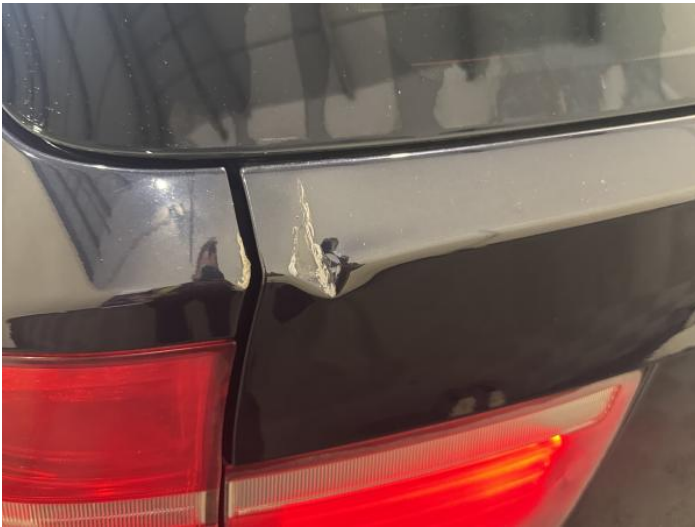
17: Boot Lid
Dented
With Paint Damage

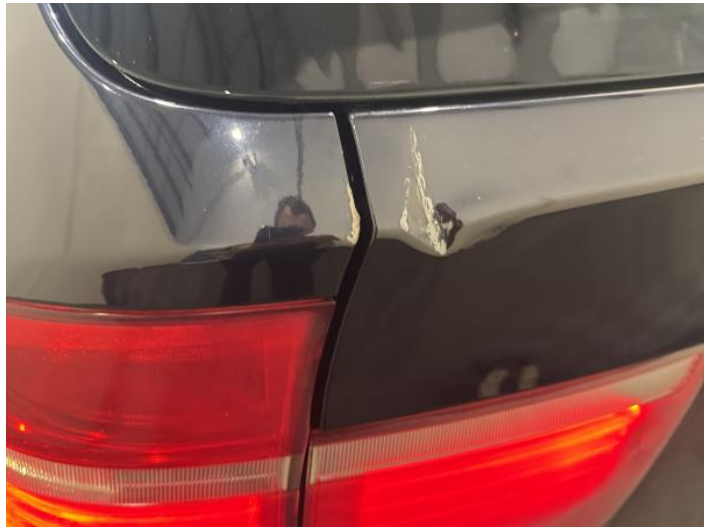
18: Qtr Panel nsr
Dented
With Paint Damage

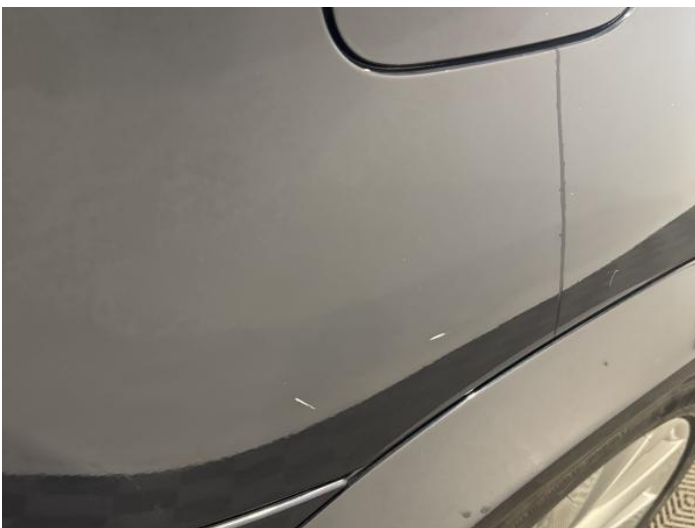
19: Qtr Panel osr
Chipped
1 To 5

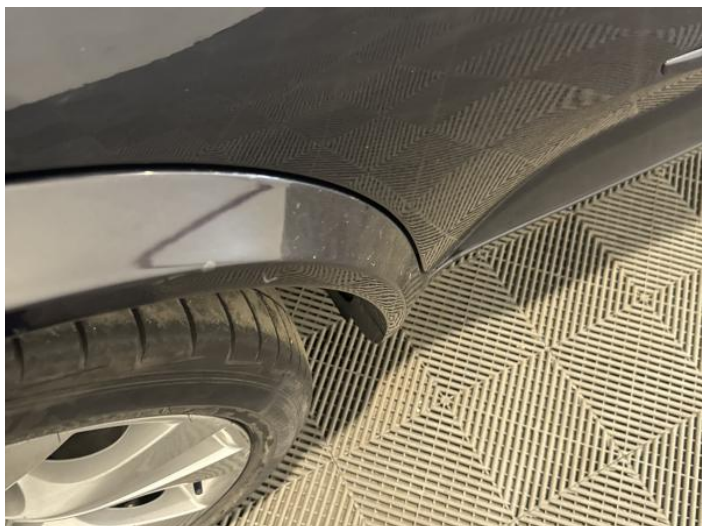
21: Qtr Panel Arch Extension os
Scratched (Painted)
Over 25mm Thru Paint

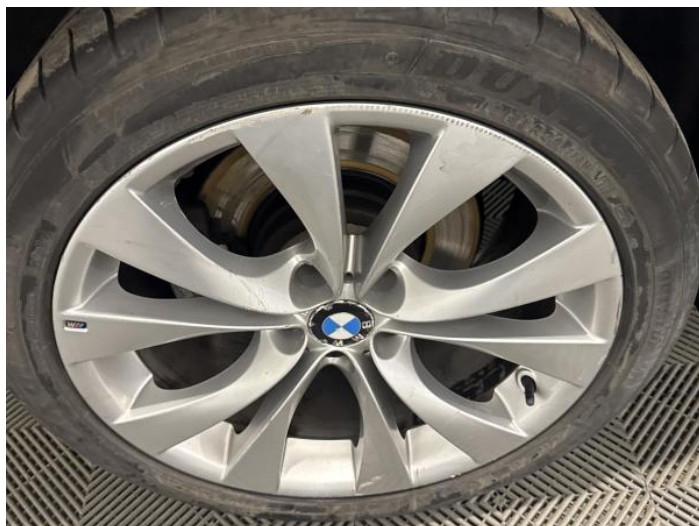
22: Wheel osr
Scratched
Over 50mm

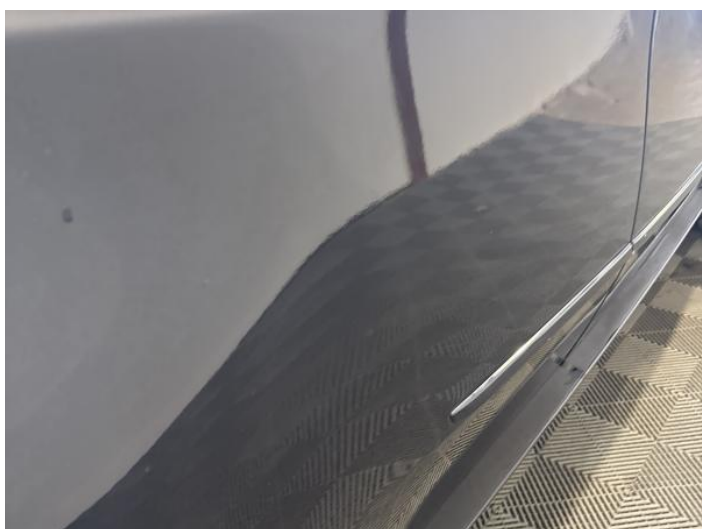
23: Door osr
Chipped
1 To 5

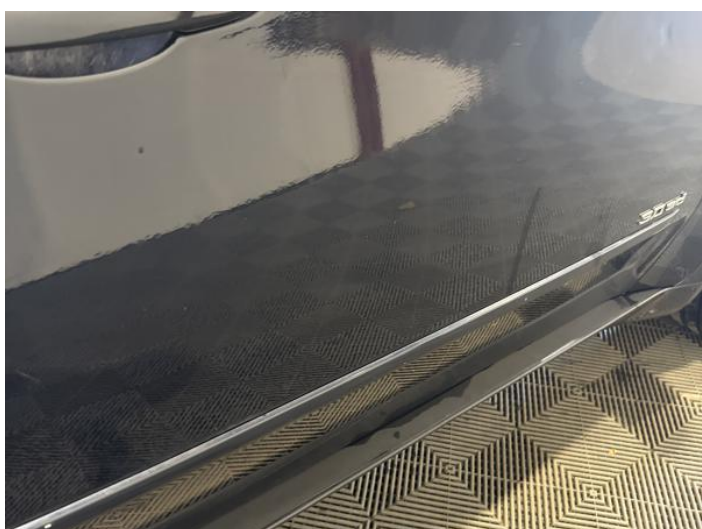
25: Door osf
Chipped
1 To 5

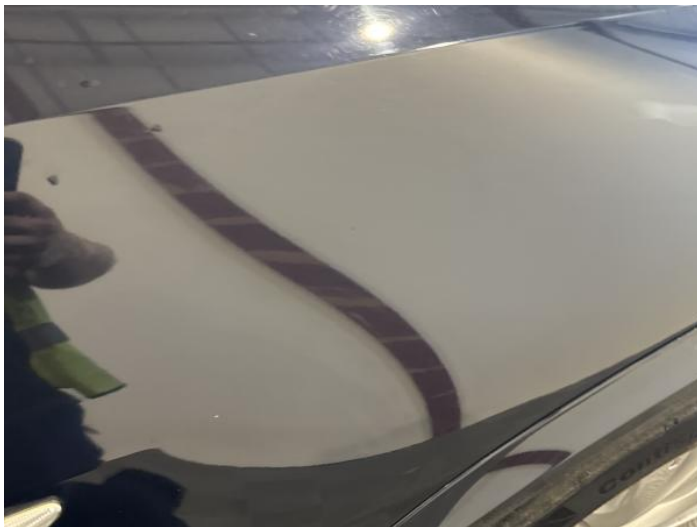
27: Wing osf
Chipped
1 To 5

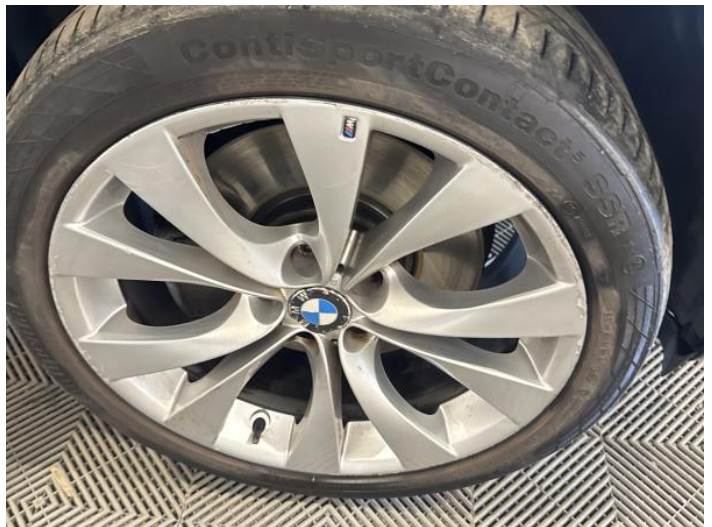
28: Wheel osf
Scratched
Over 50mm
