VEHICLE INSPECTION REPORT

WV57PKA

Volkswagen Golf 2.0T GTI 5dr

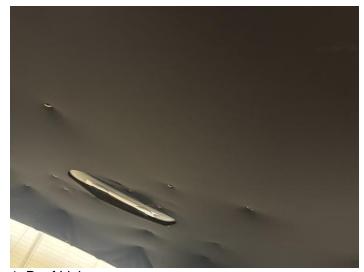
1: Roof Lining Torn Over 3mm

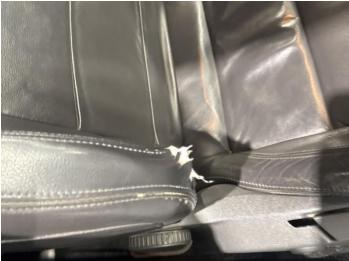
2: Seat Back Cover osf Torn Over 3mm

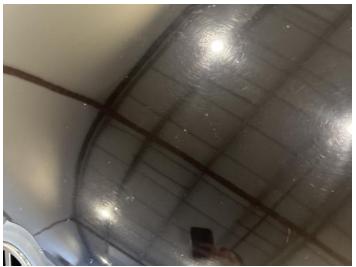
3: Bonnet Chipped Multiple Chips

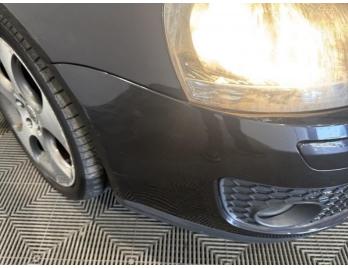
4: Bumper Front Scratched Over 100mm Thru Paint

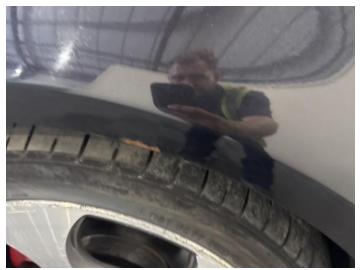
5: Wing nsf Rusted Over 5mm

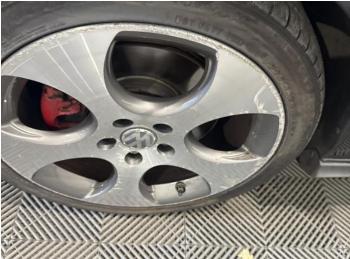
6: Wheel nsf Scratched Over 50mm

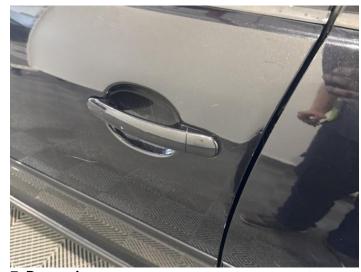
7: Door nsf Dented With Paint Damage

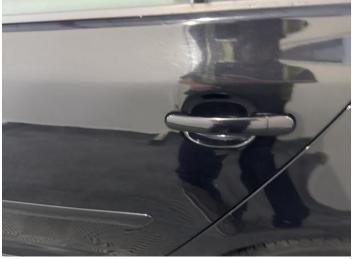
8: Door nsr Dented Over 30mm

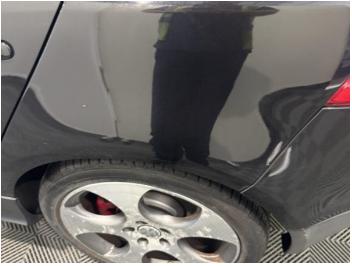
9: Qtr Panel nsr Dented With Paint Damage

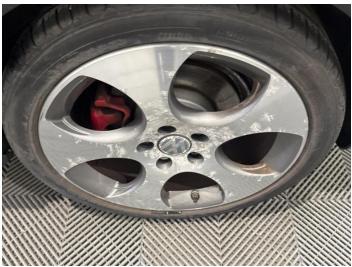
10: Wheel nsrScratchedOver 50mm

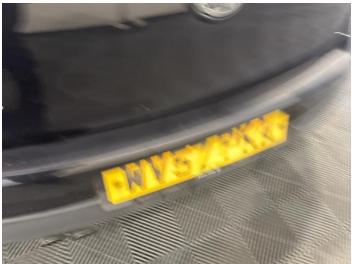
11: Bumper Rear Poor Previous Repair Poor Paint

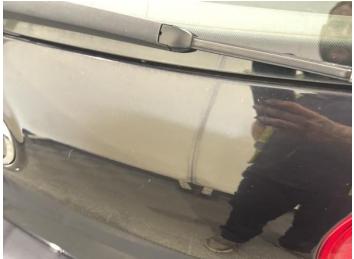
12: Boot Lid Dented Over 2 UpTo 10mm

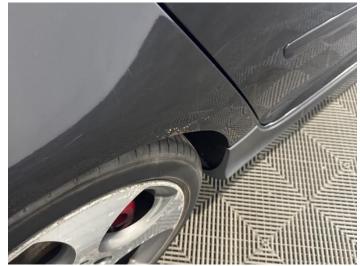
13: Qtr Panel osr Rusted Over 5mm

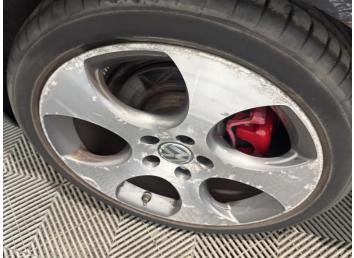
14: Wheel osr Scratched Over 50mm

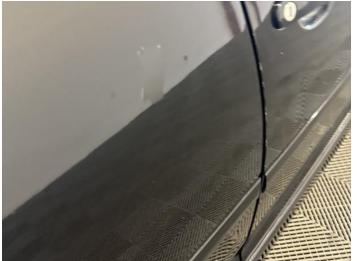
15: Door osr Poor Previous Repair Paint Flake

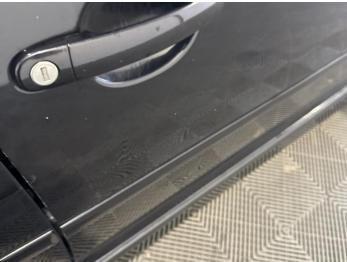
16: Door osf Dented Over 30mm

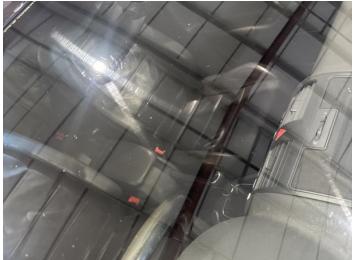
17: Screen Front Chipped UpTo 10mm

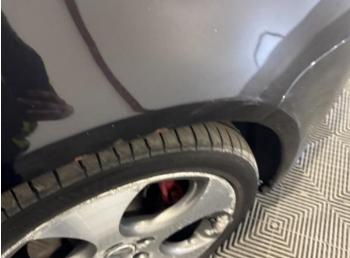
18: Wing osf Rusted Over 5mm

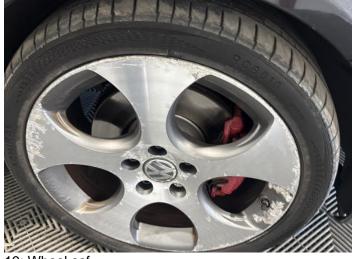
19: Wheel osf Scratched Over 50mm
