VEHICLE INSPECTION REPORT

PX61UJS

Nissan Qashqai 1.5 dCi [110] N-Tec 5dr

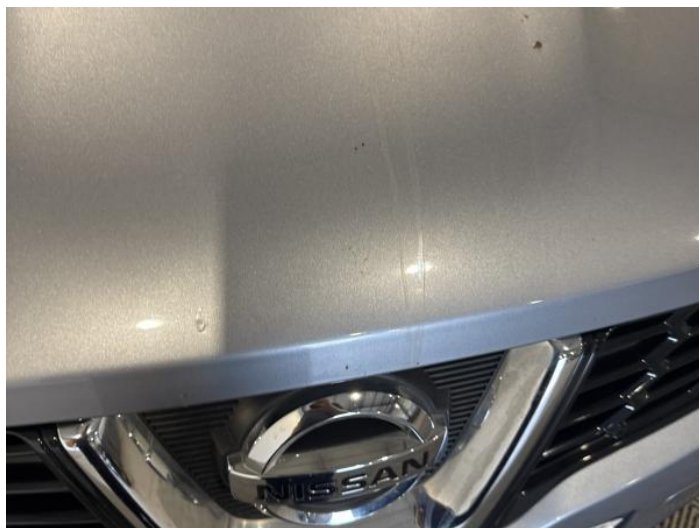
2: Bonnet
Chipped
Multiple Chips

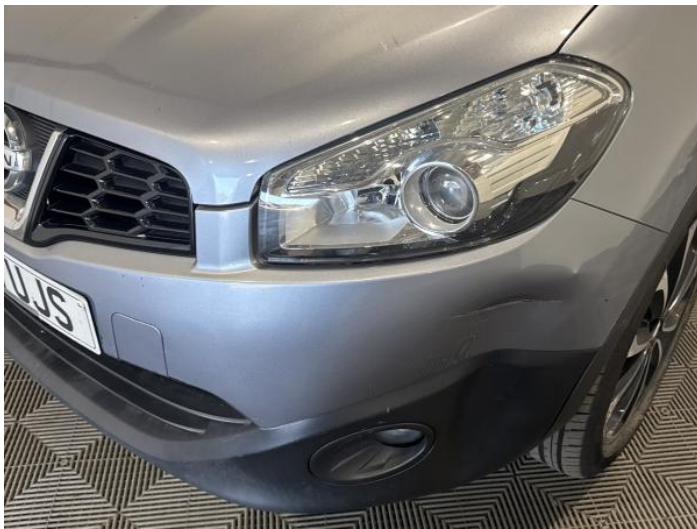
3: Bumper Front
Dented
With Paint Damage

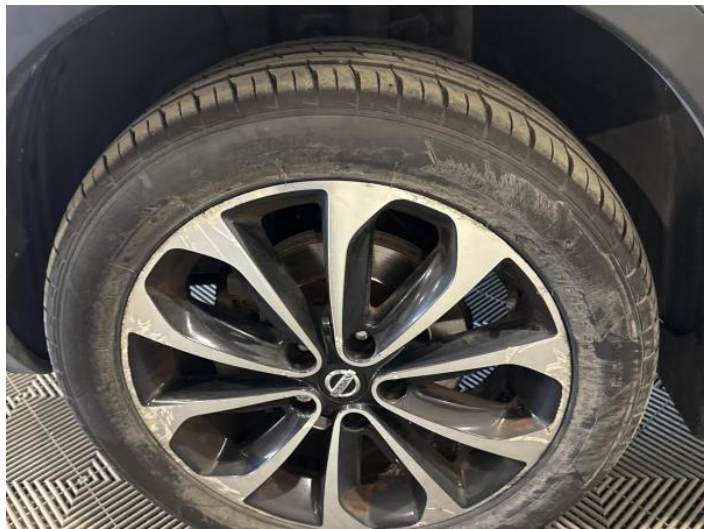
4: Wheel nsf
Scratched
Over 50mm

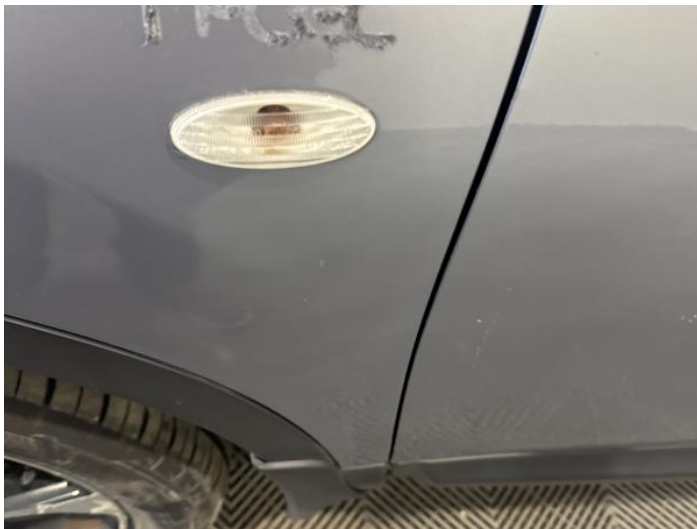
5: Wing nsf
Chipped
1 To 5

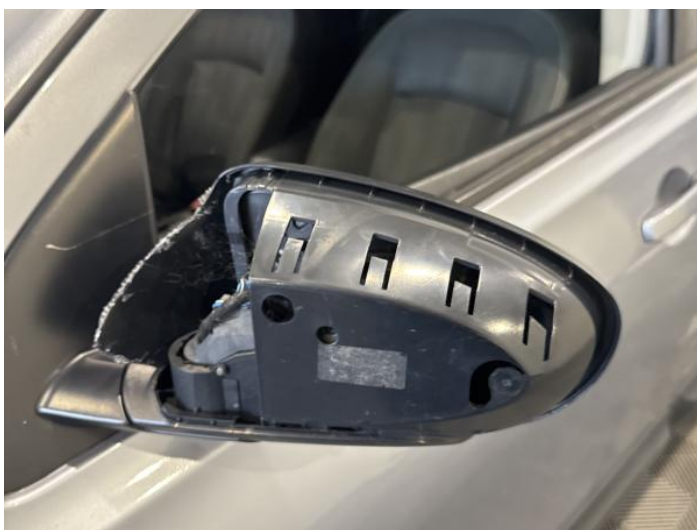
7: Door Mirror Assy nsf
Broken
Replace

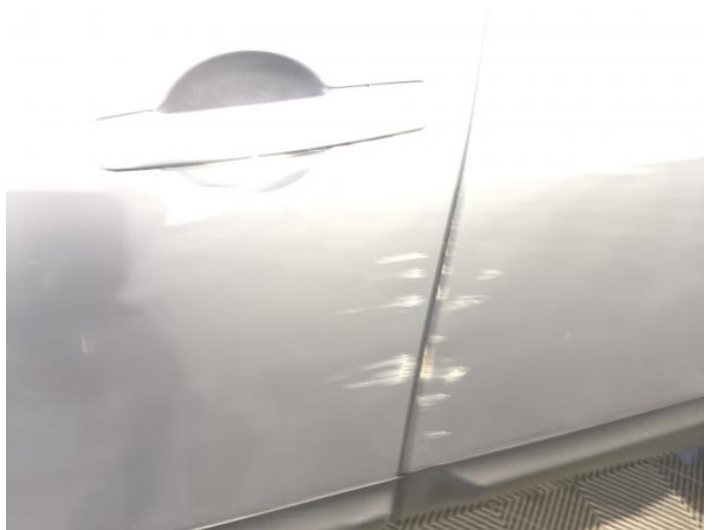
8: Door nsf
Dented
With Paint Damage

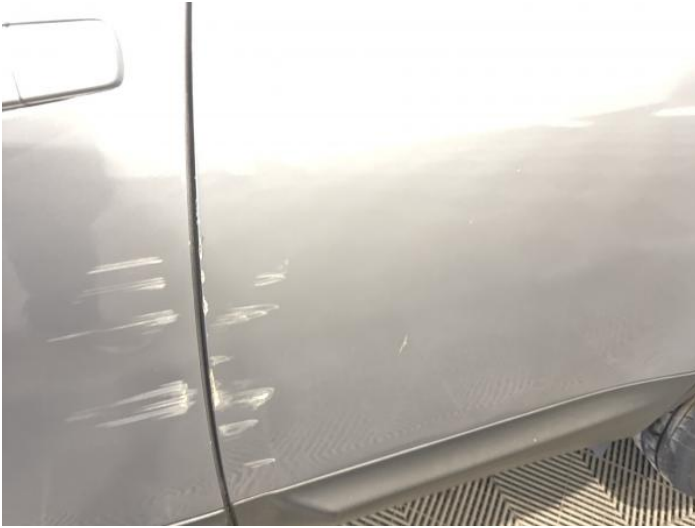
9: Door nsr
Dented
With Paint Damage

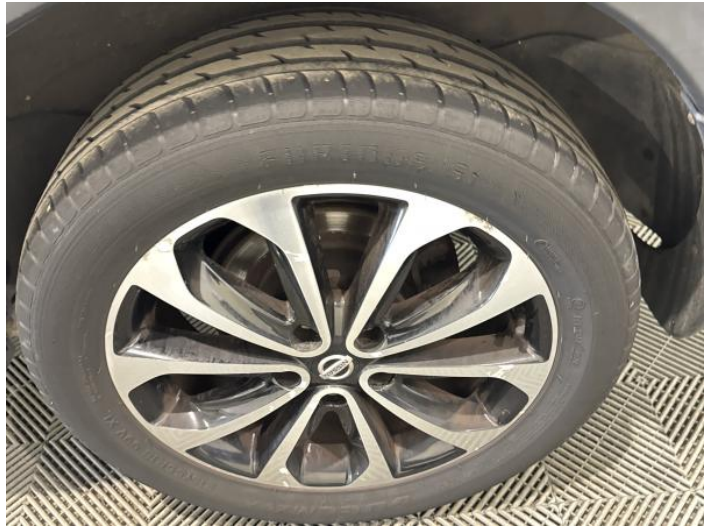
10: Wheel nsr
Scratched
Over 50mm

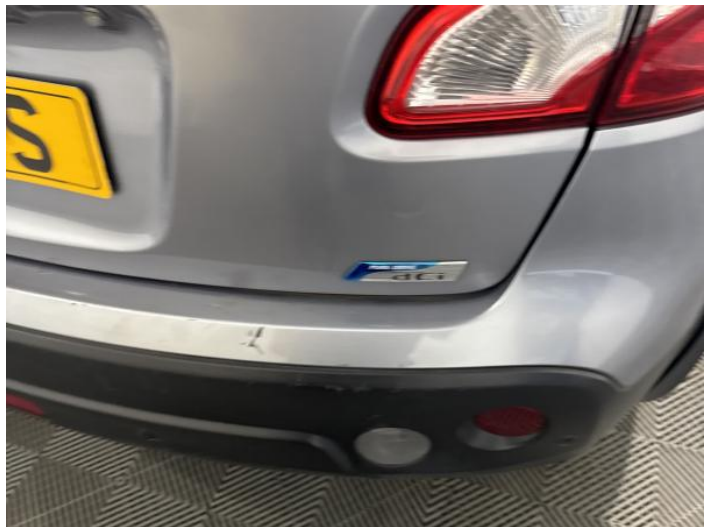
12: Bumper Rear
Scratched
Over 100mm Thru Paint

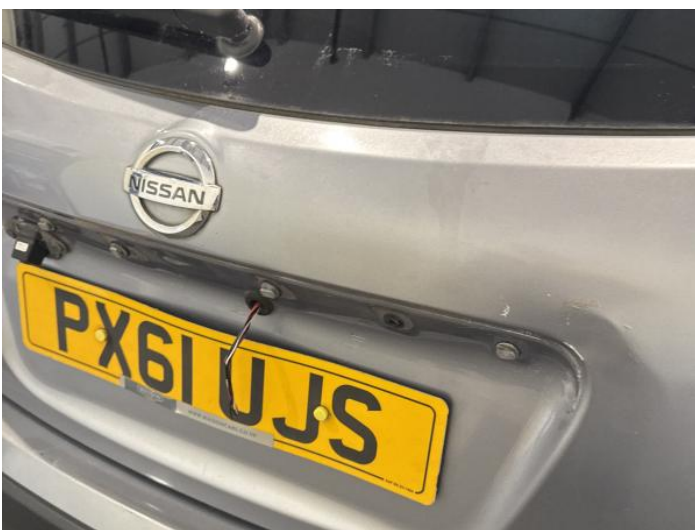
13: Boot Lid
Dented
With Paint Damage

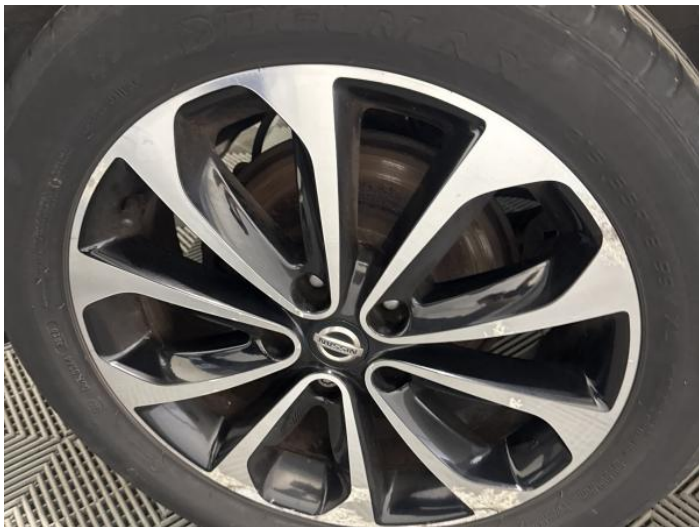
15: Wheel osr
Scratched
Over 50mm

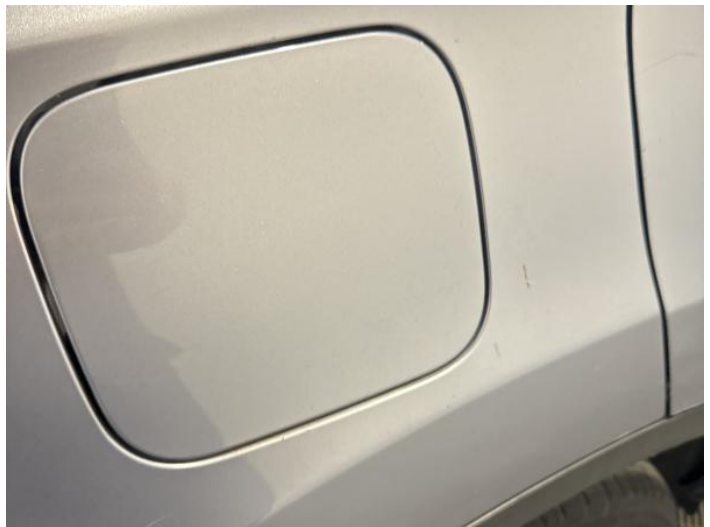
16: Qtr Panel osr
Chipped
1 To 5

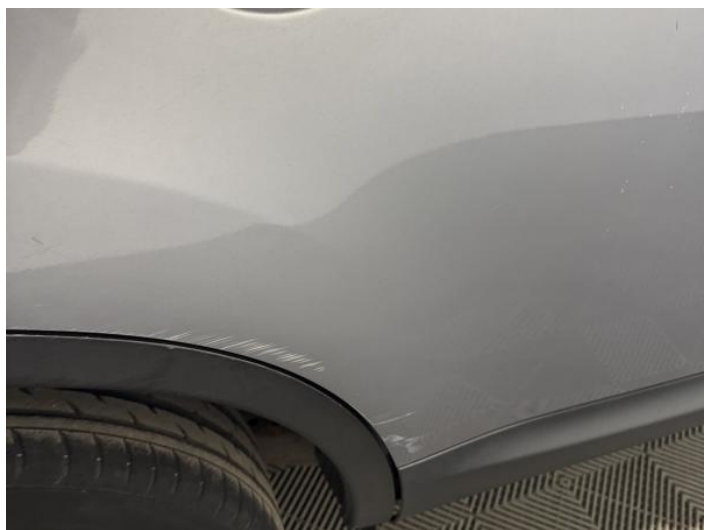
18: Door osr
Dented
With Paint Damage

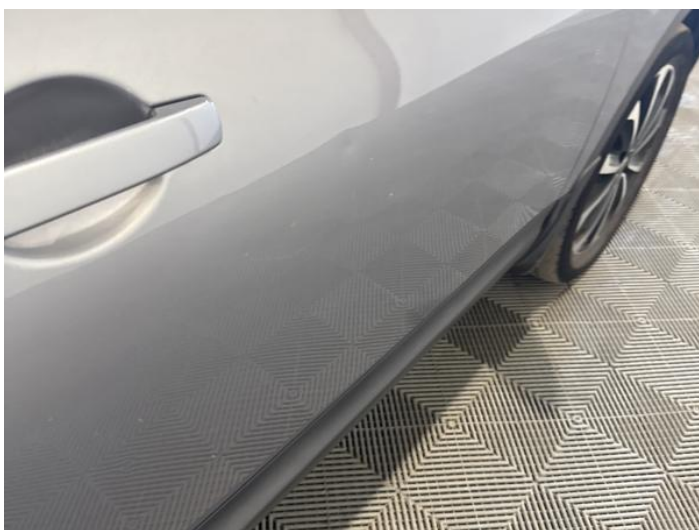
19: Door osf
Dented
With Paint Damage

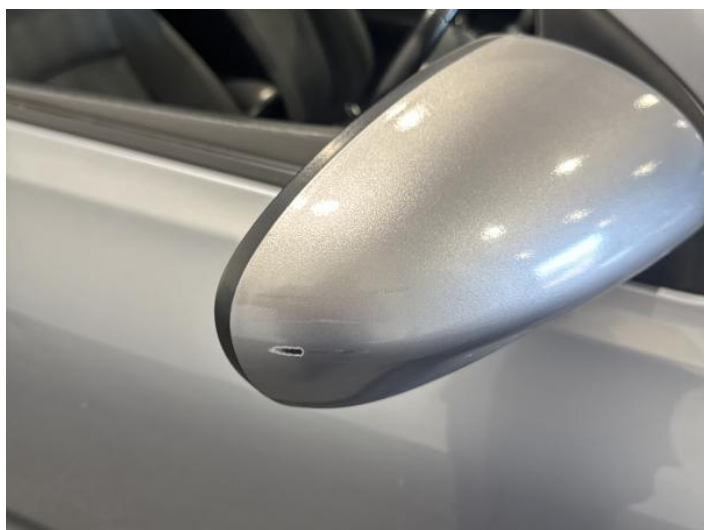
20: Door Mirror Assy osf
Scratched (Painted)
Over 25mm Thru Paint

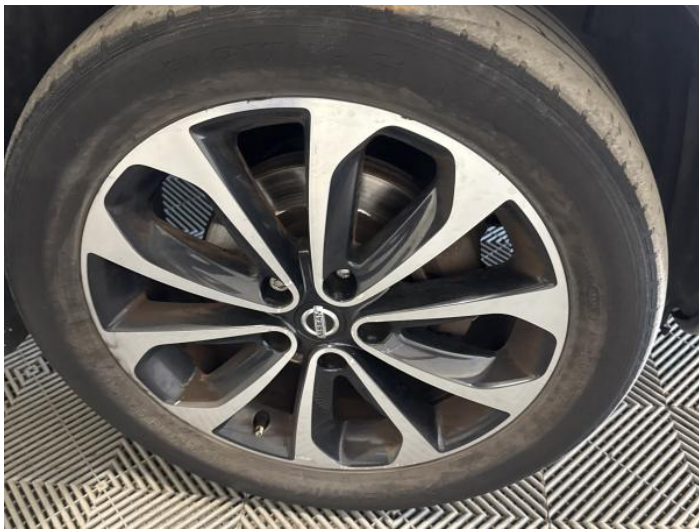
21: Wheel osf
Scratched
Over 50mm

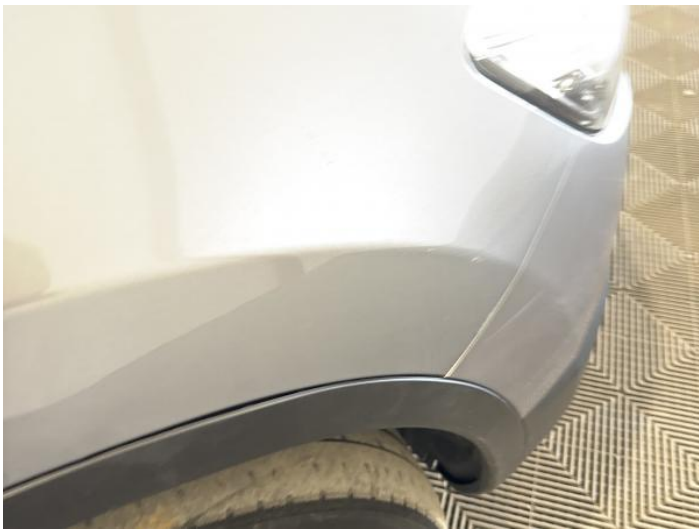
22: Wing osf
Chipped
1 To 5
