VEHICLE INSPECTION REPORT

HN07XET

Nissan Pathfinder 2.5 dCi Aventura 5dr

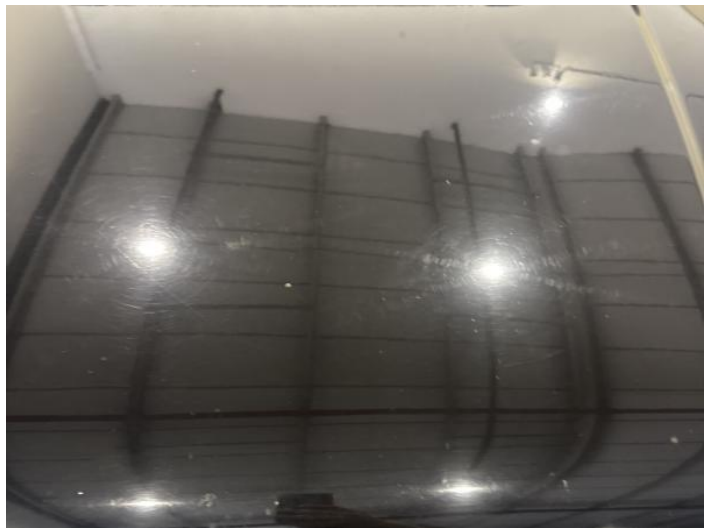
2: Bonnet
Chipped
Multiple Chips

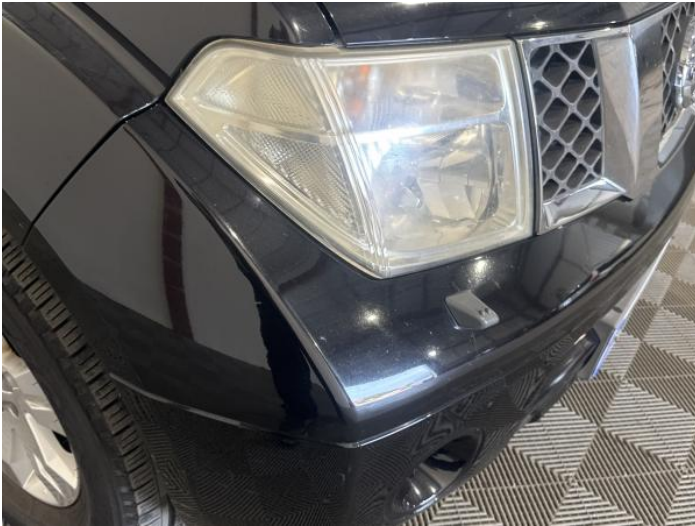
3: Bumper Front
Scratched
Over 100mm Thru Paint

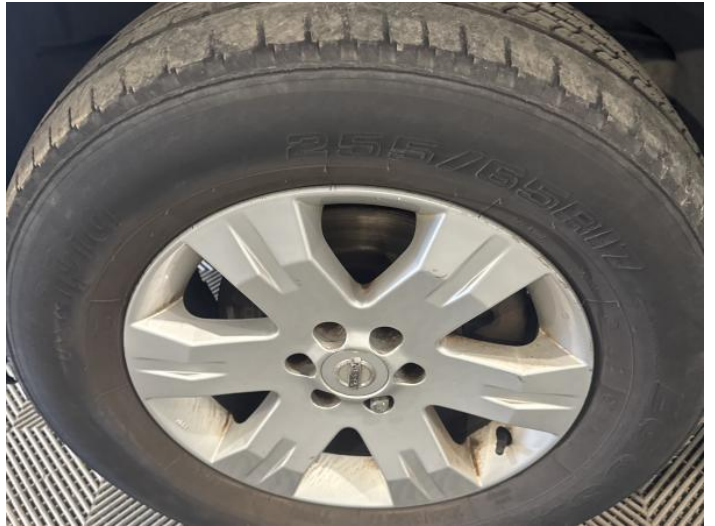
4: Wheel nsf
Scratched
Over 50mm

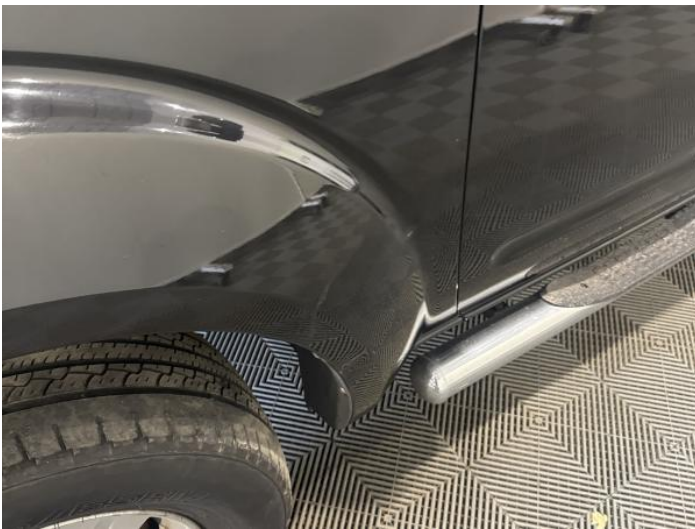
5: Wing nsf
Dented
With Paint Damage

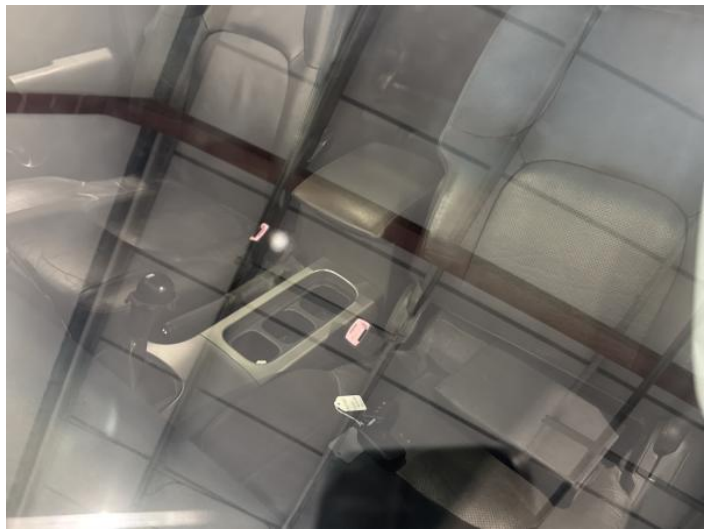
6: Screen Front
Chipped
UpTo 10mm

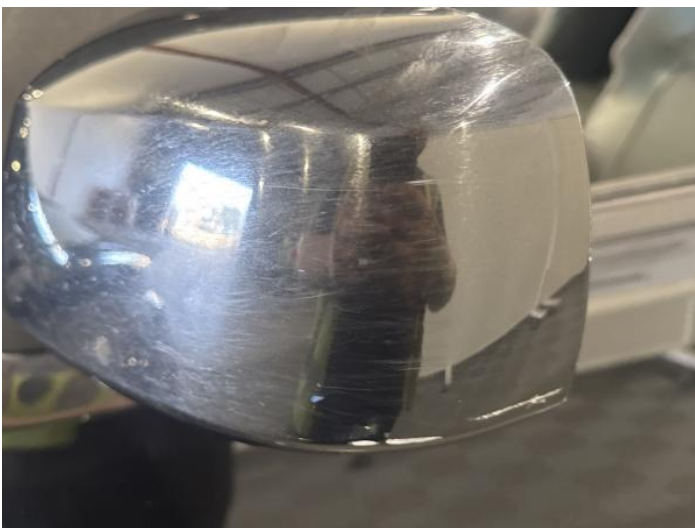
7: Door Mirror Assy nsf
Scratched (Painted)
Over 25mm Thru Paint

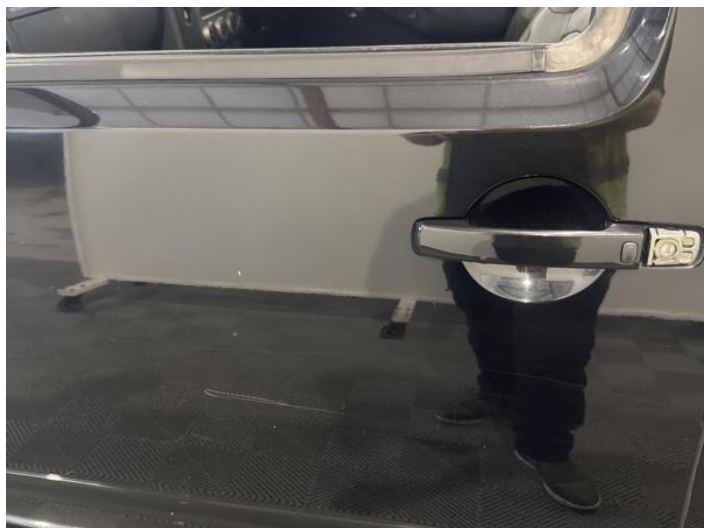
8: Door nsf
Dented
With Paint Damage

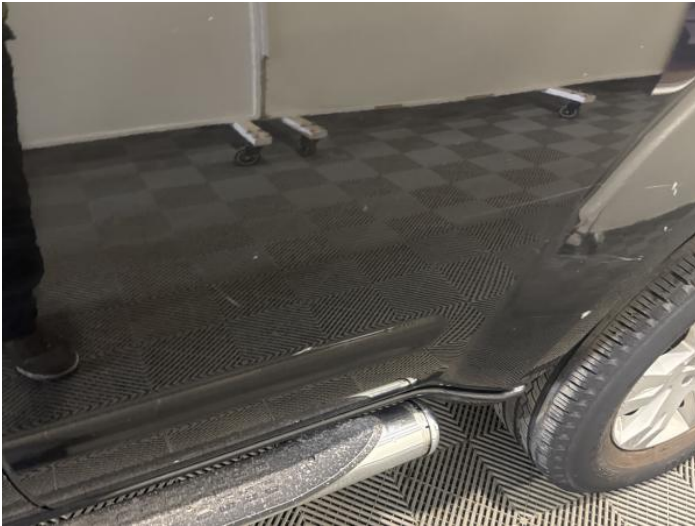
9: Door nsr
Dented
With Paint Damage

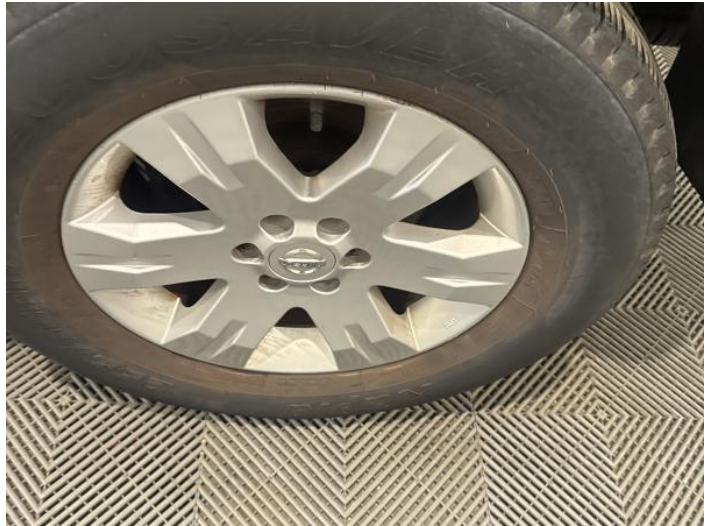
10: Wheel nsr
Scratched
Over 50mm

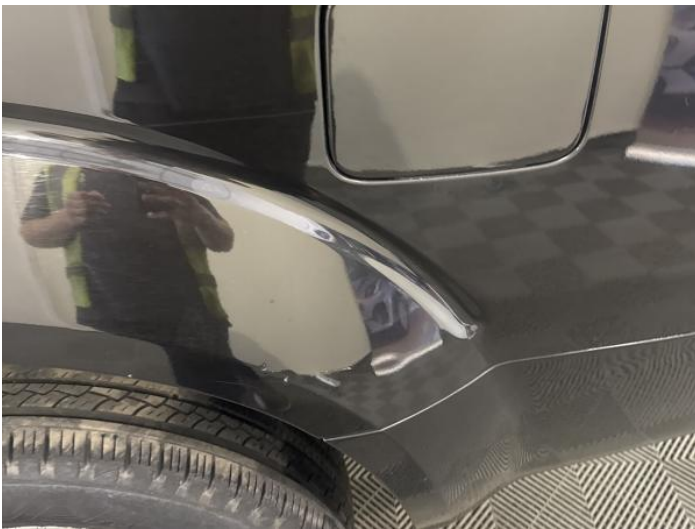
11: Qtr Panel nsr
Dented
With Paint Damage

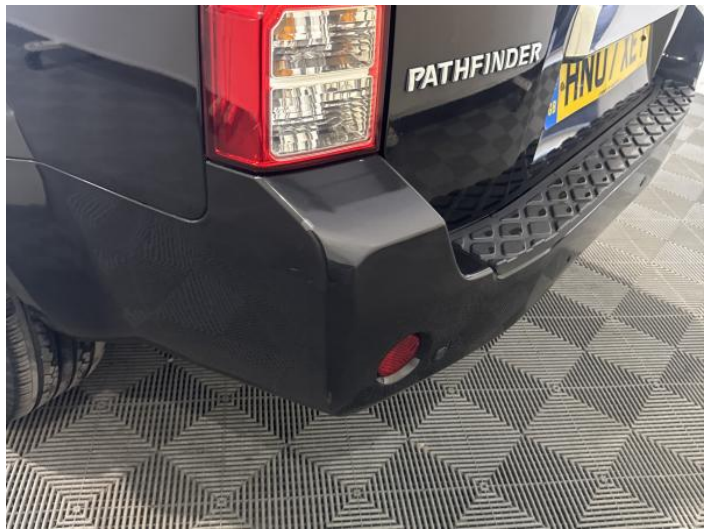
12: Bumper Rear
Scratched
Over 100mm Thru Paint

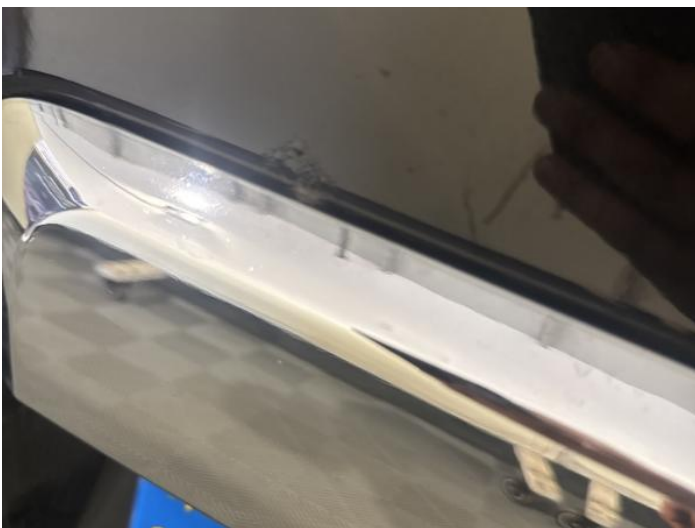
13: Boot Lid
Rusted
UpTo 5mm

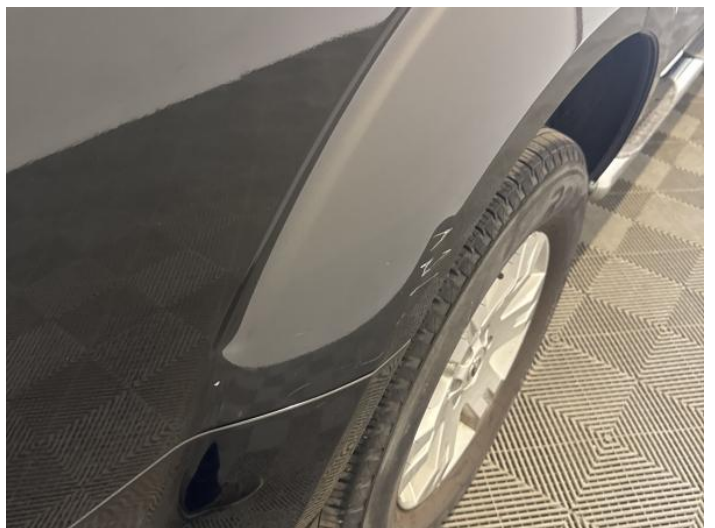
14: Qtr Panel osr
Dented
With Paint Damage

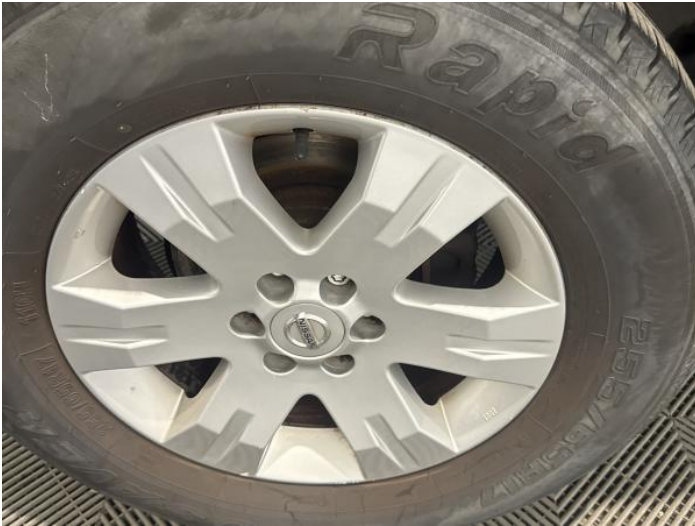
15: Wheel osr
Scratched
Over 50mm

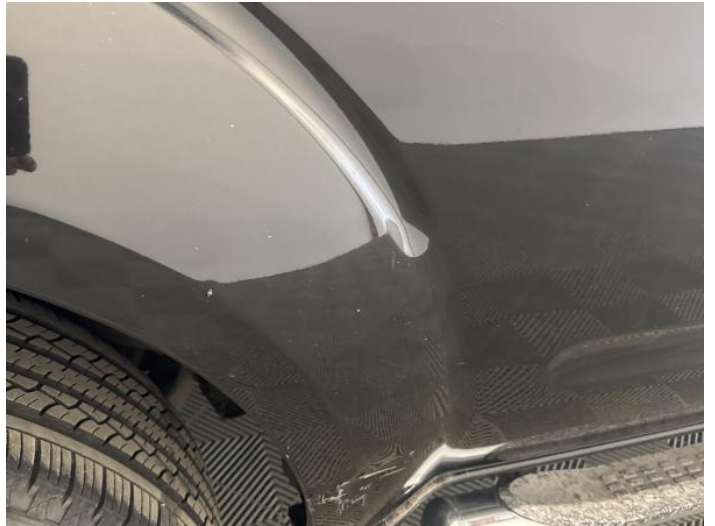
16: Qtr Panel osr
Dented
With Paint Damage

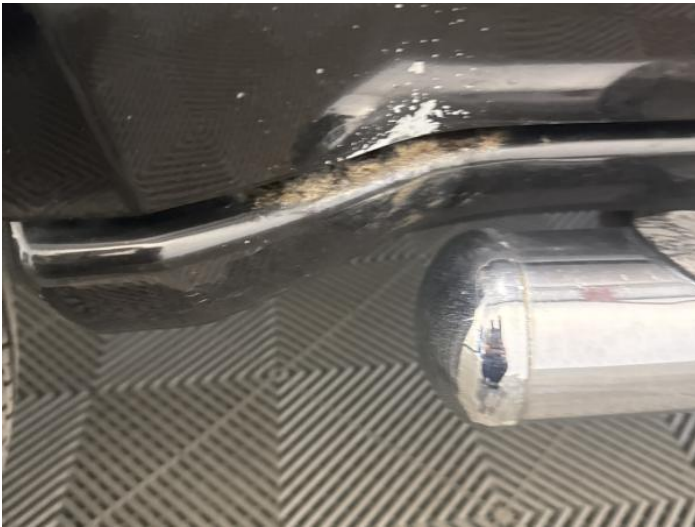
17: Sill os
Rusted
Over 5mm

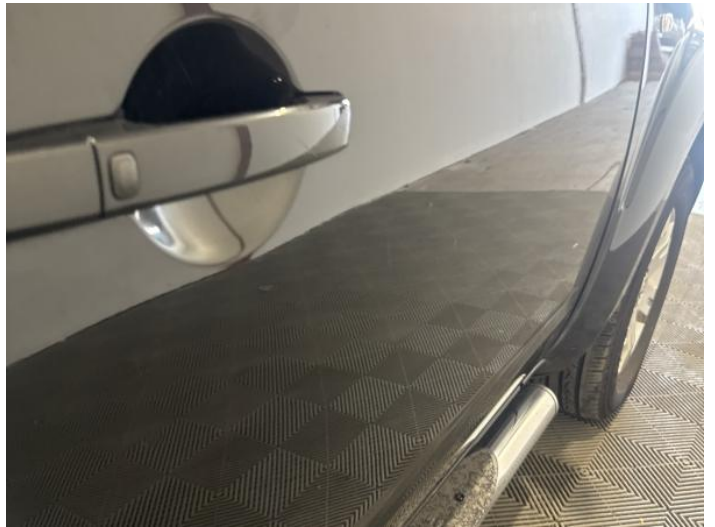
18: Door osf
Chipped
1 To 5

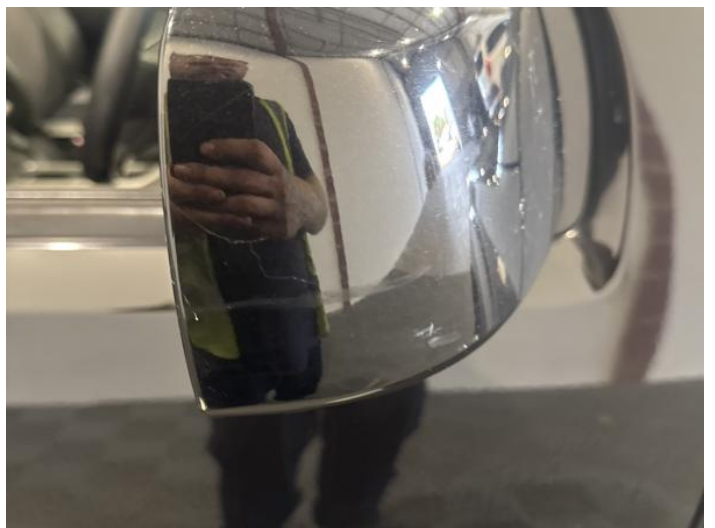
20: Door Mirror Assy osf
Scratched (Painted)
UpTo 25mm Thru Paint

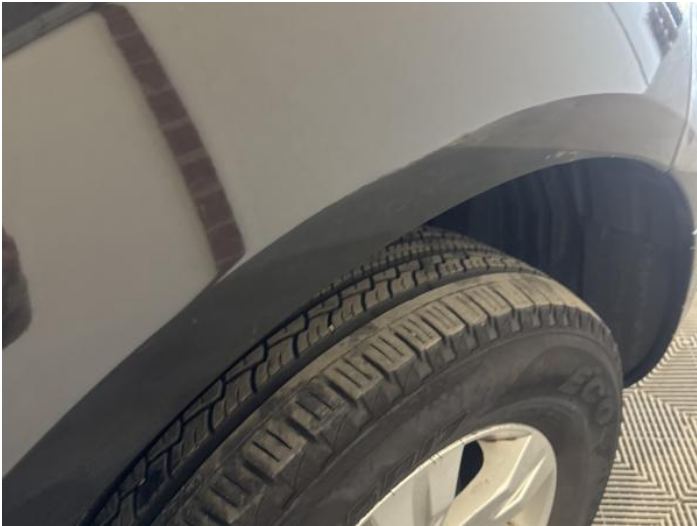
21: Wing osf
Chipped
1 To 5

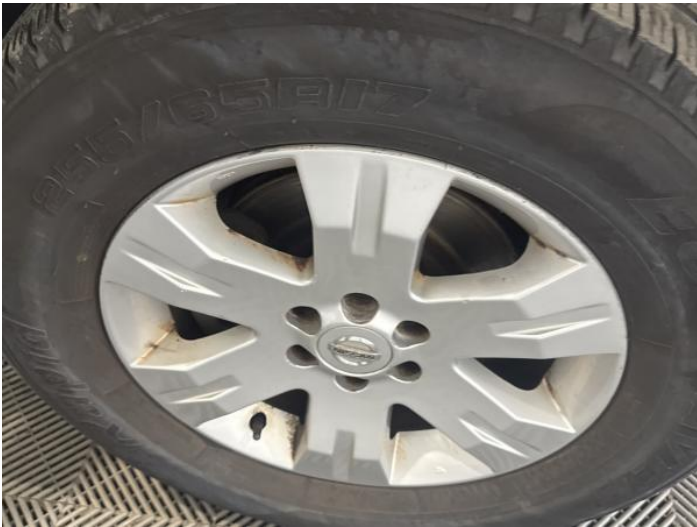
23: Wheel osf
Scratched
Over 50mm

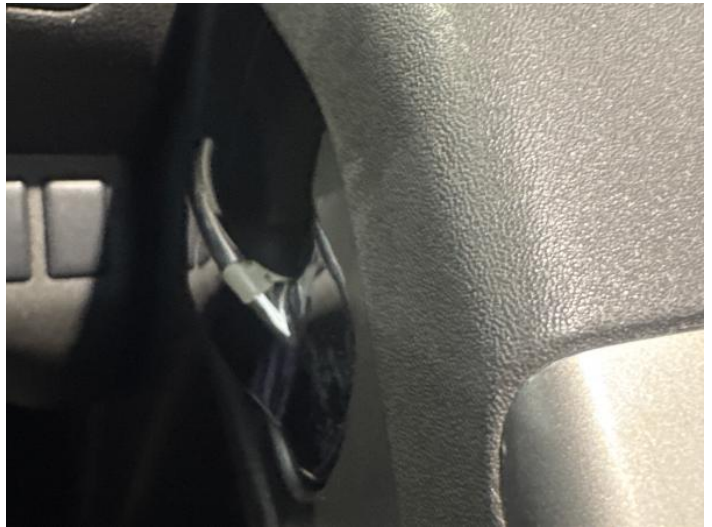
24: Handle Inner osf
Damaged
Replace

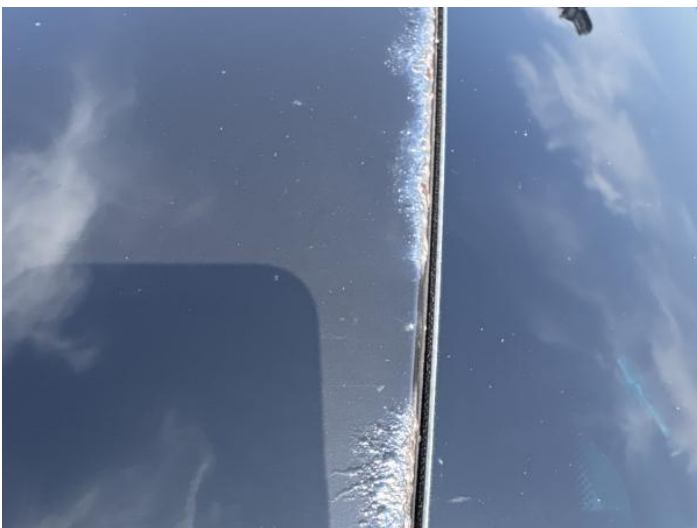
25: Roof
Rusted
Over 5mm

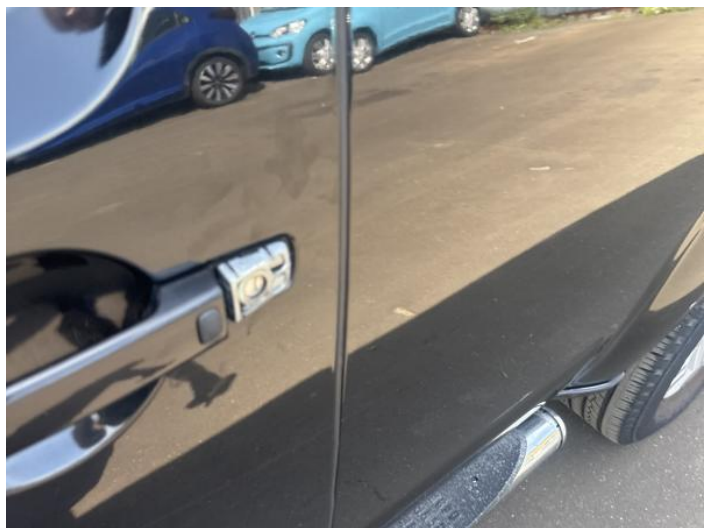
26: Handle Outer nsf
Broken
Replace
