# VEHICLE INSPECTION REPORT

**HV11UPY**

## BMW 3 Series 318i ES 4dr

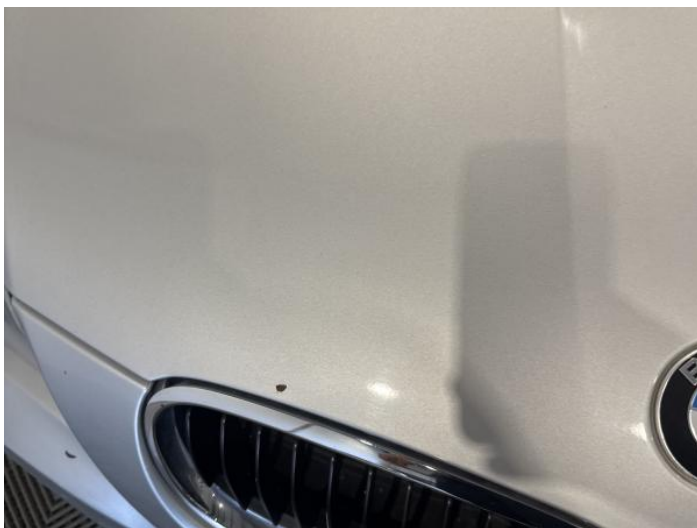
1: Bonnet  
Chipped  
Over 5mm

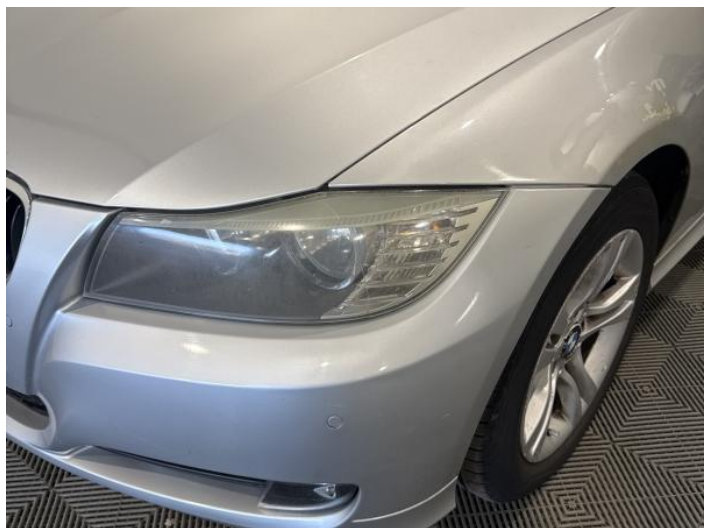
2: Bumper Front  
Scratched  
Over 100mm Thru Paint

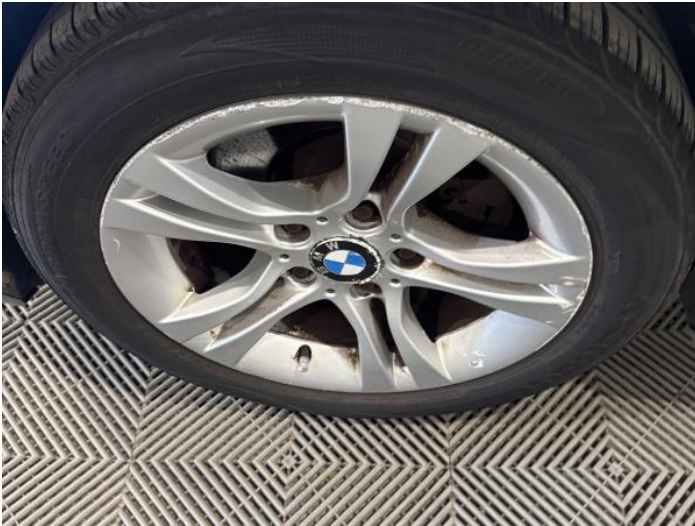
3: Wheel nsf  
Scratched  
Over 50mm

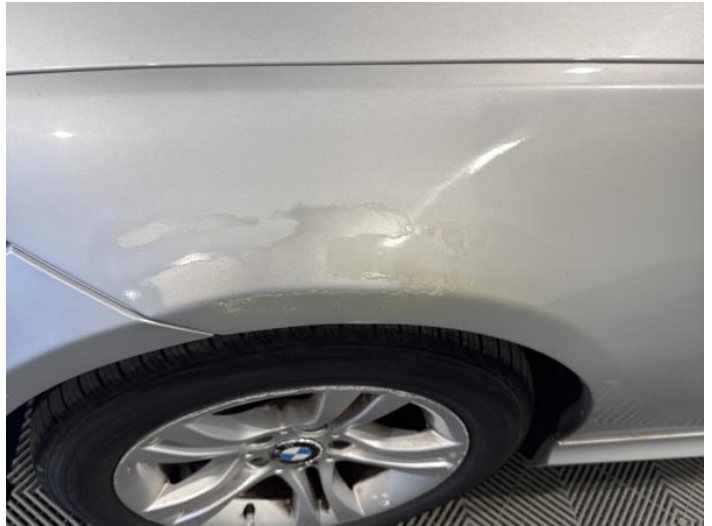
4: Wing nsf  
Poor Previous Repair  
Poor Paint

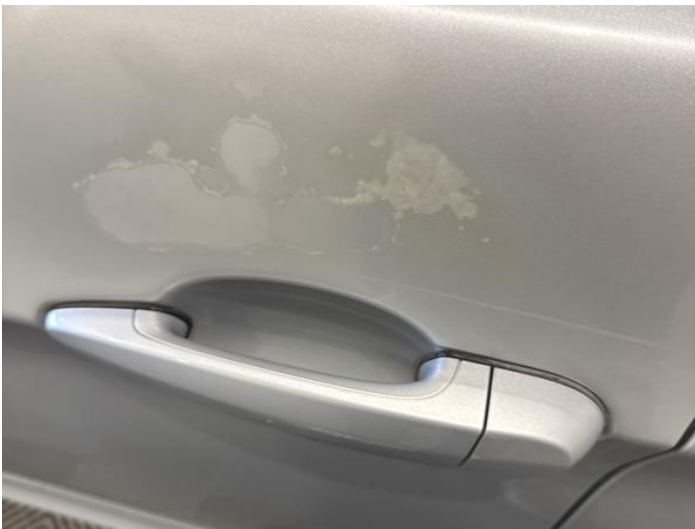
5: Door nsf  
Poor Previous Repair  
Poor Paint

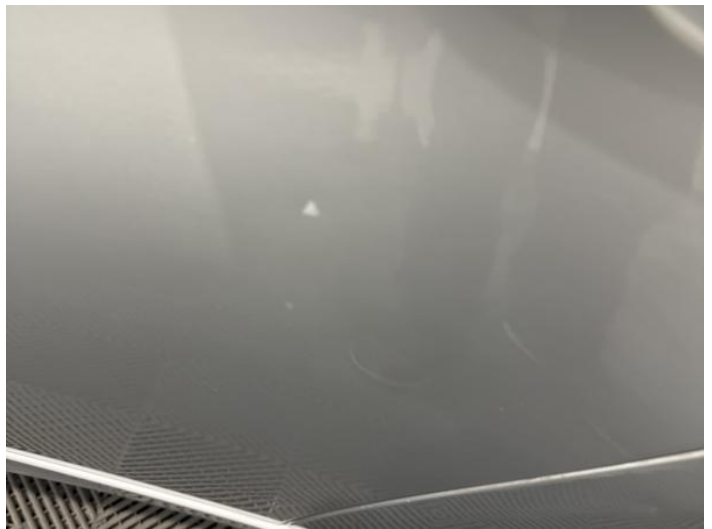
6: Door nsr  
Dented  
Between 10mm + 30mm

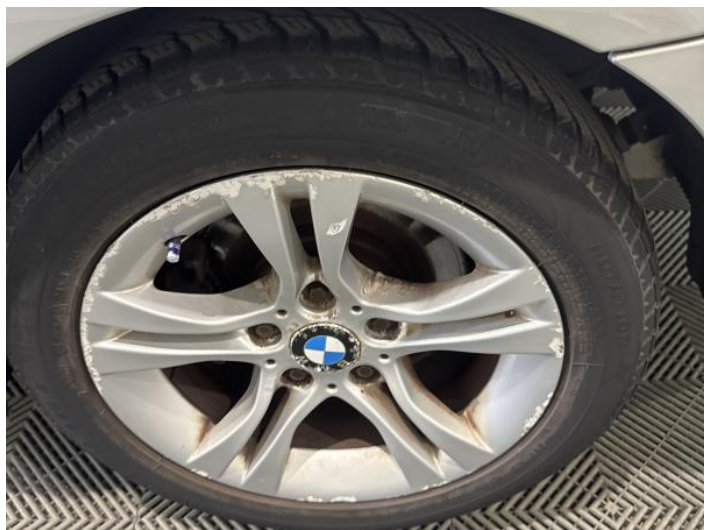
8: Wheel nsr  
Scratched  
Over 50mm

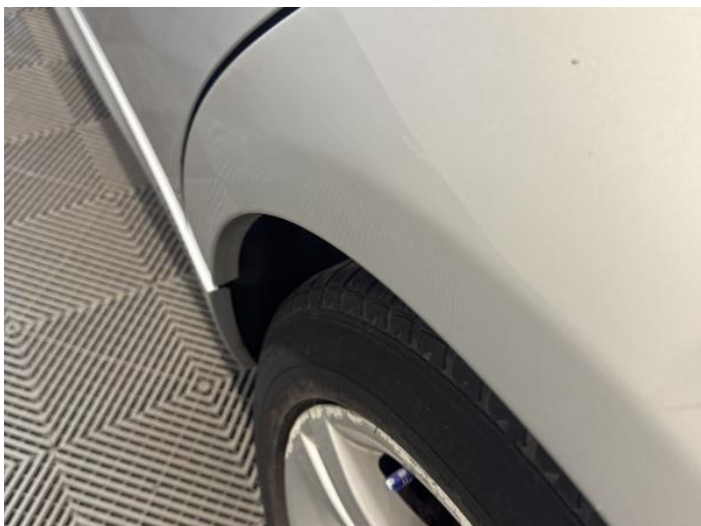
9: Qtr Panel nsr  
Dented  
Between 10mm + 30mm

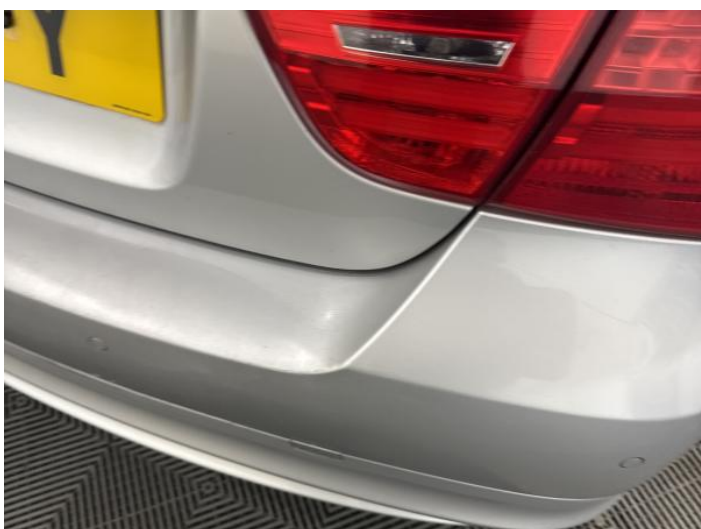
11: Bumper Rear  
Poor Previous Repair  
Poor Paint

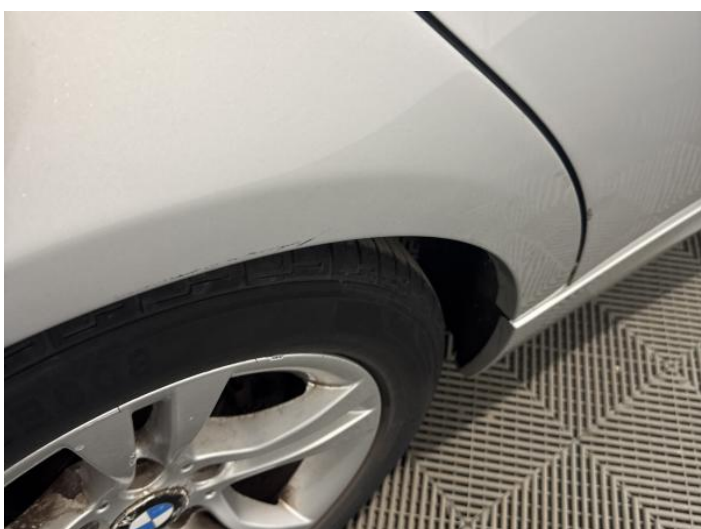
13: Qtr Panel osr  
Dented  
With Paint Damage

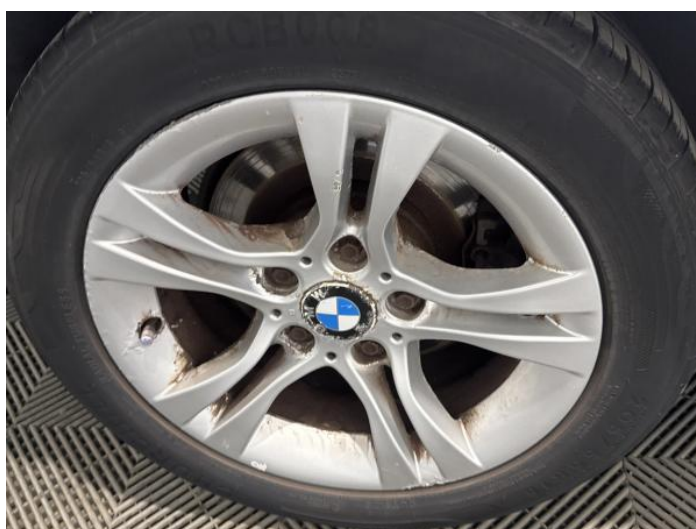
14: Wheel osr  
Scratched  
Over 50mm

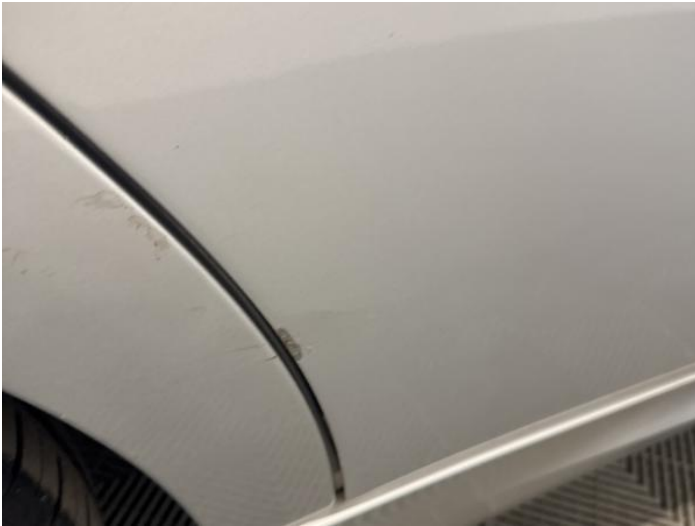
15: Door osr  
Scratched  
UpTo 25mm Thru Paint

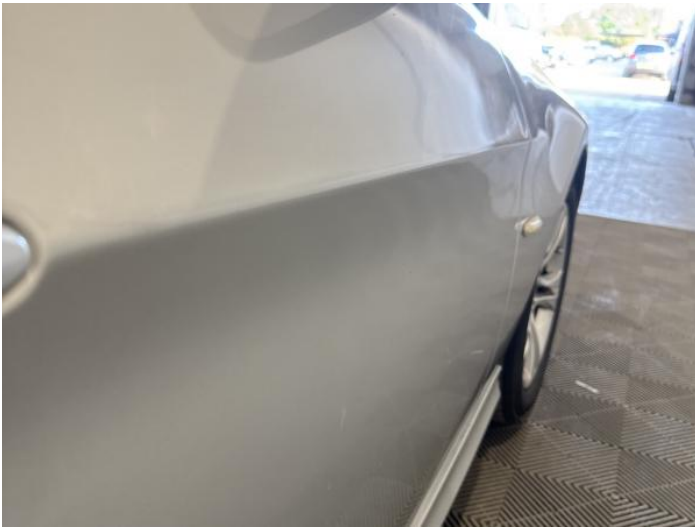
17: Door osf  
Dented  
With Paint Damage

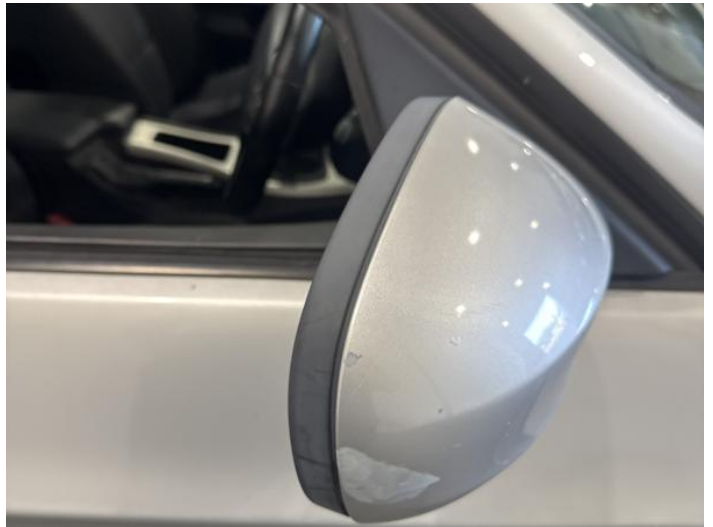
18: Door Mirror Assy osf  
Scratched (Painted)  
Over 25mm Thru Paint

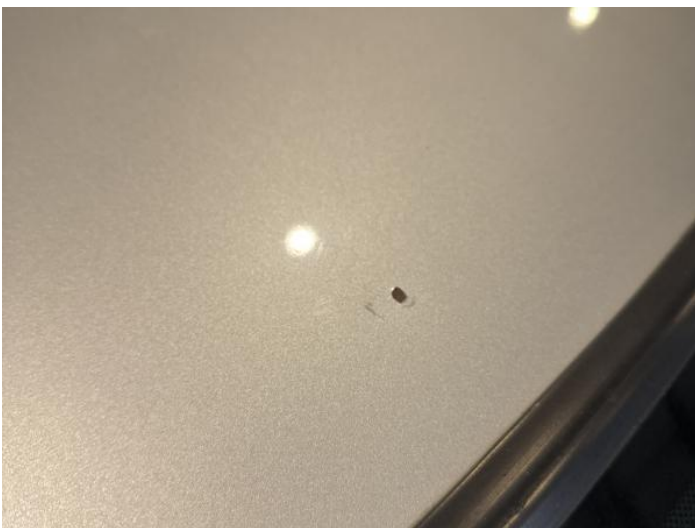
19: Roof  
Chipped  
1 To 5

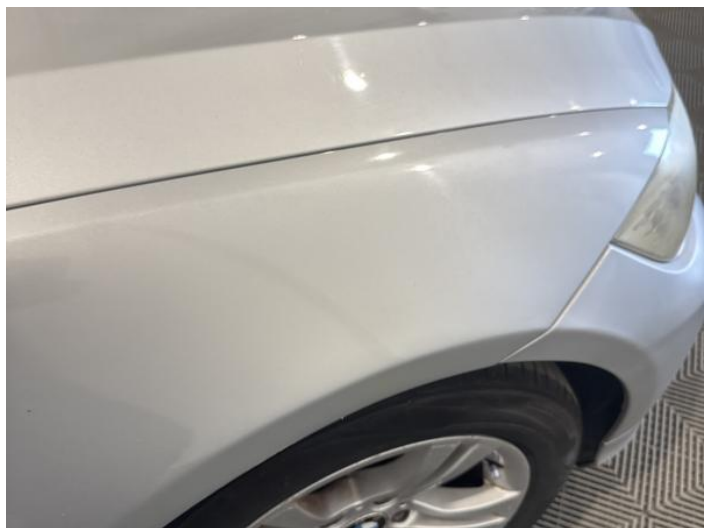
20: Wing osf  
Poor Previous Repair  
Poor Paint

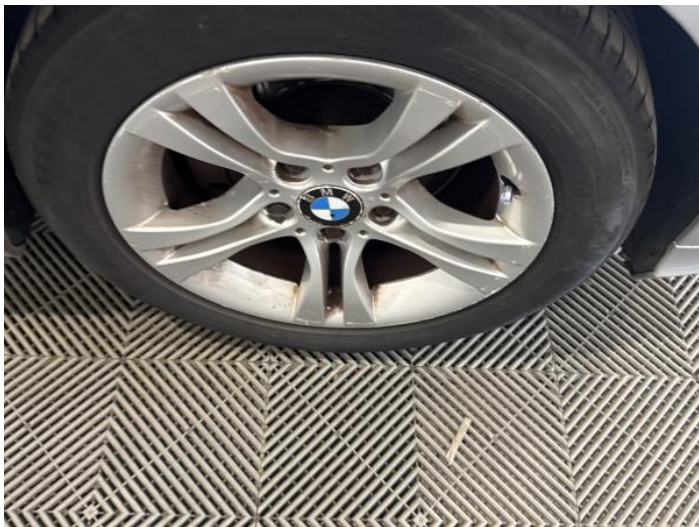
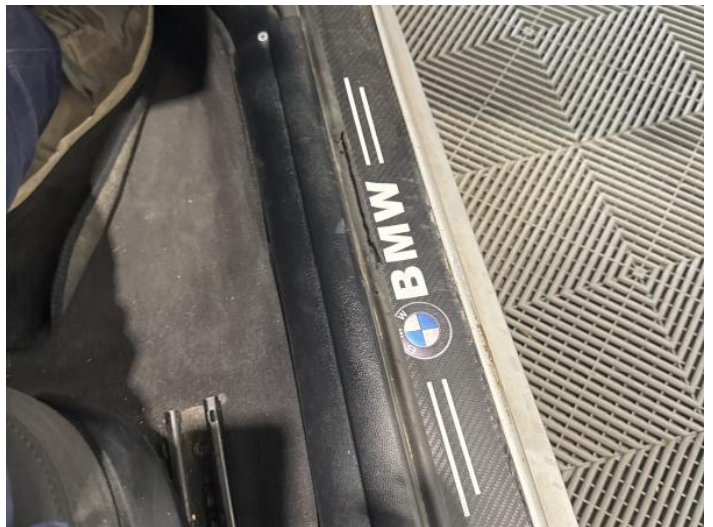
21: Wheel osf  
Scratched  
Over 50mm
