VEHICLE INSPECTION REPORT

AU15NNZ

Renault Scenic 1.6 dCi Limited Energy 5dr

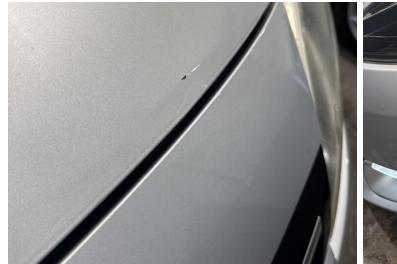
1: Bonnet Dented With Paint Damage

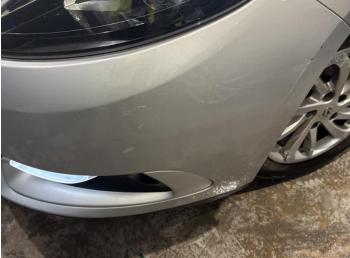
2: Bumper Front Dented With Paint Damage

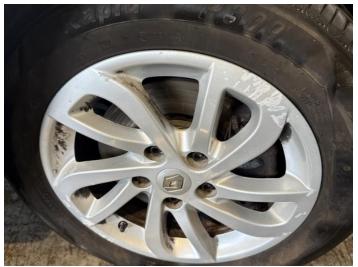
3: Wheel osf Scratched Over 50mm

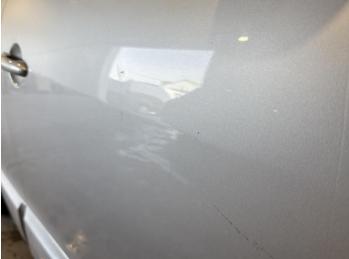
4: Door osf Dented With Paint Damage

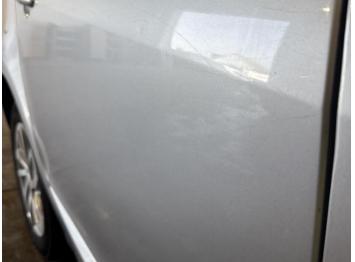
5: Door osr Dented Between 10mm + 30mm

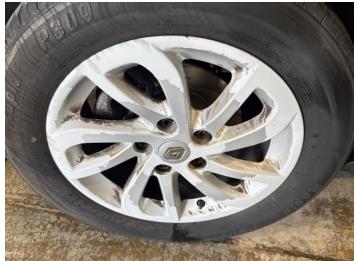
6: Wheel osr Scratched Over 50mm

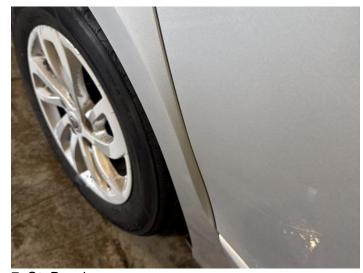
7: Qtr Panel osr Dented Between 10mm + 30mm

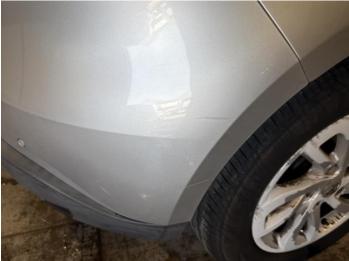
8: Bumper Rear Scratched Over 100mm Thru Paint

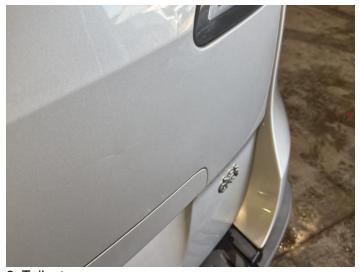
9: Tailgate Scratched Over 25mm Thru Paint

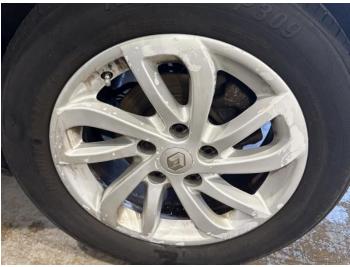
10: Wheel nsr Scratched Over 50mm

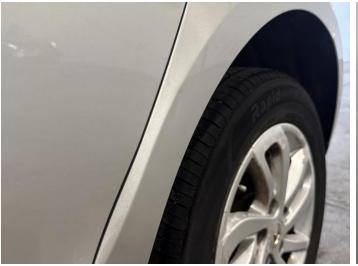
11: Qtr Panel nsr Dented Between 10mm + 30mm

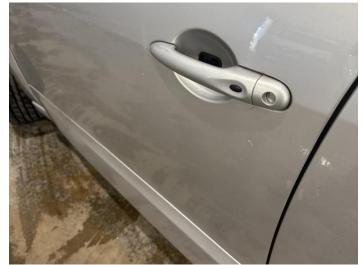
13: Door nsf Scratched Over 25mm Thru Paint

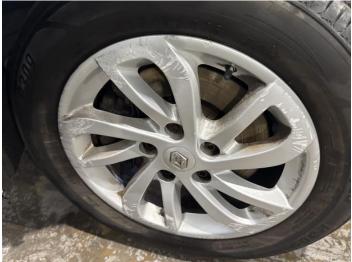
14: Wheel nsf Scratched Over 50mm

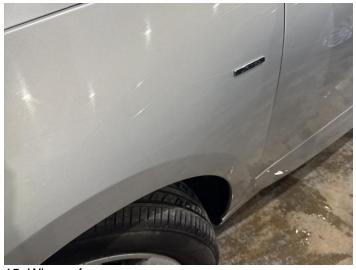
15: Wing nsf Scratched Over 25mm Thru Paint

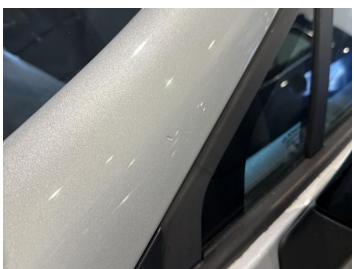
16: A Post ns Chipped 1 To 5

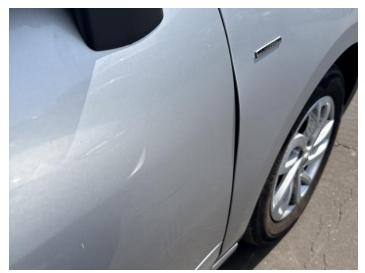
17: Wing osf Dented Over 30mm
