VEHICLE INSPECTION REPORT

HK64FLR

Ford Focus 1.0 EcoBoost Titanium Navigator 5dr

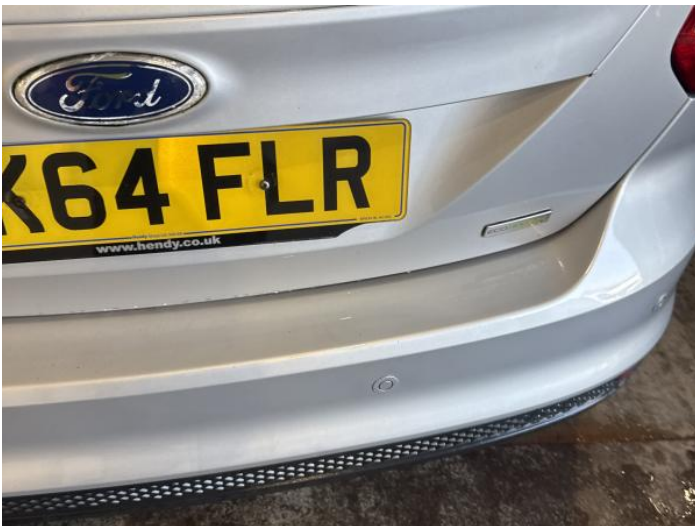
1: Bumper Rear
Scratched
25 to 100mm Thru Paint

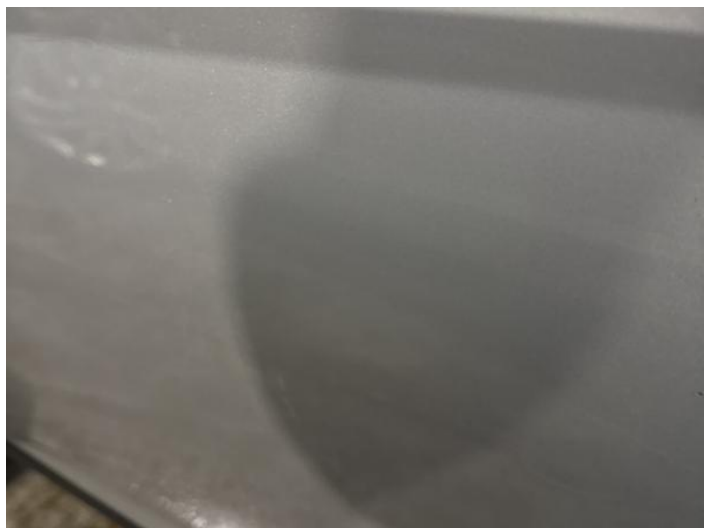
7: Door nsr
Scratched
Over 25mm Not Thru Paint

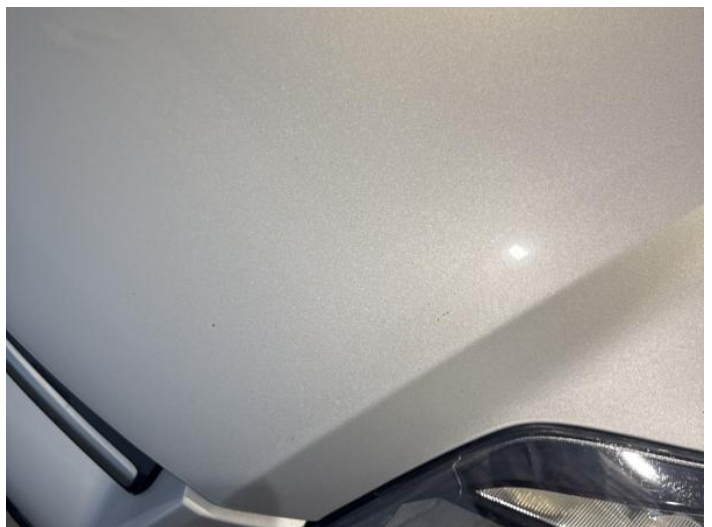
13: Bumper Front
Scratched
Over 25mm Not Thru Paint

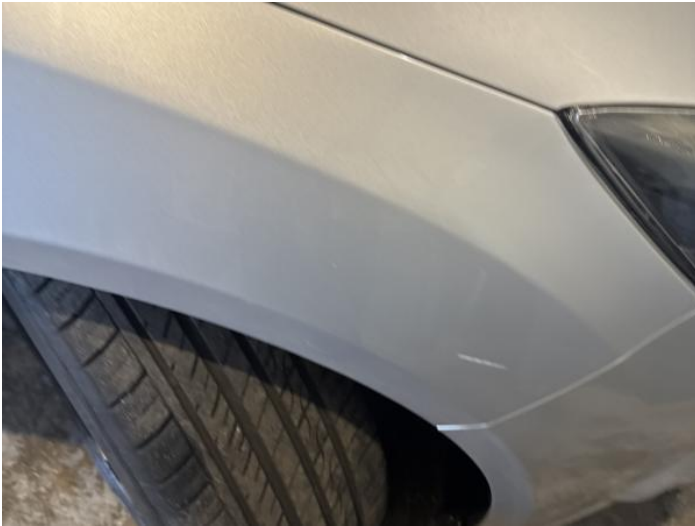
15: Wing osf
Chipped
1 To 5

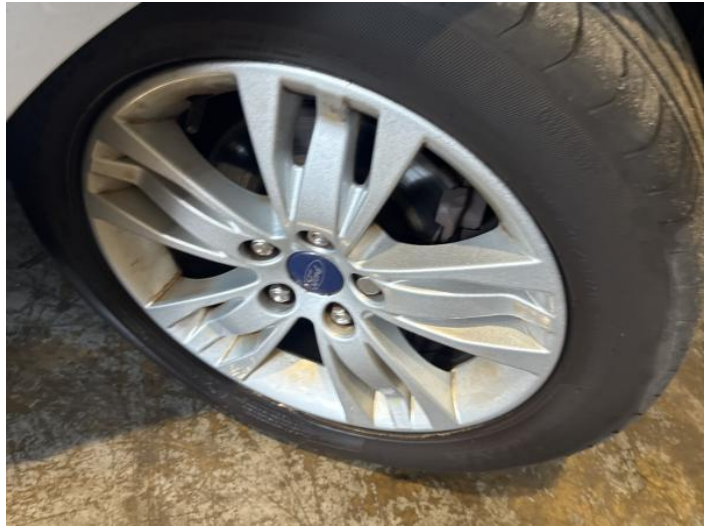
16: Wheel osf
Scratched
Up To 50mm

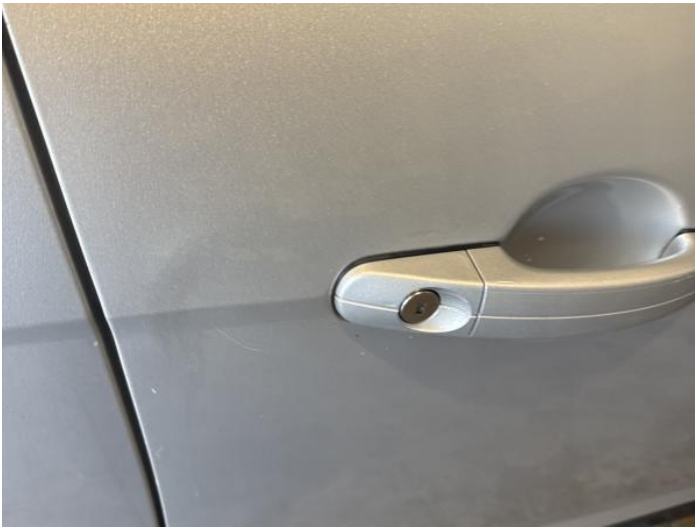
17: Door osf
Dented
Over 30mm

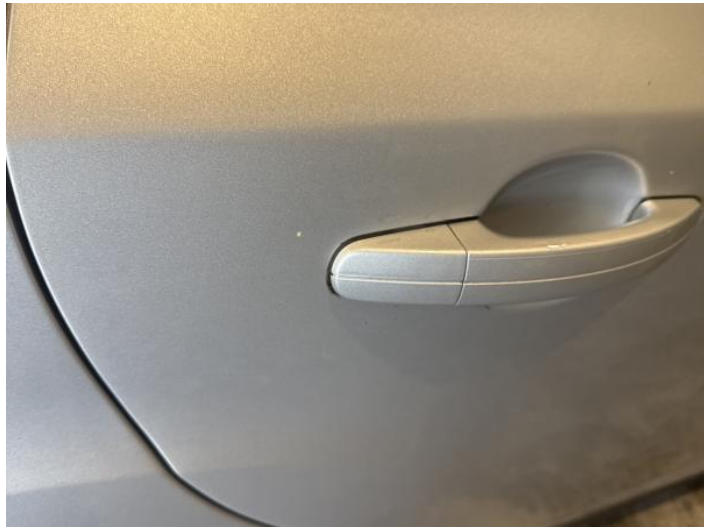
18: Door osr
Chipped
1 To 5

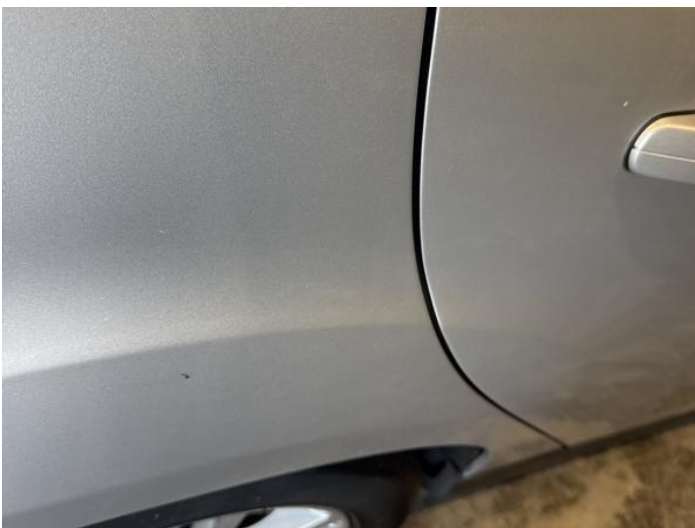
19: Qtr Panel osr
Dented
2 Or Less UpTo 10mm

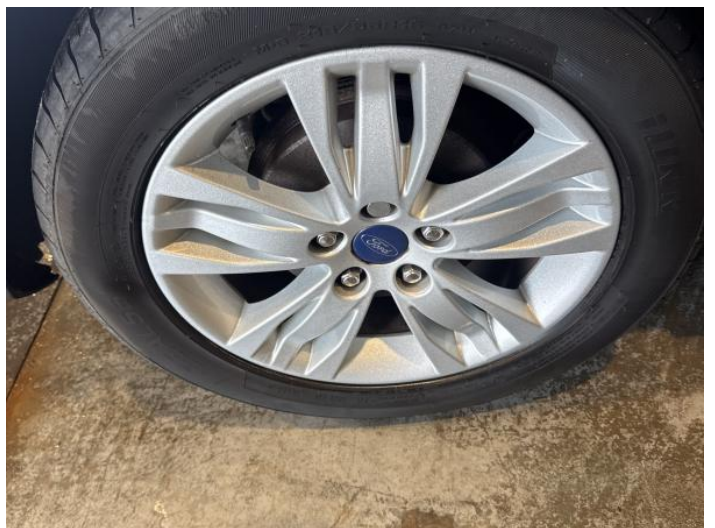
20: Wheel osr
Scratched
Up To 50mm
