VEHICLE INSPECTION REPORT

EJ65HCO

Volvo XC60 D5 [220] SE Lux Nav 5dr AWD Geartronic

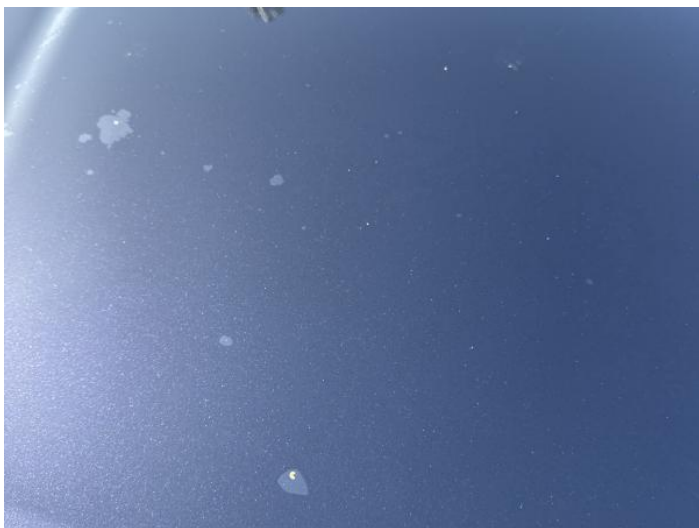
1: Bonnet
Chipped
1 To 5

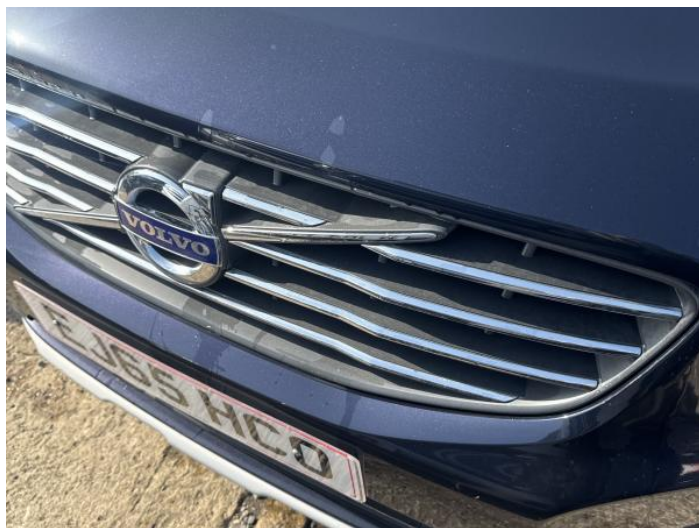
2: Bumper Front
Scratched
25 to 100mm Thru Paint

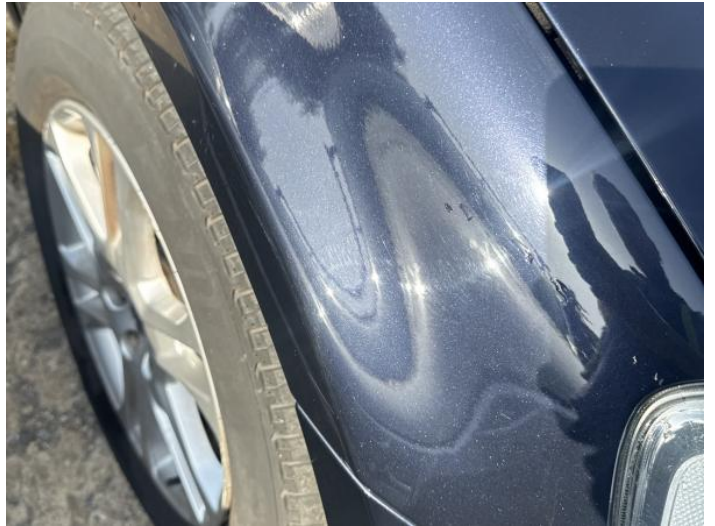
4: Wing osf
Chipped
1 To 5

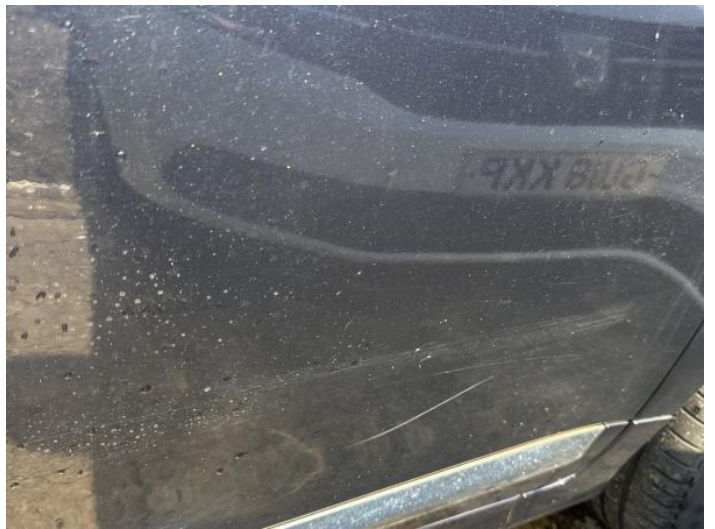
6: Door osf
Scratched
Over 25mm Thru Paint

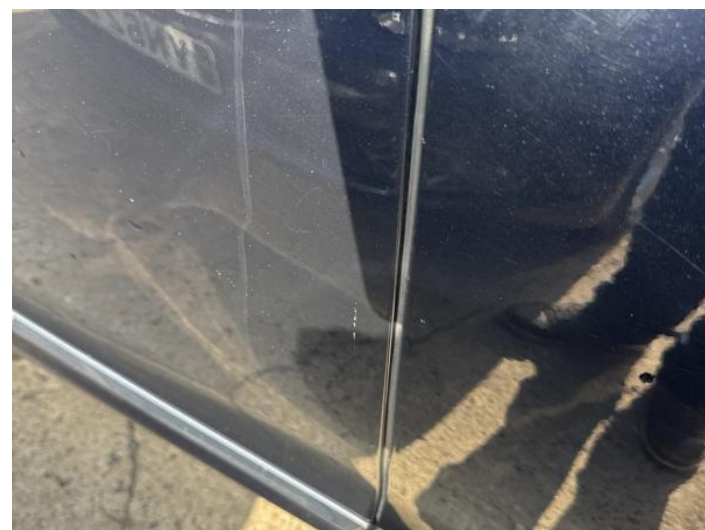
7: Door osr
Chipped
1 To 5

8: Door osr
Scratched
Over 25mm Not Thru Paint

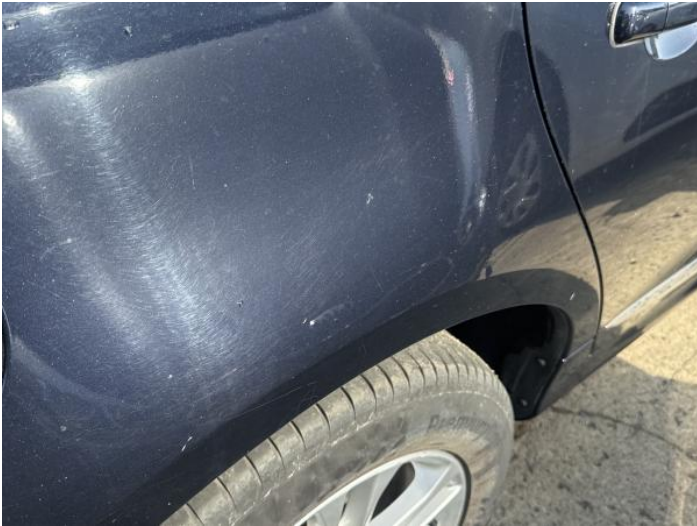
9: Qtr Panel osr
Chipped
Multiple Chips

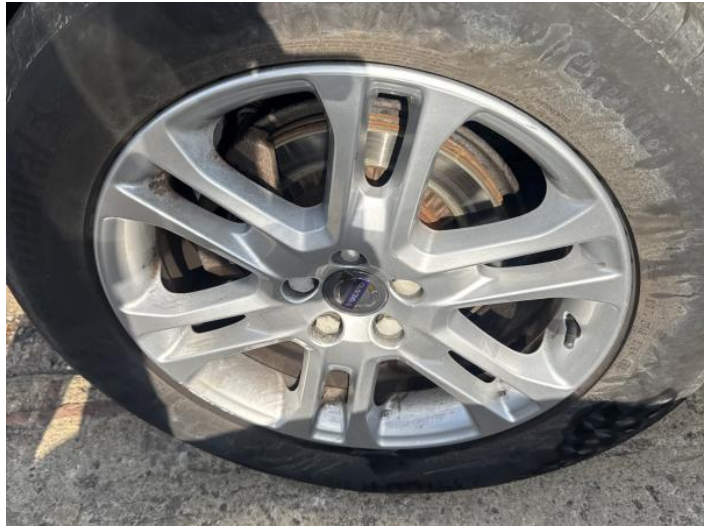
10: Wheel osr
Scratched
Over 50mm

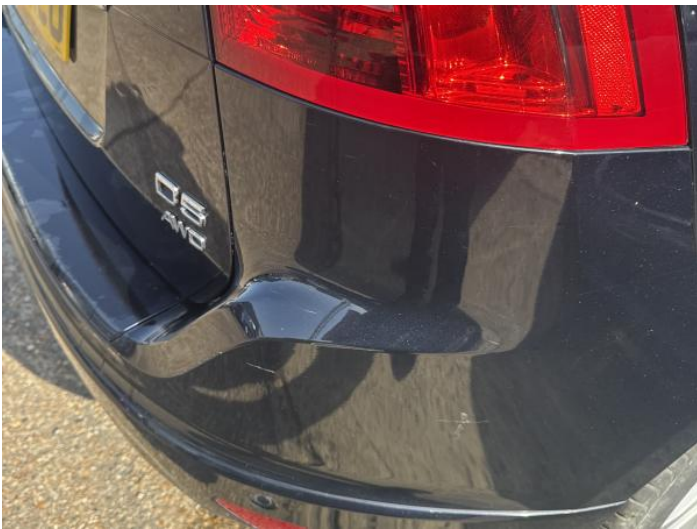
11: Bumper Rear
Scratched
Over 100mm Thru Paint

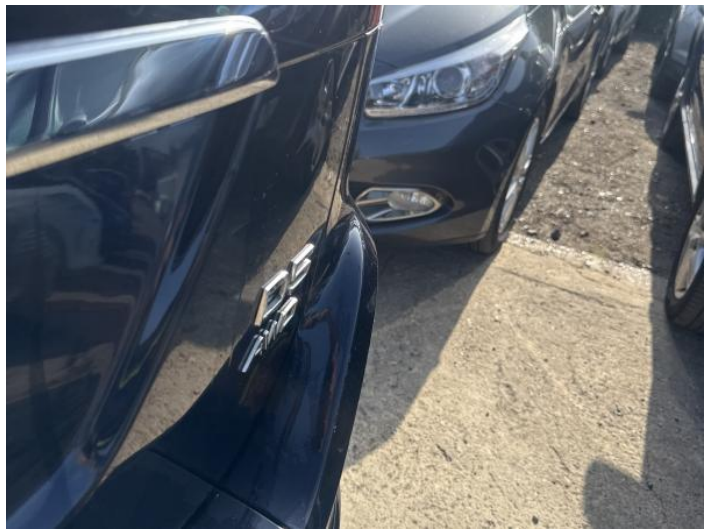
12: Boot Lid
Dented
Over 30mm

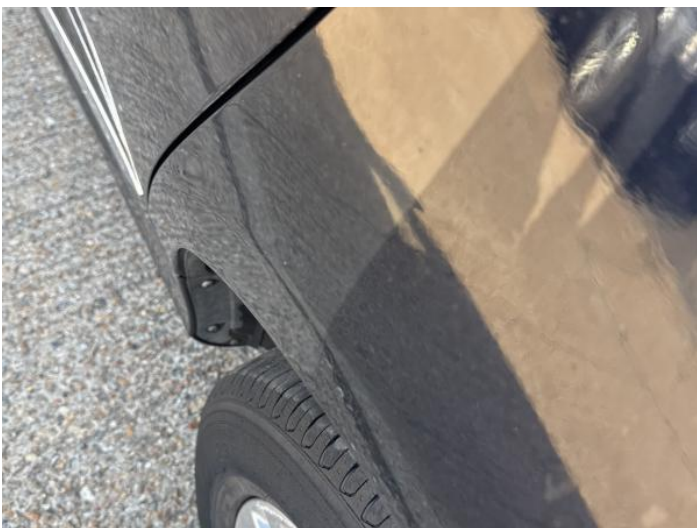
13: Qtr Panel nsr
Dented
Between 10mm + 30mm

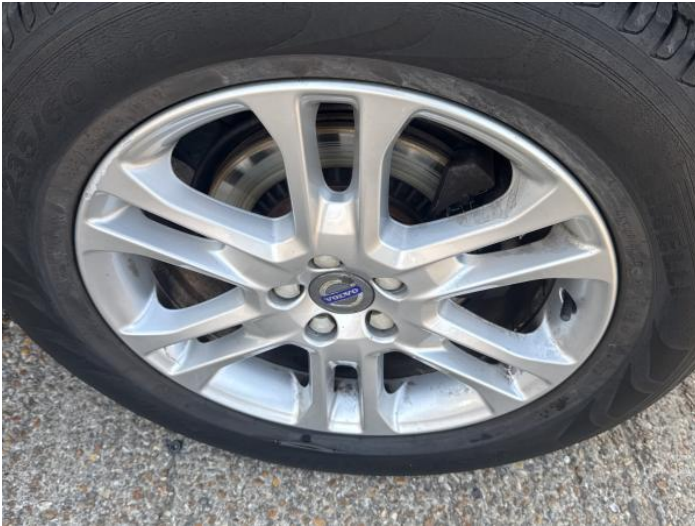
15: Wheel nsr
Scratched
Over 50mm

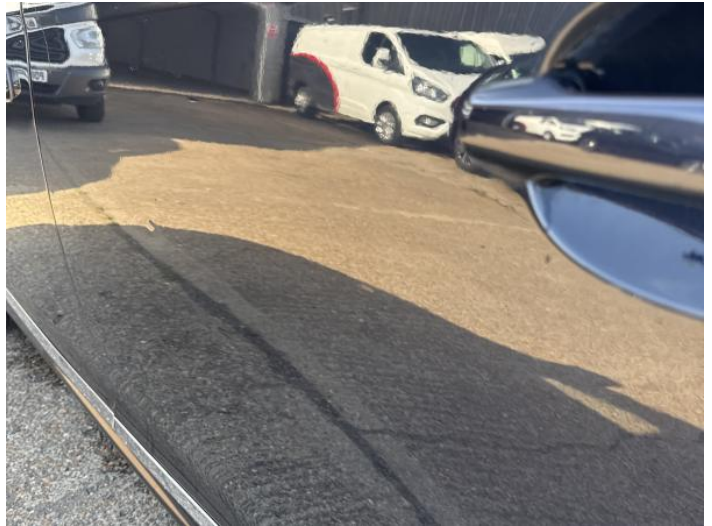
16: Door nsr
Dented
Between 10mm + 30mm

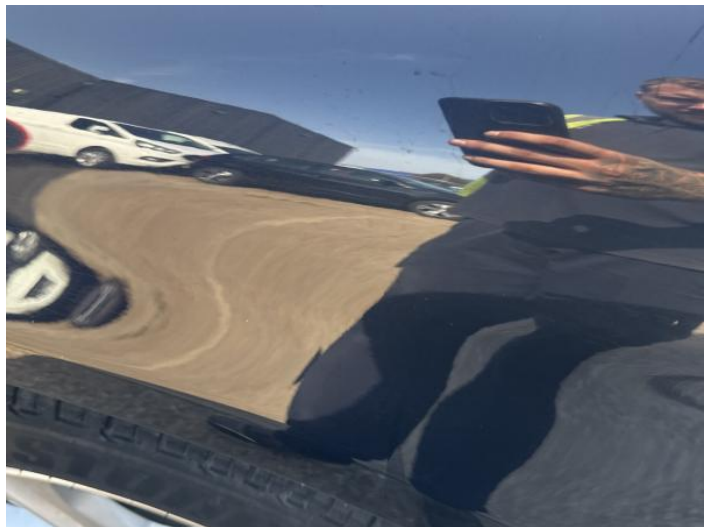
18: Wing nsf
Chipped
1 To 5

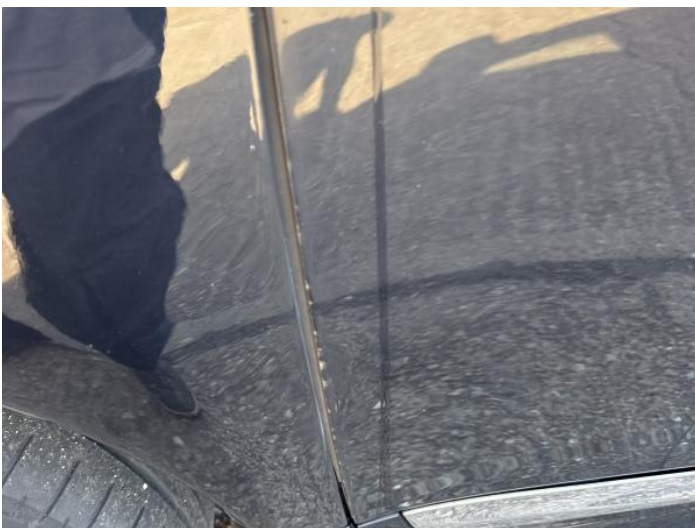
19: Door nsf
Rusted
Over 5mm

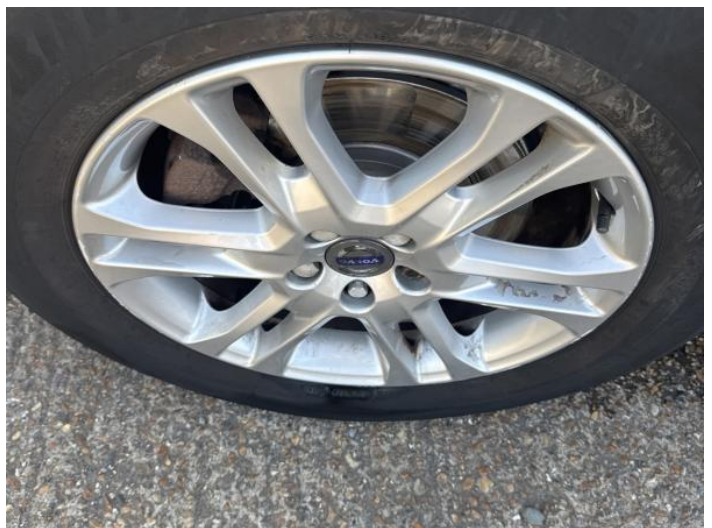
20: Wheel nsf
Scratched
Over 50mm

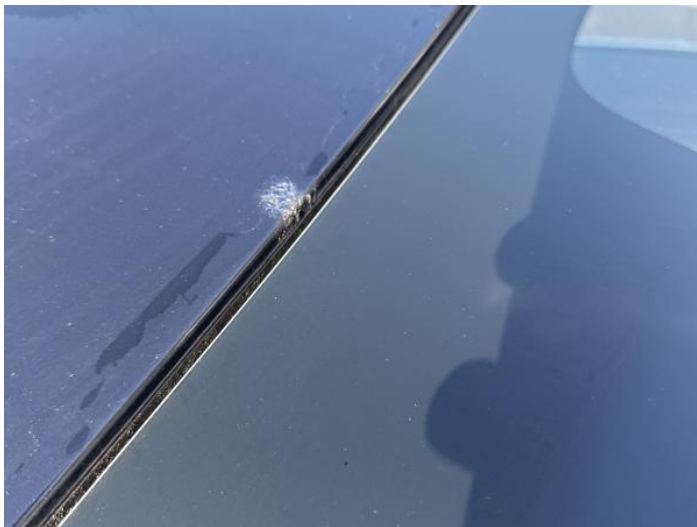
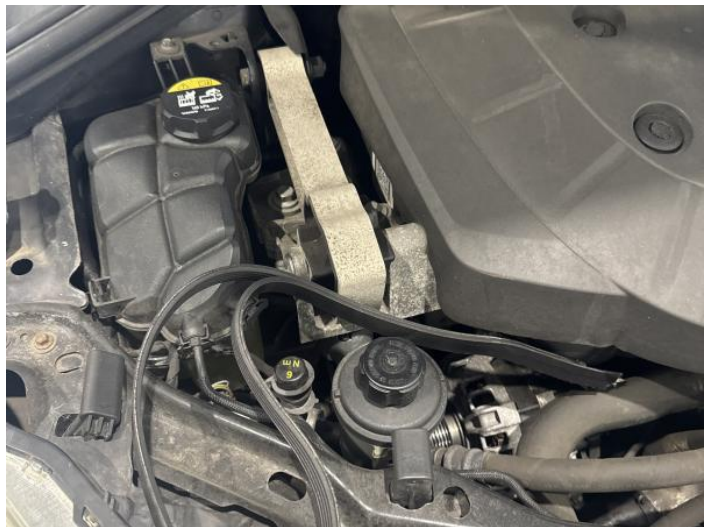
21: Roof
Rusted
Over 5mm
