VEHICLE INSPECTION REPORT

LR05UFP

Land Rover Discovery 2.7 Td V6 HSE 5dr Auto

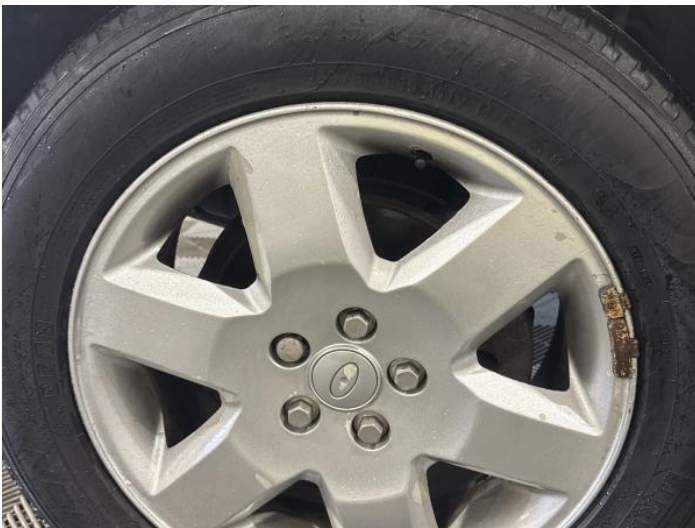
1: Wheel nsf
Scratched
Over 50mm

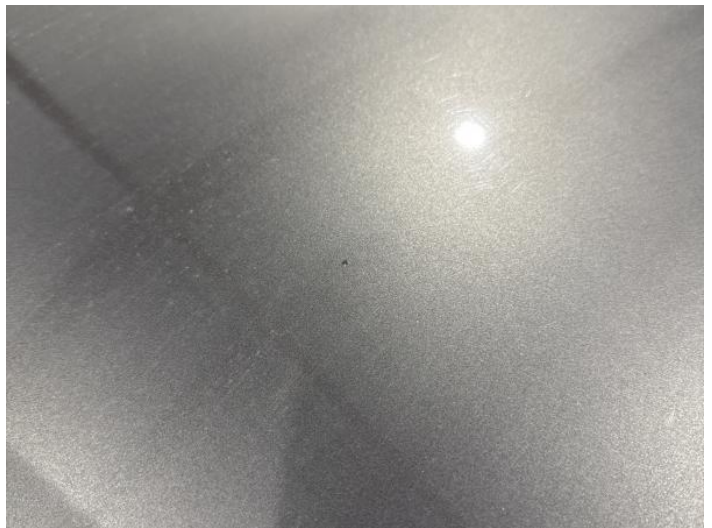
2: Bonnet
Chipped
1 To 5

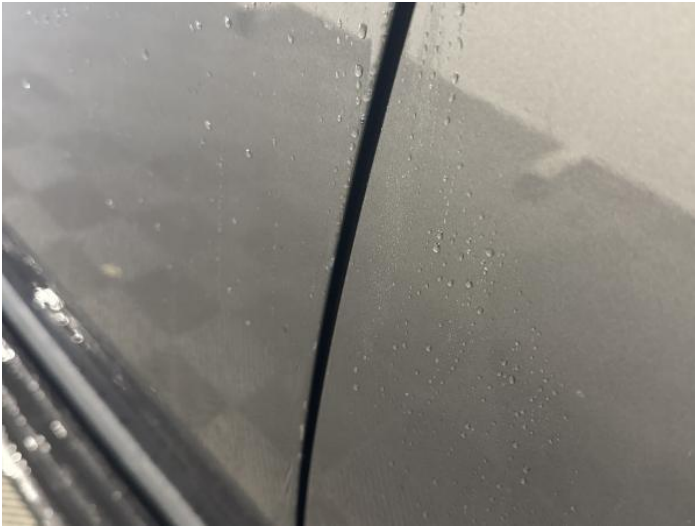
3: Door nsf
Chipped
Edge Chip

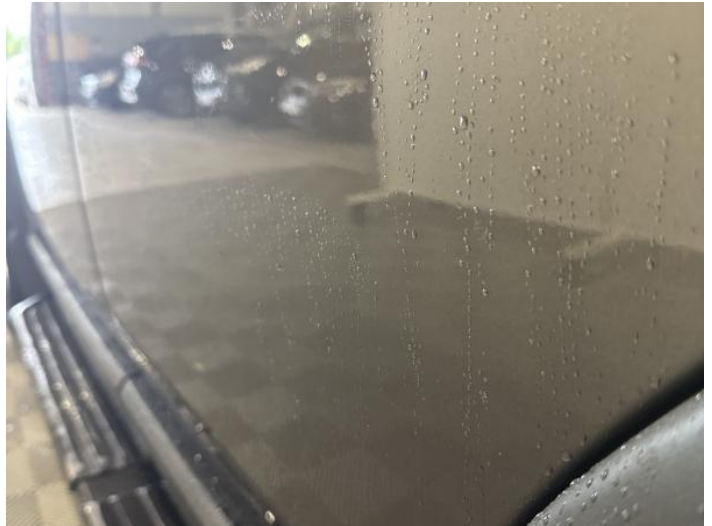
4: Door nsr
Dented
Between 10mm + 30mm

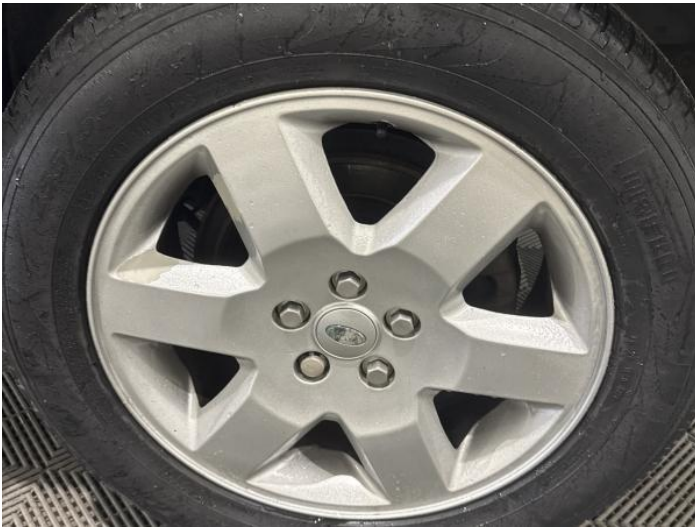
5: Wheel nsr
Scratched
Over 50mm

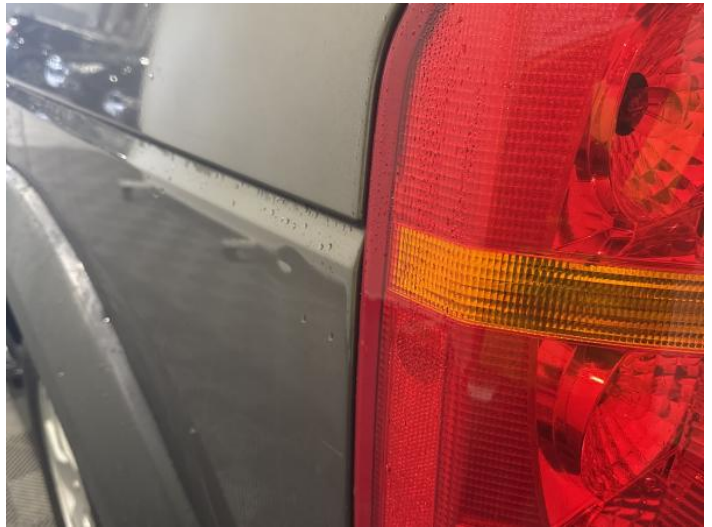
6: Qtr Panel nsr
Dented
Between 10mm + 30mm

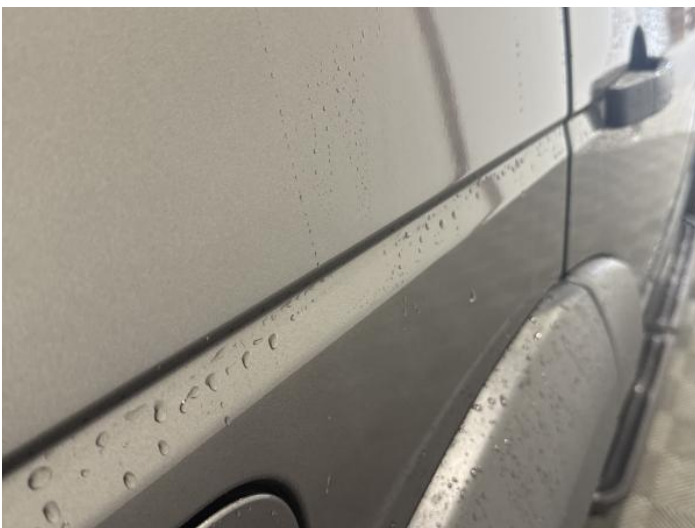
7: Qtr Panel osr
Dented
Between 10mm + 30mm

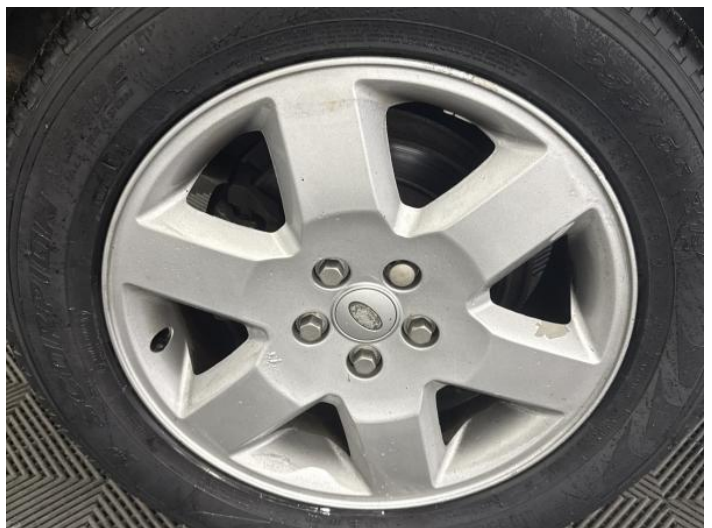
8: Wheel osr
Scratched
Over 50mm

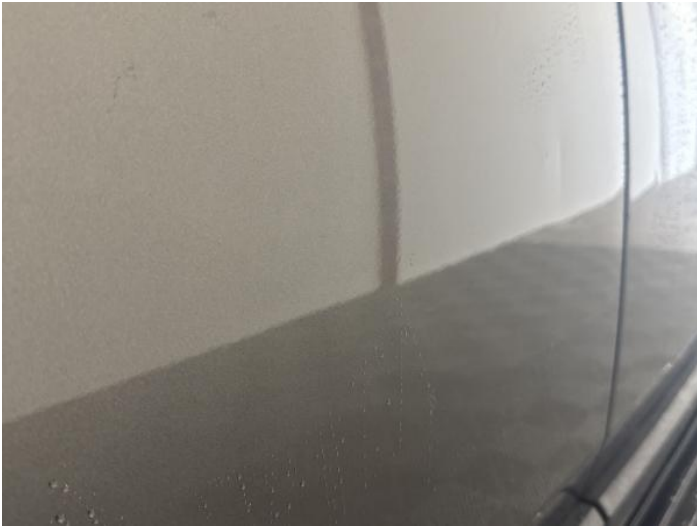
9: Door osr
Dented
Over 30mm

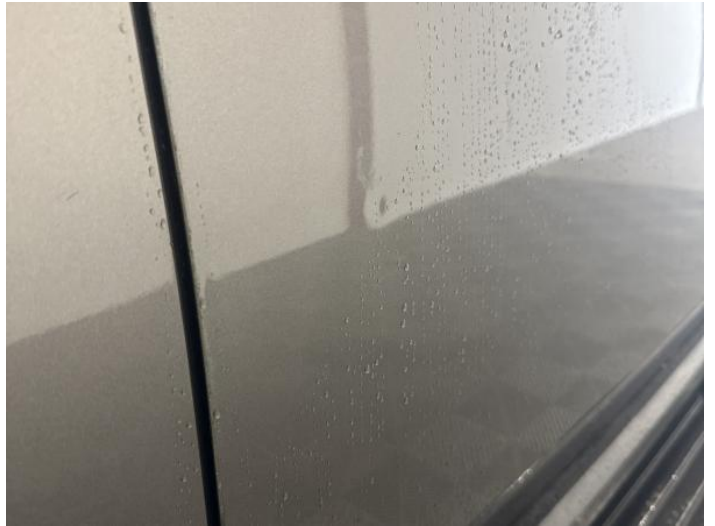
10: Door osf
Dented
With Paint Damage

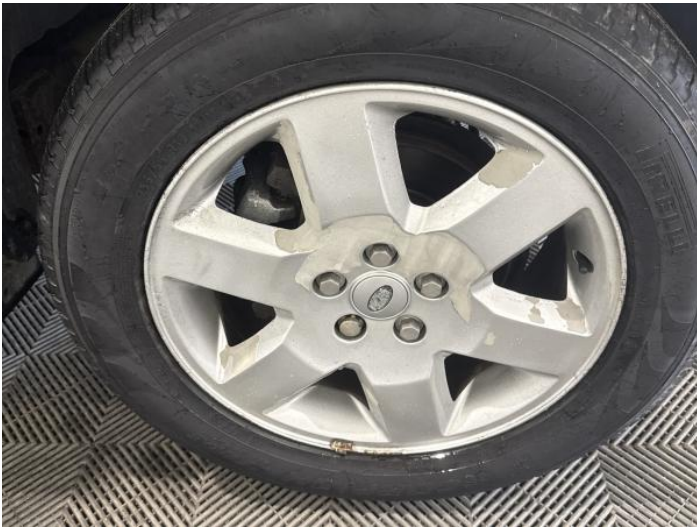
11: Wheel osf
Scratched
Over 50mm

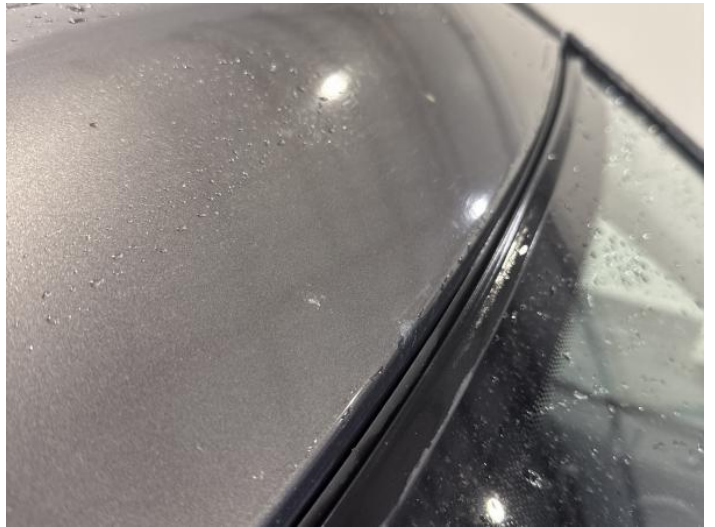
12: Roof
Chipped
Over 5mm

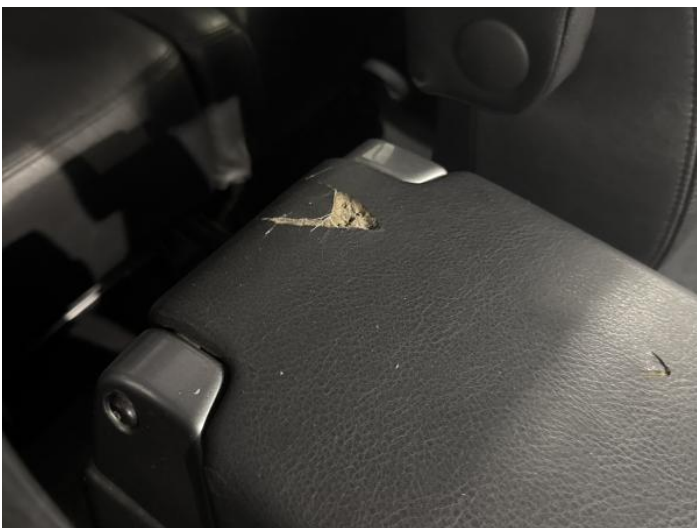
13: Fascia Panel
Holed
Over 3mm
