VEHICLE INSPECTION REPORT

B3EPE

Alfa Romeo Giulietta 1.4 TB MultiAir Veloce 5dr

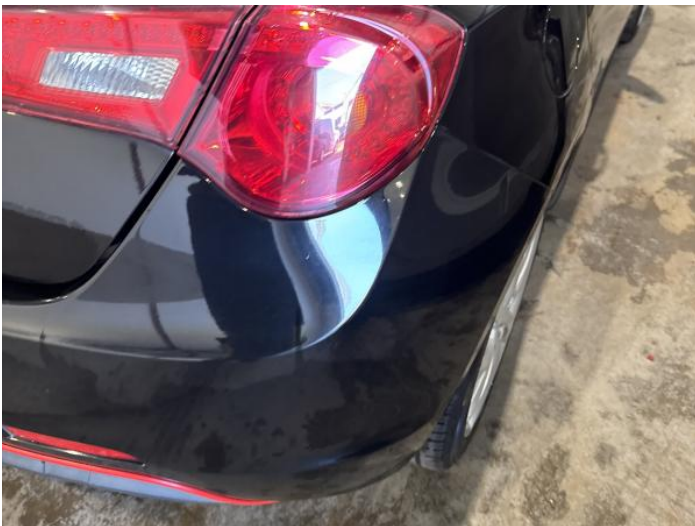
1: Bumper Rear
Chipped
Multiple Chips

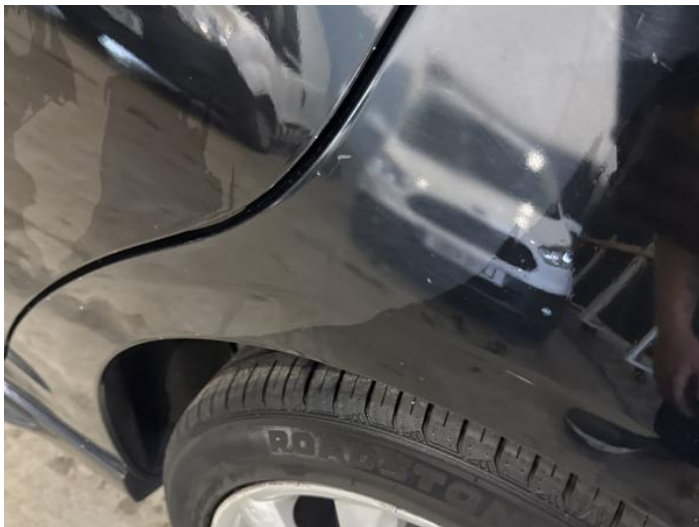
3: Qtr Panel nsr
Poor Previous Repair
Poor Paint

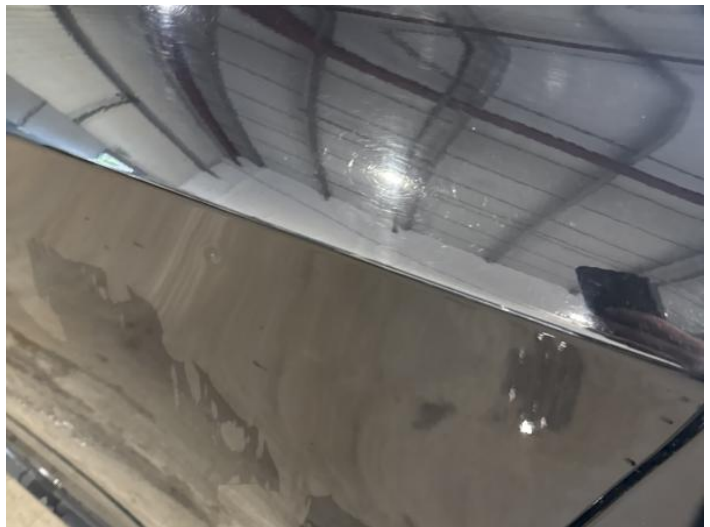
4: Door nsr
Poor Previous Repair
Poor Paint

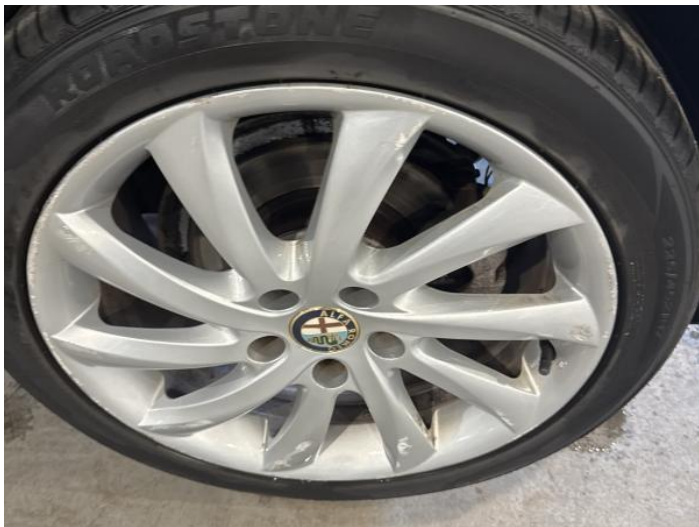
5: Wheel nsr
Scratched
Over 50mm

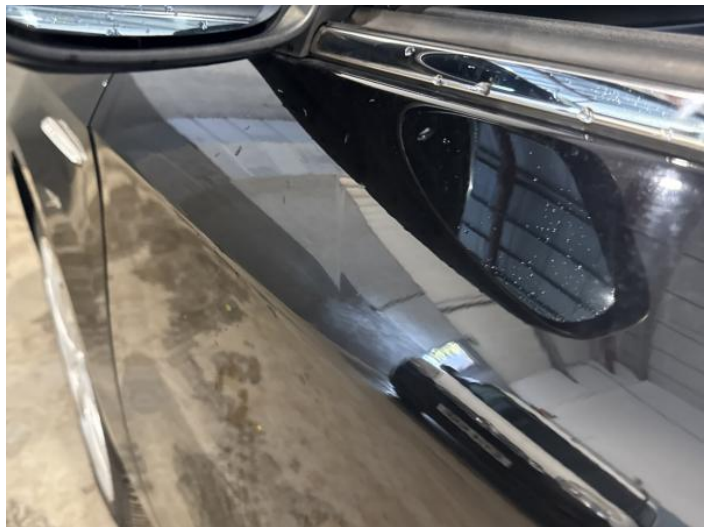
6: Door nsf
Dented
Between 10mm + 30mm

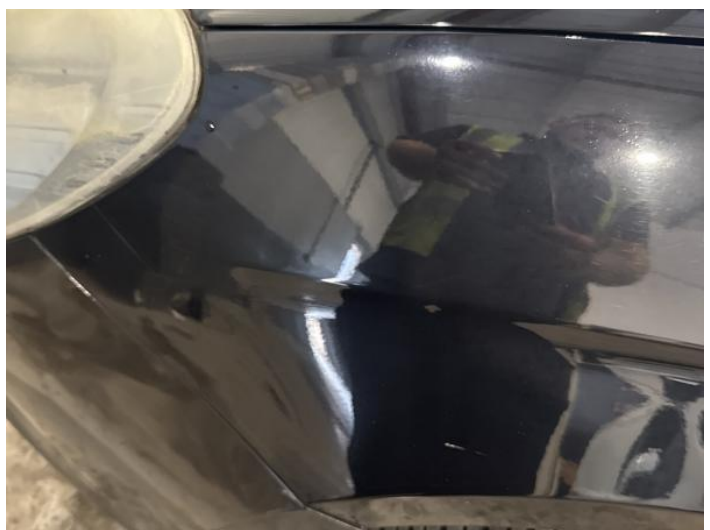
8: Wing nsf
Dented
With Paint Damage

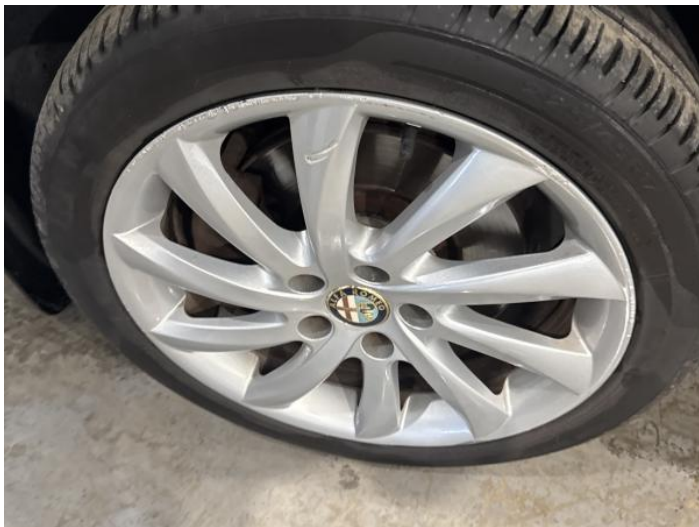
9: Wheel nsf
Scratched
Over 50mm

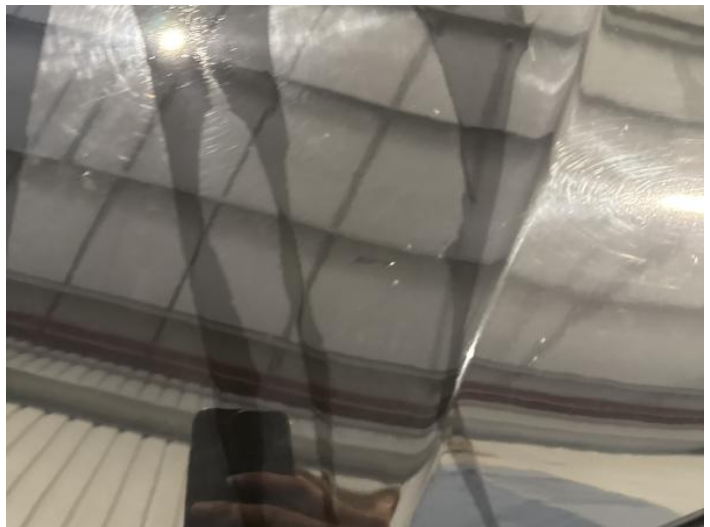
10: Bonnet
Chipped
1 To 5

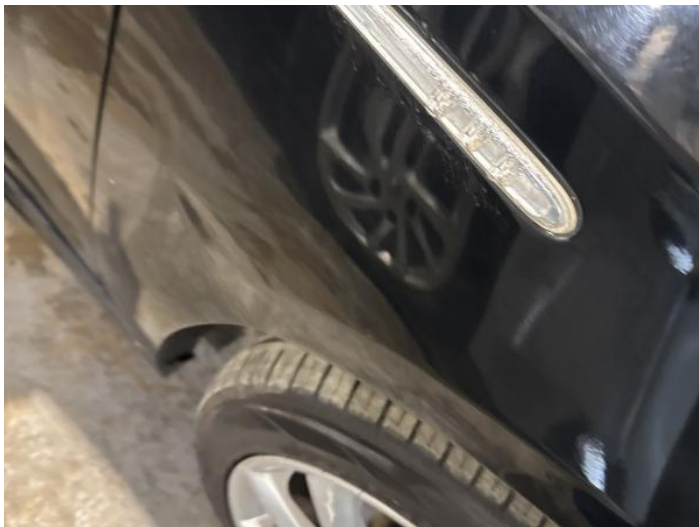
11: Wing osf
Dented
Over 30mm

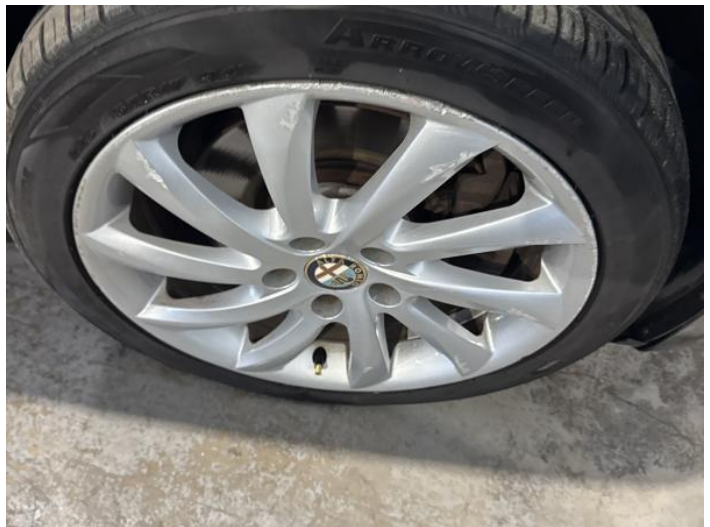
12: Wheel osf
Scratched
Over 50mm

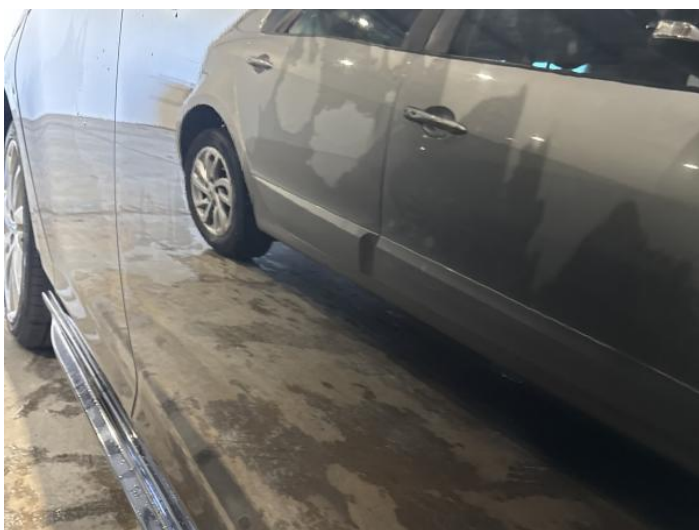
13: Door osf
Chipped
1 To 5

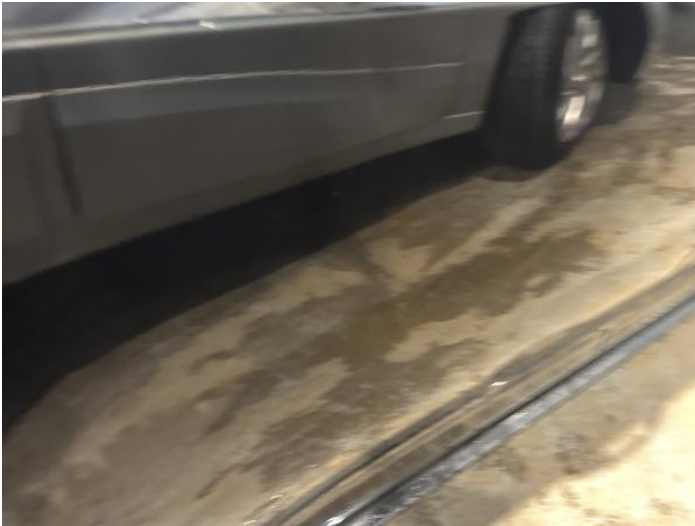
15: Door osr
Dented
Over 2 UpTo 10mm

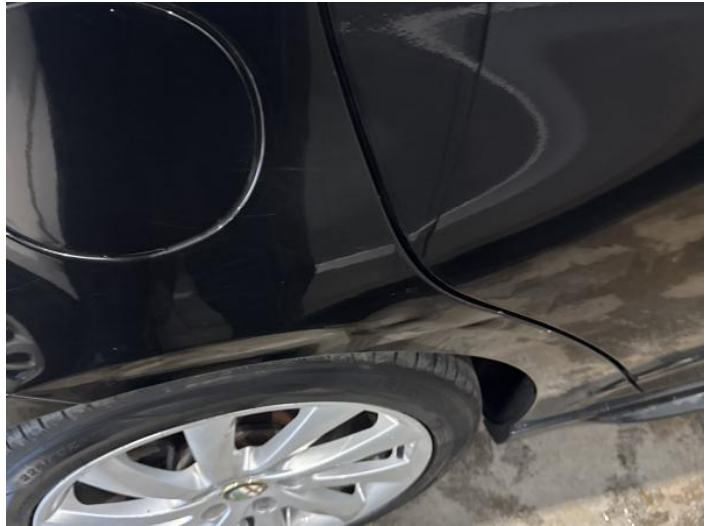
16: Qtr Panel osr
Dented
With Paint Damage

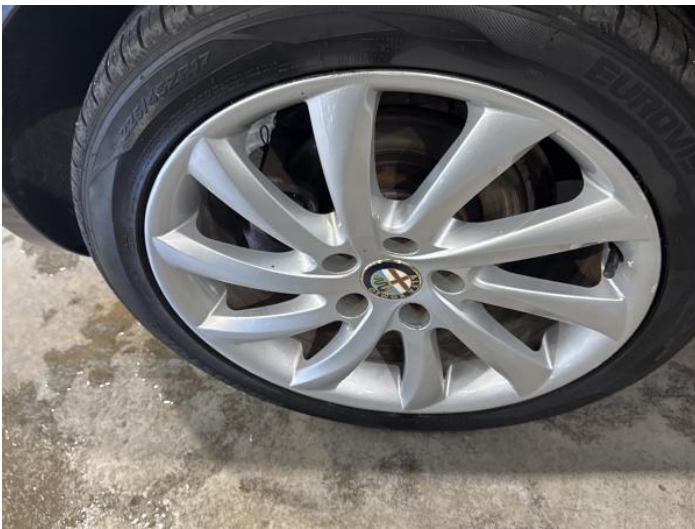
17: Wheel osr
Scratched
Over 50mm

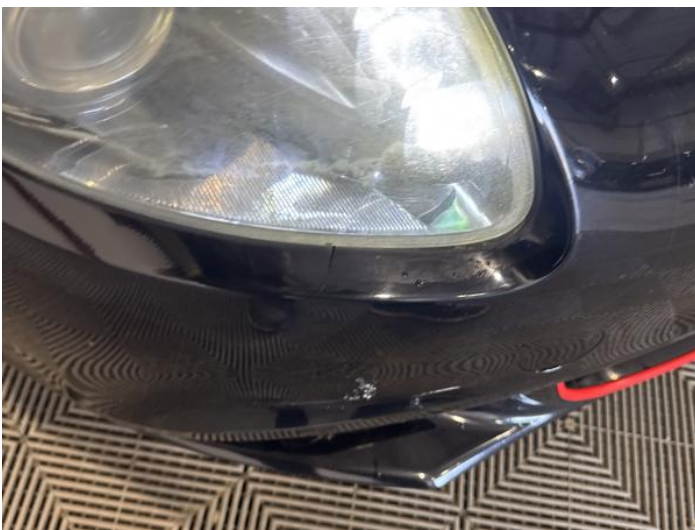
19: Bumper Front
Cracked
UpTo 25mm

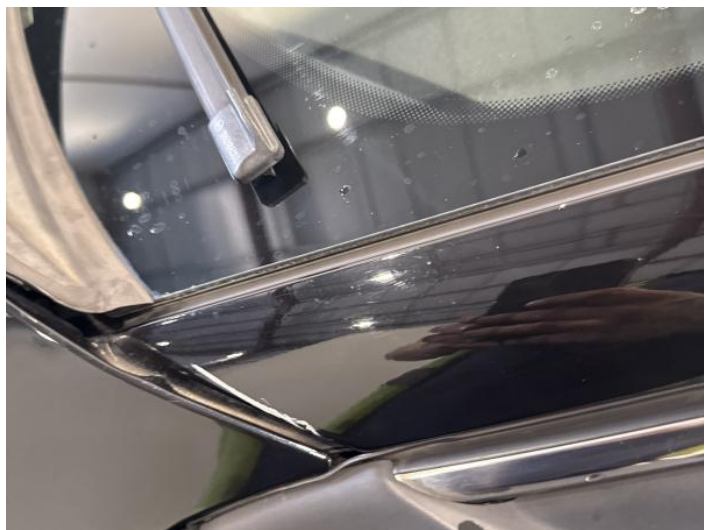
20: A Post ns
Scratched
Over 25mm Thru Paint
