VEHICLE INSPECTION REPORT

DV55WSK

Mercedes-Benz CLK CLK220 CDI AVANTGARDE

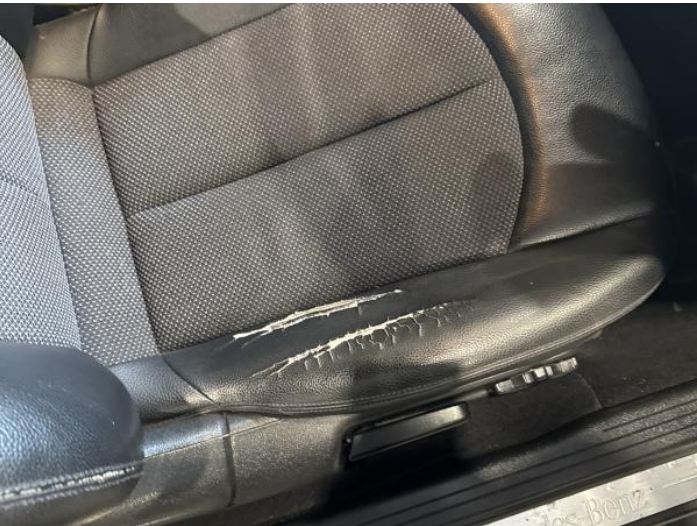
1: Seat Base Cover osf
Torn
Over 3mm

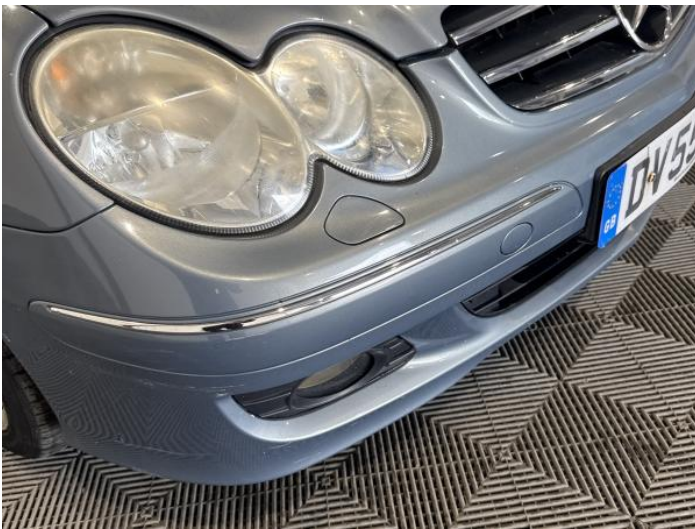
5: Bumper Front
Scratched
Over 100mm Thru Paint

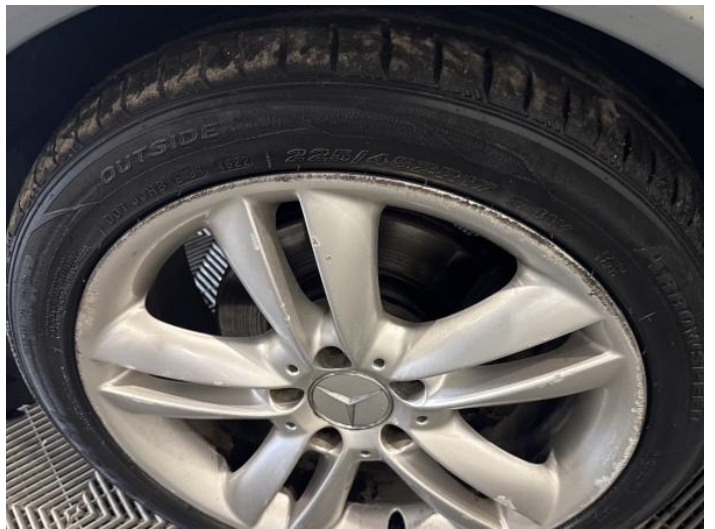
6: Wheel nsf
Scratched
Over 50mm

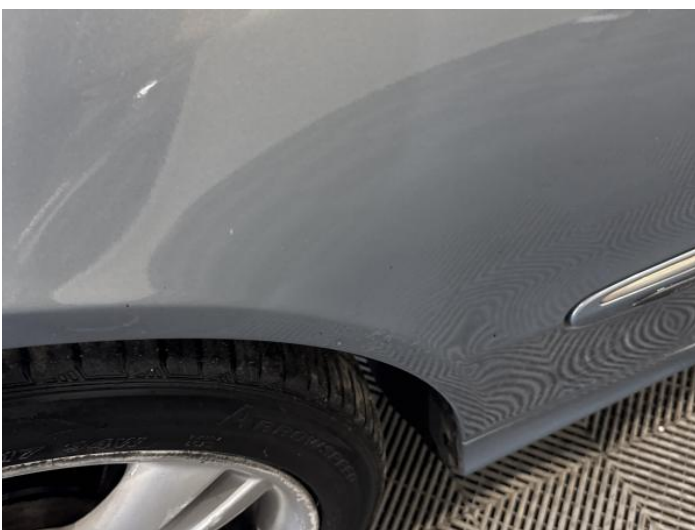
7: Wing nsf
Scratched
Over 25mm Thru Paint

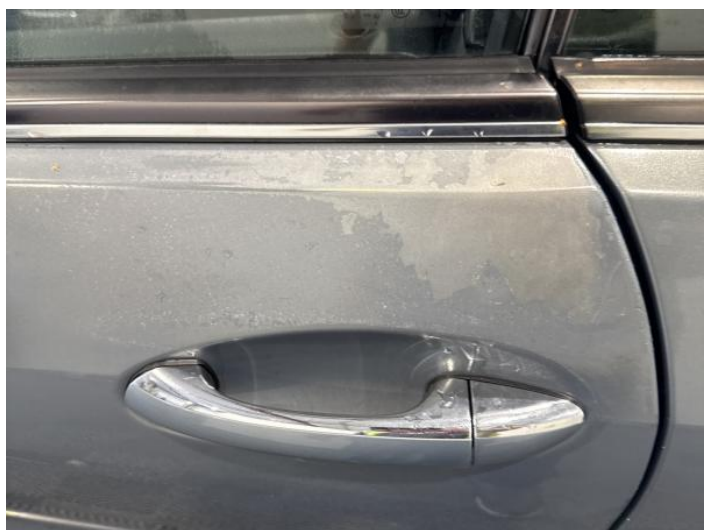
8: Door nsf
Poor Previous Repair
Paint Flake

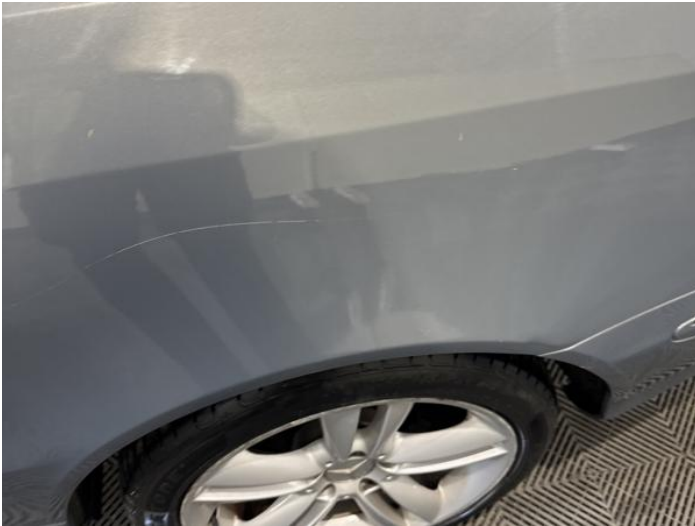
9: Qtr Panel nsr
Dented
With Paint Damage

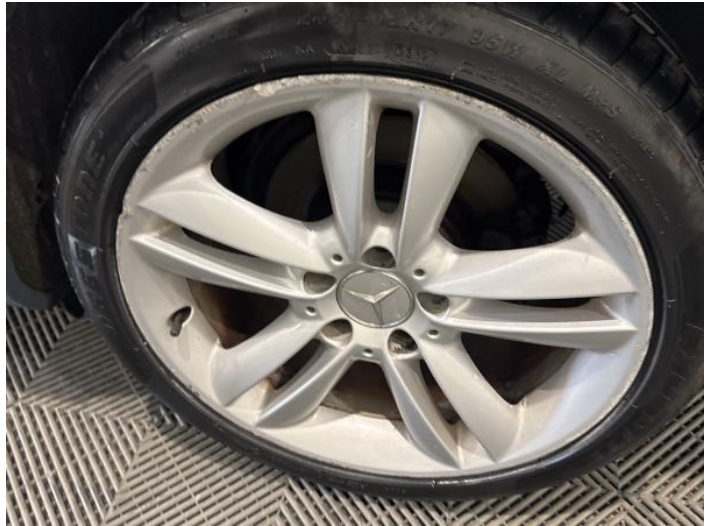
10: Wheel nsr
Scratched
Over 50mm

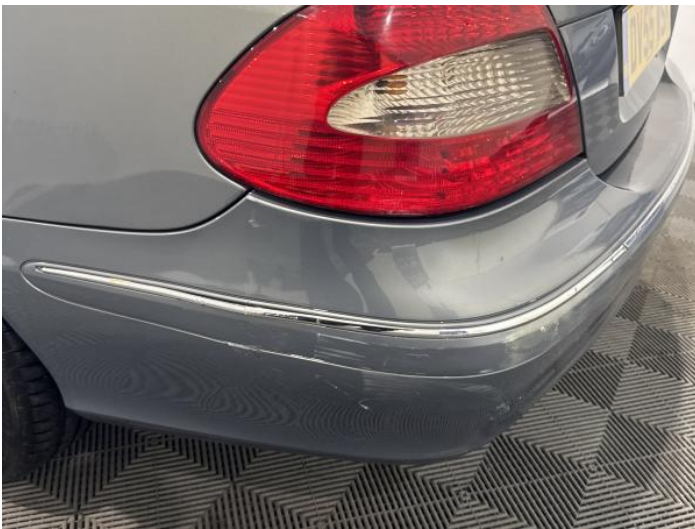
11: Bumper Rear
Scratched
Over 100mm Thru Paint

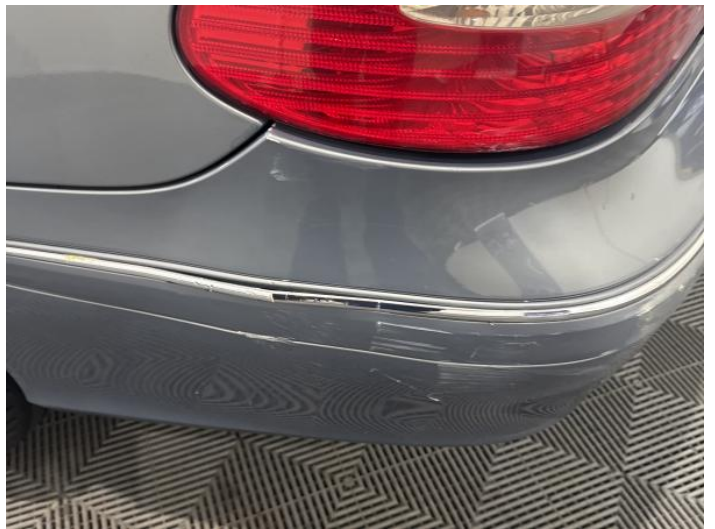
12: Bumper Rear Moulding
Broken
Replace

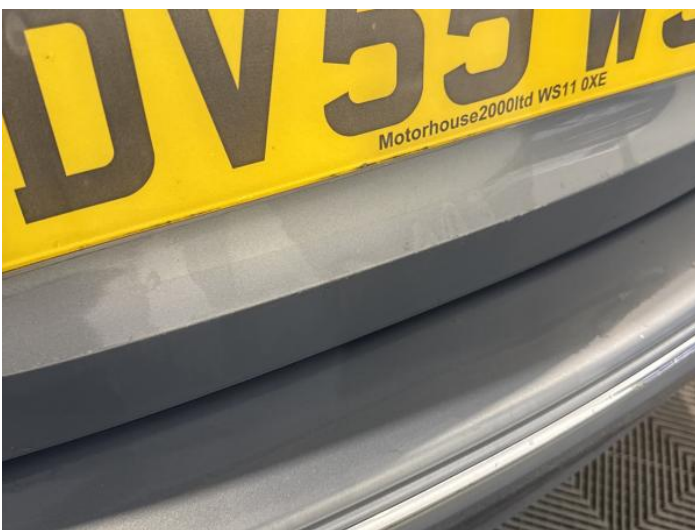
13: Boot Lid
Scratched
Over 25mm Thru Paint

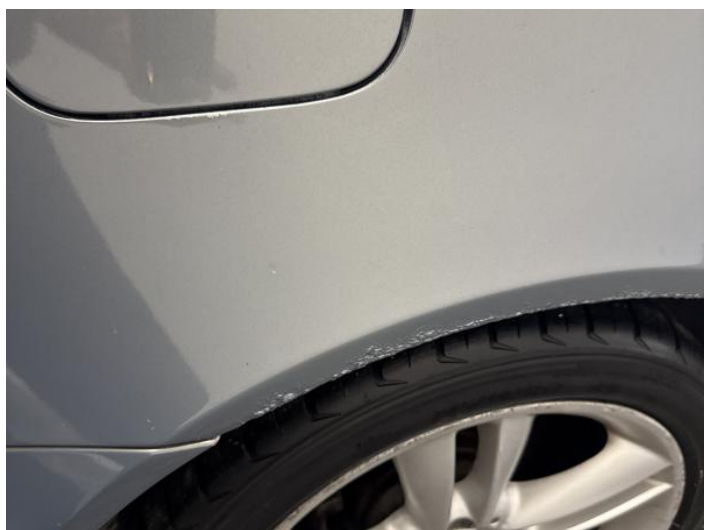
14: Qtr Panel osr
Rusted
Over 5mm

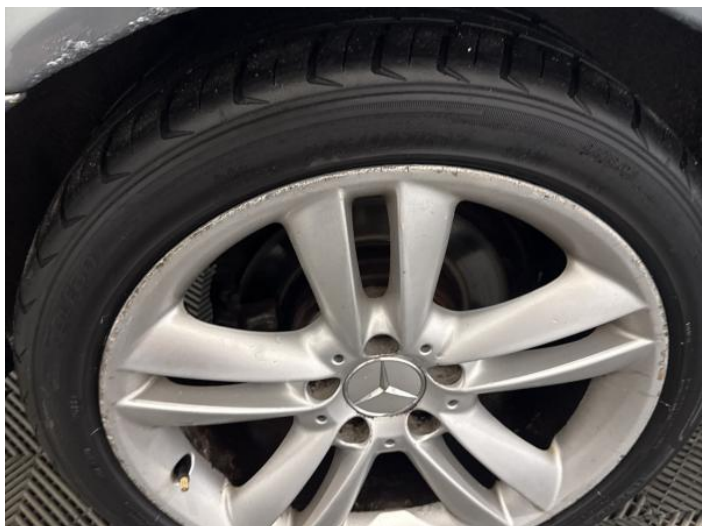
15: Wheel osr
Scratched
Over 50mm

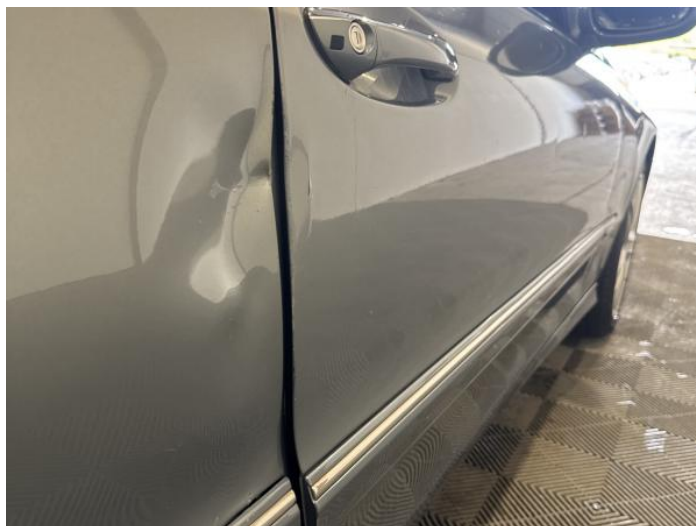
16: Door osf
Dented
Over 30mm

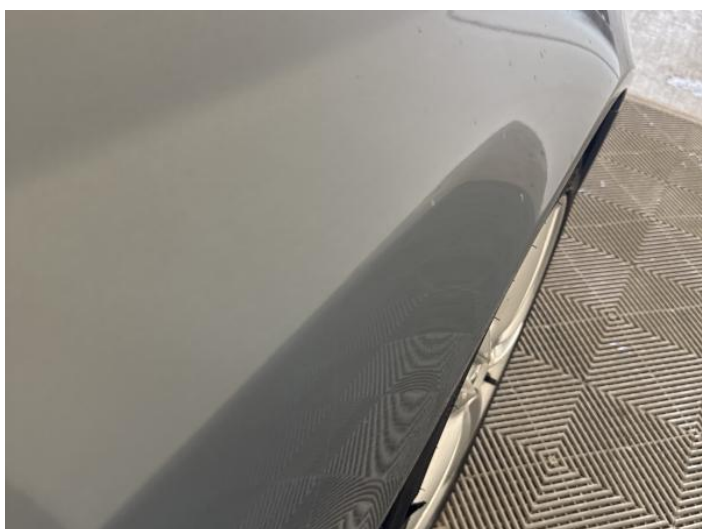
17: Wing osf
Dented
With Paint Damage

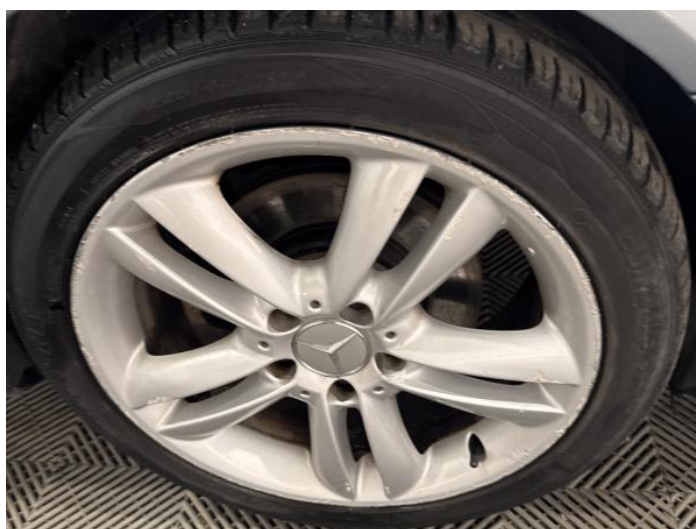
18: Wheel osf
Scratched
Over 50mm

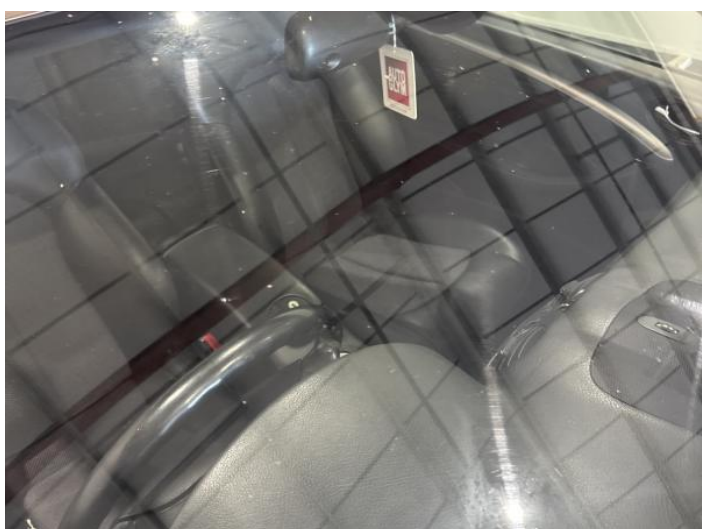
19: Screen Front
Chipped
UpTo 10mm
