# **VEHICLE INSPECTION REPORT**

**GJ62NYT**

# Volkswagen Passat 2.0 TDI Bluemotion Tech SE 5dr DSG

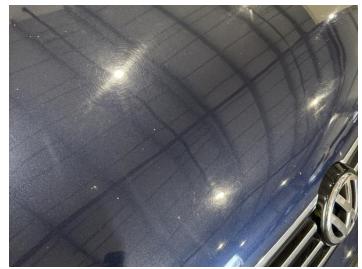
1: Bonnet Chipped Multiple Chips

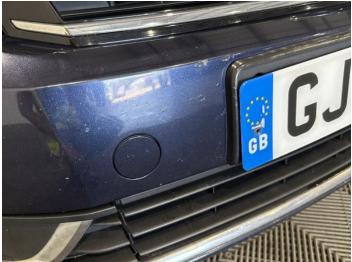
2: Bumper Front Scratched Over 100mm Thru Paint

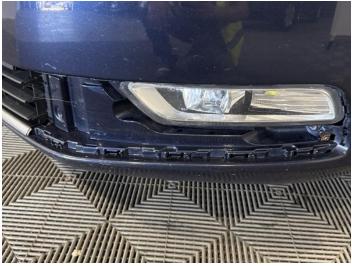
3: Bumper Front Moulding Missing Replace

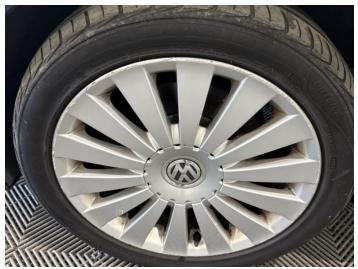
4: Wheel nsf Scratched Over 50mm

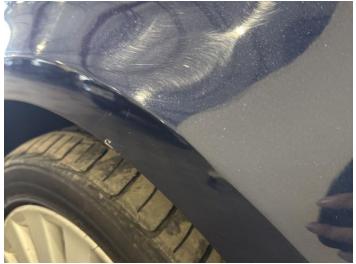
5: Wing nsf Dented With Paint Damage

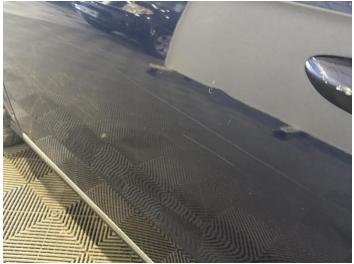
6: Door nsf Dented With Paint Damage

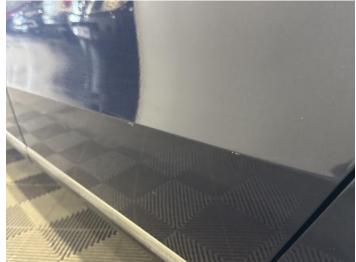
7: Door nsr Scratched Over 25mm Thru Paint

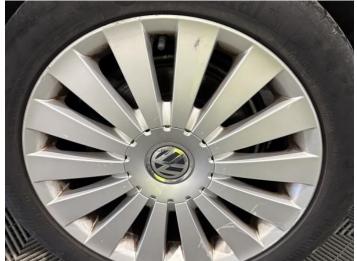
8: Wheel nsr Scratched Over 50mm

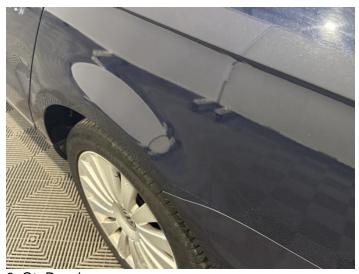
9: Qtr Panel nsr Scratched Over 25mm Thru Paint

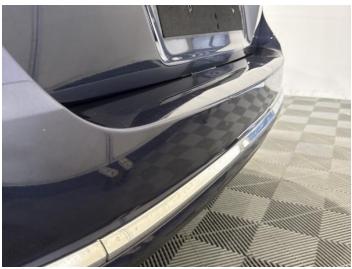
10: Bumper Rear Dented With Paint Damage

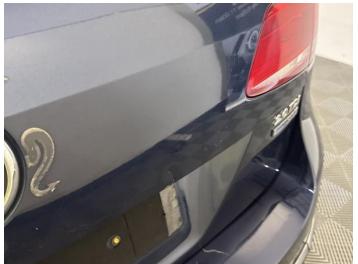
11: Tailgate Dented Over 30mm

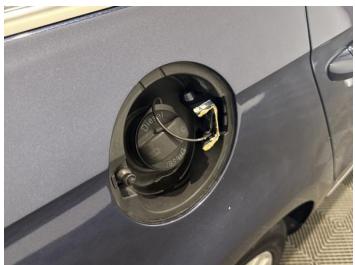
12: Fuel Flap Missing Replace

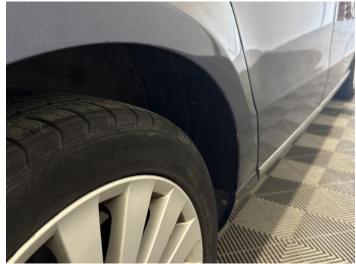
13: Qtr Panel osr Scratched Over 25mm Thru Paint

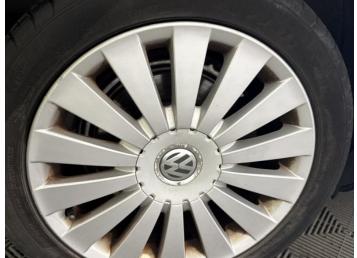
14: Wheel osr Scratched Over 50mm

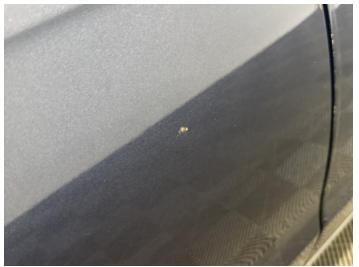
15: Door osr Chipped Over 5mm

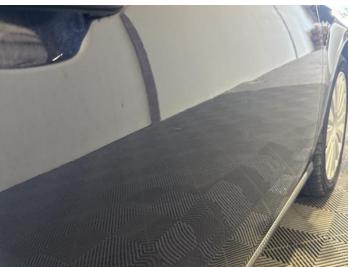
16: Door osf Dented Over 30mm

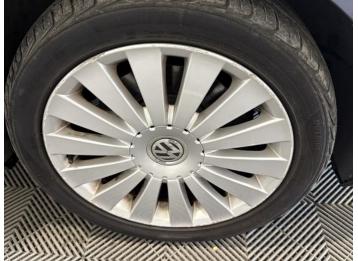
17: Wheel osf Scratched Over 50mm

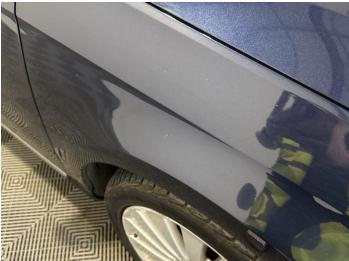
18: Wing osf Chipped 1 To 5

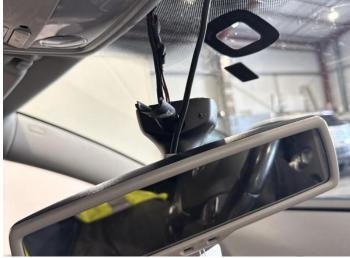
19: Fascia Panel Broken Replace
