# VEHICLE INSPECTION REPORT

**KS57LSN**

## Vauxhall Corsa 1.4i 16V Club 5dr [AC]

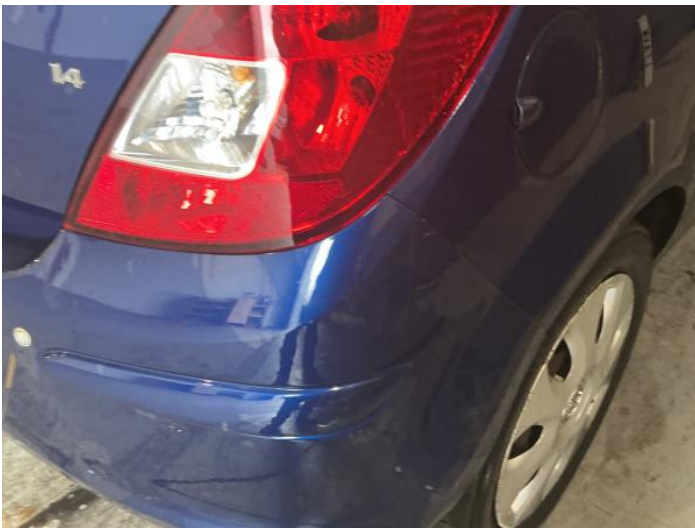
1: Bumper Rear  
Dented  
With Paint Damage

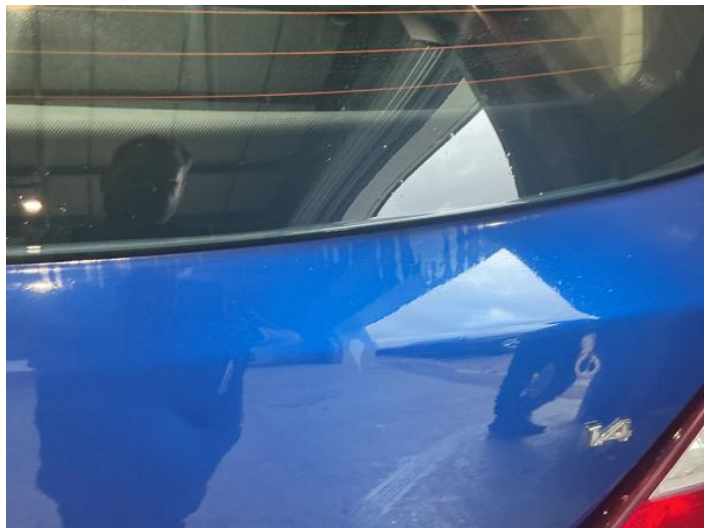
2: Boot Lid  
Dented  
With Paint Damage

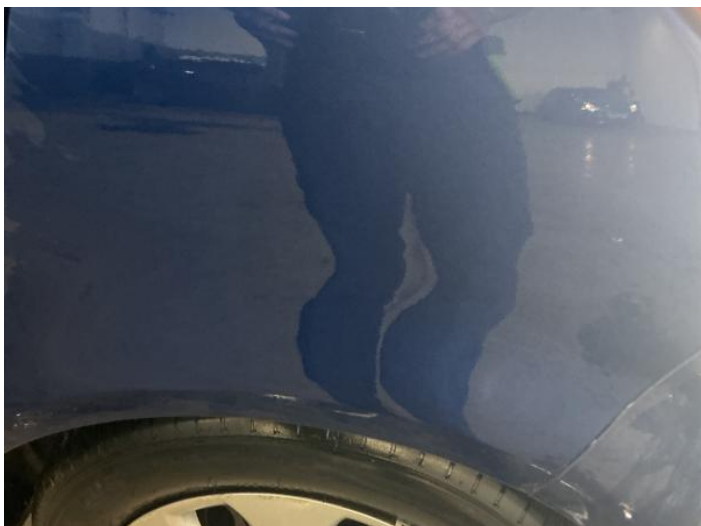
3: Qtr Panel nsr  
Dented  
With Paint Damage

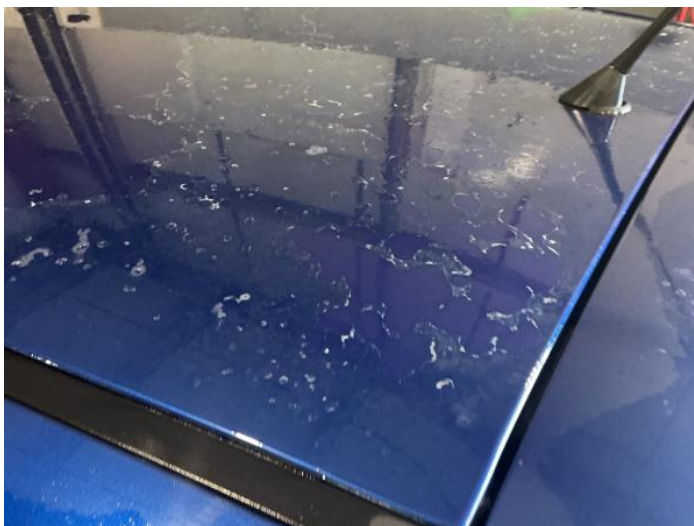
4: Roof  
Poor Previous Repair  
Paint Flake

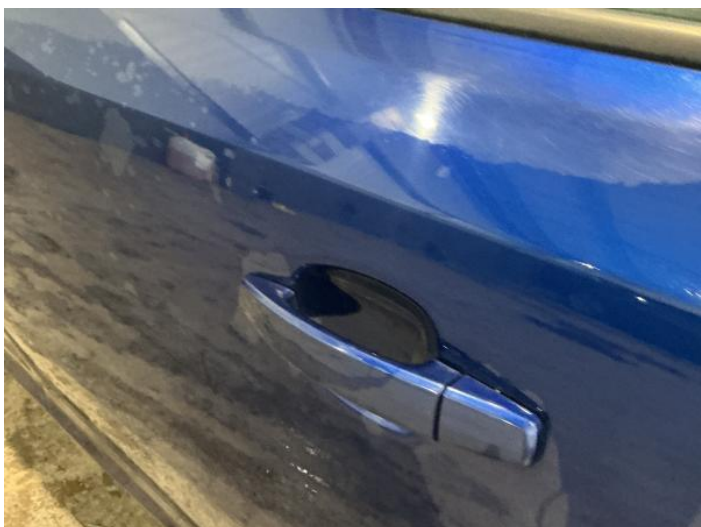
5: Door nsr  
Dented  
2 Or Less UpTo 10mm

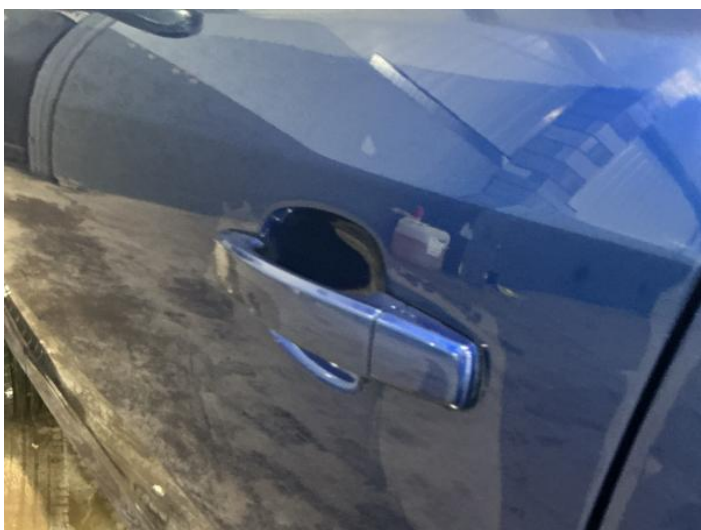
7: Door nsf  
Rusted  
Over 5mm

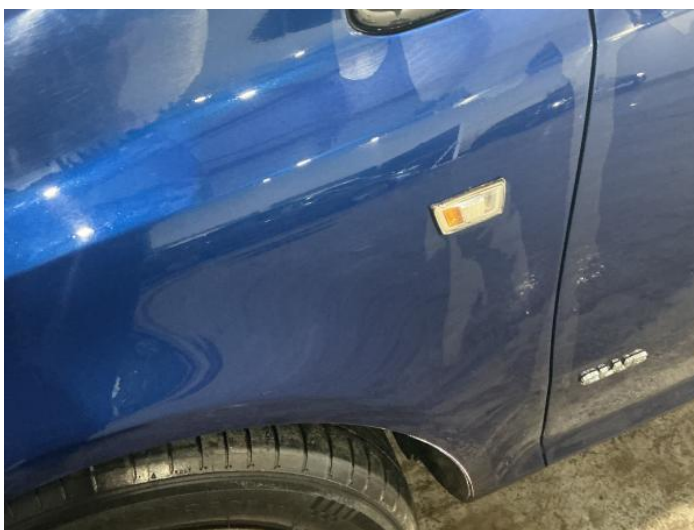
8: Wing nsf  
Chipped  
1 To 5

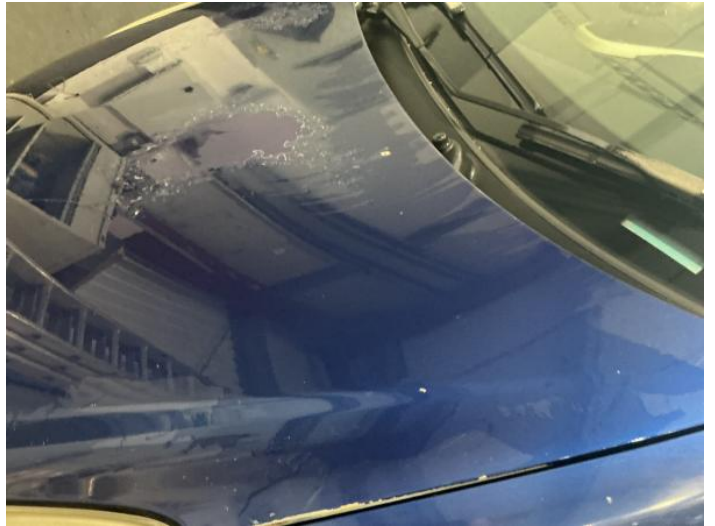
10: Bonnet  
Dented  
With Paint Damage

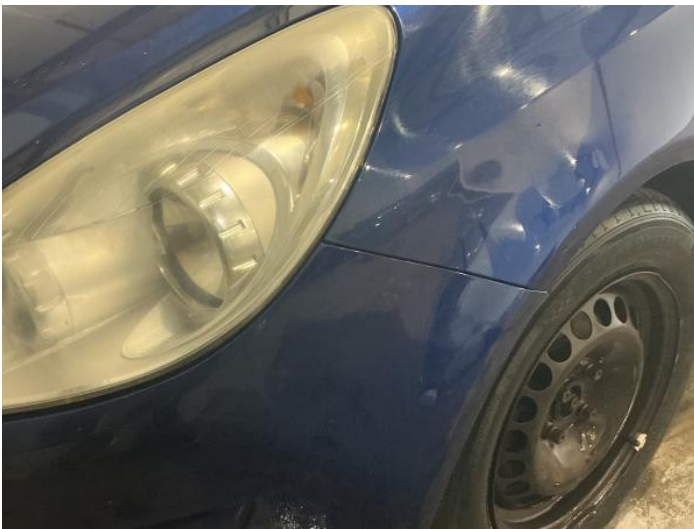
11: Bumper Front  
Scratched  
Over 100mm Thru Paint

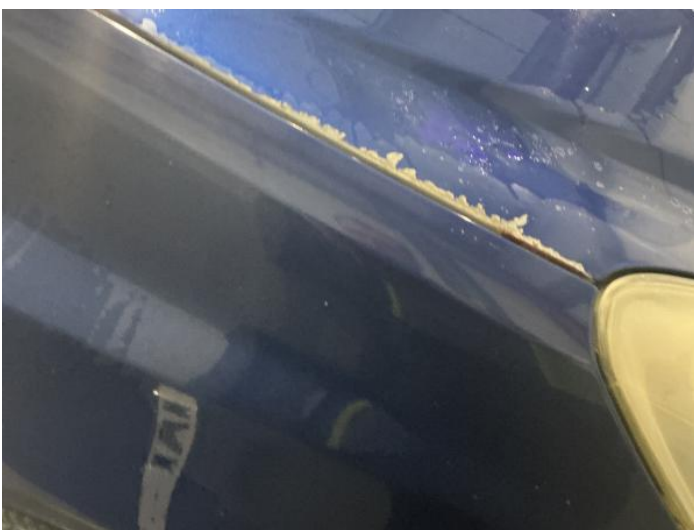
13: Wing osf  
Chipped  
1 To 5

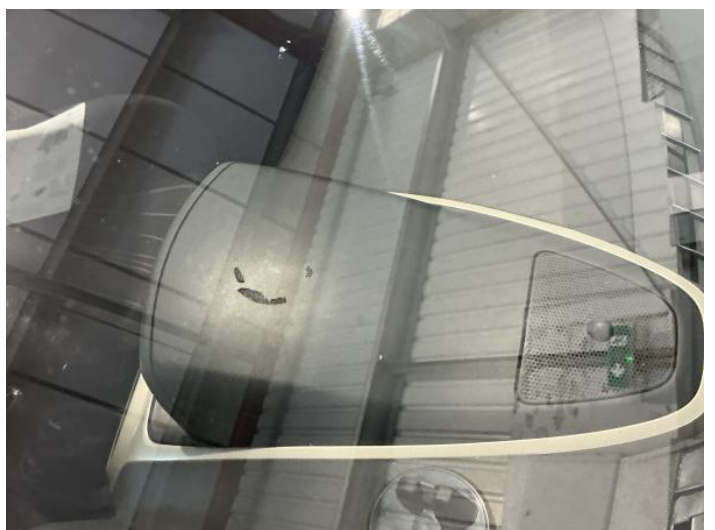
14: Screen Front  
Chipped  
UpTo 10mm

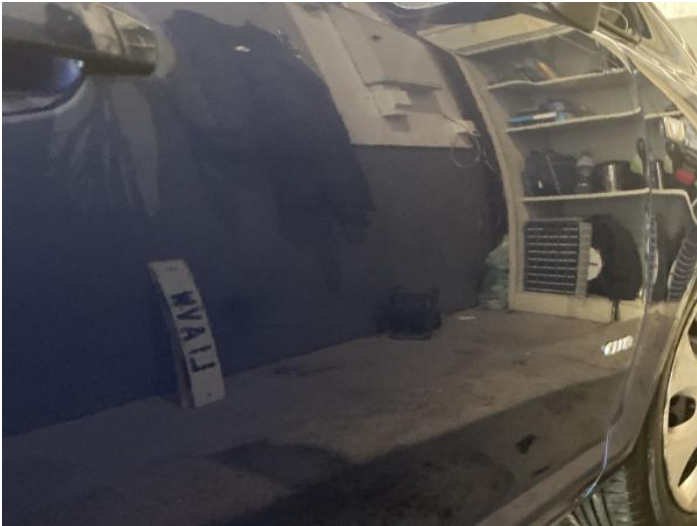
15: Door osf  
Chipped  
1 To 5

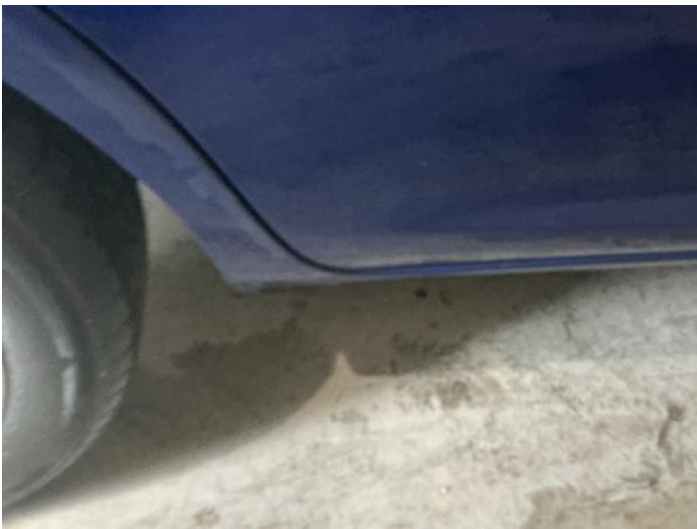
17: Sill os  
Rusted  
Over 5mm

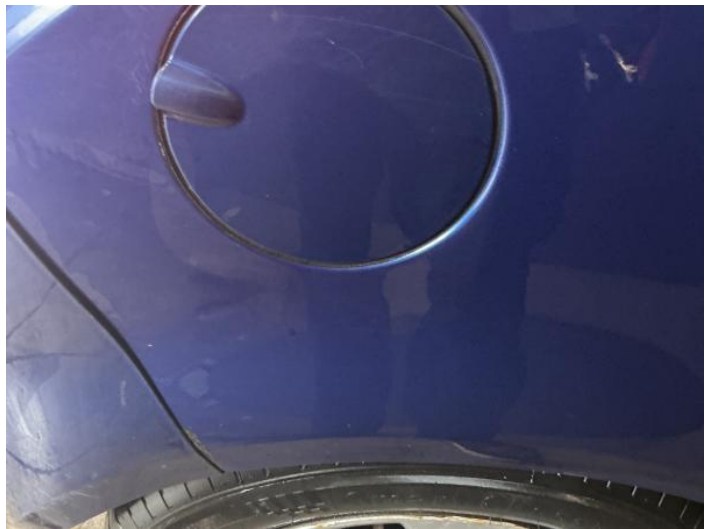
18: Qtr Panel osr  
Rusted  
UpTo 5mm

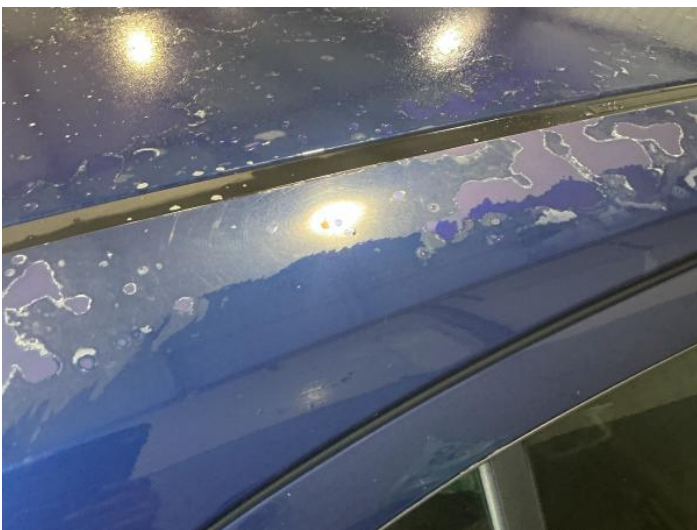
19: D Post os  
Poor Previous Repair  
Paint Flake

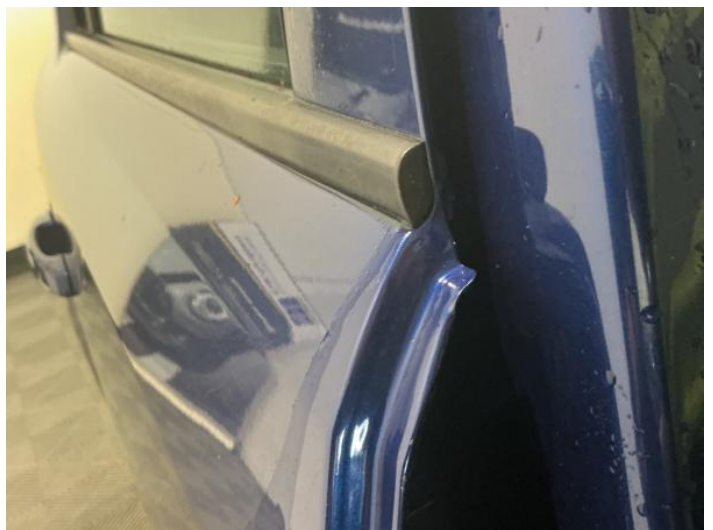
20: Door osr  
Poor Previous Repair  
Poor Paint
