# VEHICLE INSPECTION REPORT

**LG66UMY**

## Ford Mondeo 1.5 TDCi ECONetic Style 5dr

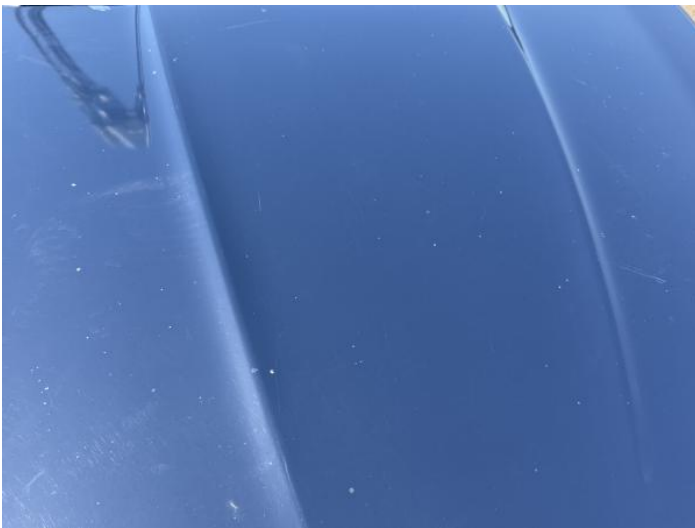
1: Bonnet  
Chipped  
Multiple Chips

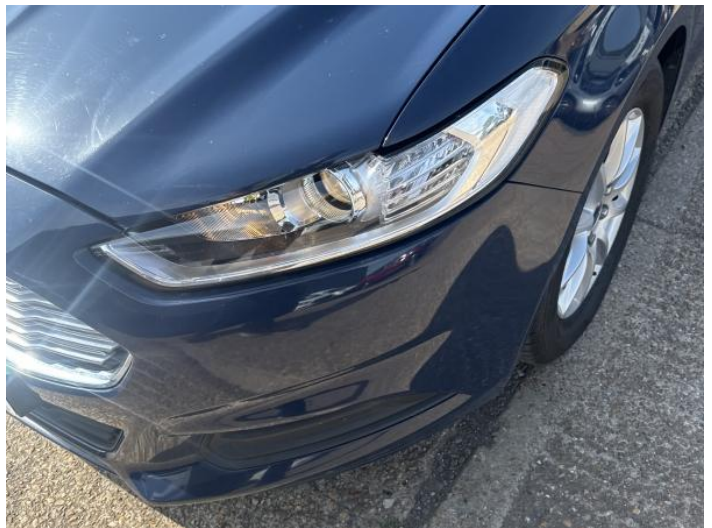
2: Bumper Front  
Scratched  
Over 100mm Thru Paint

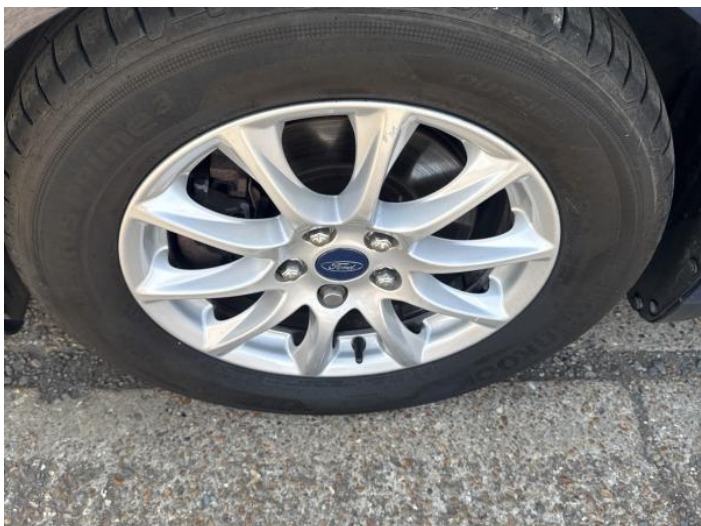
3: Wheel nsf  
Scratched  
Up To 50mm

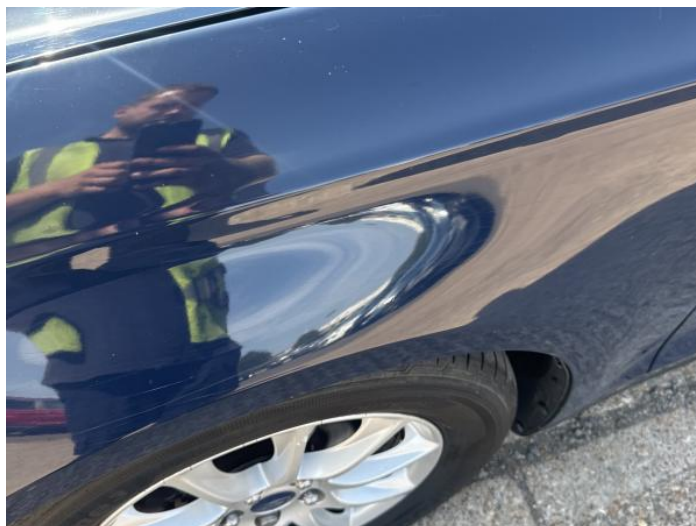
4: Wing nsf  
Chipped  
1 To 5

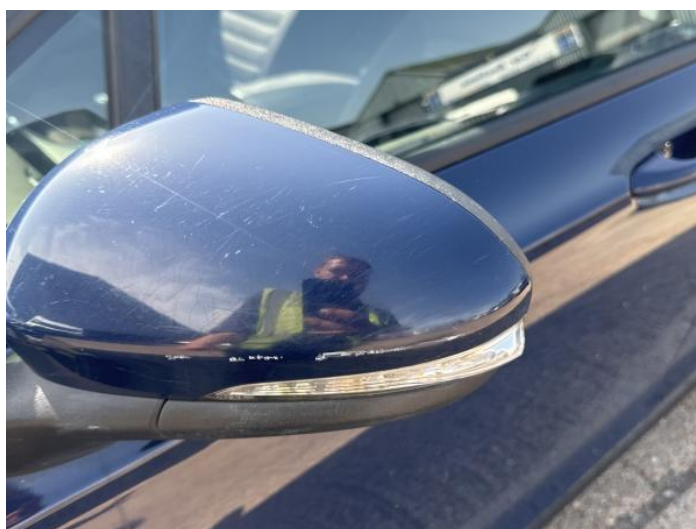
6: Door nsf  
Scratched  
Over 25mm Thru Paint

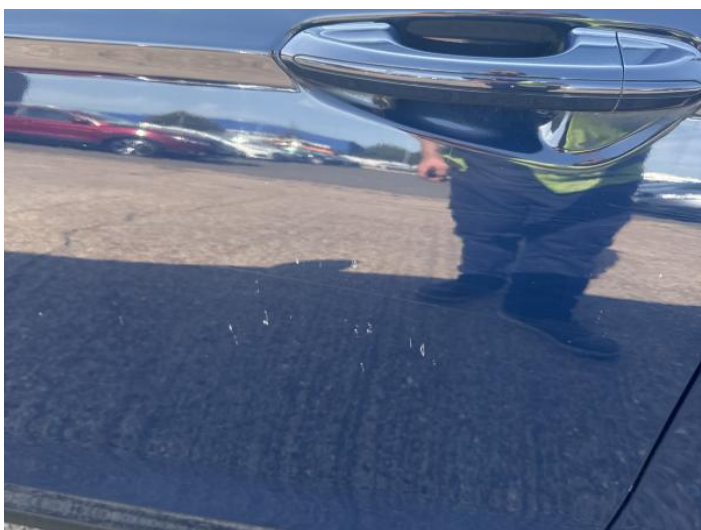
7: Door nsf  
Chipped  
Multiple Chips

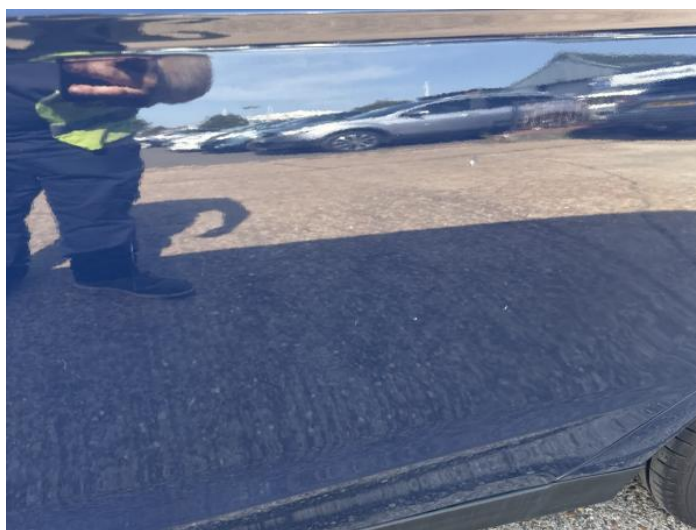
8: Door nsr  
Poor Previous Repair  
Poor Paint

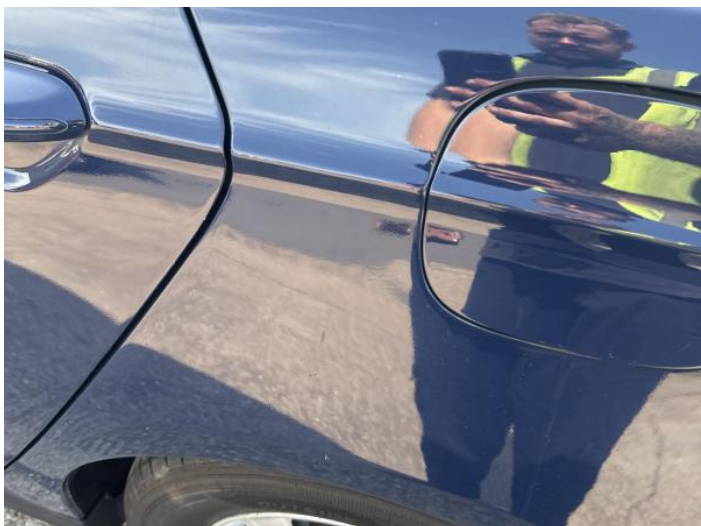
9: Qtr Panel nsr  
Poor Previous Repair  
Poor Paint

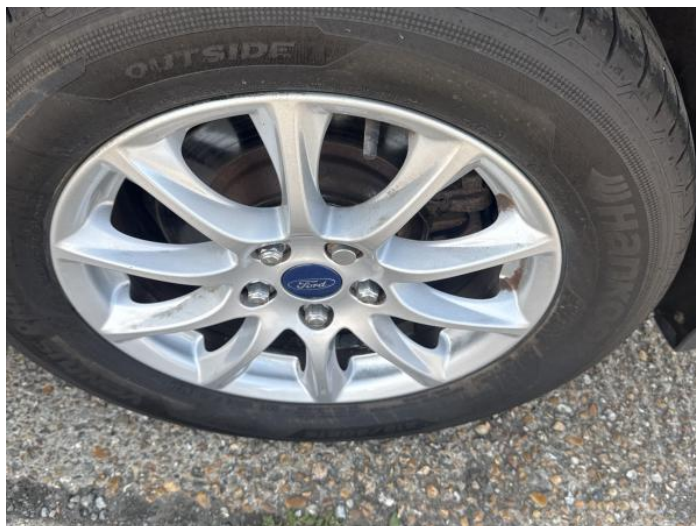
10: Wheel nsr  
Scratched  
Over 50mm

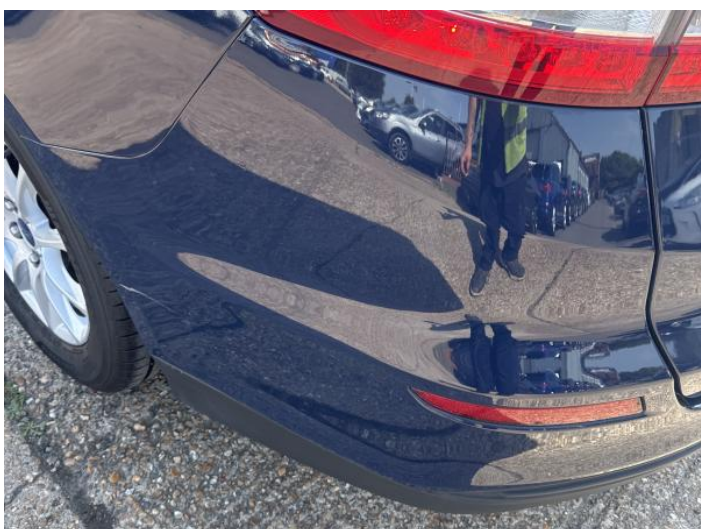
11: Bumper Rear  
Scratched  
25 to 100mm Thru Paint

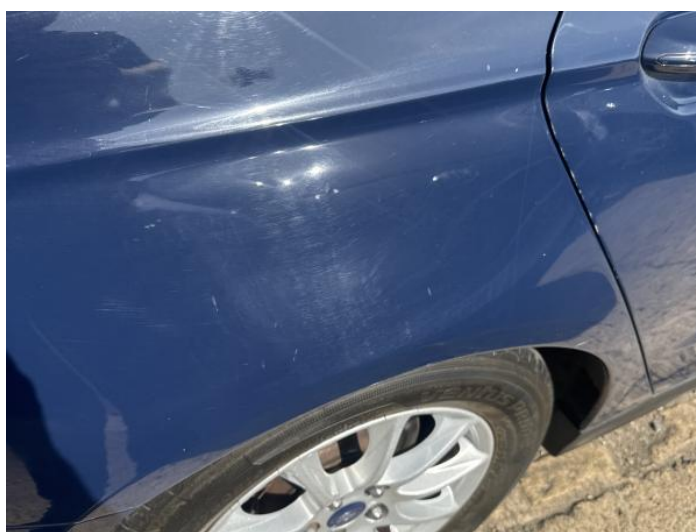
14: Qtr Panel osr  
Dented  
With Paint Damage

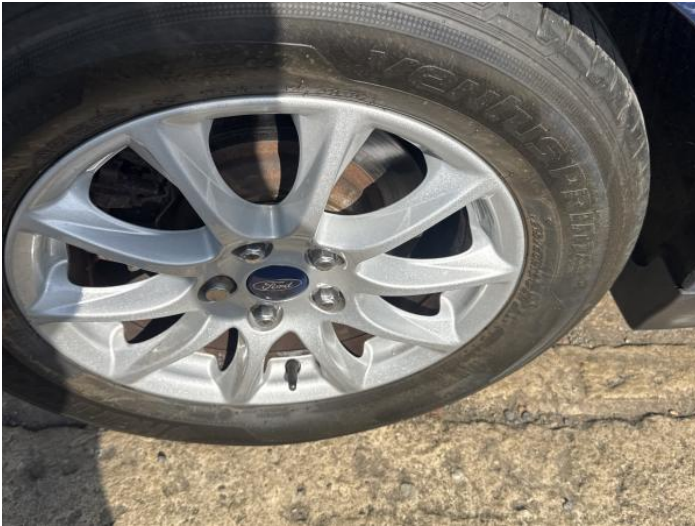
15: Wheel osf  
Scratched  
Over 50mm

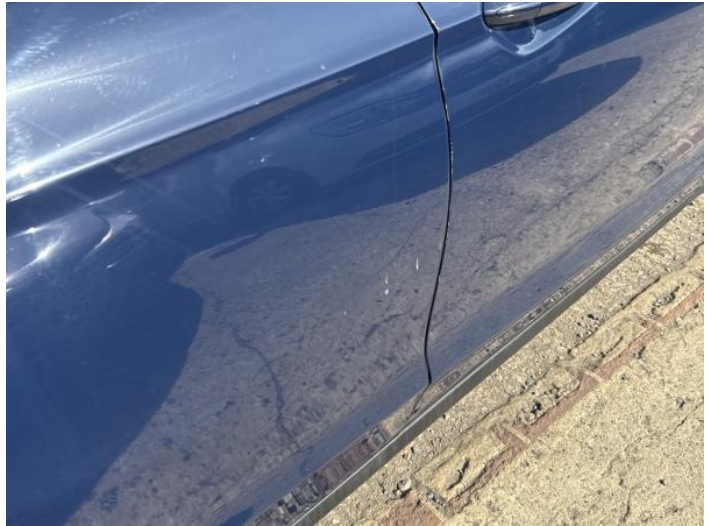
16: Door osf  
Dented  
With Paint Damage

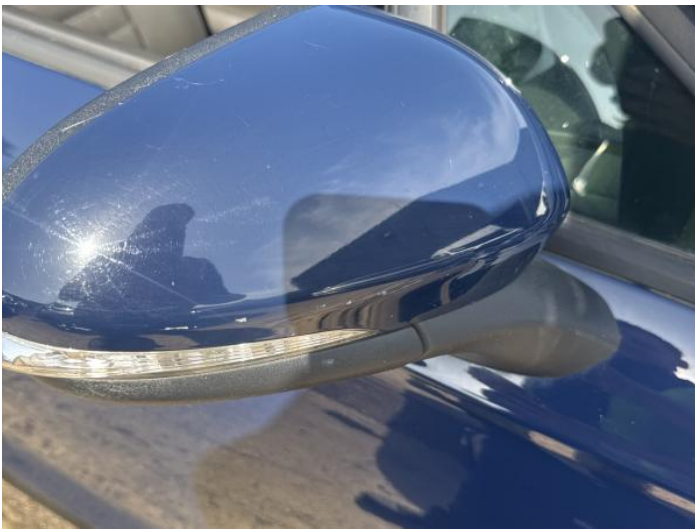
17: Door Mirror Assy osf  
Scratched (Painted)  
Over 25mm Thru Paint

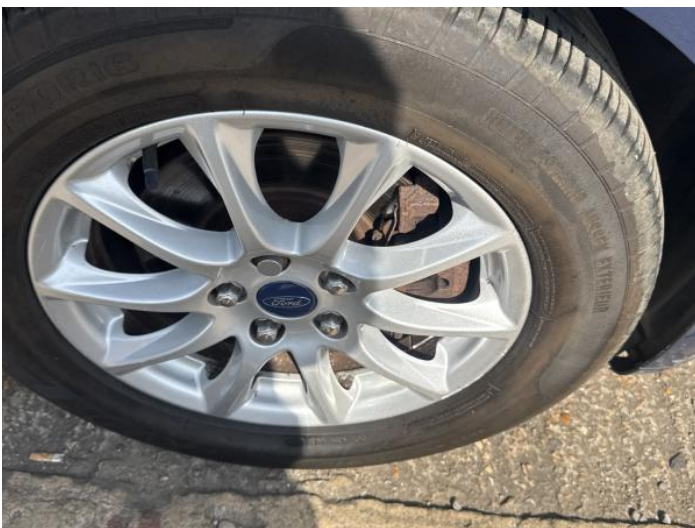
19: Wheel osf  
Scratched  
Up To 50mm
