VEHICLE INSPECTION REPORT

GF22PZL

Alfa Romeo Stelvio 2.0 Turbo 280 Veloce 5dr Auto

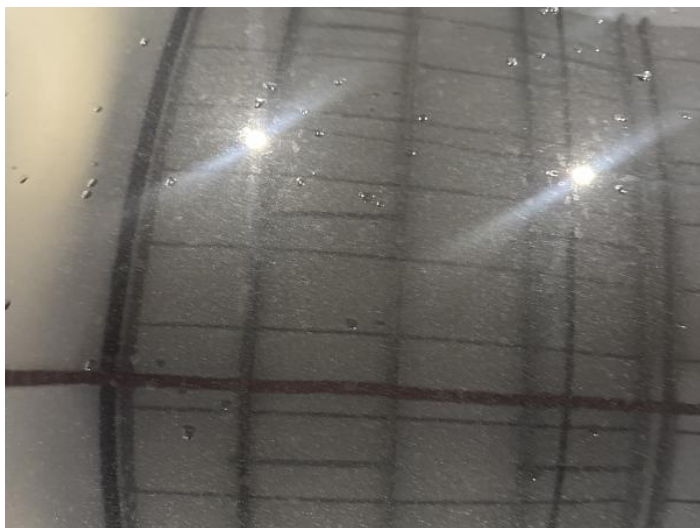
1: Bonnet
Chipped
1 To 5

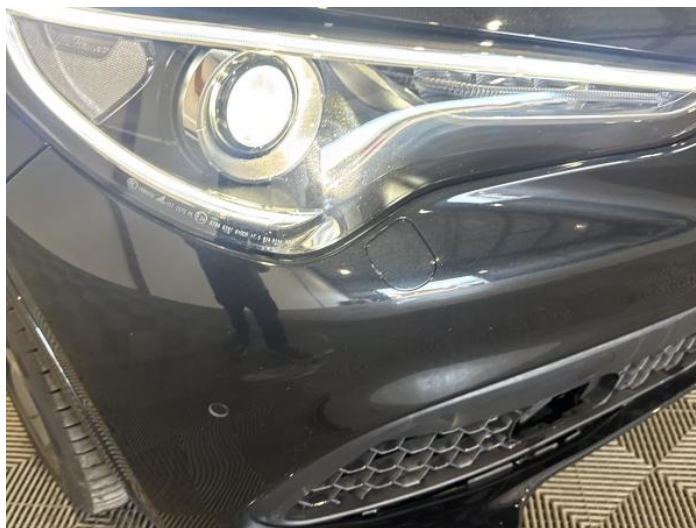
2: Bumper Front
Scratched
Over 100mm Thru Paint

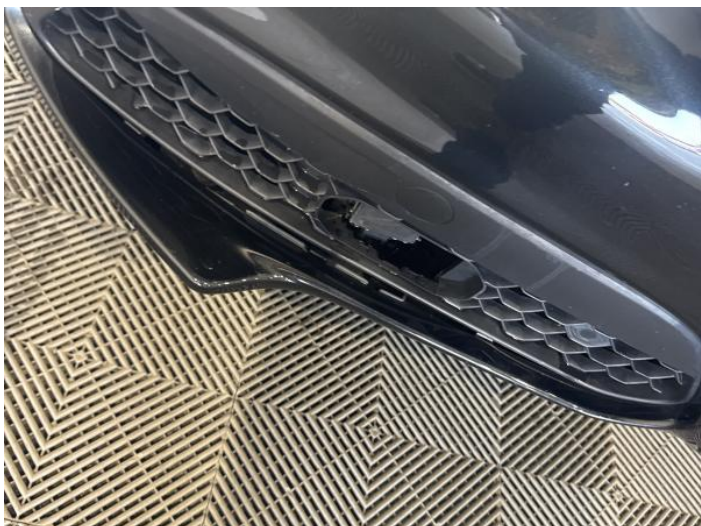
3: Bumper Front Moulding
Broken
Replace

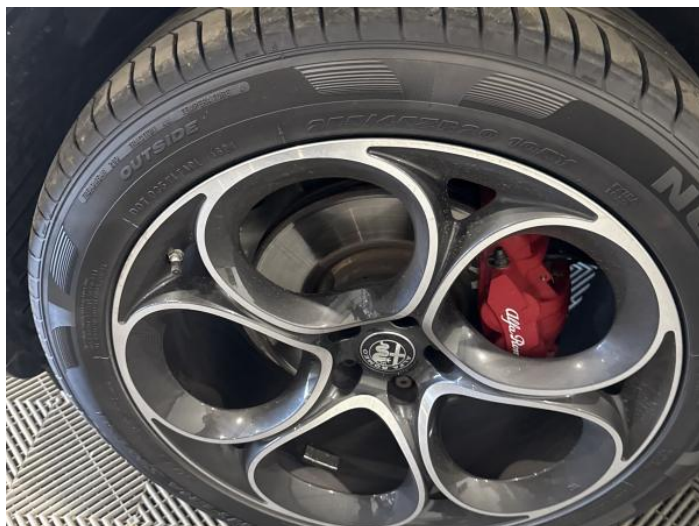
4: Wheel nsf
Scratched
Up To 50mm

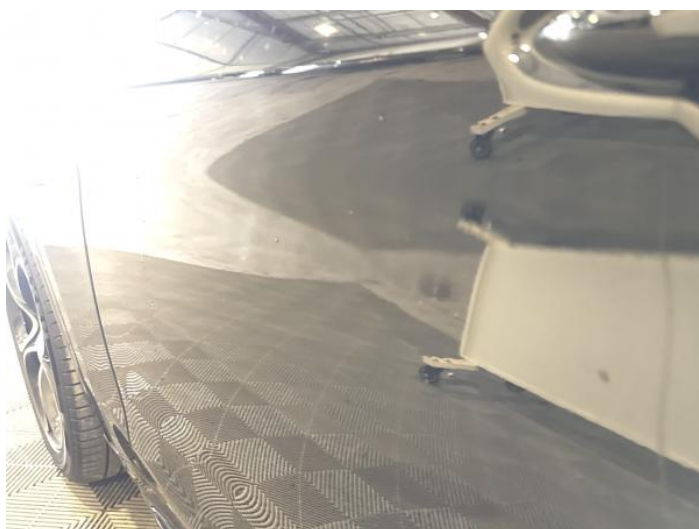
6: Door nsf
Dented
2 Or Less UpTo 10mm

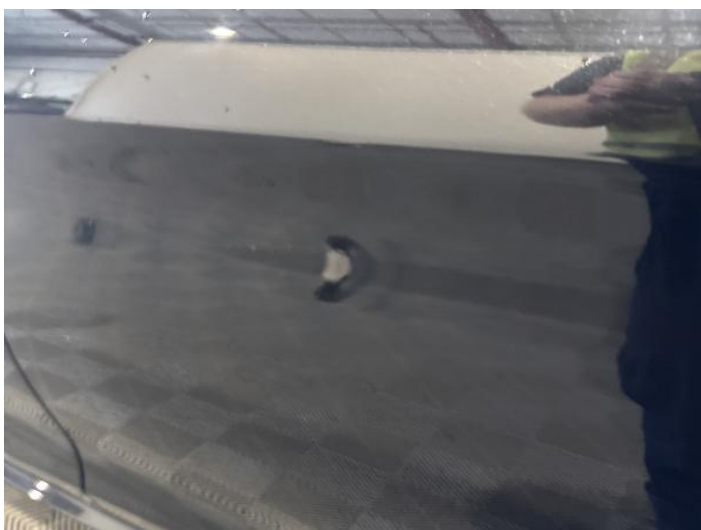
7: Door nsr
Chipped
1 To 5

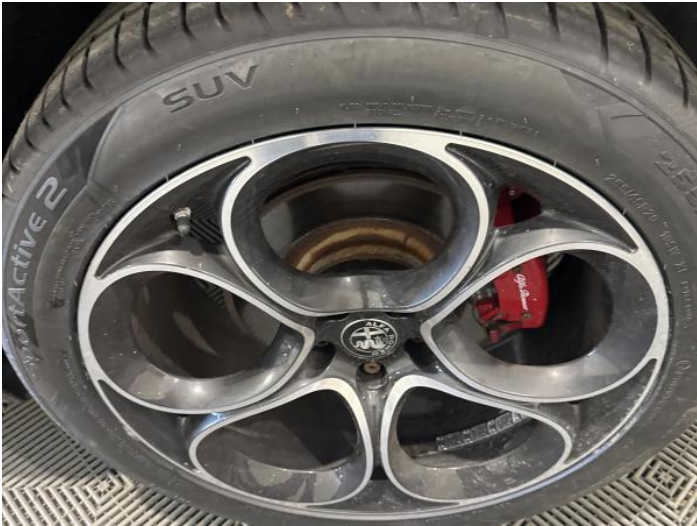
9: Wheel nsr
Scratched
Up To 50mm

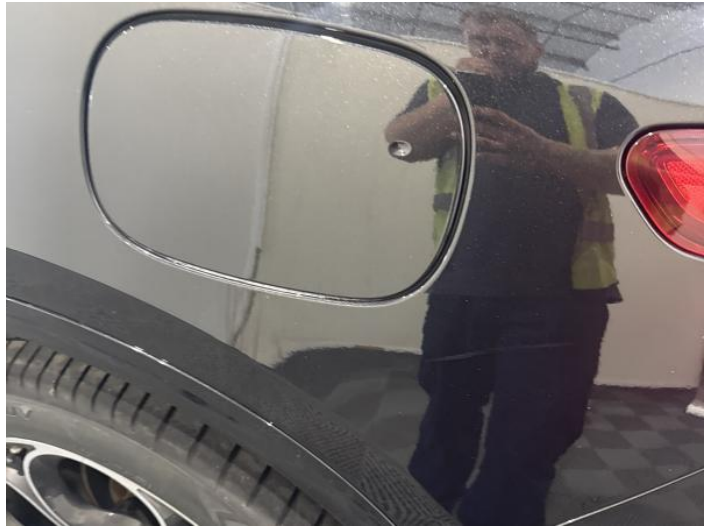
10: Qtr Panel nsr
Chipped
1 To 5

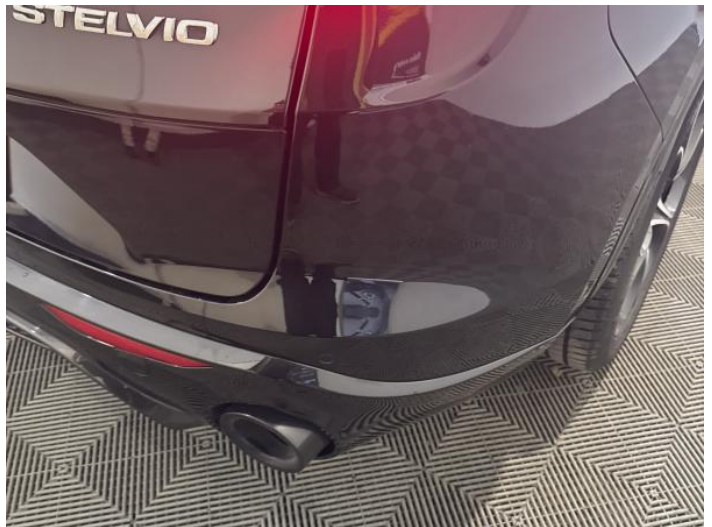
12: Bumper Rear
Chipped
Multiple Chips

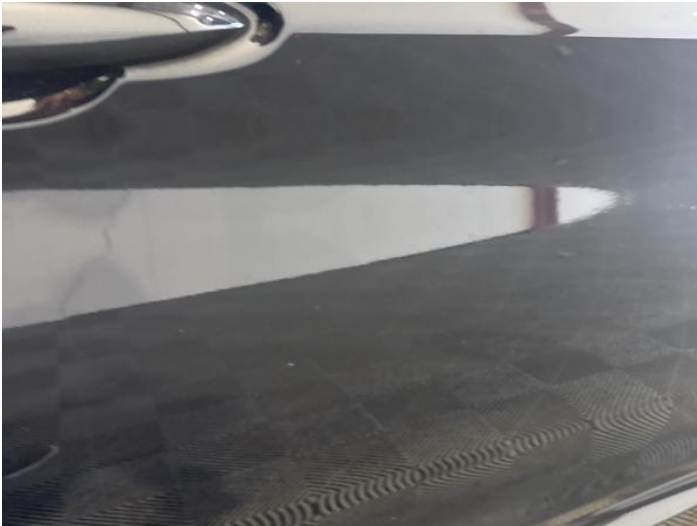
15: Door osf
Chipped
1 To 5

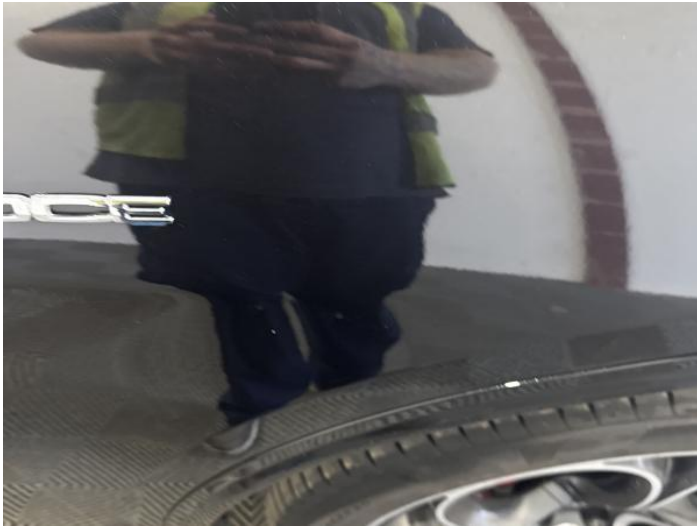
16: Wing osf
Chipped
1 To 5

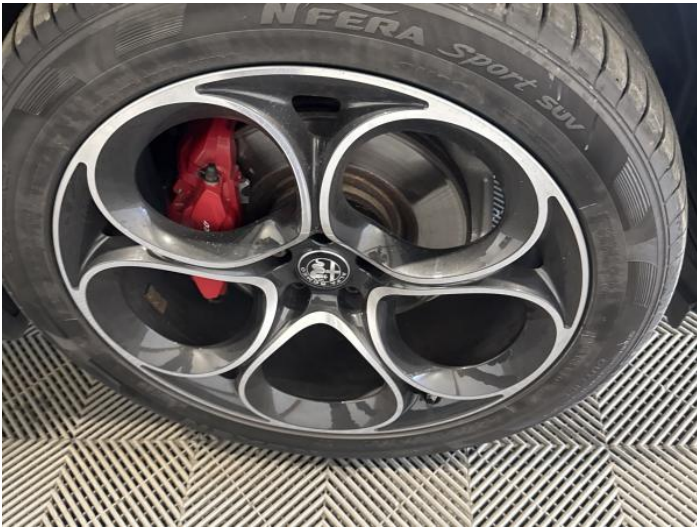
17: Wheel osf
Scratched
Up To 50mm
