VEHICLE INSPECTION REPORT

LM69TOV

Toyota Prius 1.8 VVTi Business Edition Plus 5dr CVT

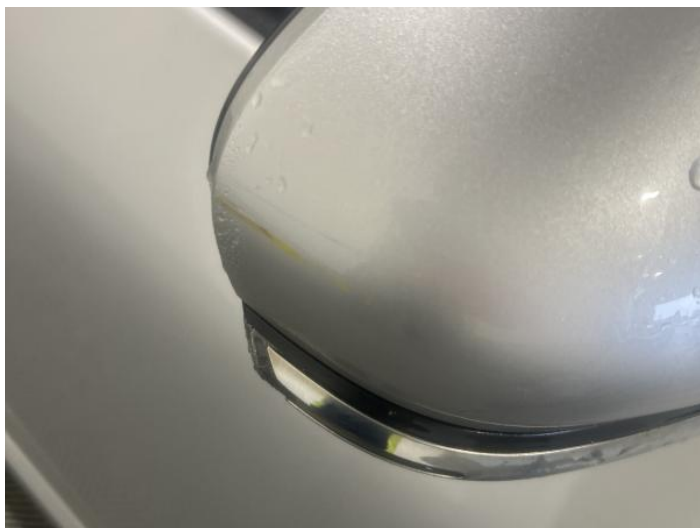
1: Door Mirror Assy osf
Scratched (Painted)
UpTo 25mm Not Thru Paint

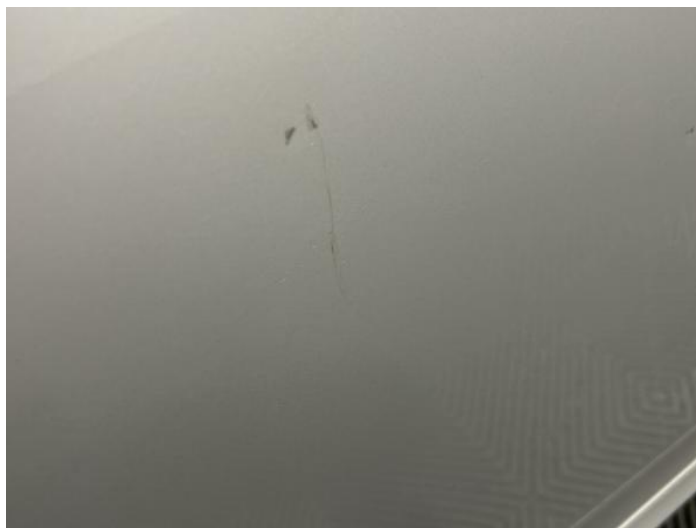
2: Door osf
Scratched
Over 25mm Thru Paint

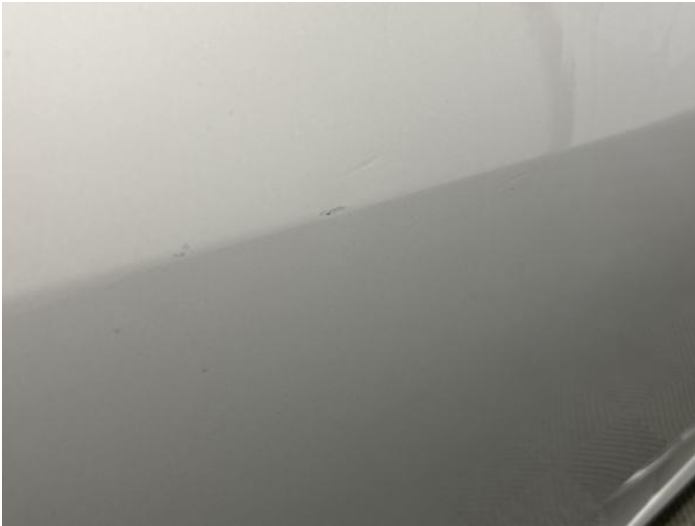
3: Door osr
Chipped
1 To 5

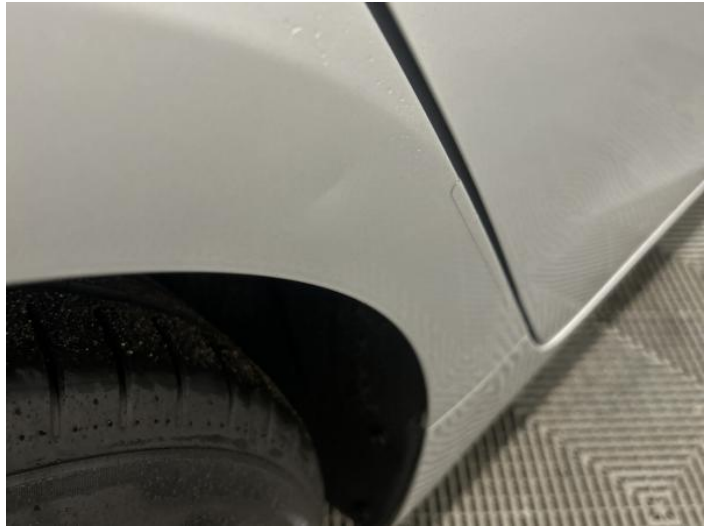
4: Qtr Panel osr
Dented
2 Or Less UpTo 10mm

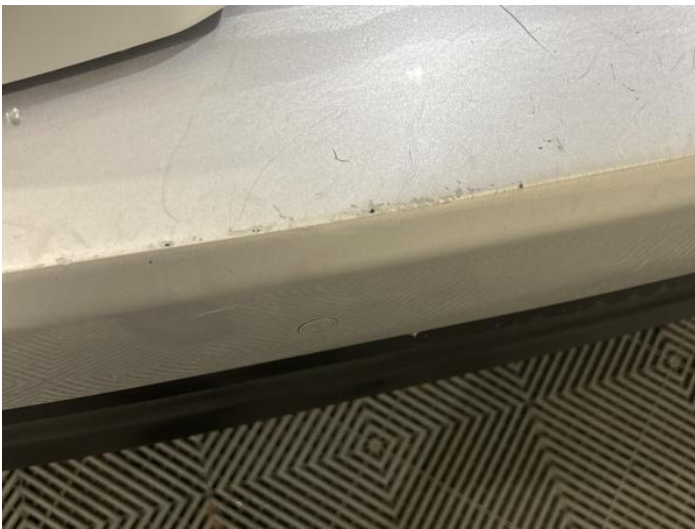
5: Bumper Rear
Chipped
Multiple Chips

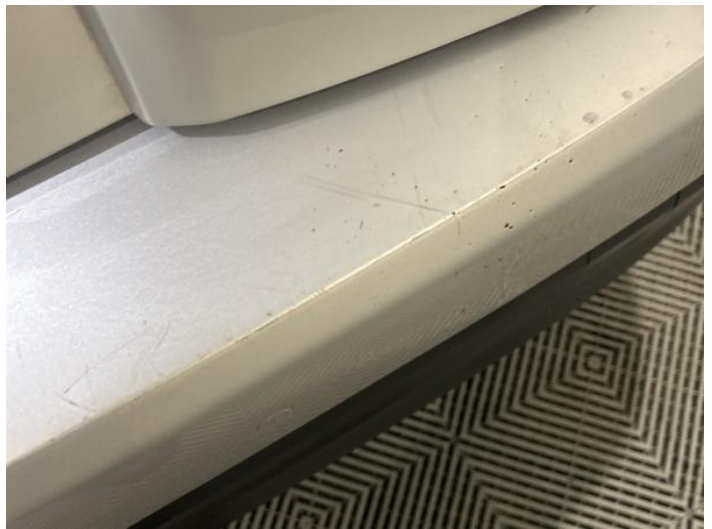
6: Bumper Rear
Scratched
25 to 100mm Thru Paint

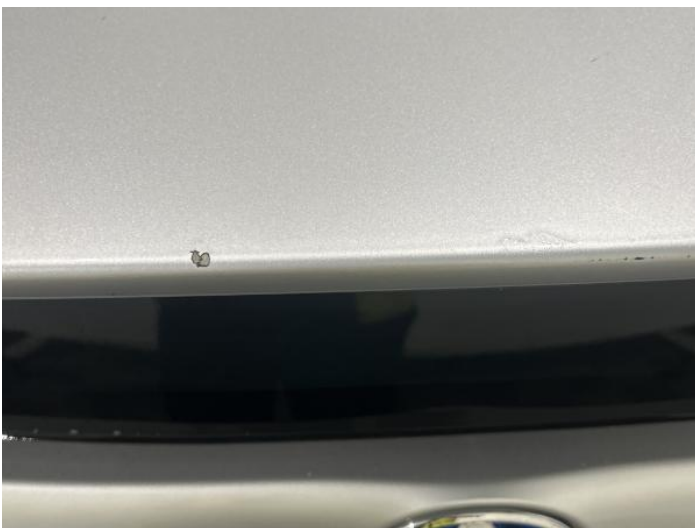
7: Boot Lid
Chipped
1 To 5

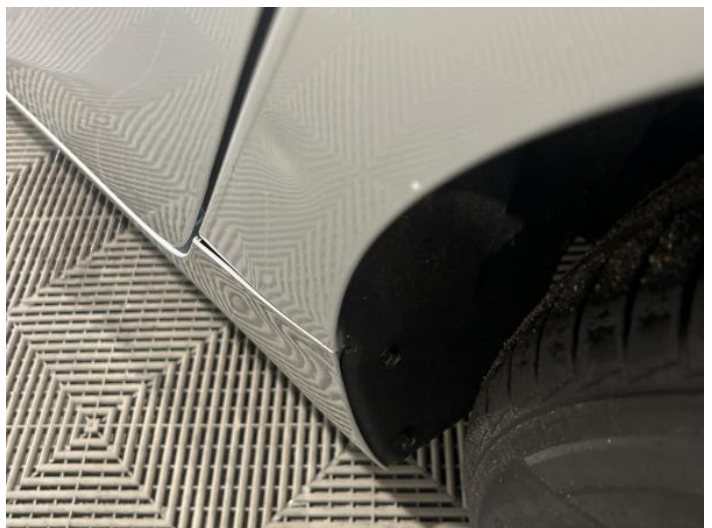
8: Qtr Panel nsr
Dented
Between 10mm + 30mm

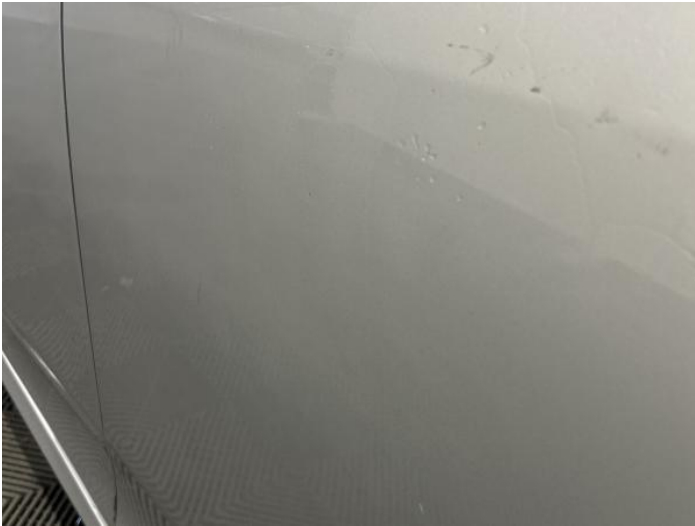
9: Door nsr
Poor Previous Repair
Poor Paint

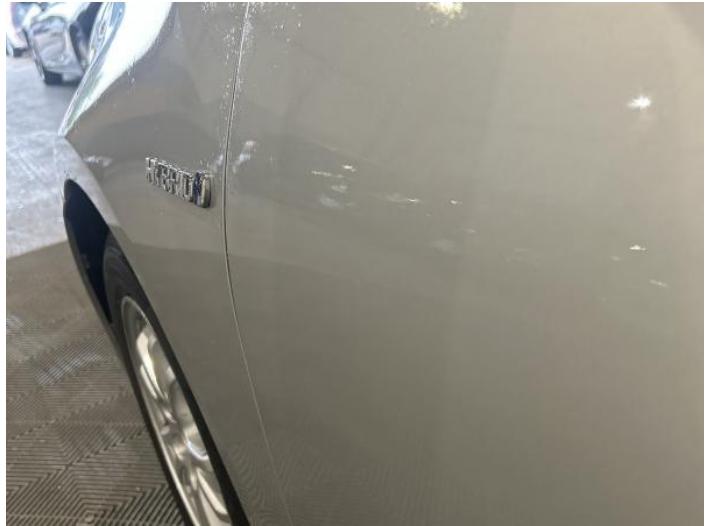
10: Door nsf
Dented
2 Or Less UpTo 10mm

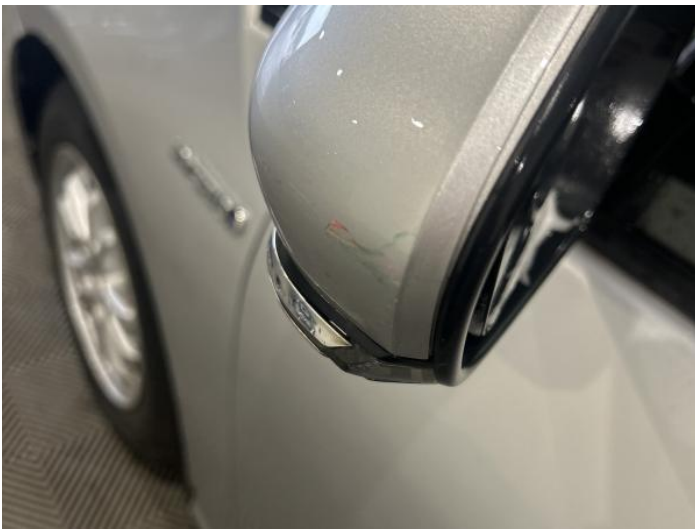
11: Door Mirror Assy nsf
Scratched (Painted)
UpTo 25mm Thru Paint

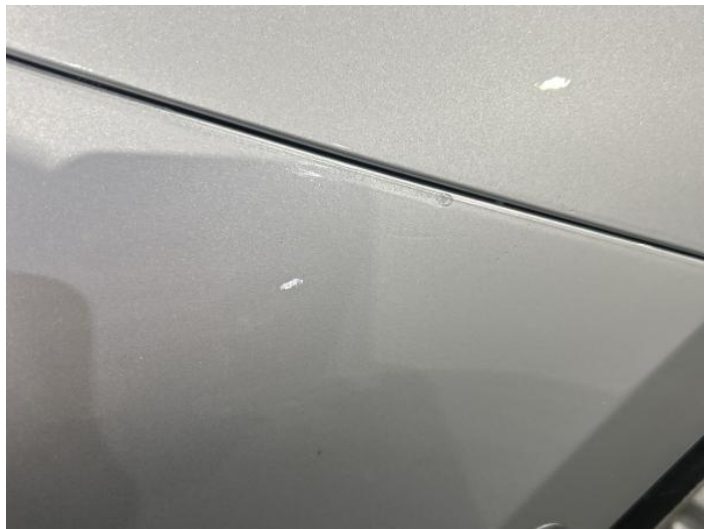
12: Bumper Front
Poor Previous Repair
Poor Paint

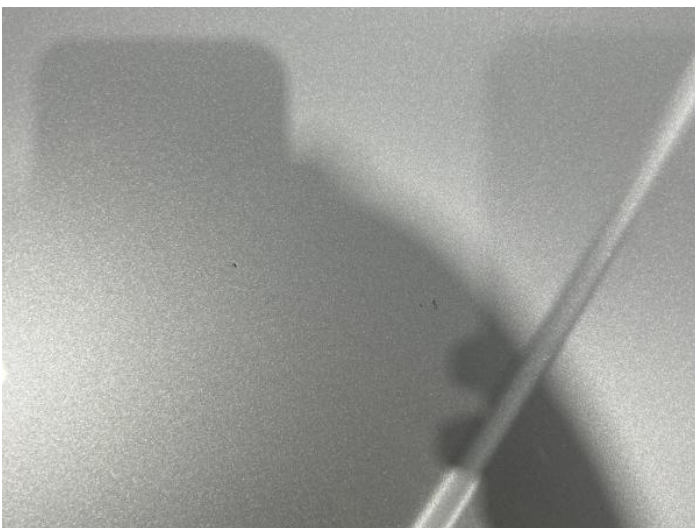
13: Bonnet
Chipped
1 To 5
