VEHICLE INSPECTION REPORT

LF19ALM

Ford Mondeo 1.5 EcoBoost 165 Titanium Edition 5dr

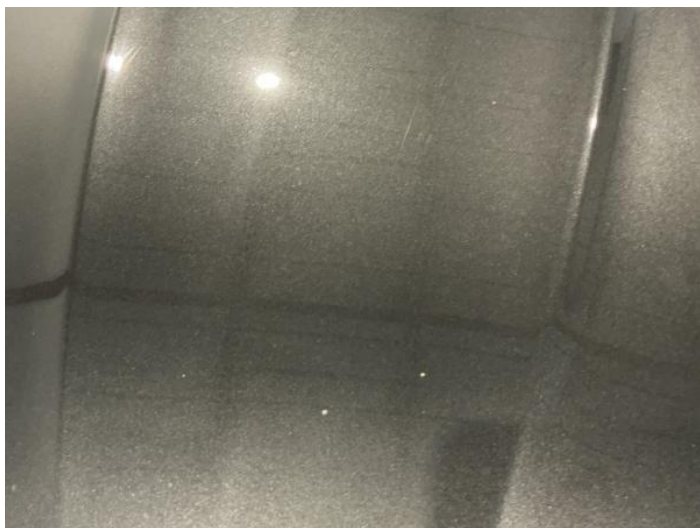
1: Bonnet
Chipped
1 To 5

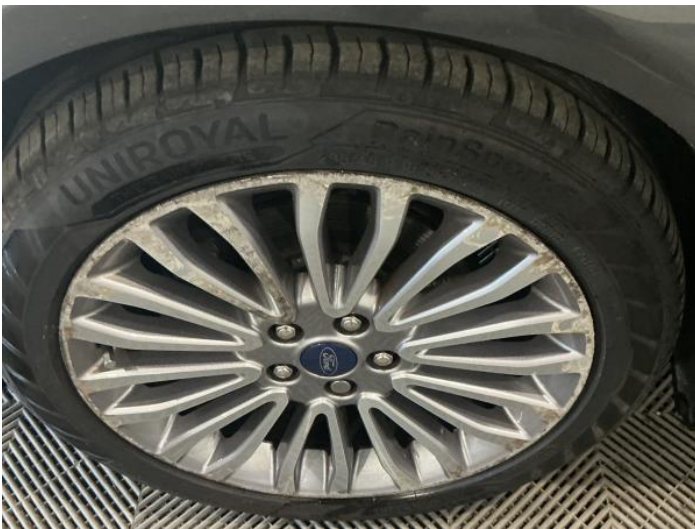
5: Wheel nsf
Scratched
Over 50mm

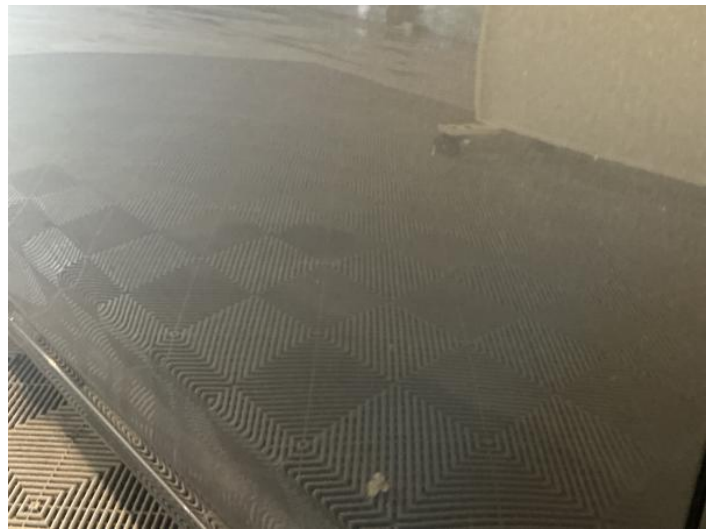
6: Door nsf
Dented
2 Or Less UpTo 10mm

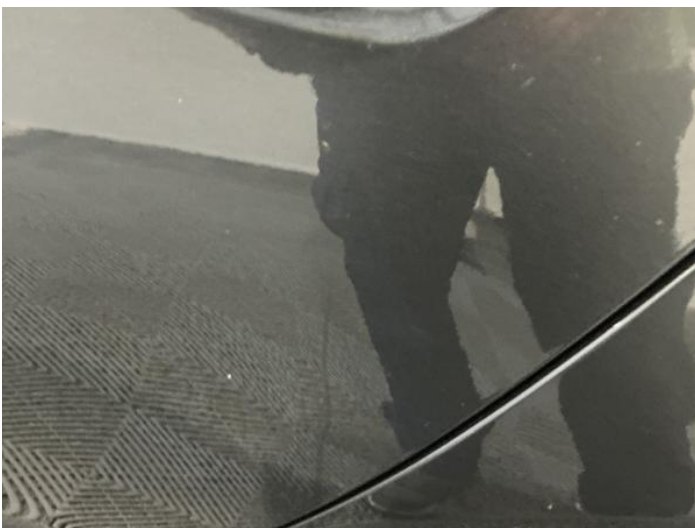
7: Door nsr
Chipped
1 To 5

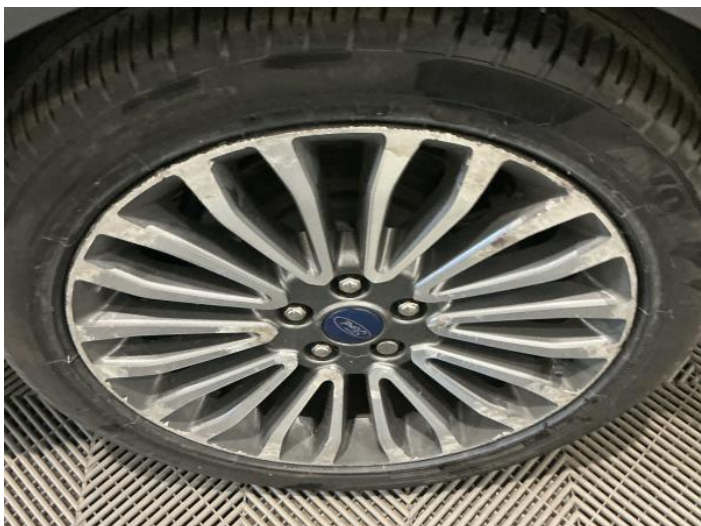
9: Wheel nsr
Scratched
Over 50mm

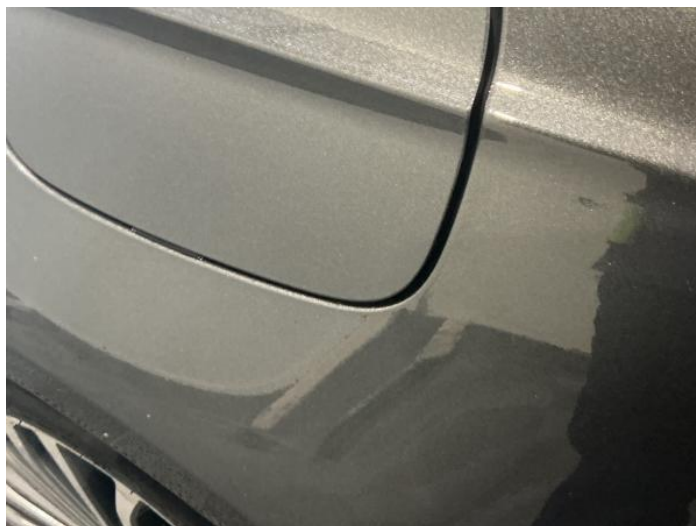
10: Qtr Panel nsr
Chipped
1 To 5

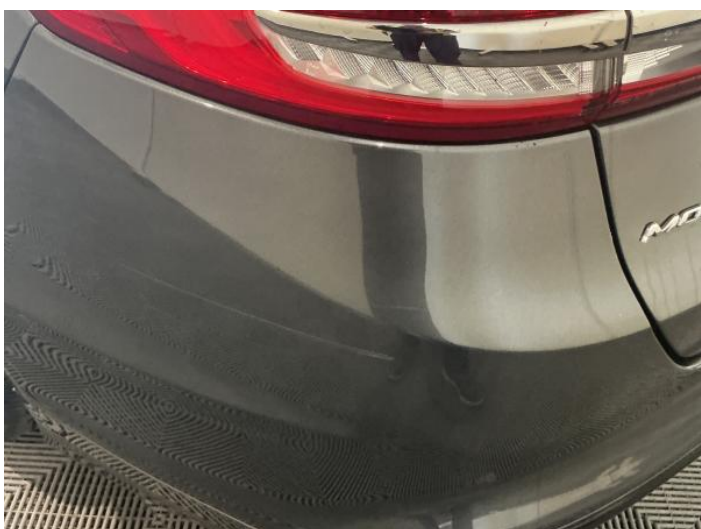
11: Bumper Rear
Scratched
25 to 100mm Thru Paint

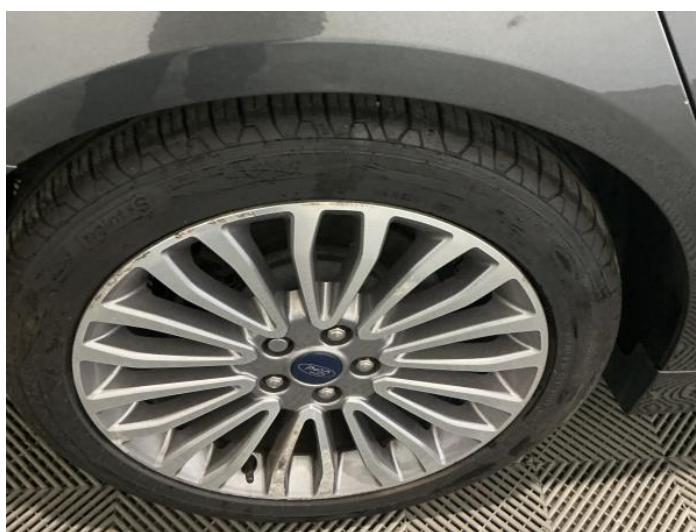
14: Wheel osr
Scratched
Over 50mm

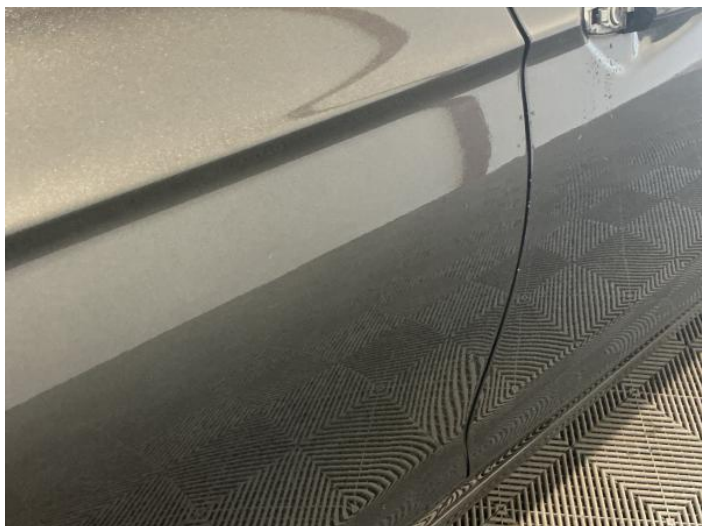
15: Door osr
Dented
2 Or Less UpTo 10mm

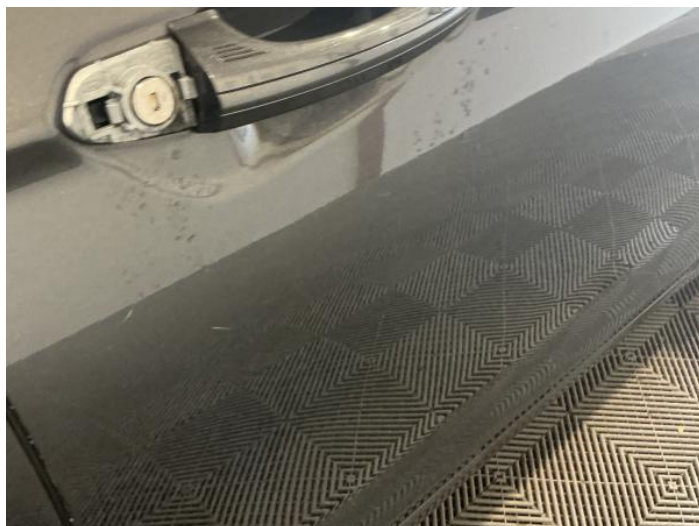
16: Door osf
Chipped
1 To 5

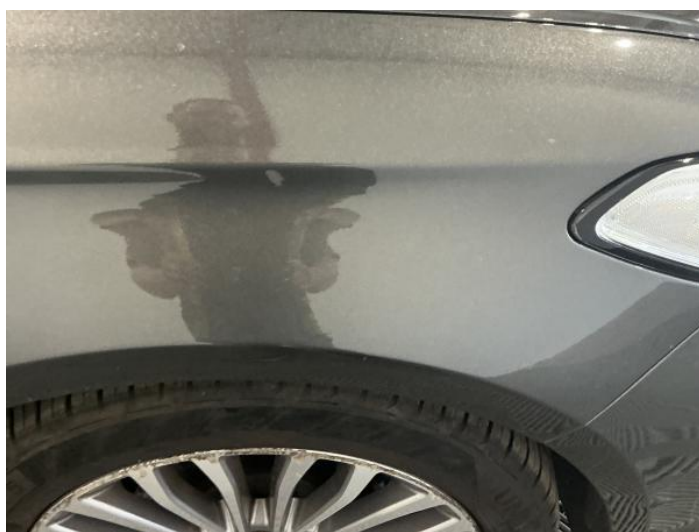
18: Wing osf
Chipped
1 To 5

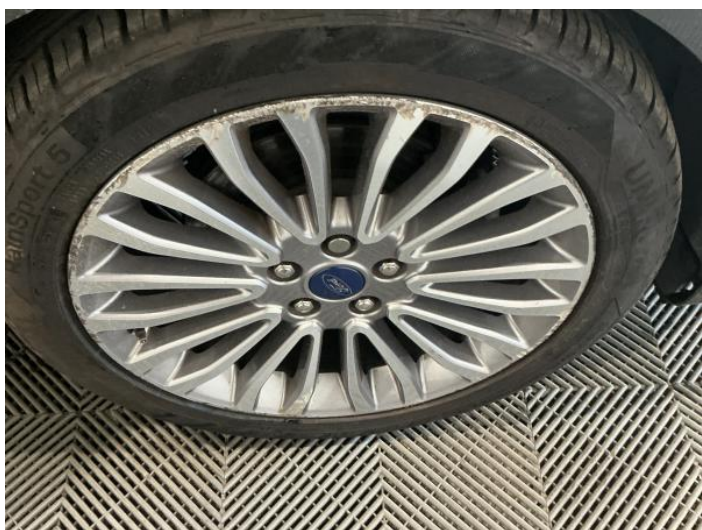
19: Wheel osf
Scratched
Over 50mm
