# VEHICLE INSPECTION REPORT

**LC13JBZ**

## Vauxhall Corsa 1.0 ecoFLEX S 3dr

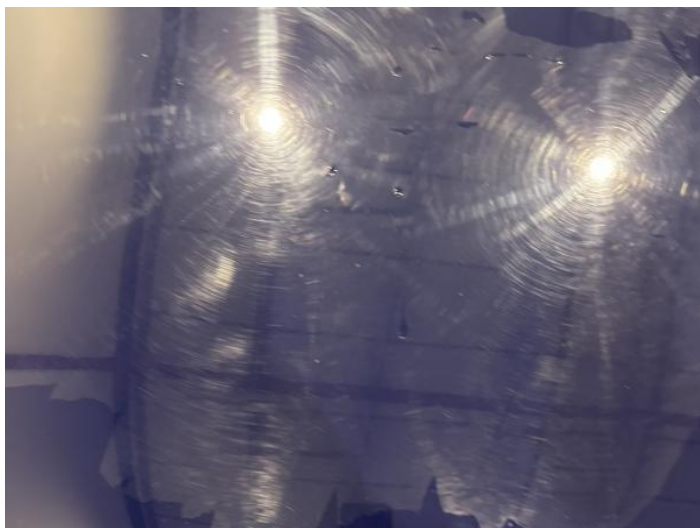
1: Bonnet  
Chipped  
1 To 5

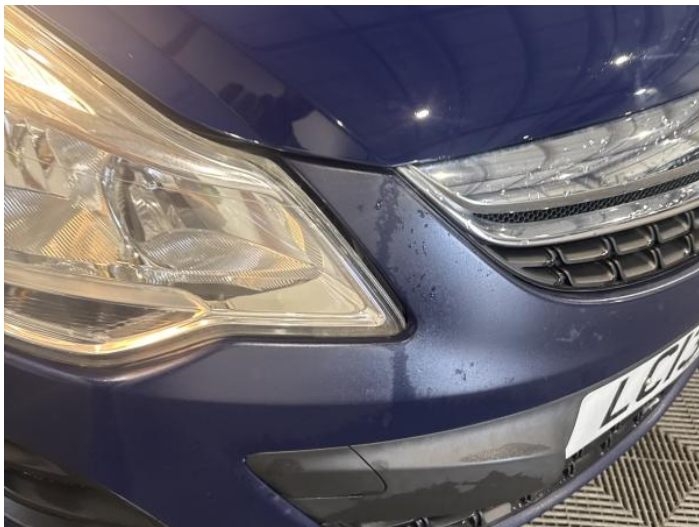
3: Bumper Front  
Poor Previous Repair  
Poor Paint

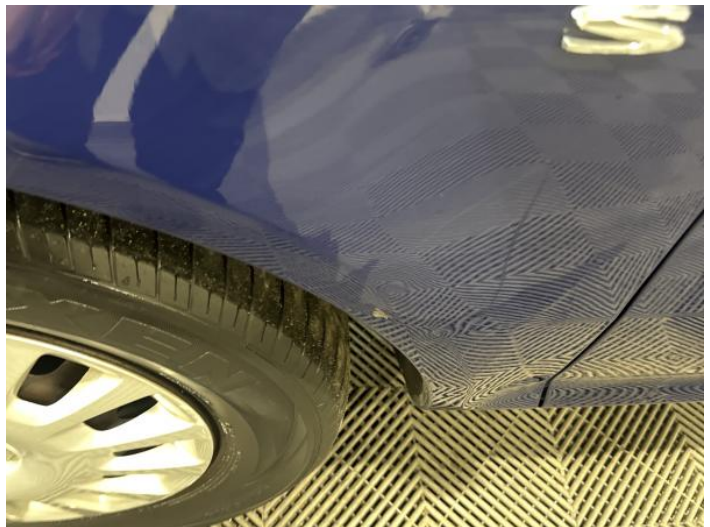
4: Wing nsf  
Dented  
Over 2 UpTo 10mm

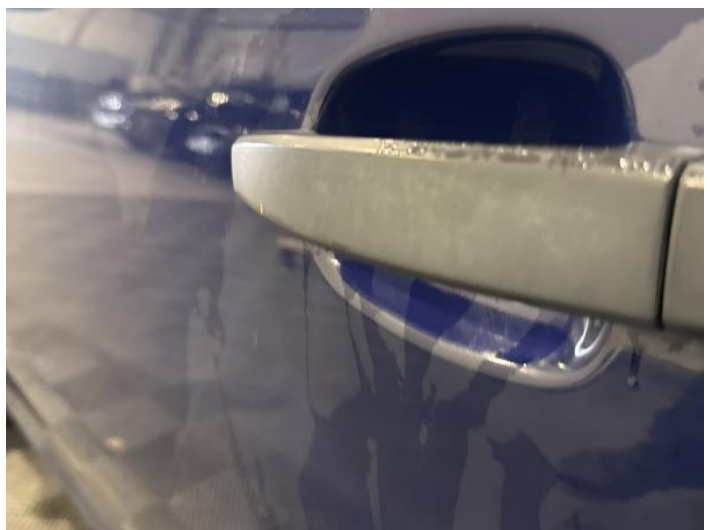
6: Door nsf  
Dented  
Over 2 UpTo 10mm

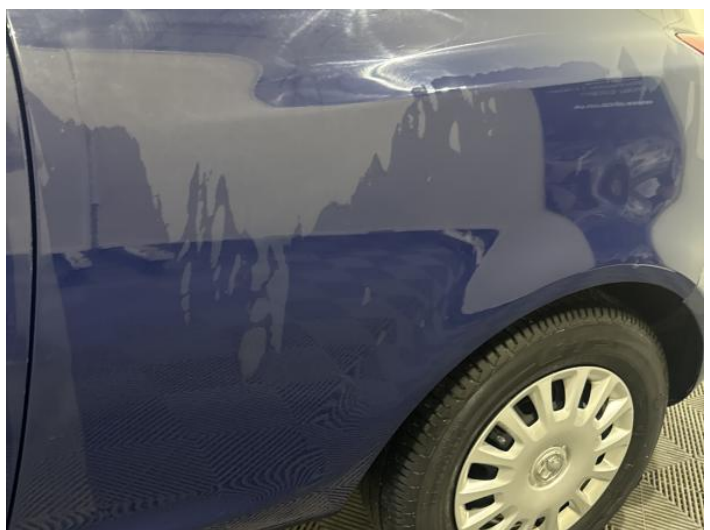
8: Qtr Panel nsr  
Dented  
With Paint Damage

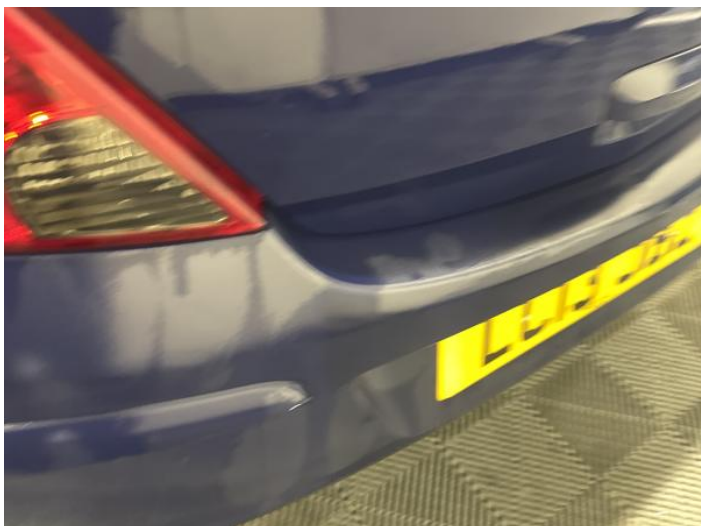
9: Bumper Rear  
Poor Previous Repair  
Poor Paint

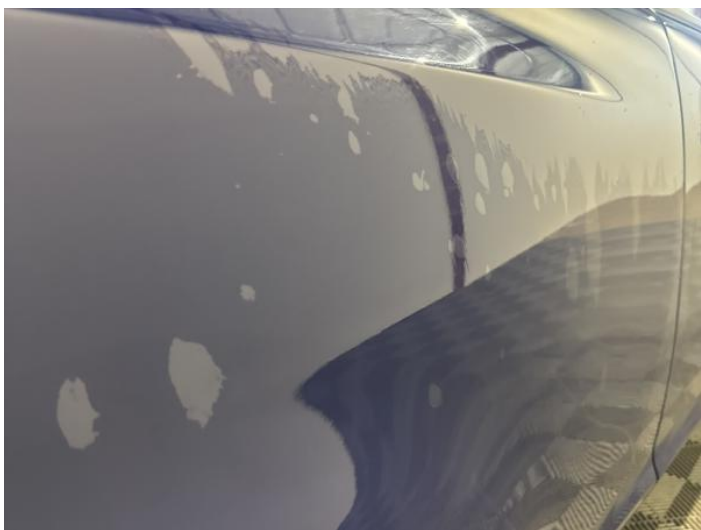
11: Qtr Panel osr  
Chipped  
1 To 5

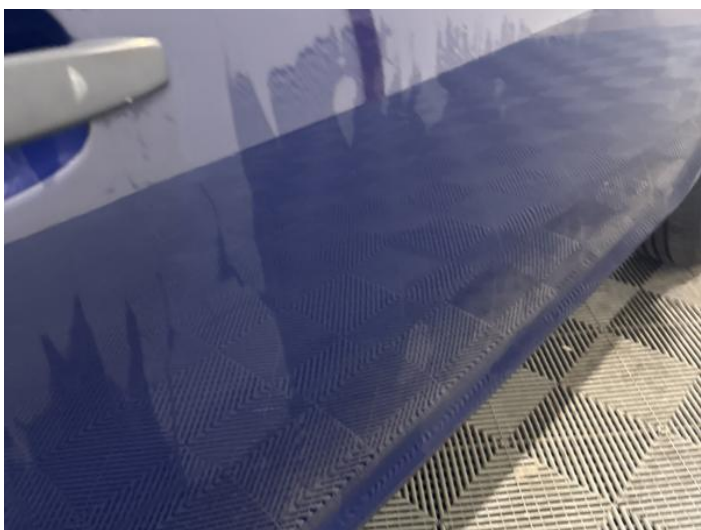
13: Door osf  
Chipped  
1 To 5

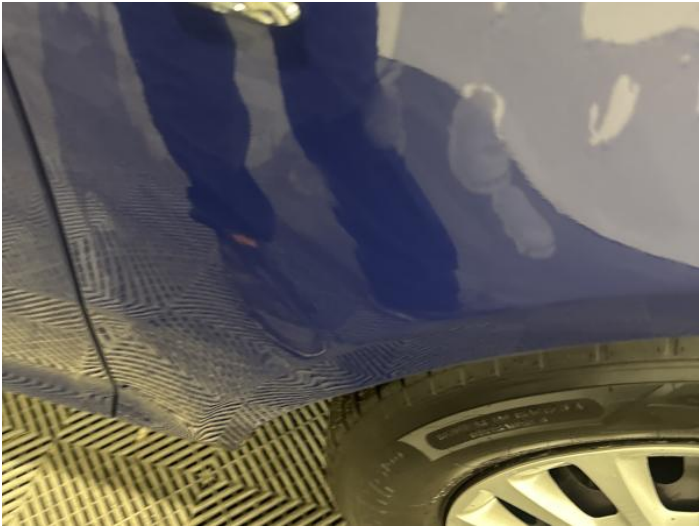
15: Wing osf  
Dented  
Over 2 UpTo 10mm
