VEHICLE INSPECTION REPORT

CY17EYO

Citroen Grand C4 Picasso 1.6 BlueHDi Flair 5dr EAT6

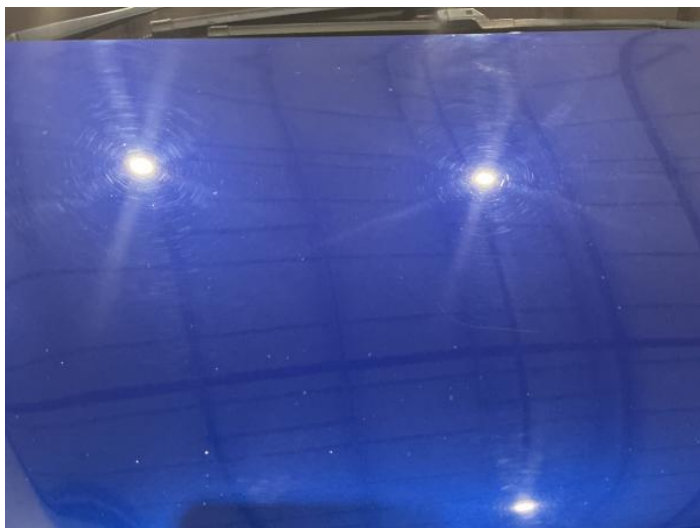
1: Bonnet
Chipped
Multiple Chips

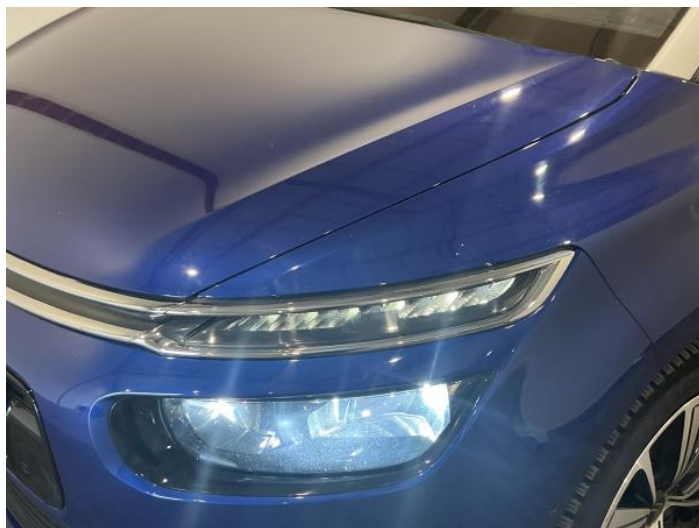
2: Bumper Front
Chipped
Multiple Chips

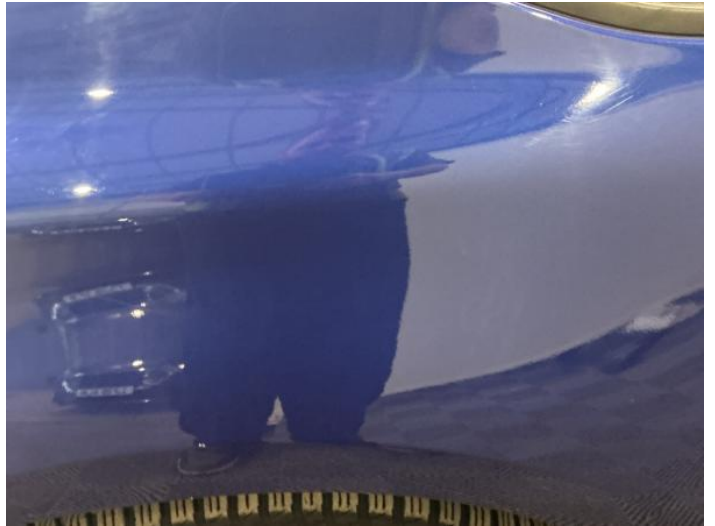
4: Wing nsf
Chipped
1 To 5

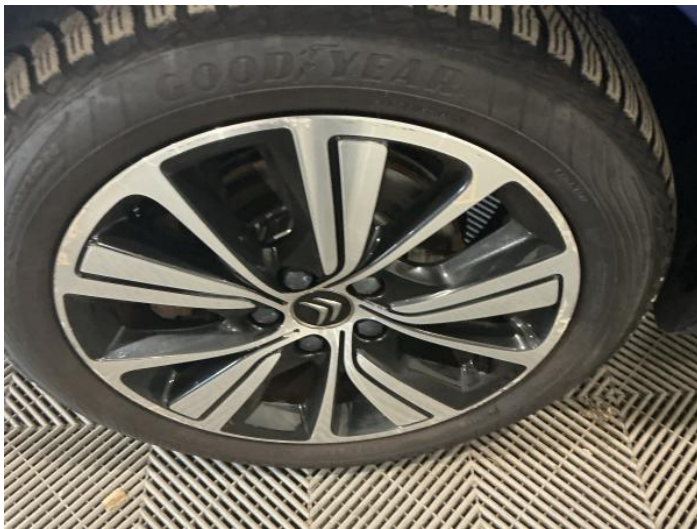
5: Wheel nsf
Scratched
Over 50mm

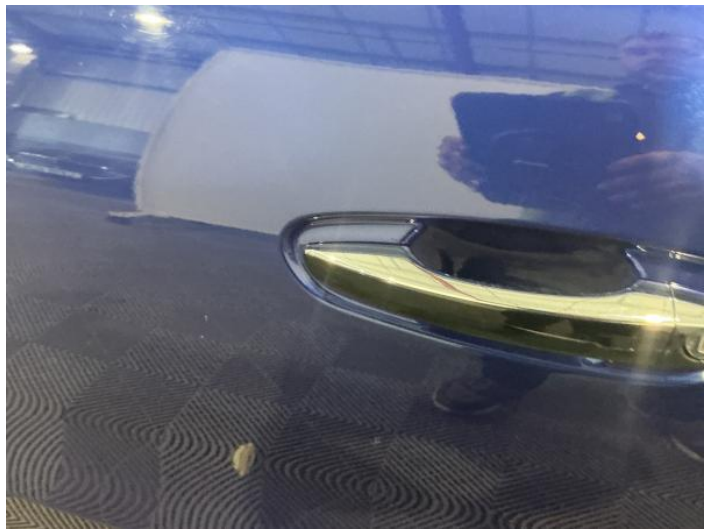
6: Door nsf
Dented
Between 10mm + 30mm

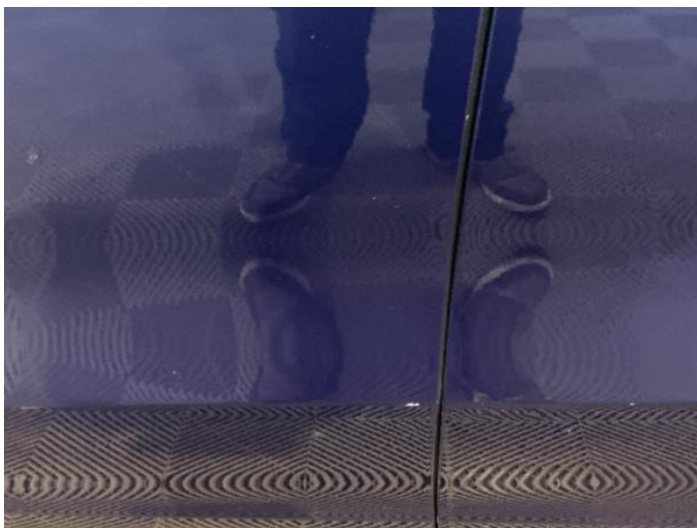
7: Door nsf
Chipped
1 To 5

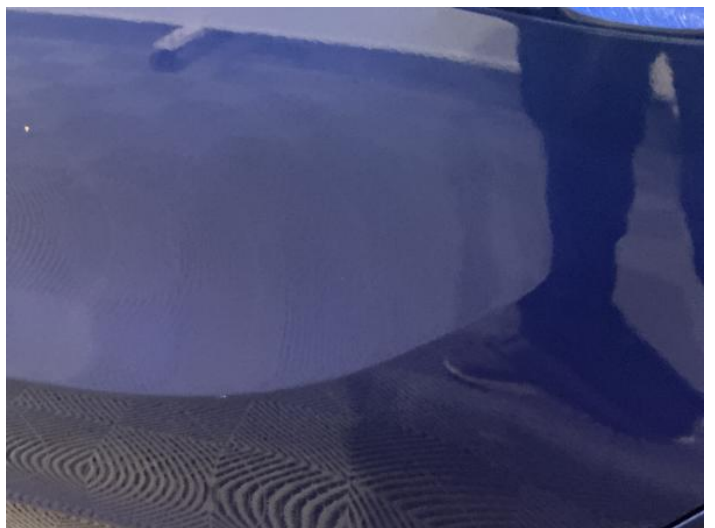
8: Door nsr
Chipped
1 To 5

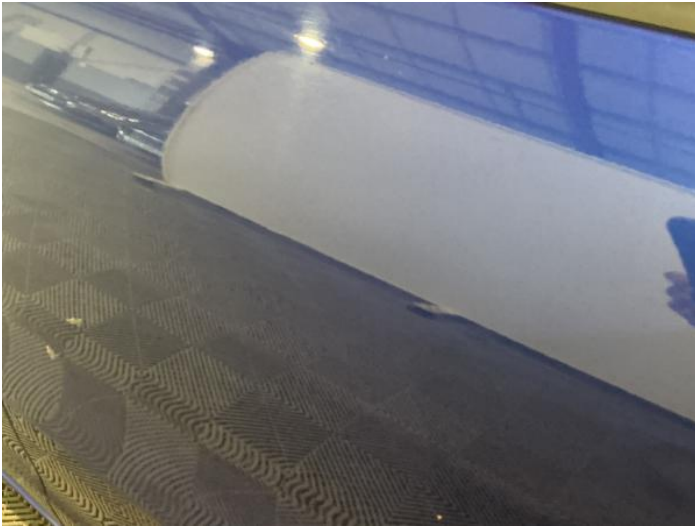
9: Door nsr
Dented
Between 10mm + 30mm

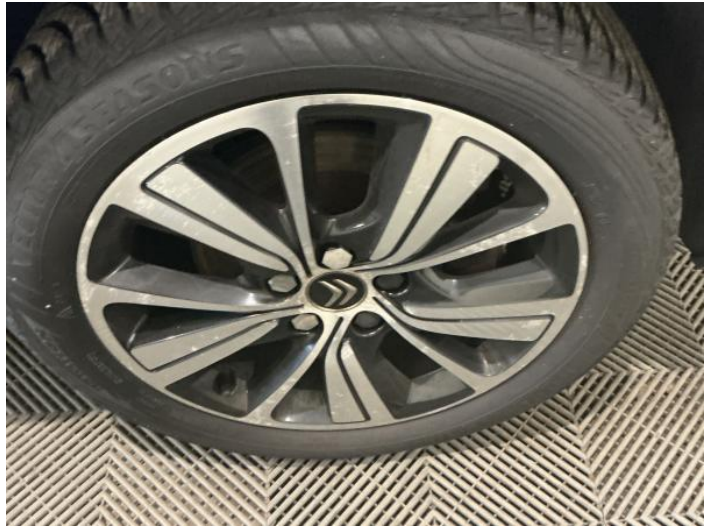
10: Wheel nsr
Scratched
Over 50mm

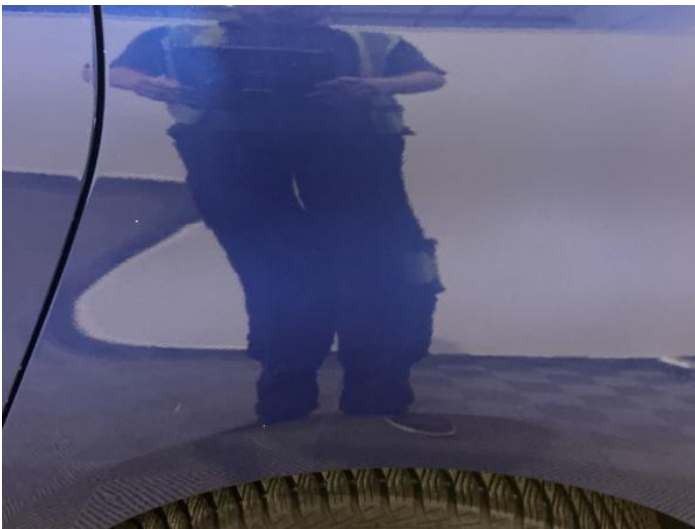
11: Qtr Panel nsr
Poor Previous Repair
Poor Paint

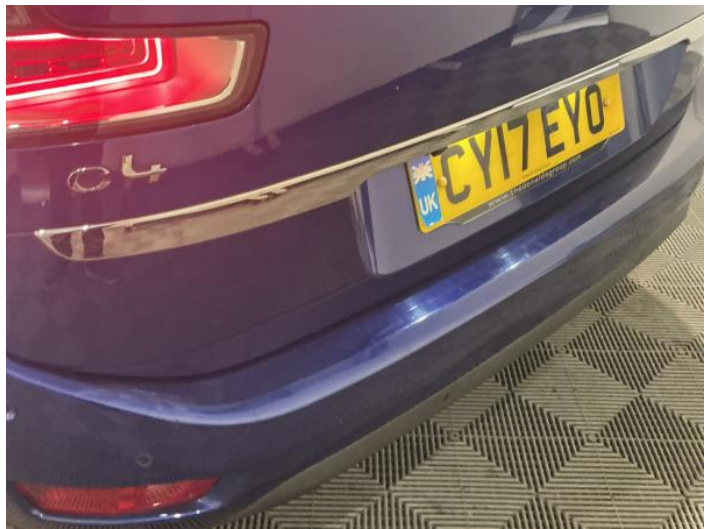
12: Bumper Rear
Poor Previous Repair
Rippled UpTo 30%

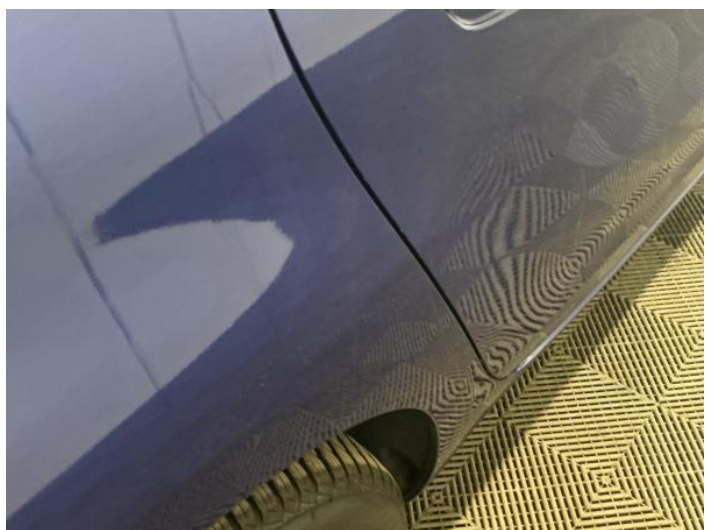
14: Qtr Panel osr
Dented
2 Or Less UpTo 10mm

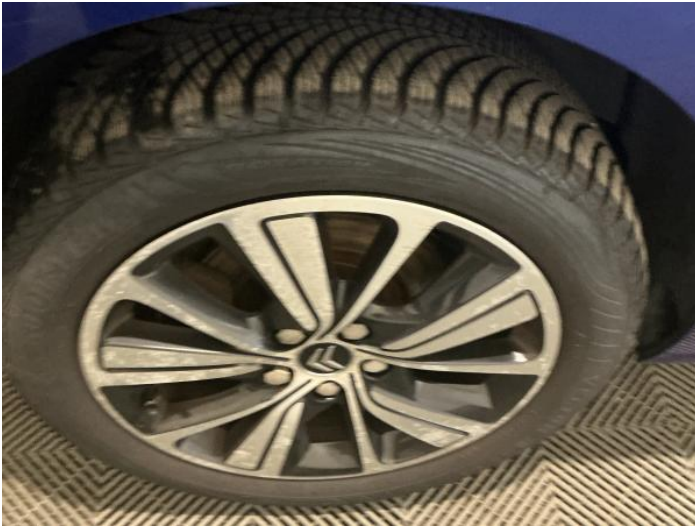
15: Wheel osr
Scratched
Over 50mm

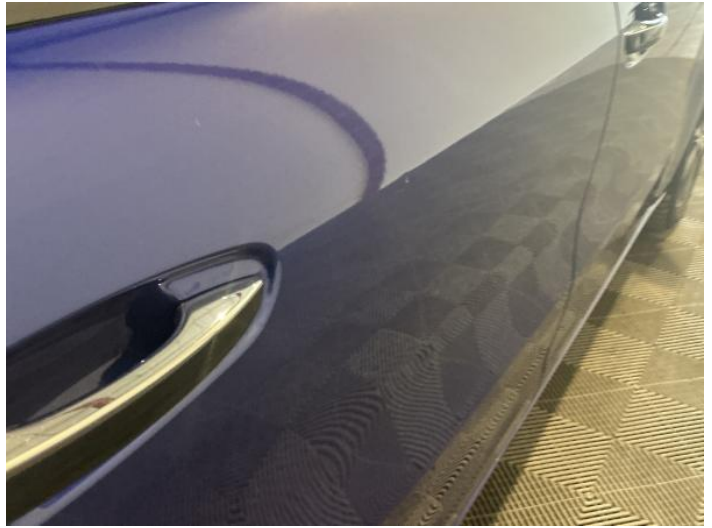
16: Door osr
Chipped
1 To 5

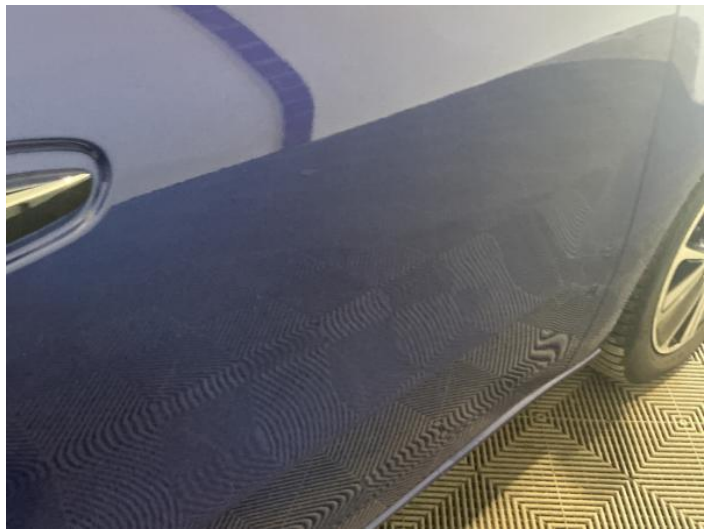
18: Door osf
Dented
Over 2 UpTo 10mm

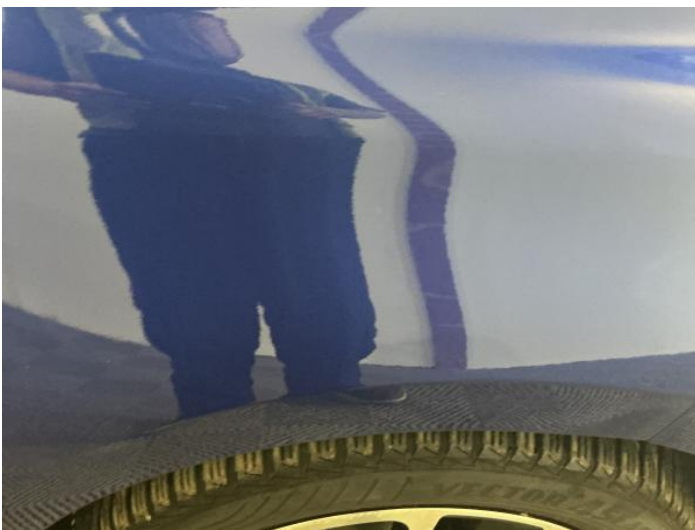
19: Wing osf
Chipped
1 To 5

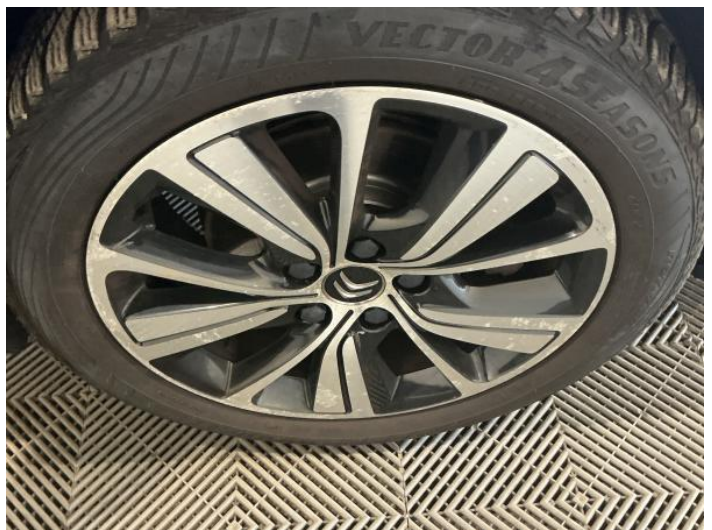
20: Wheel osf
Scratched
Over 50mm

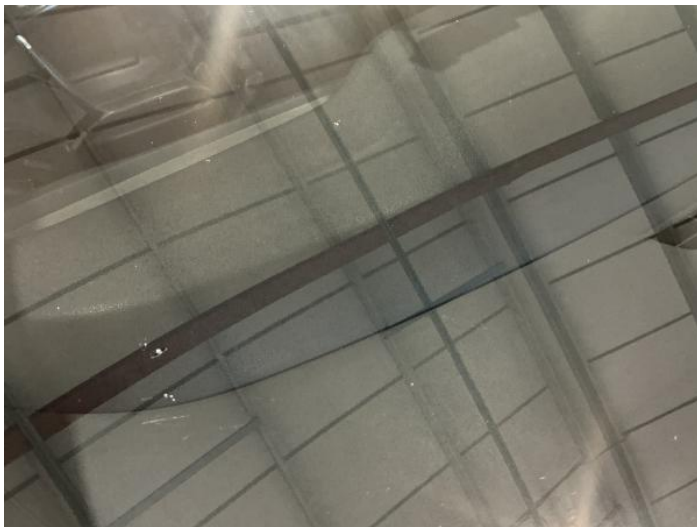
21: Screen Front
Chipped
UpTo 10mm

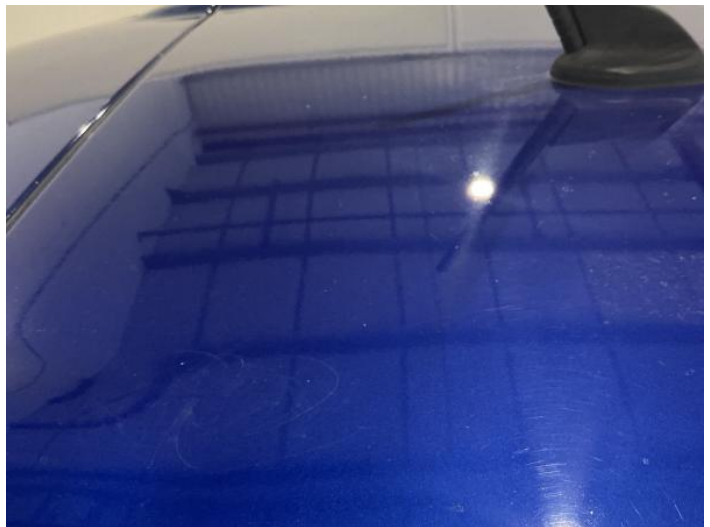
22: Roof
Dented
Between 10mm + 30mm
