VEHICLE INSPECTION REPORT

GU12FKH

Ford Fiesta 1.4 TDCi [70] Zetec 5dr

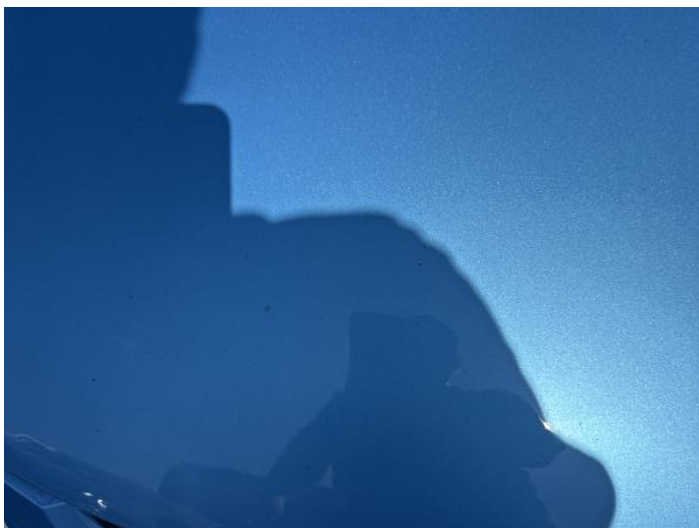
1: Bonnet
Chipped
1 To 5

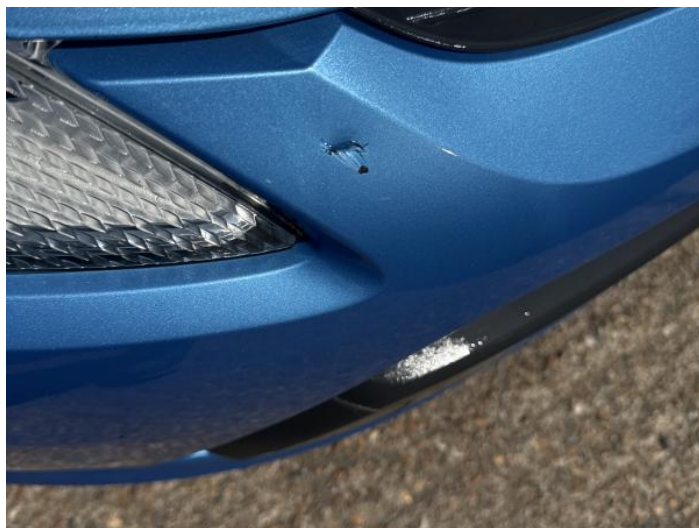
2: Bumper Front
Dented
With Paint Damage

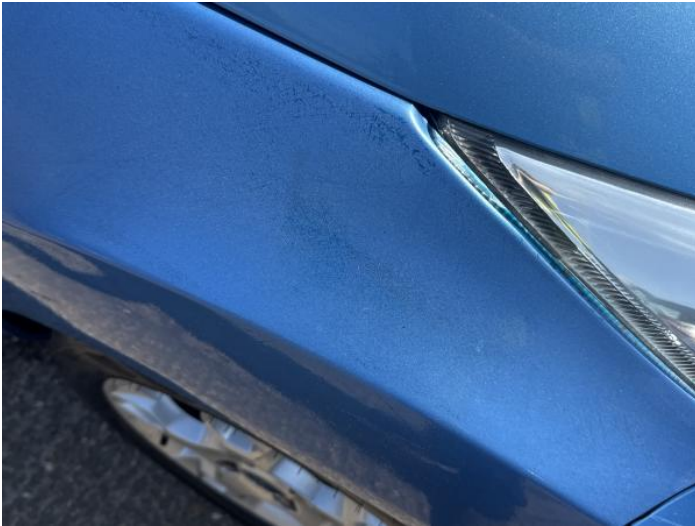
3: Wing osf
Dented
With Paint Damage

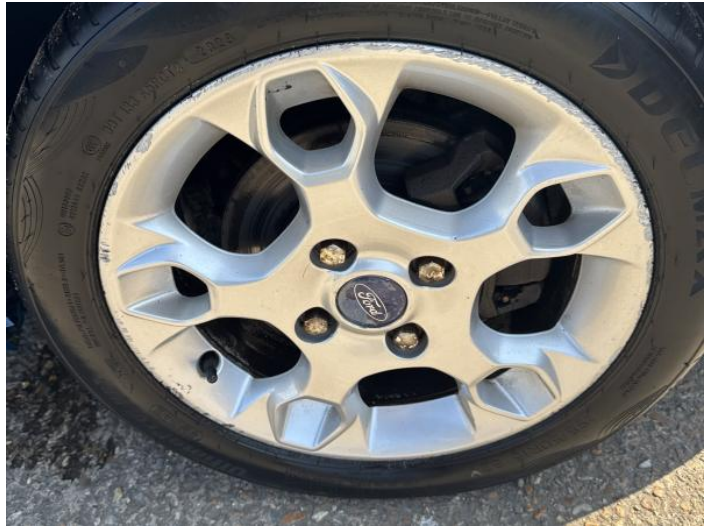
4: Wheel osf
Scratched
Over 50mm

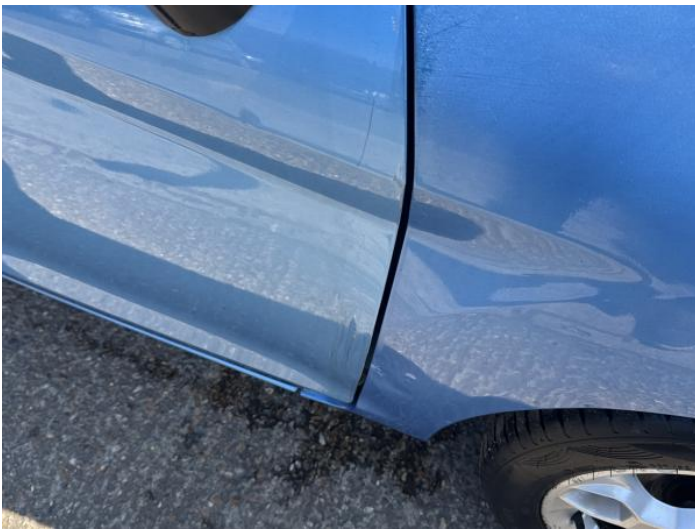
5: Door osf
Dented
With Paint Damage

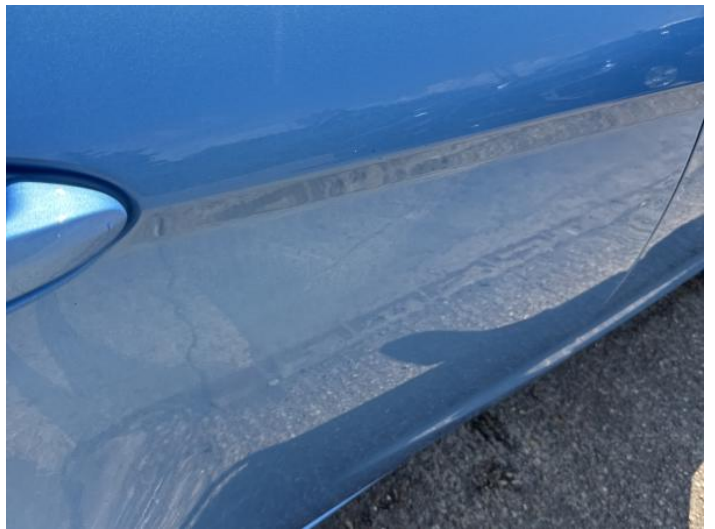
6: Door osf
Poor Previous Repair
Poor Paint

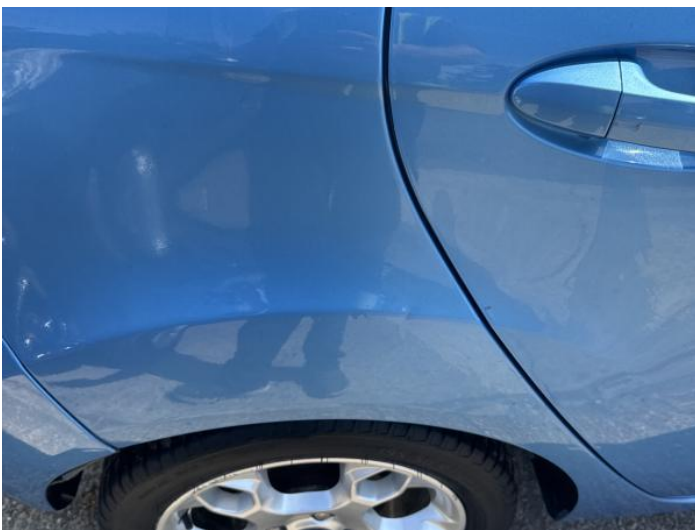
7: Qtr Panel osr
Dented
With Paint Damage

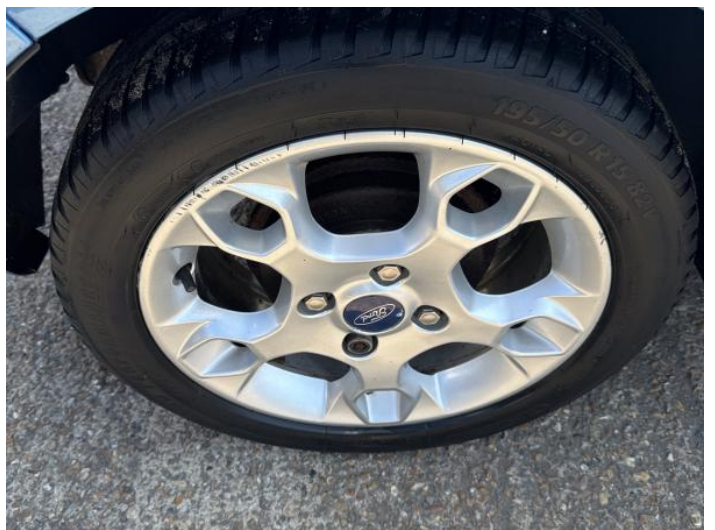
8: Wheel osr
Scratched
Over 50mm

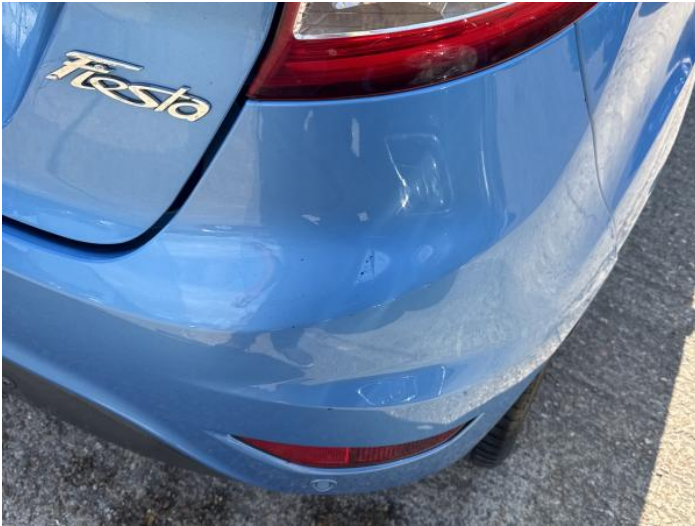
9: Bumper Rear
Scratched
Over 100mm Thru Paint

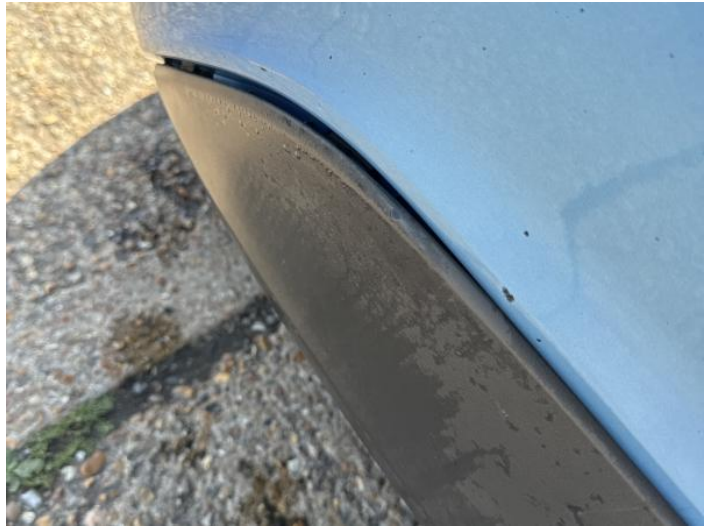
10: Bumper Rear Moulding
Broken
Replace

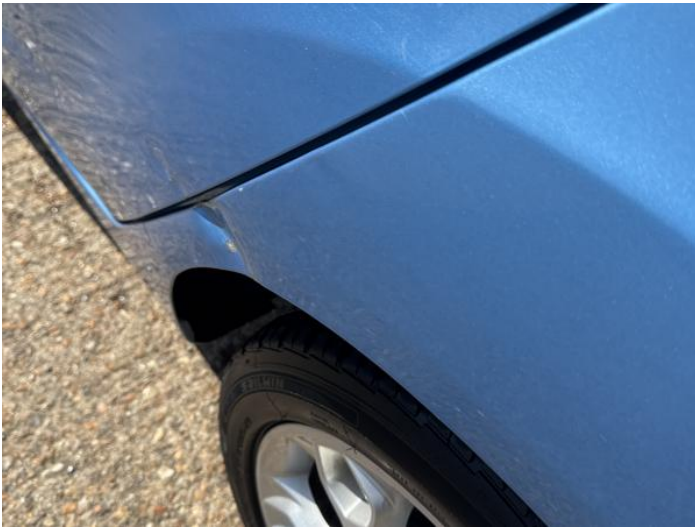
11: Qtr Panel nsr
Dented
With Paint Damage

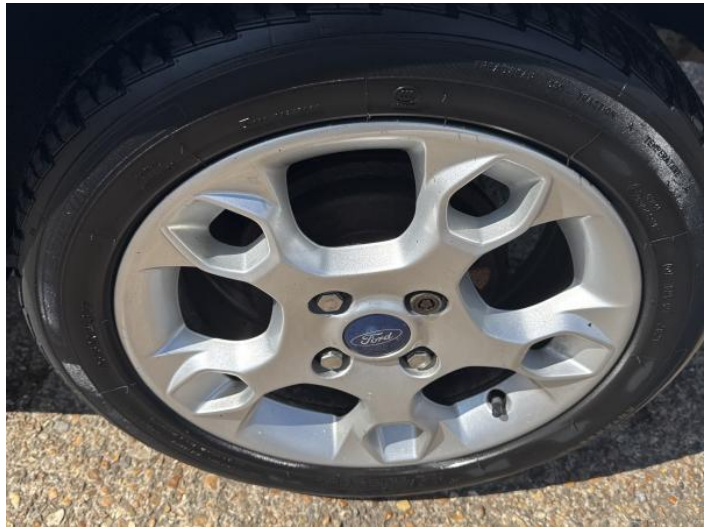
12: Wheel nsr
Scratched
Up To 50mm

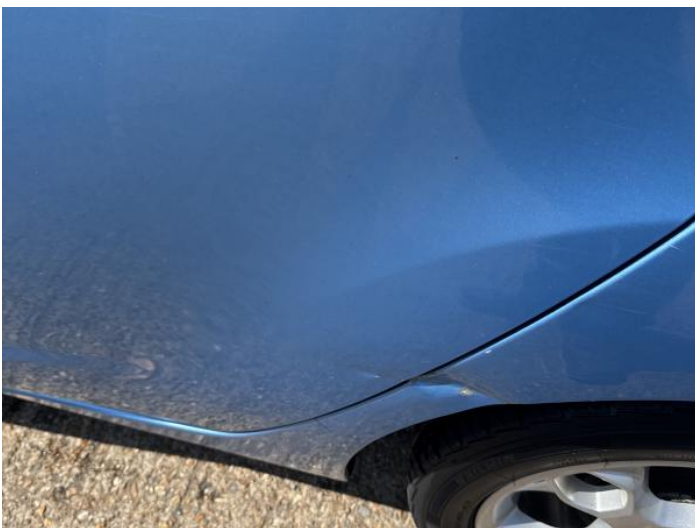
13: Door nsr
Dented
With Paint Damage

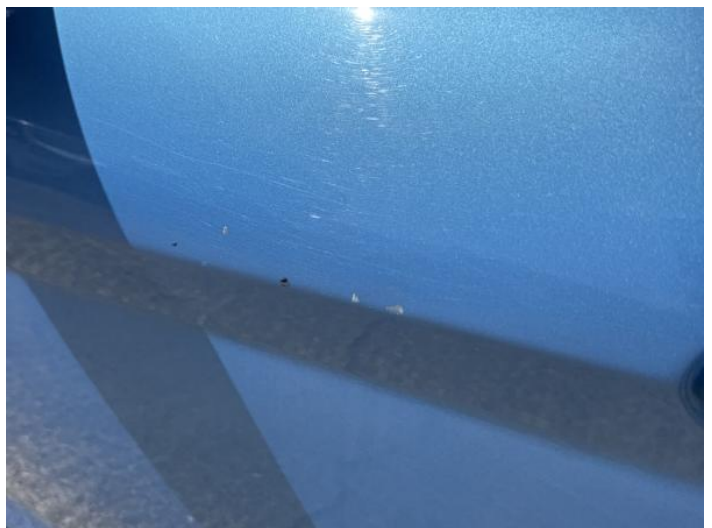
14: Door nsf
Chipped
Multiple Chips

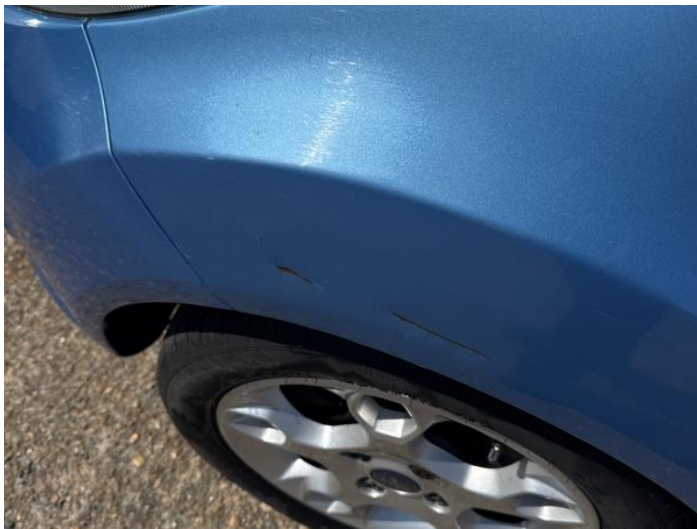
15: Wing nsf
Dented
With Paint Damage

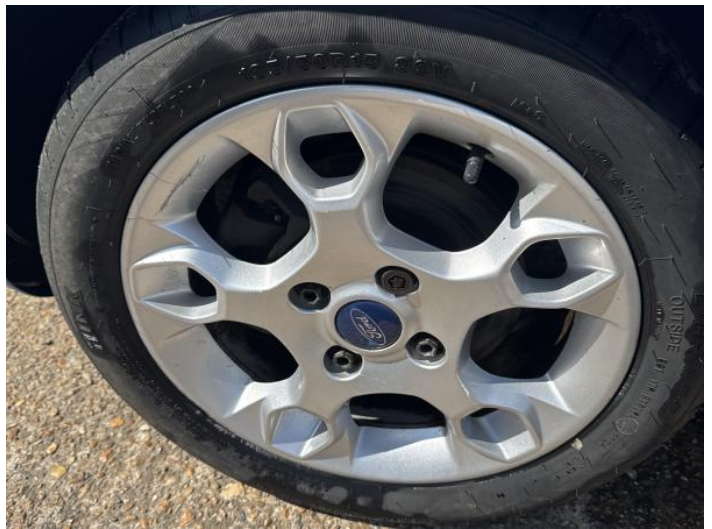
16: Wheel nsf
Scratched
Over 50mm
