VEHICLE INSPECTION REPORT

BT61MVM

Vauxhall Corsa 1.4i 16V [100] SE 5dr

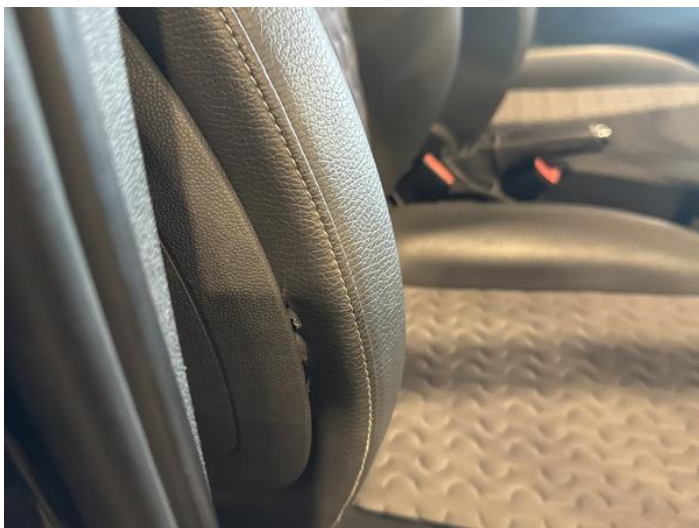
1: Seat Back Cover osf
Torn
UpTo 3mm

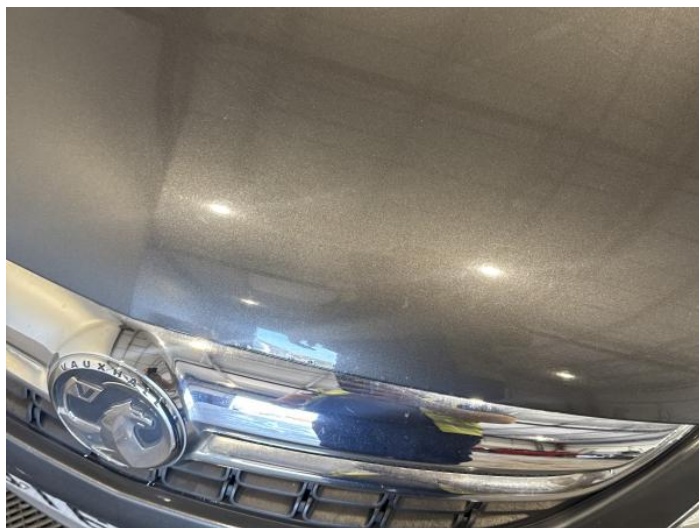
2: Bonnet
Rusted
UpTo 5mm

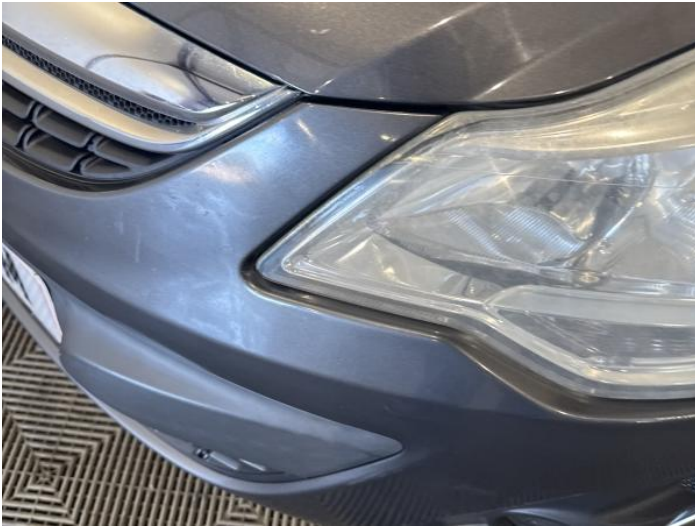
3: Bumper Front
Poor Previous Repair
Poor Paint

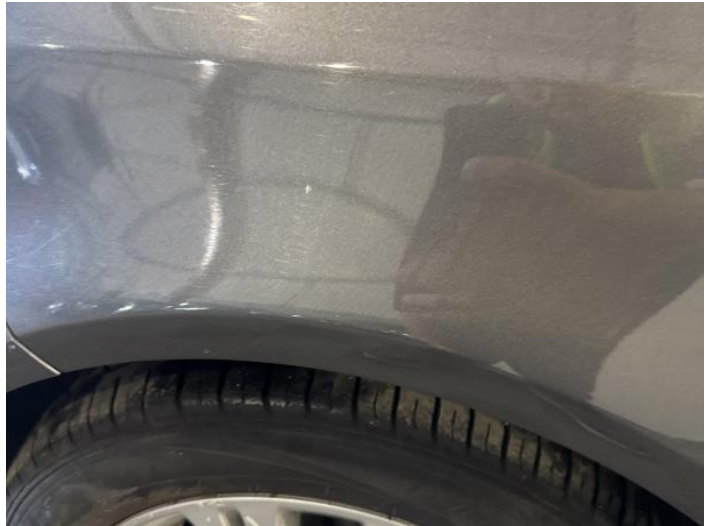
4: Wing nsf
Chipped
1 To 5

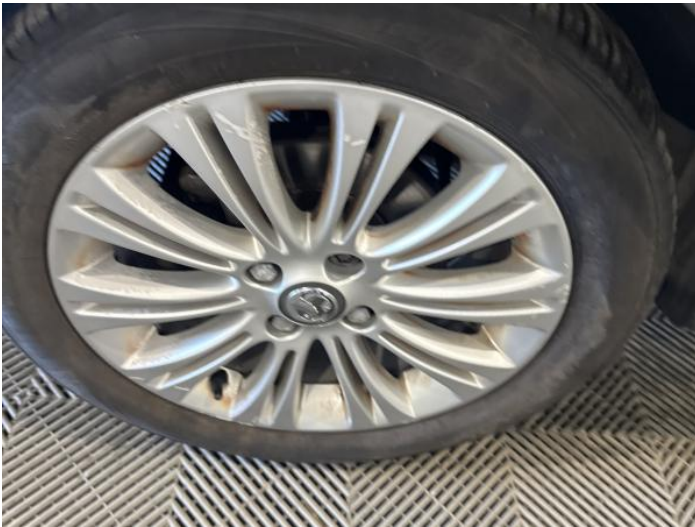
5: Wheel nsf
Scratched
Over 50mm

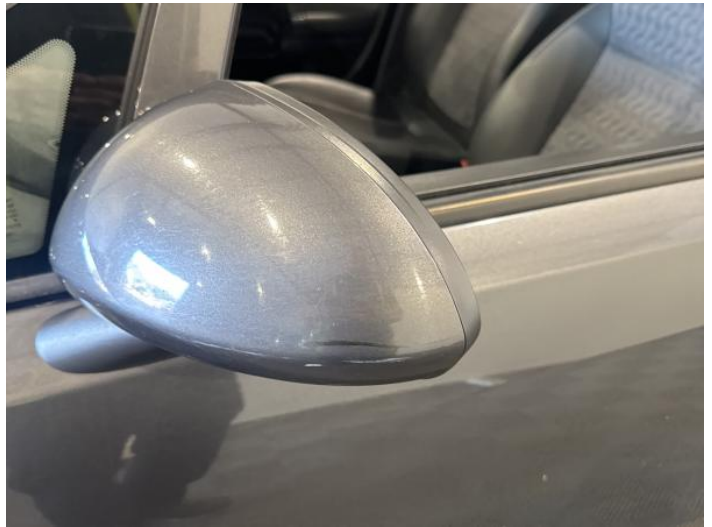
6: Door Mirror Assy nsf
Scratched (Painted)
Over 25mm Thru Paint

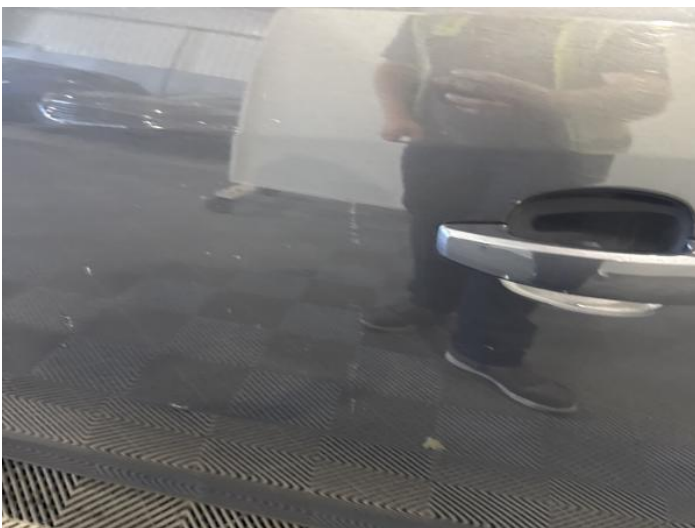
7: Door nsf
Scratched
Over 25mm Thru Paint

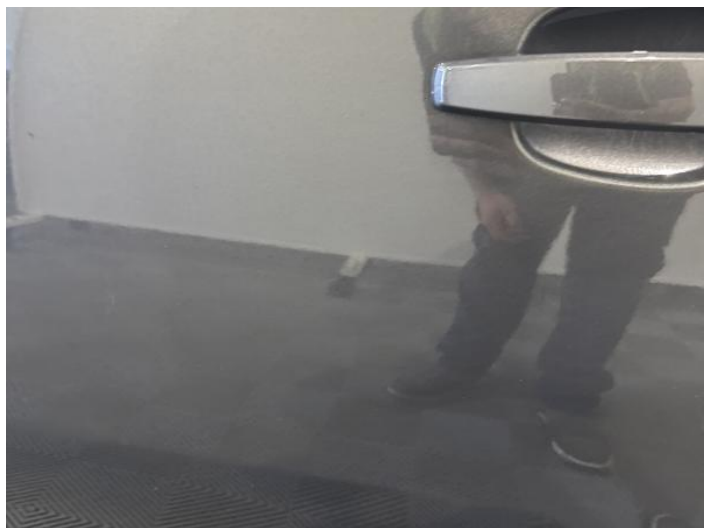
8: Door nsr
Chipped
1 To 5

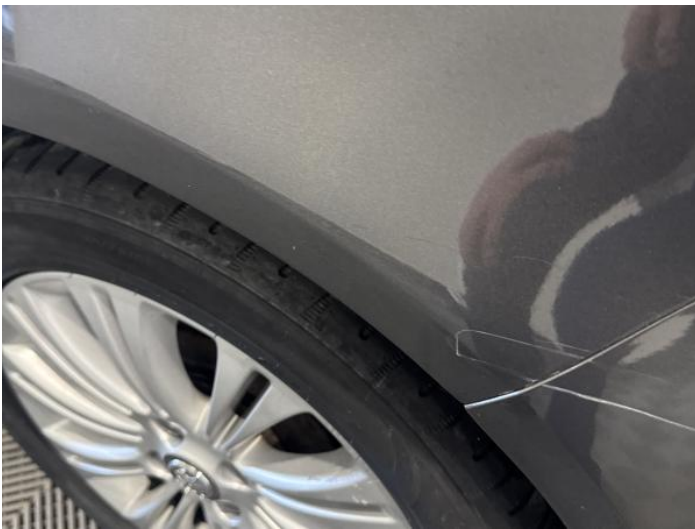
11: Qtr Panel nsr
Scratched
Over 25mm Thru Paint

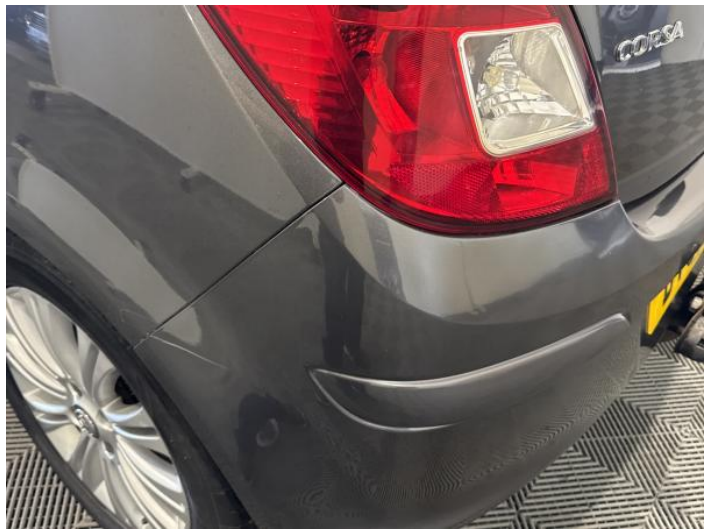
12: Bumper Rear
Poor Previous Repair
Poor Paint

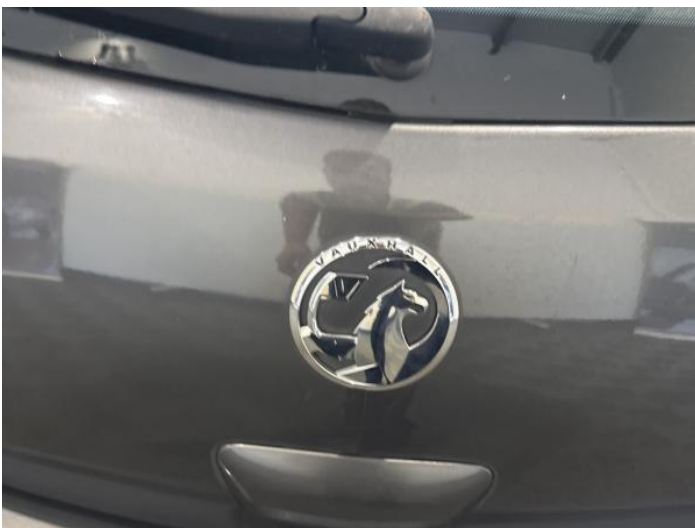
13: Boot Lid
Chipped
1 To 5

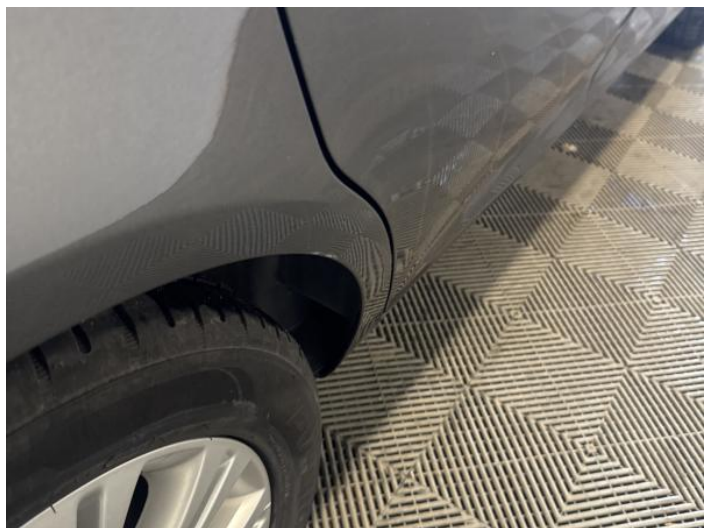
14: Qtr Panel osr
Dented
With Paint Damage

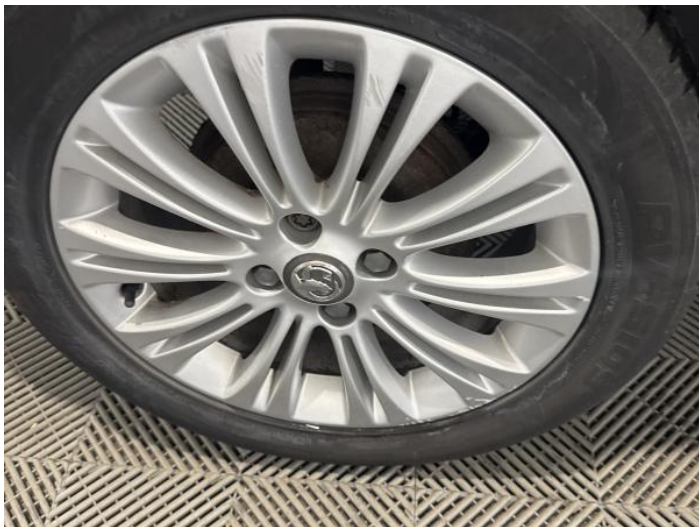
15: Wheel osr
Scratched
Over 50mm

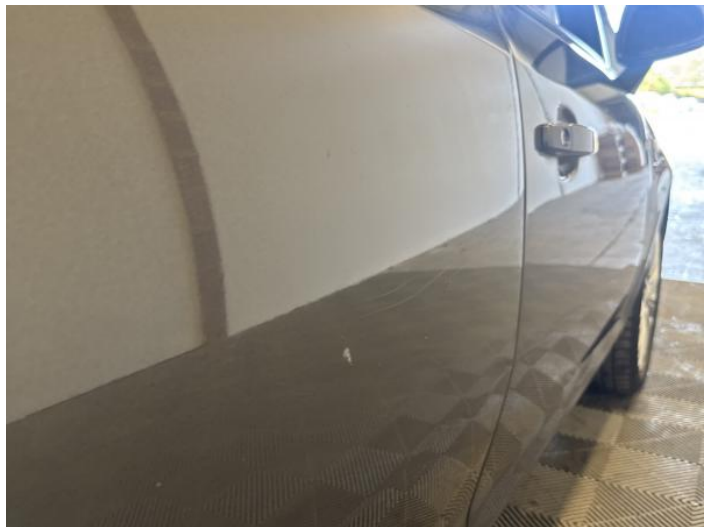
16: Door osr
Chipped
1 To 5

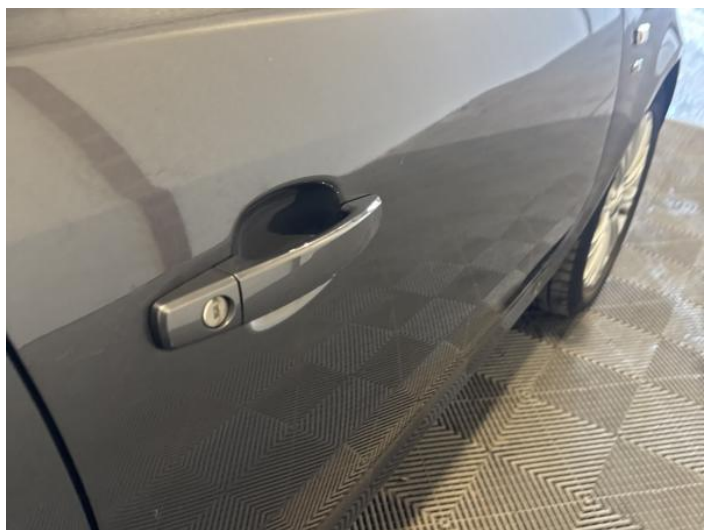
18: Door osf
Poor Previous Repair
Poor Paint

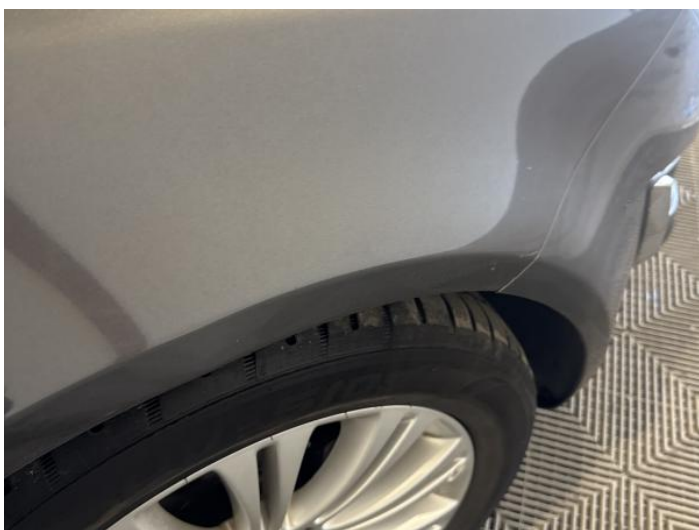
19: Wing osf
Dented
With Paint Damage

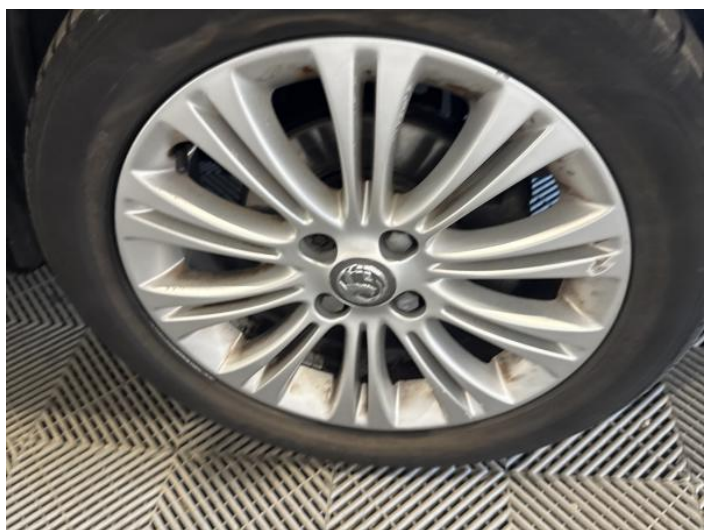
20: Wheel osf
Scratched
Over 50mm

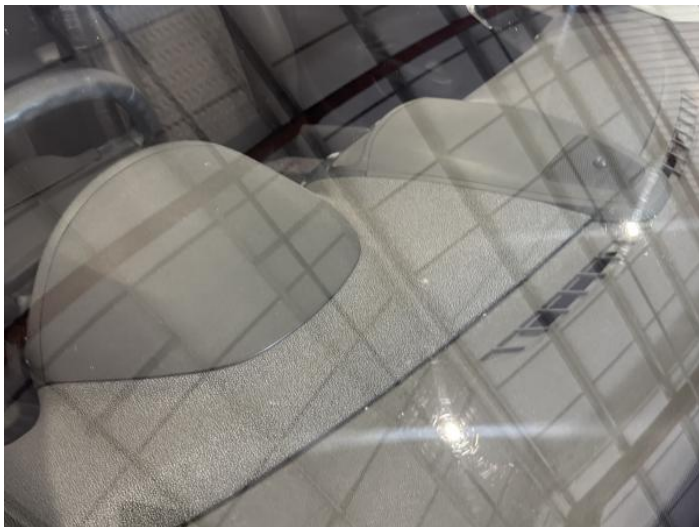
21: Screen Front
Chipped
UpTo 10mm
