VEHICLE INSPECTION REPORT

WF13OWB

Volvo V60 D3 [136] SE Lux 5dr Geartronic

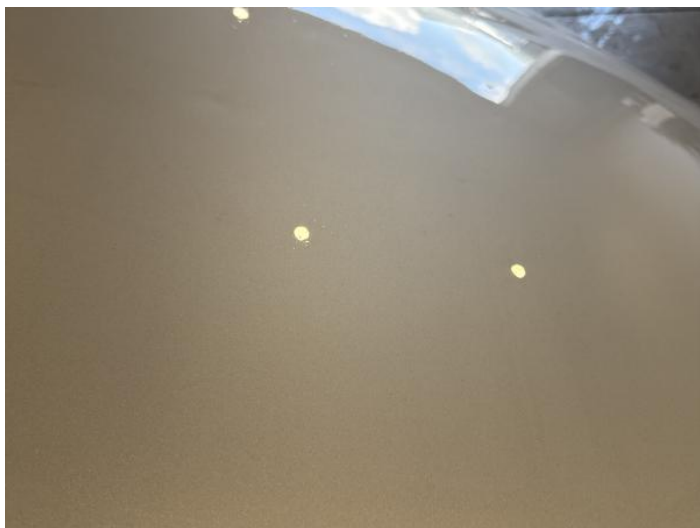
1: Bonnet
Dented
Over 30mm

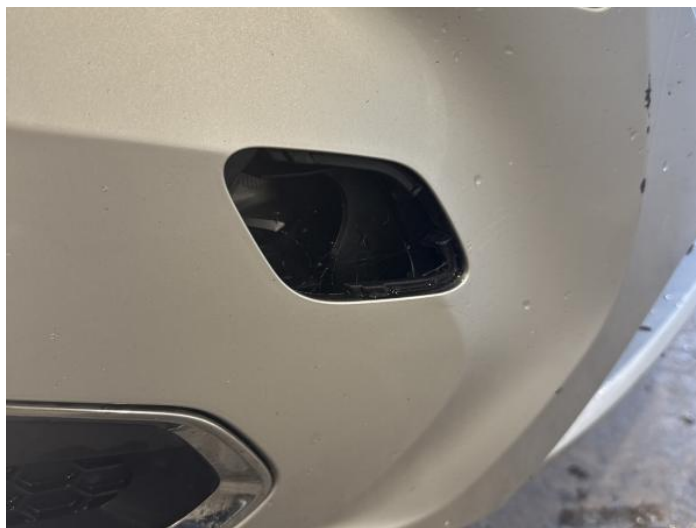
2: Front TowEye Cvr
Missing
Replace

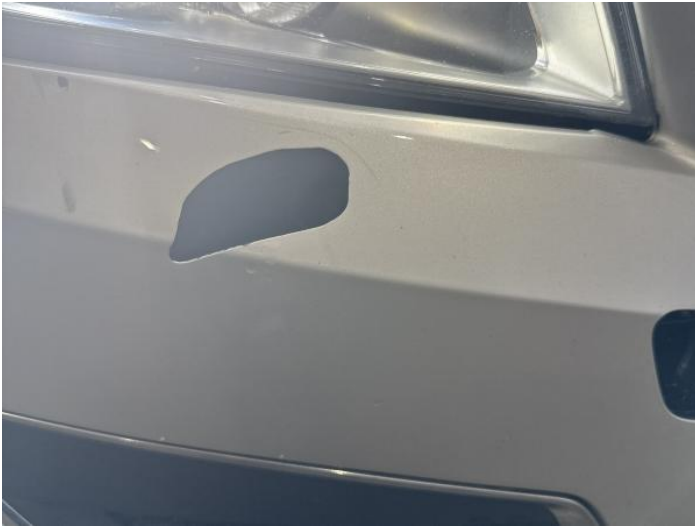
3: Headlamp Washer os
Missing
Replace

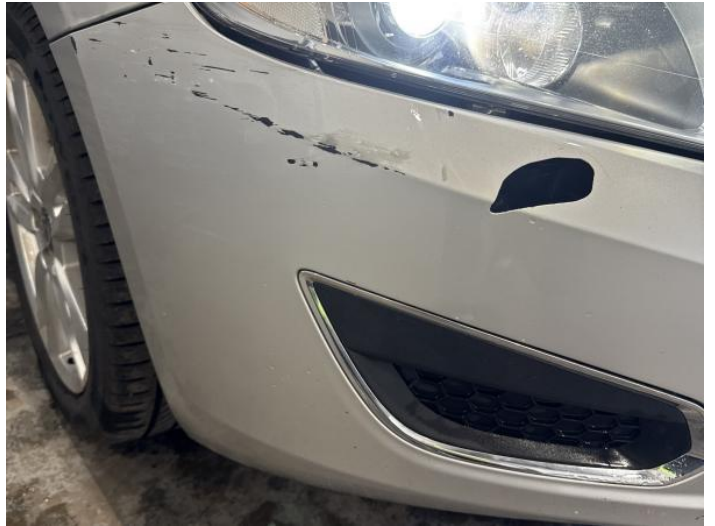
4: Bumper Front
Scratched
Over 100mm Thru Paint

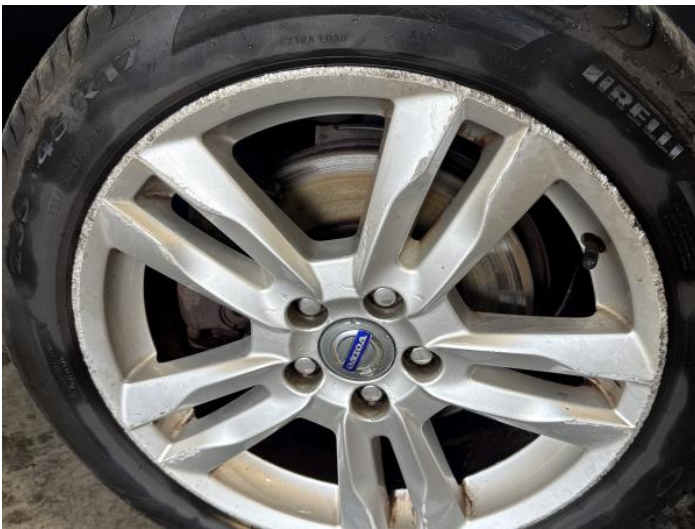
5: Wheel nsf
Scratched
Over 50mm

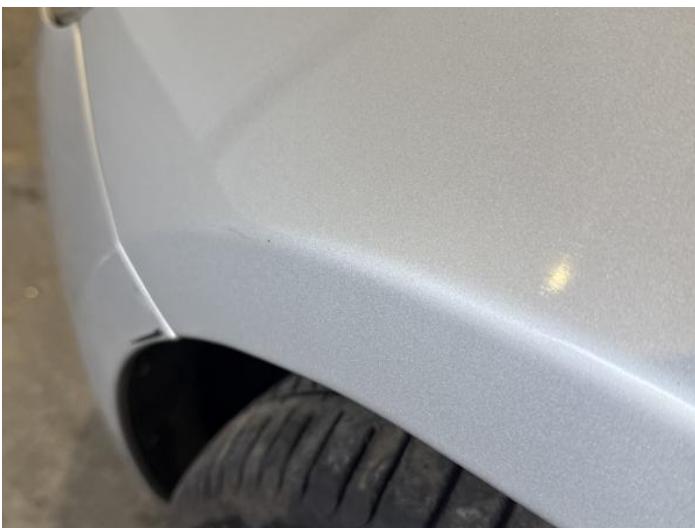
7: Wing nsf
Scratched
UpTo 25mm Thru Paint

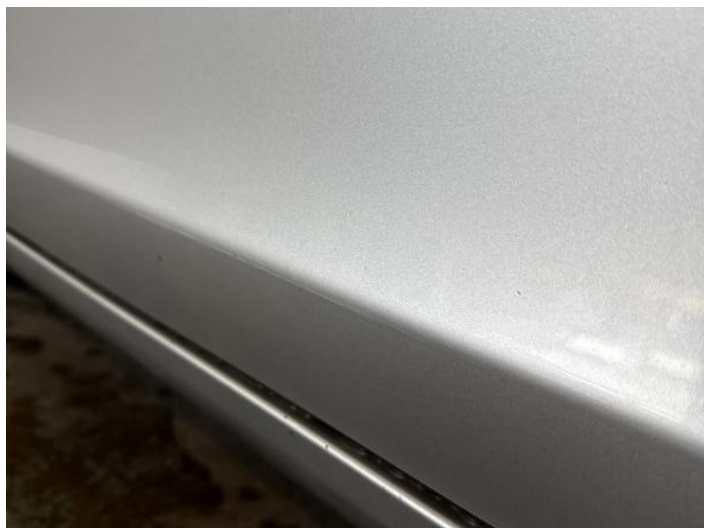
8: Door nsf
Scratched
Over 25mm Thru Paint

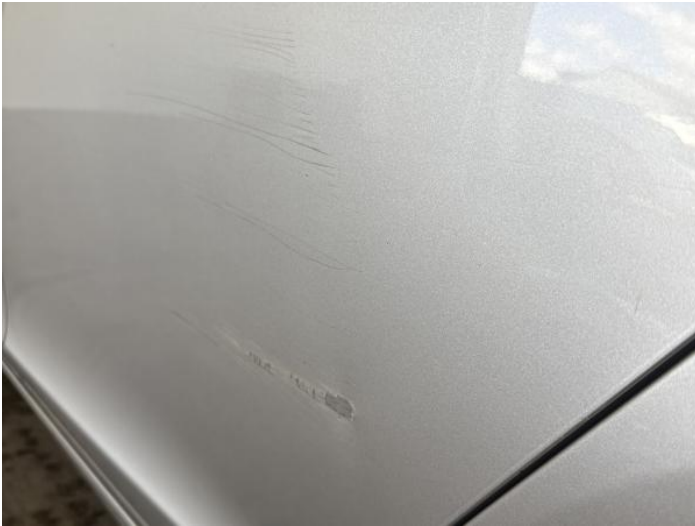
9: Door nsr
Dented
With Paint Damage

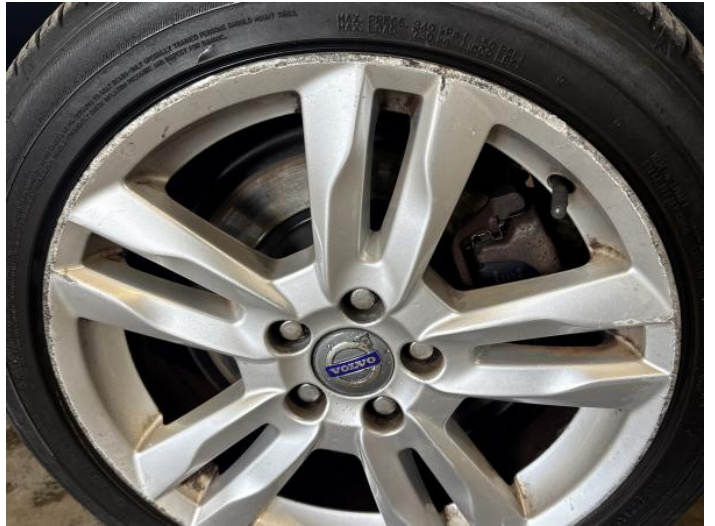
10: Wheel nsr
Scratched
Over 50mm

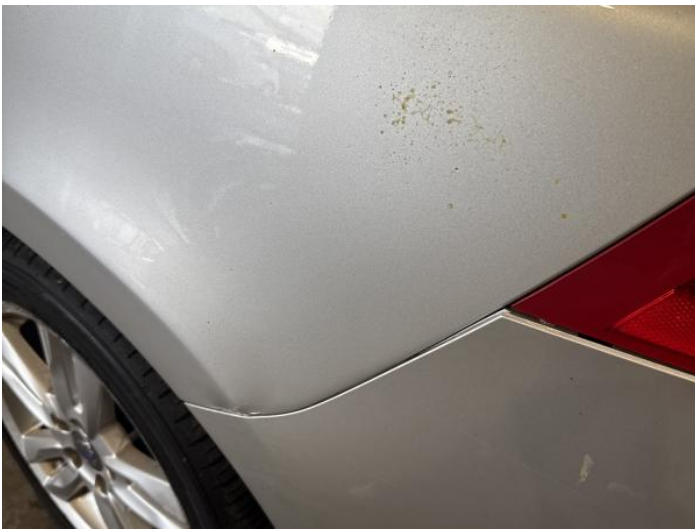
11: Qtr Panel nsr
Dented
With Paint Damage

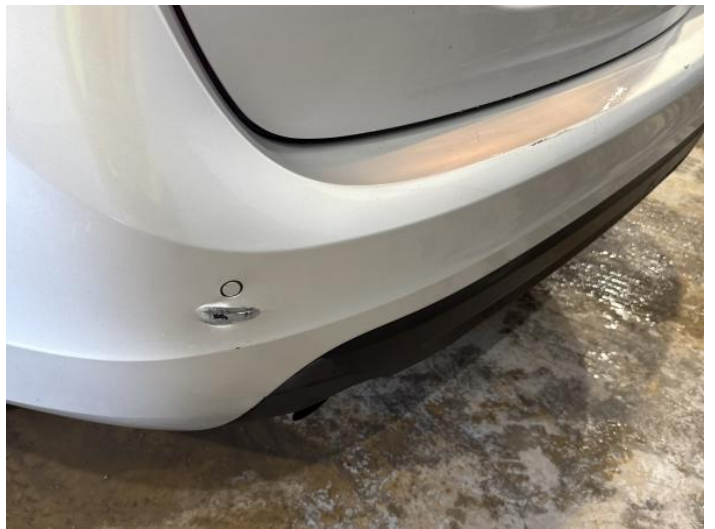
12: Bumper Rear
Dented
With Paint Damage

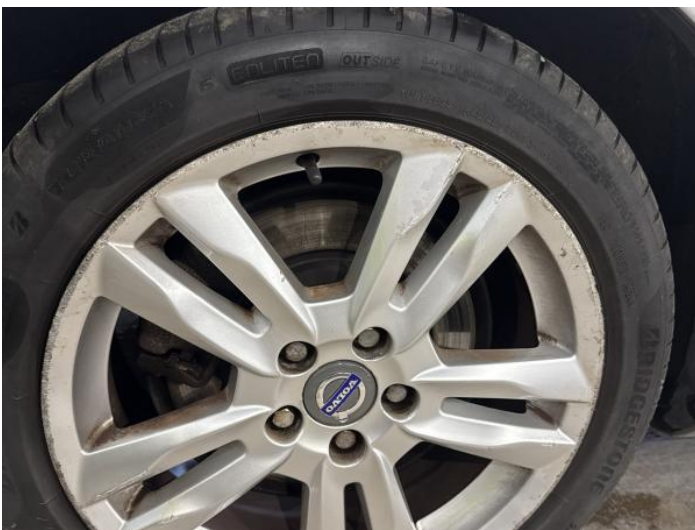
13: Wheel osr
Scratched
Over 50mm

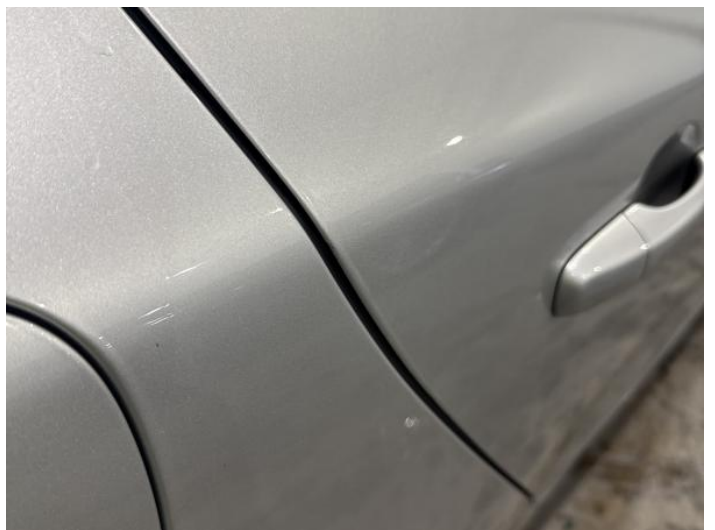
14: Door osr
Chipped
Edge Chip

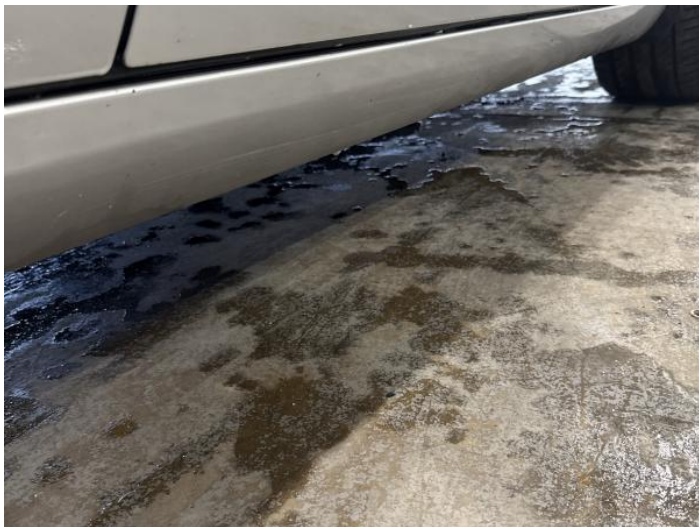
15: Sill os
Scratched
Over 25mm Thru Paint

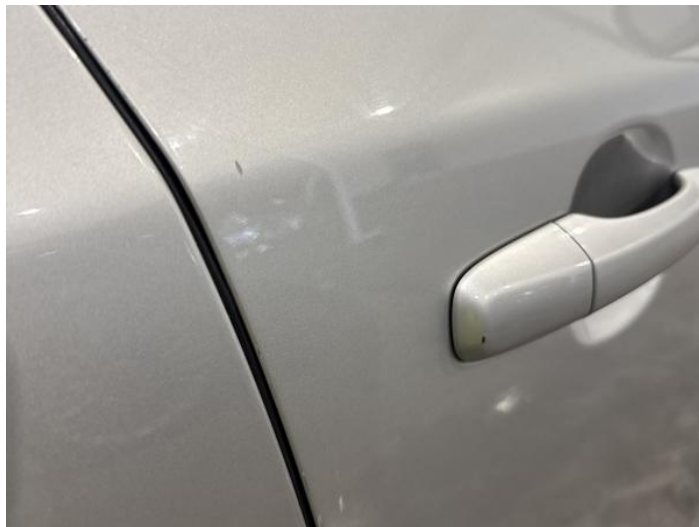
16: Door osf
Chipped
Over 5mm

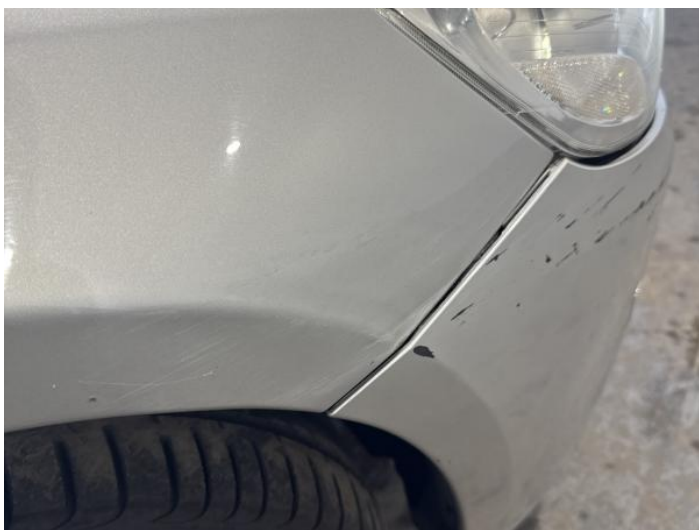
17: Wing osf
Dented
With Paint Damage

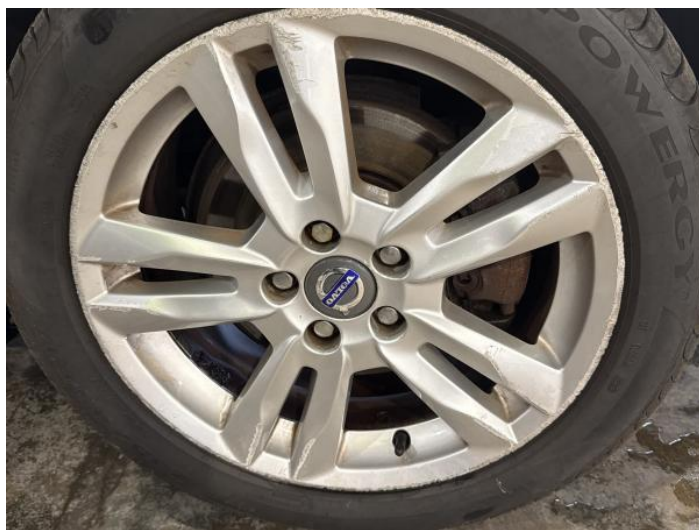
18: Wheel osf
Scratched
Over 50mm

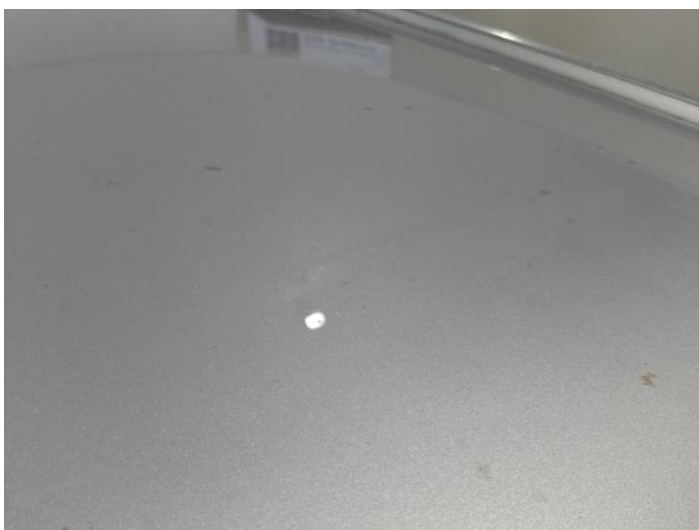
19: Roof
Dented
Between 10mm + 30mm
