VEHICLE INSPECTION REPORT

LN63HTP

Jaguar F-Type 3.0 Supercharged V6 S 2dr Auto

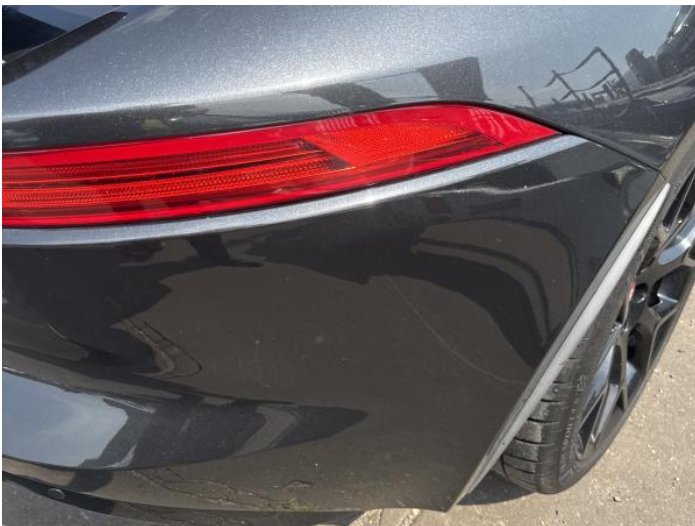
1: Bumper Rear
Chipped
Multiple Chips

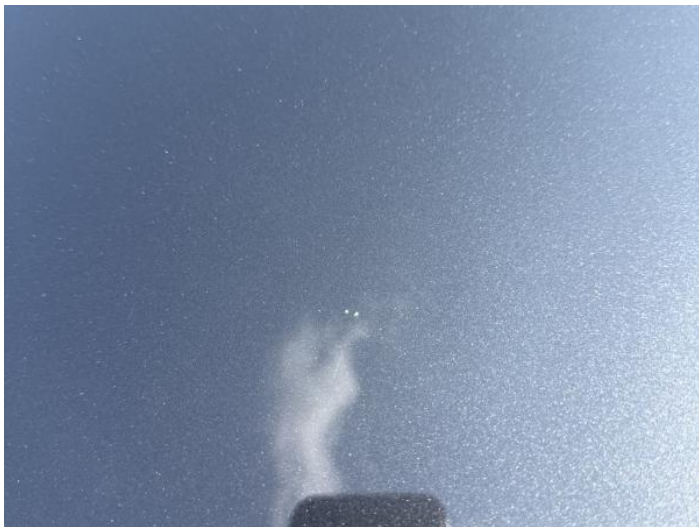
3: Boot Lid
Chipped
1 To 5

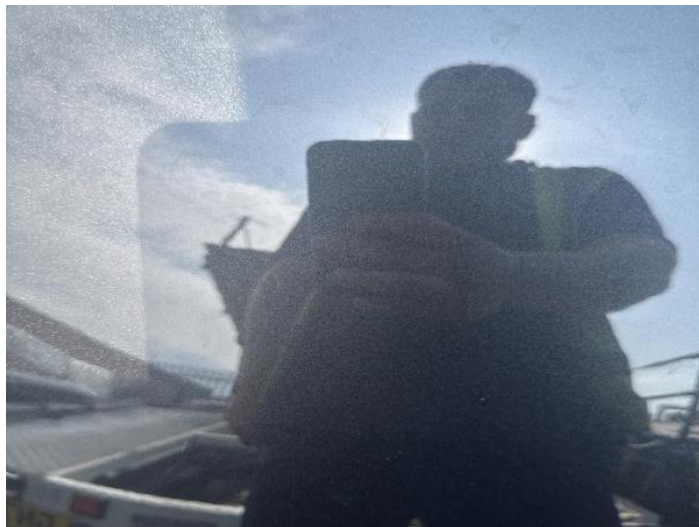
4: Qtr Panel osr
Dented
Between 10mm + 30mm

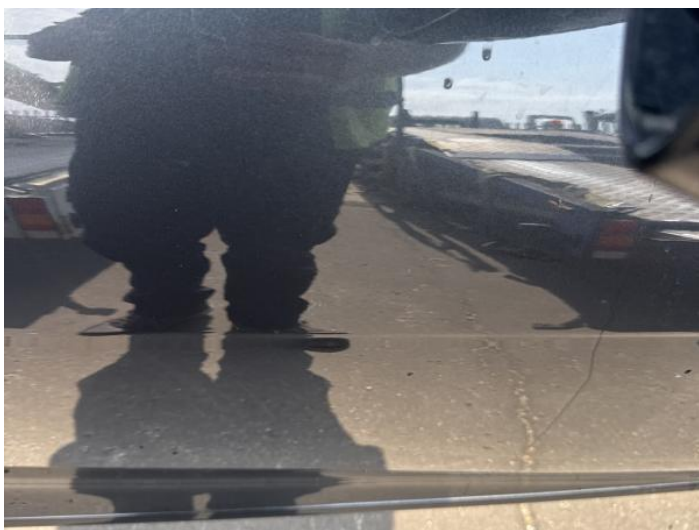
5: Door osf
Chipped
1 To 5

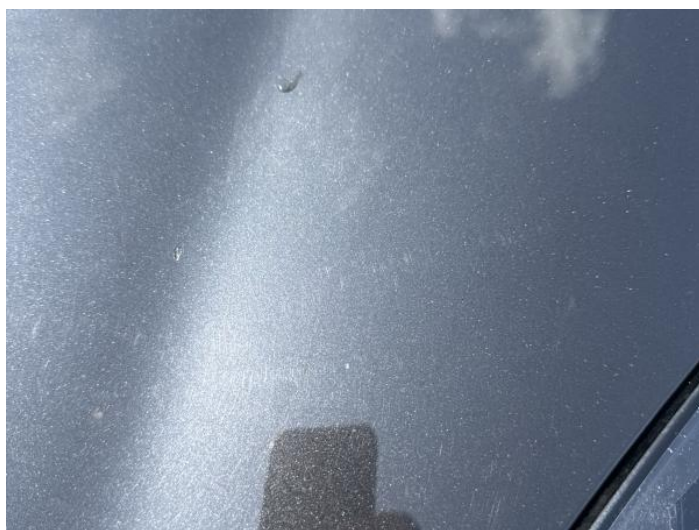
8: Bonnet
Chipped
1 To 5

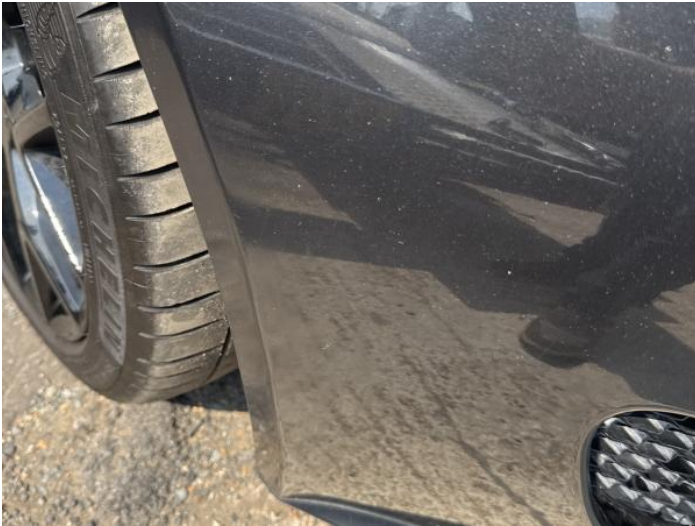
9: Bumper Front
Poor Previous Repair
Poor Paint

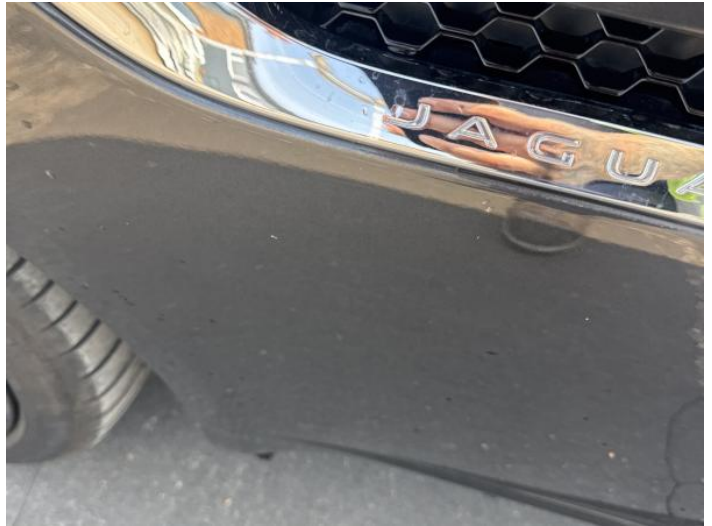
10: Wing nsf
Chipped
1 To 5

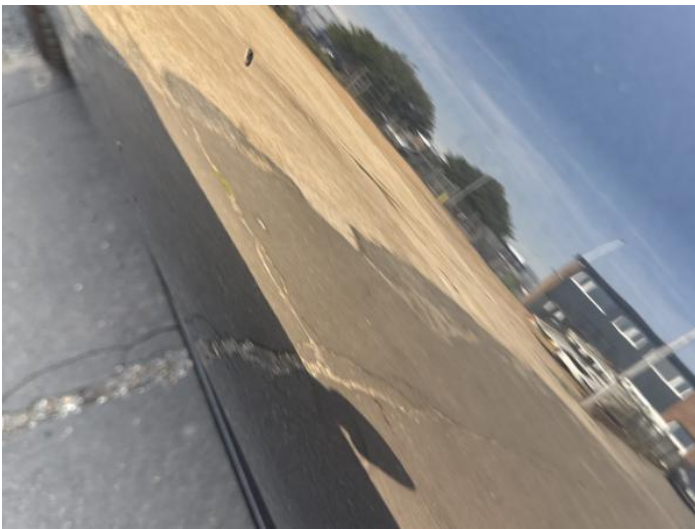
11: Door nsf
Dented
2 Or Less UpTo 10mm

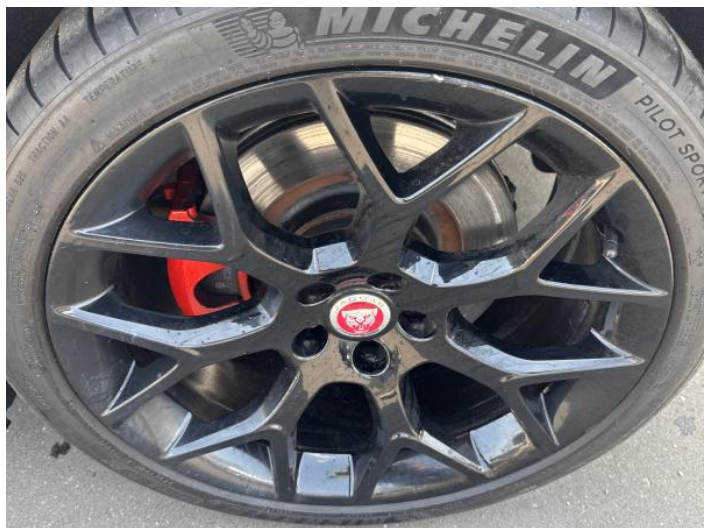
14: Wheel nsr
Scratched
Up To 50mm
