VEHICLE INSPECTION REPORT

EK71ZVX

Peugeot 208 1.2 PureTech 100 Allure Premium 5dr EAT8

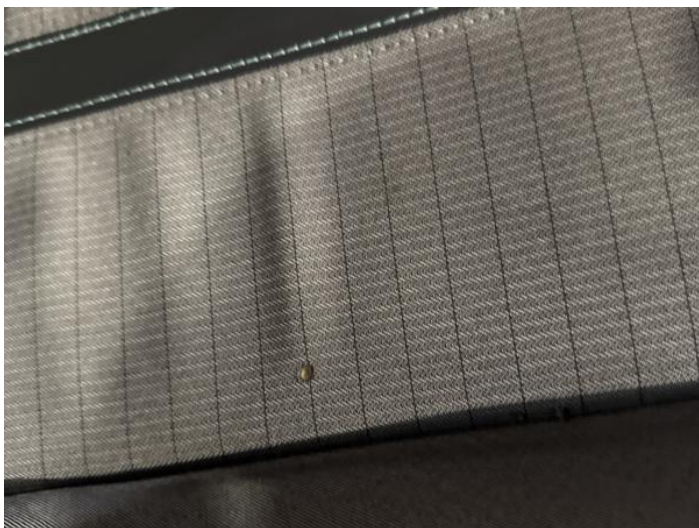
1: Seat Base Cover osf
Holed
UpTo 3mm

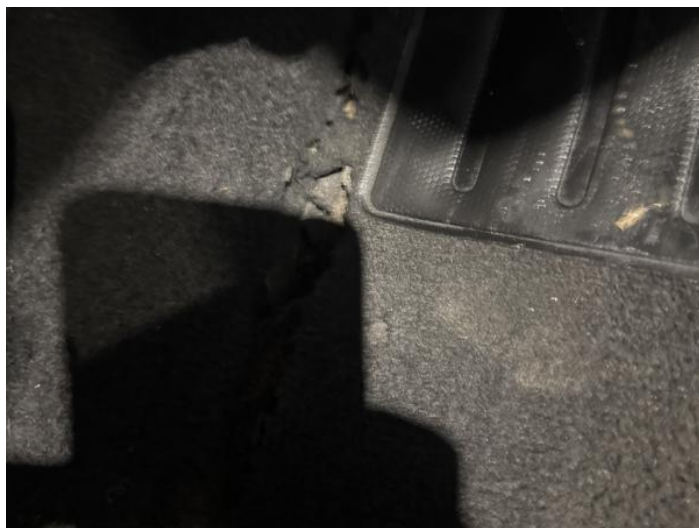
2: Carpets Front
Torn
Over 10mm

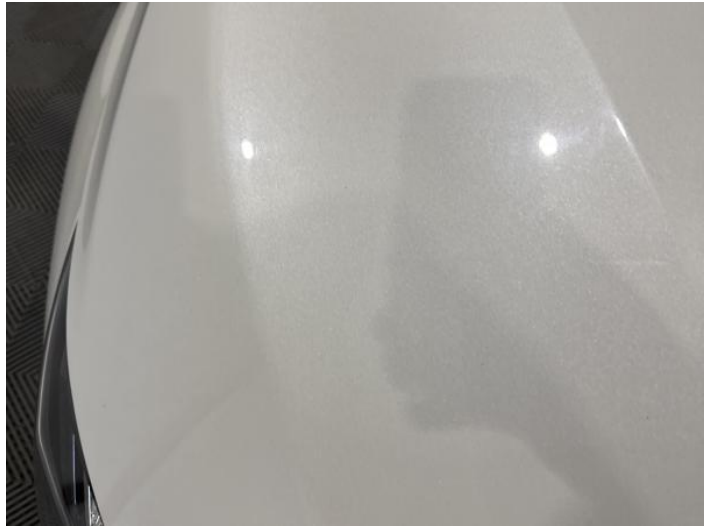
4: Bonnet
Chipped
1 To 5

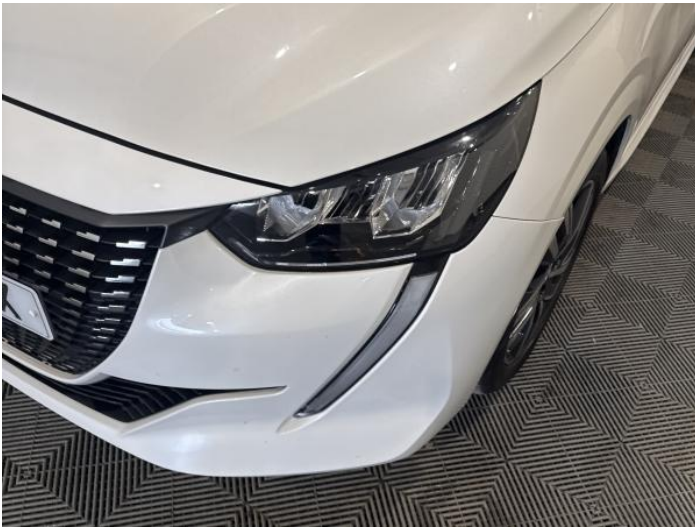
5: Bumper Front
Chipped
Multiple Chips

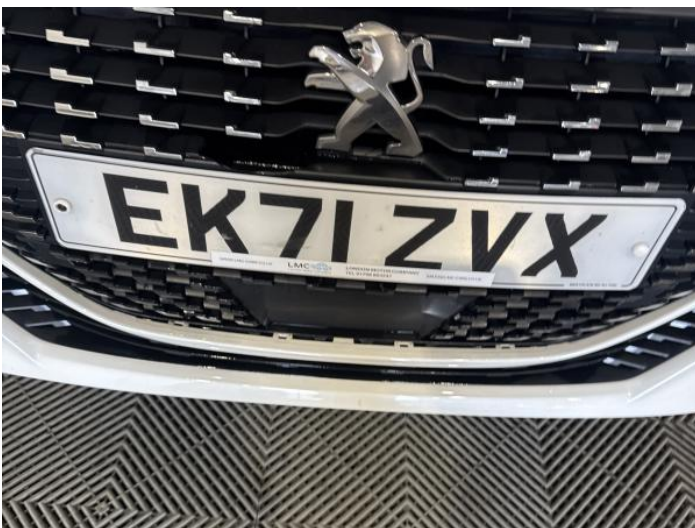
7: Bumper Front Grill
Broken
Replace

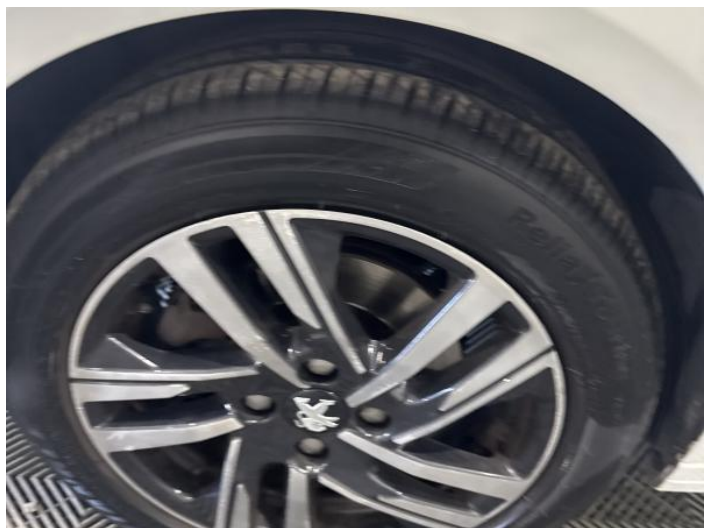
8: Wheel nsf
Scratched
Over 50mm

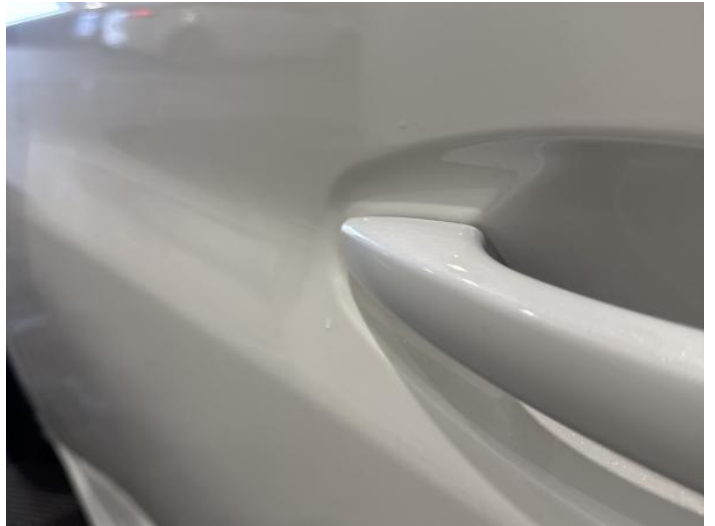
9: Wing nsf
Scratched
Over 25mm Not Thru Paint

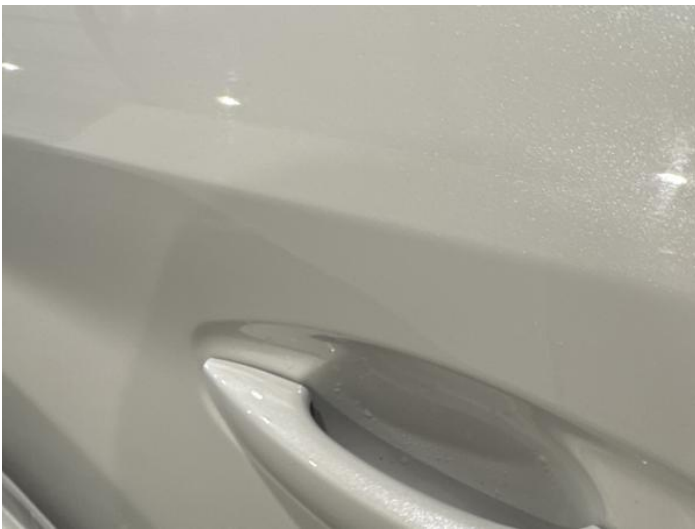
11: Door nsr
Dented
2 Or Less UpTo 10mm

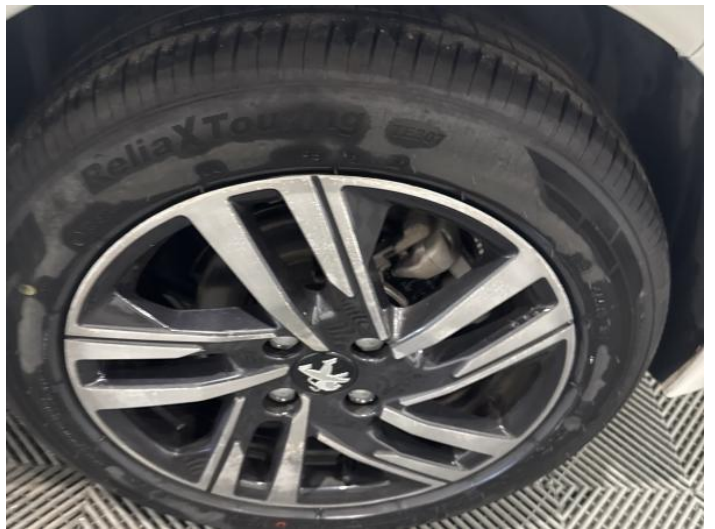
12: Wheel nsr
Scratched
Over 50mm

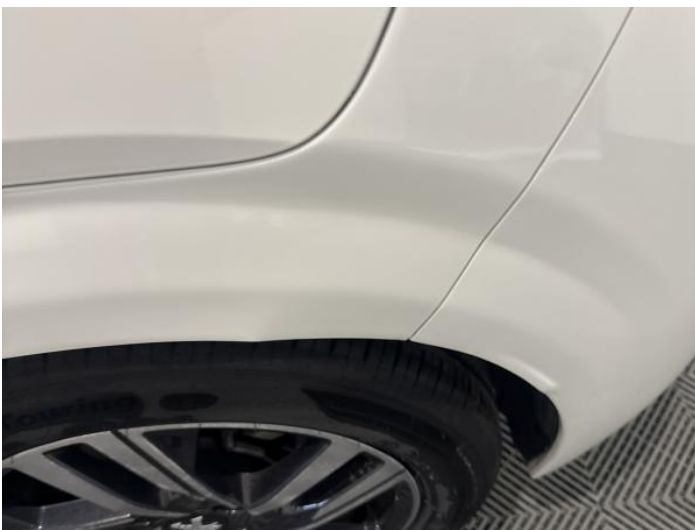
13: Qtr Panel nsr
Dented
With Paint Damage

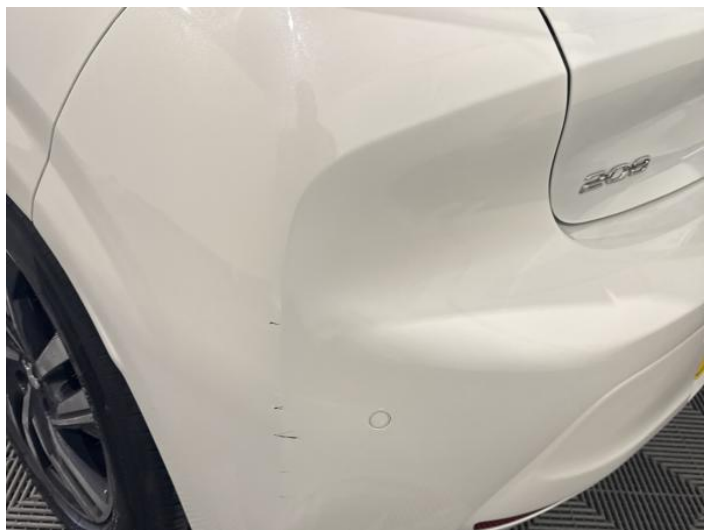
14: Bumper Rear
Scratched
25 to 100mm Thru Paint

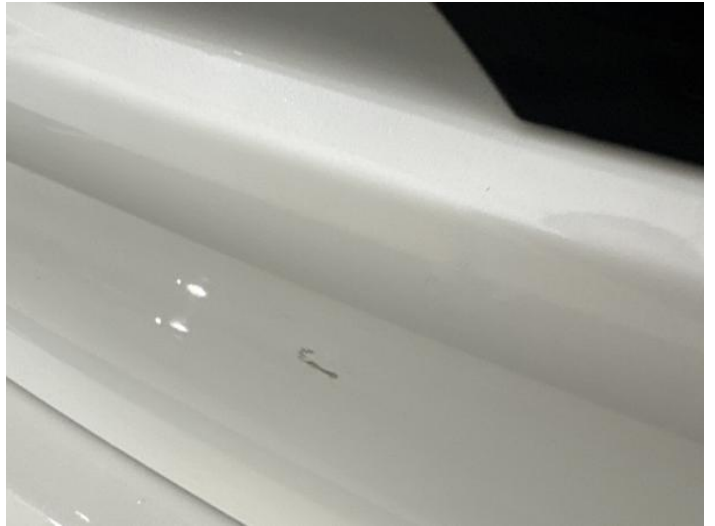
15: Bumper Rear
Scratched
Over 25mm Not Thru Paint

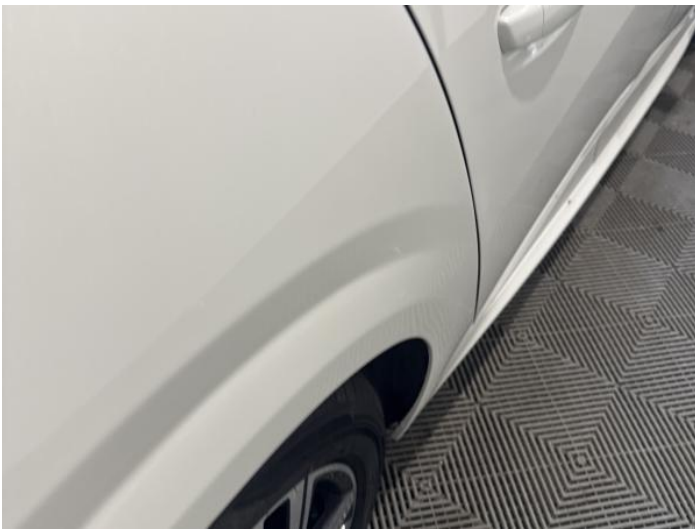
17: Qtr Panel osr
Chipped
1 To 5

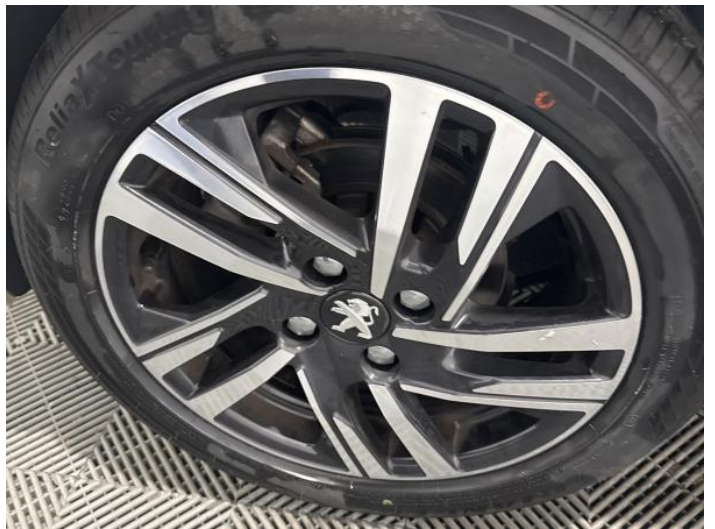
18: Wheel osr
Scratched
Over 50mm

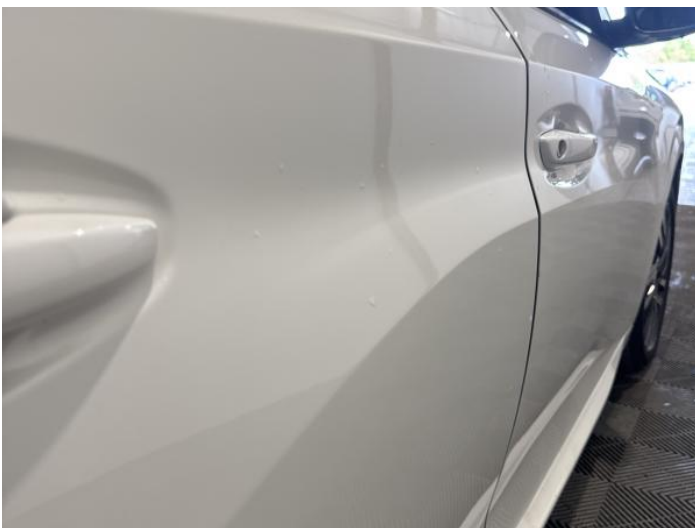
19: Door osr
Dented
2 Or Less UpTo 10mm

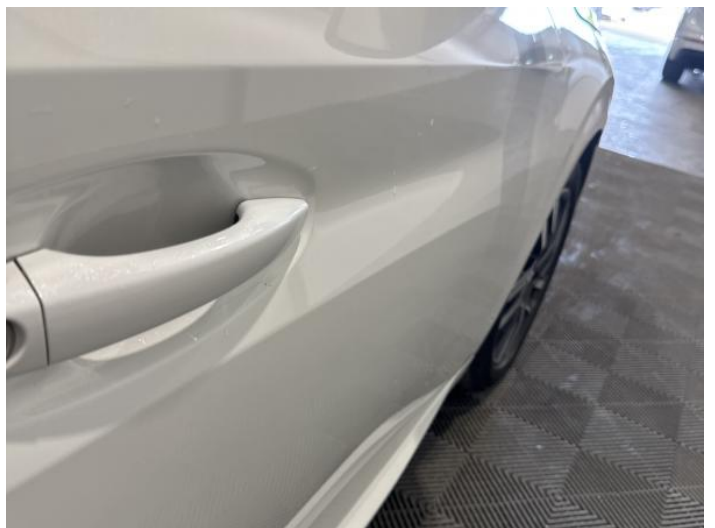
20: Door osf
Chipped
1 To 5

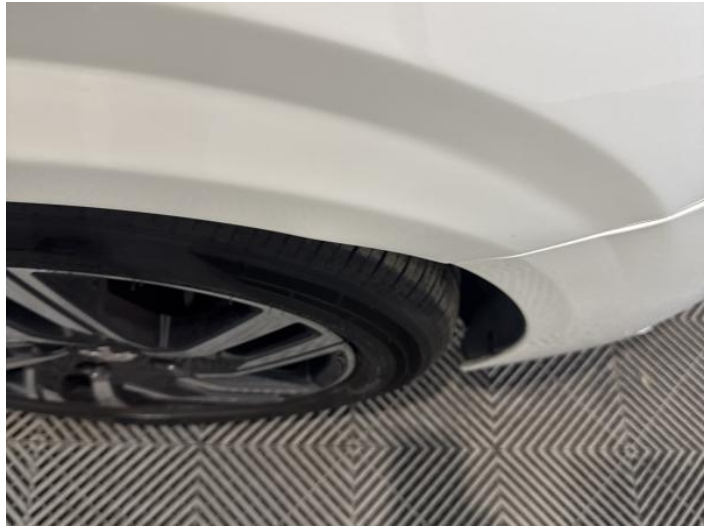
21: Door osf
Scratched
Over 25mm Not Thru Paint

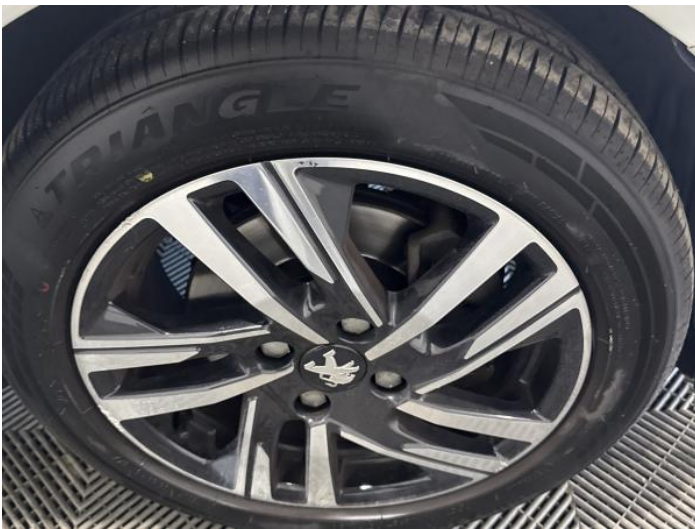
23: Wheel osf
Scratched
Over 50mm
