# VEHICLE INSPECTION REPORT

**GX15YRD**

## Ford Focus 1.5 EcoBoost Zetec S 5dr

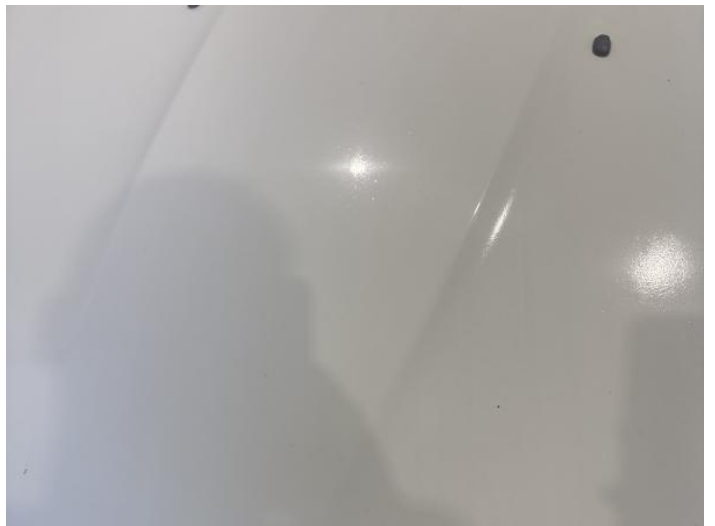
2: Bonnet  
Chipped  
1 To 5

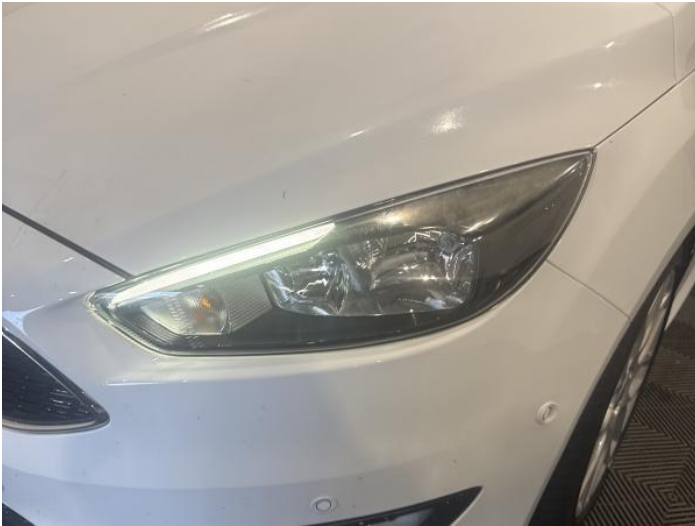
3: Bumper Front  
Chipped  
Multiple Chips

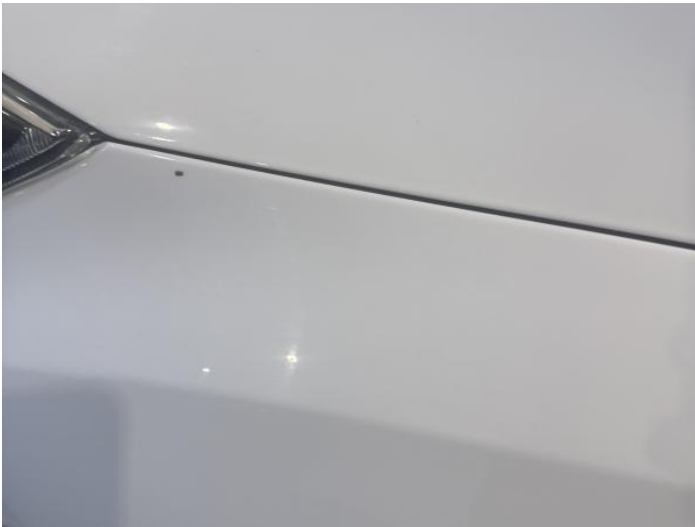
5: Wing nsf  
Chipped  
1 To 5

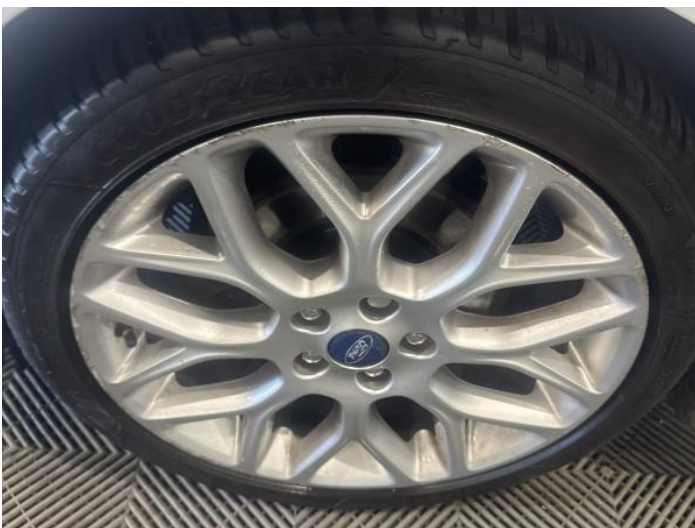
7: Wheel nsf  
Scratched  
Over 50mm

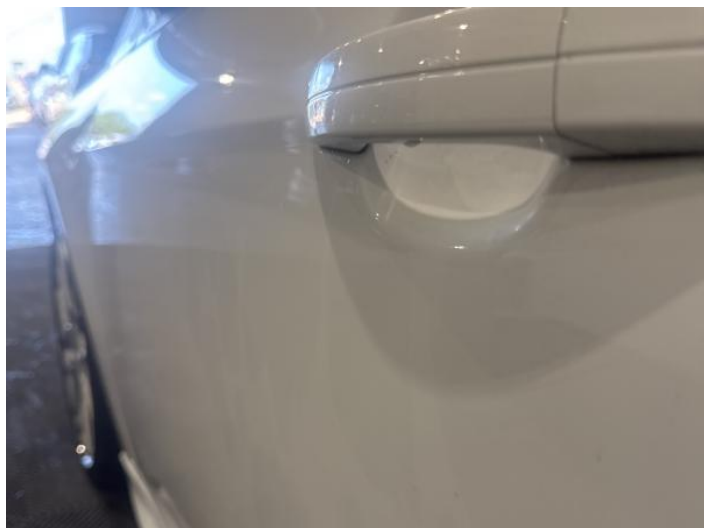
8: Door nsf  
Dented  
Over 2 UpTo 10mm

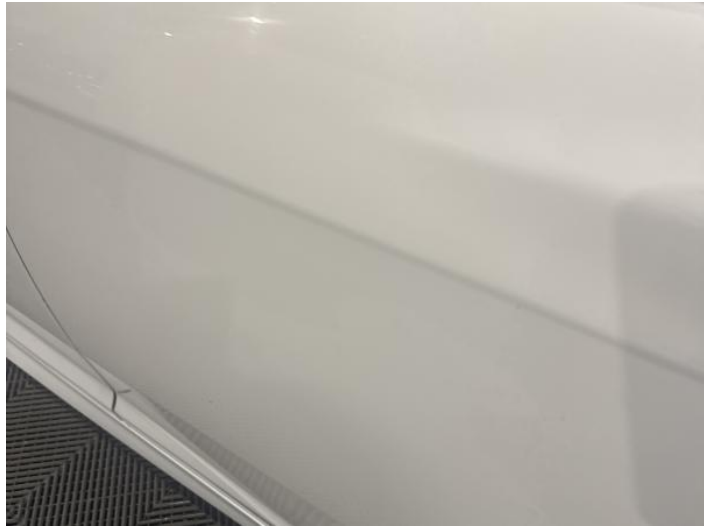
10: Door nsr  
Chipped  
1 To 5

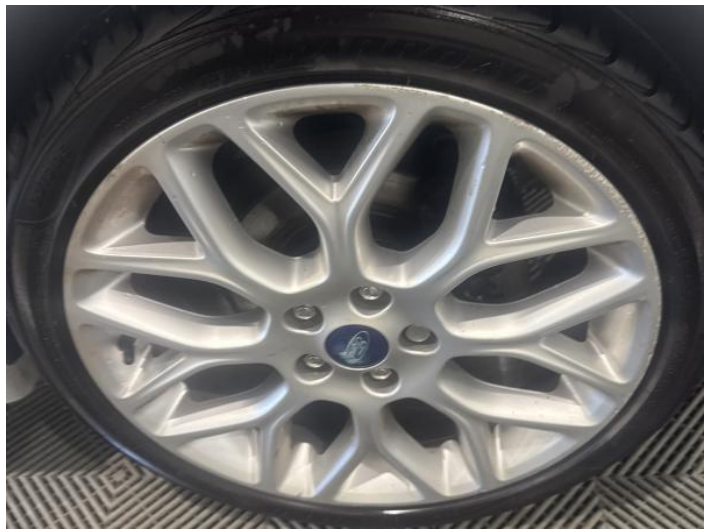
12: Wheel nsr  
Scratched  
Over 50mm

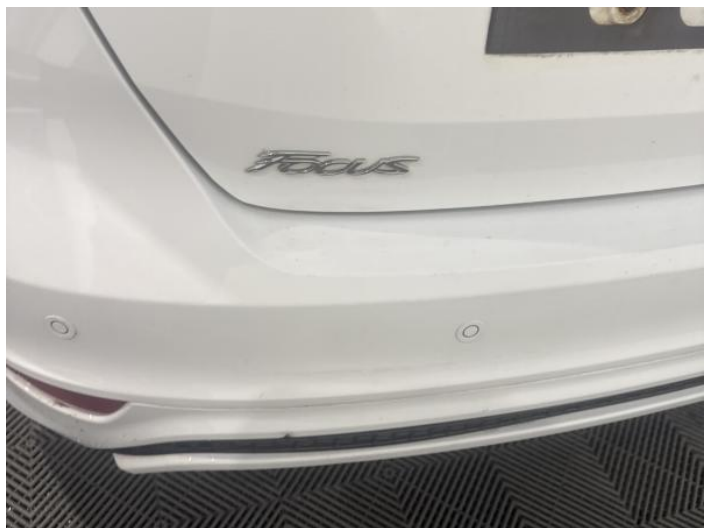
14: Bumper Rear  
Dented  
With Paint Damage

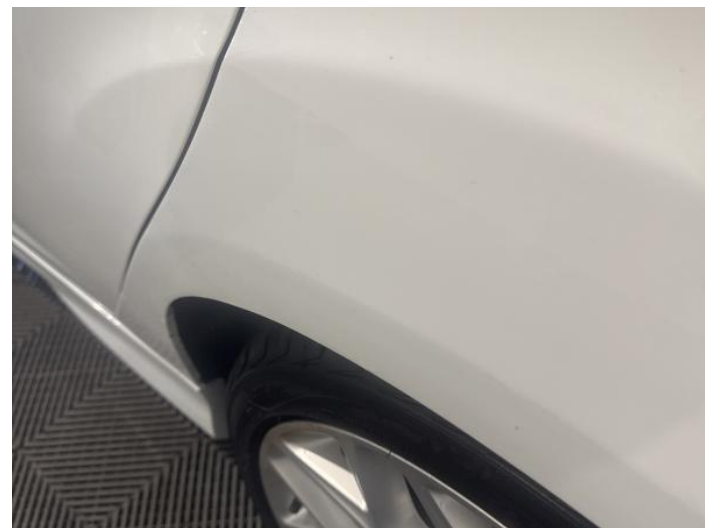
13: Qtr Panel nsr  
Dented  
With Paint Damage

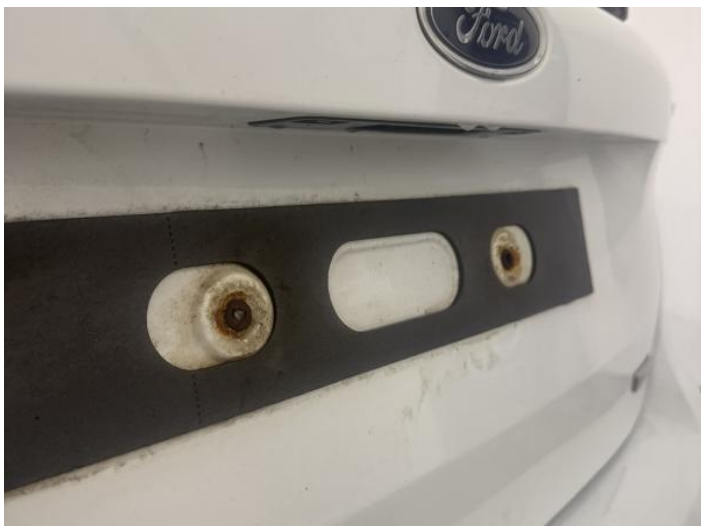
15: Boot Lid  
Chipped  
1 To 5

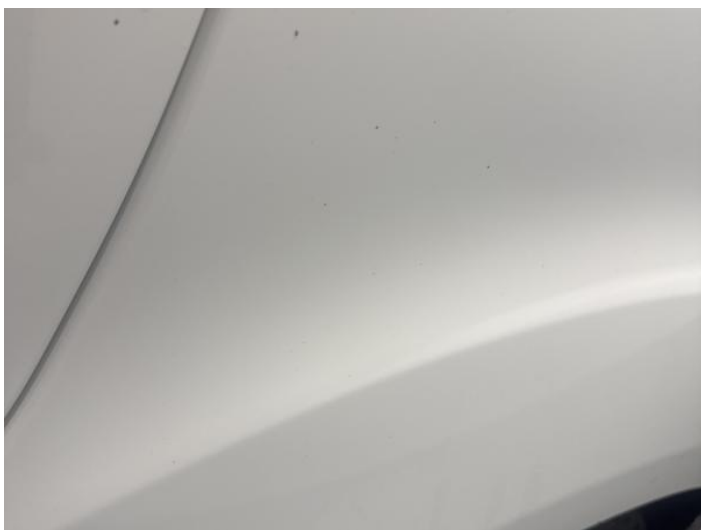
17: Qtr Panel osr  
Chipped  
1 To 5

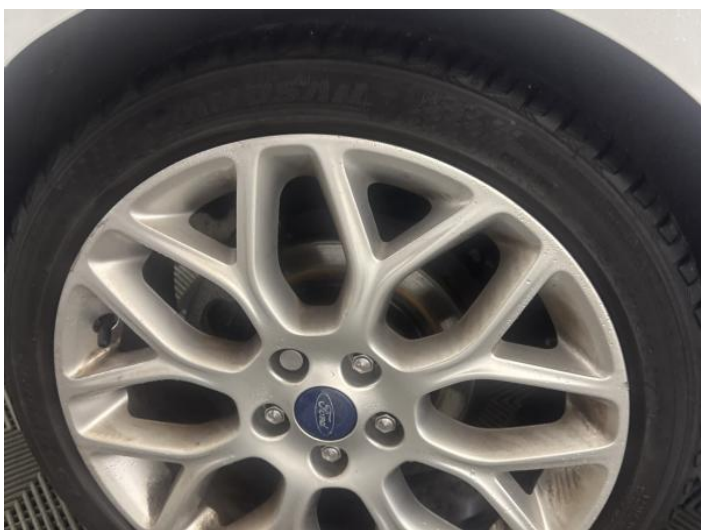
19: Wheel osr  
Scratched  
Over 50mm

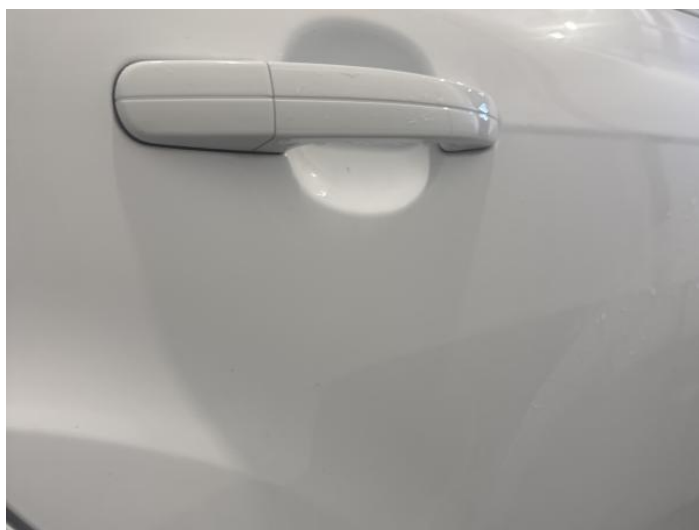
20: Door osr  
Chipped  
1 To 5

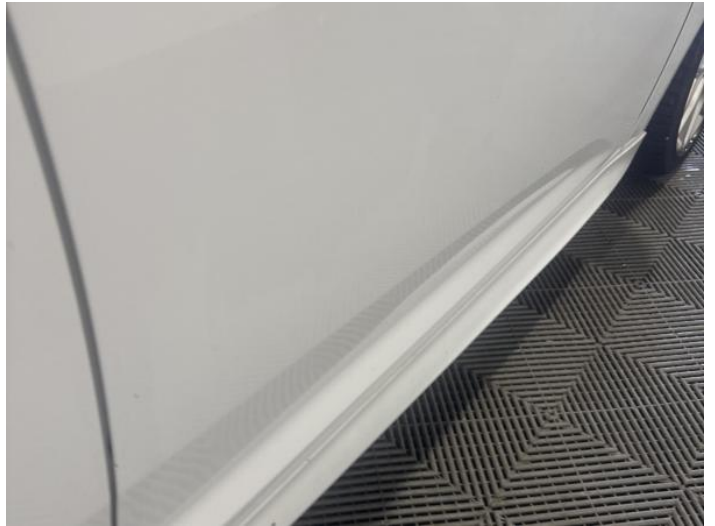
21: Door osr  
Scratched  
Over 25mm Not Thru Paint

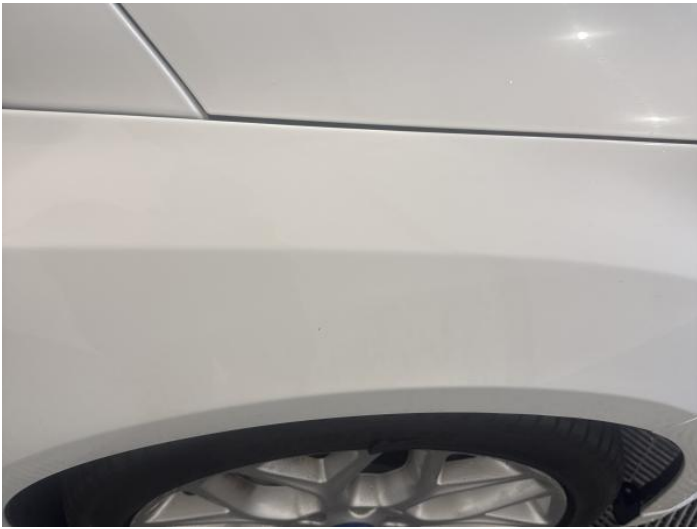
23: Wing osf  
Chipped  
1 To 5

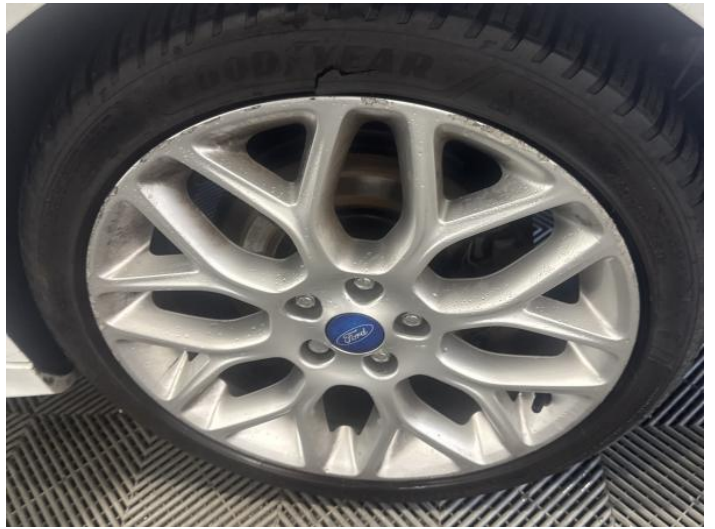
24: Wheel osf  
Scratched  
Over 50mm

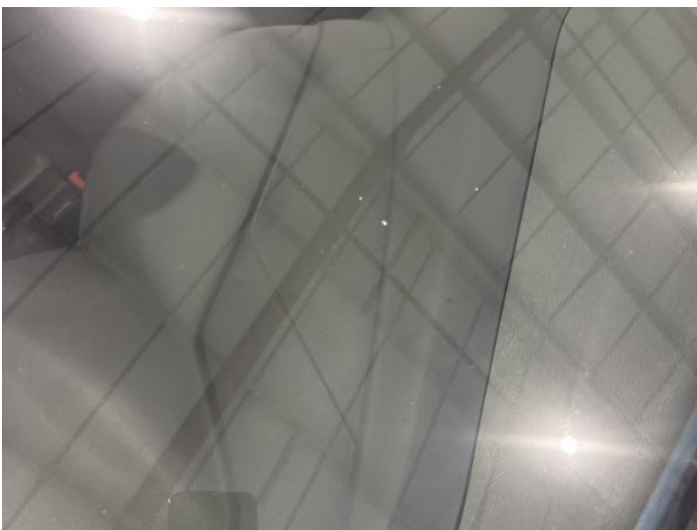
25: Screen Front  
Chipped  
UpTo 10mm
