VEHICLE INSPECTION REPORT

VK68FPG

Vauxhall Astra 1.6 CDTi 16V 136 SRi Nav 5dr Auto

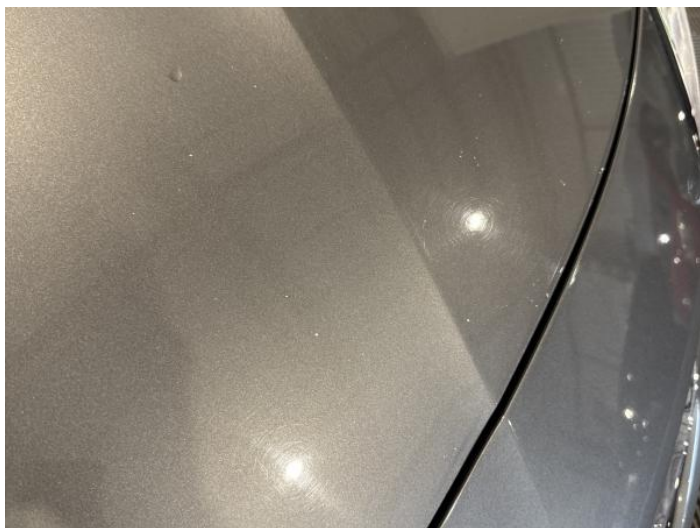
1: Bonnet
Dented
With Paint Damage

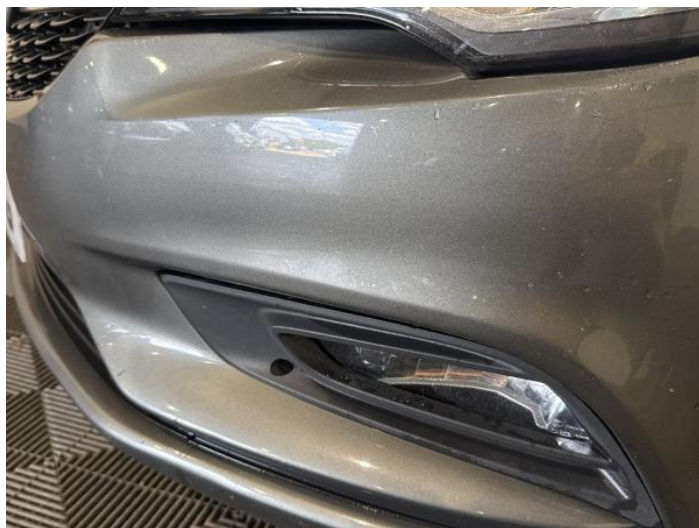
2: Bumper Front
Chipped
Multiple Chips

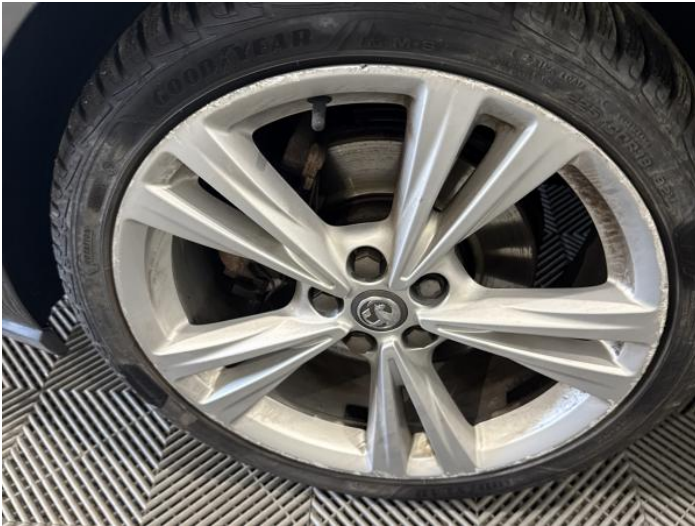
3: Wheel osf
Scratched
Over 50mm

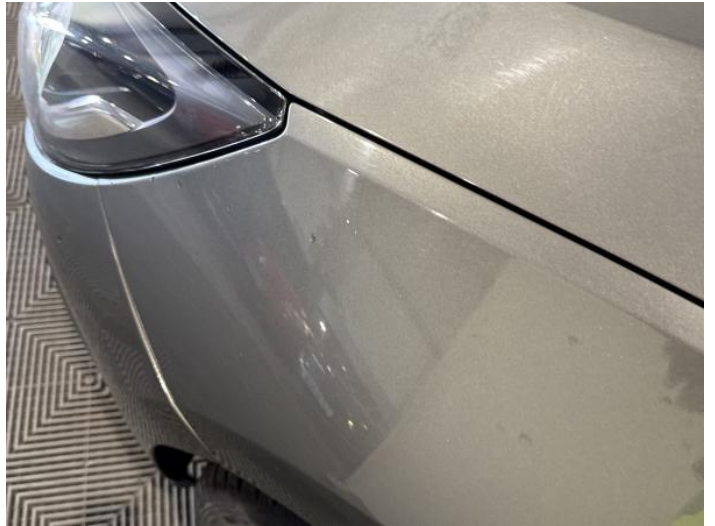
4: Wing nsf
Chipped
1 To 5

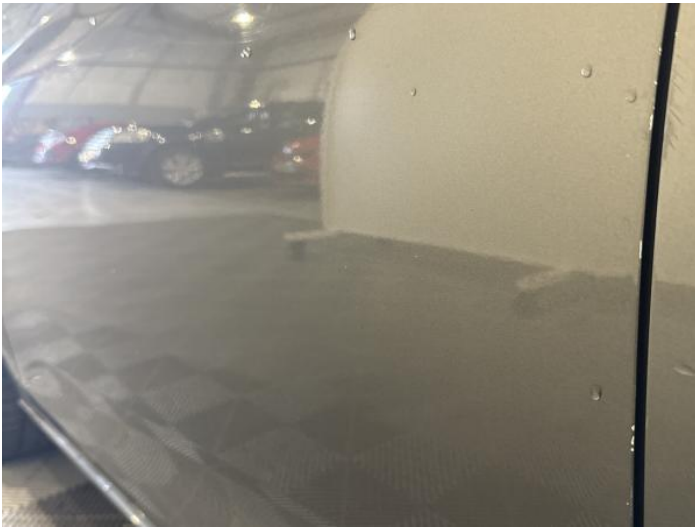
5: Door osf
Dented
Between 10mm + 30mm

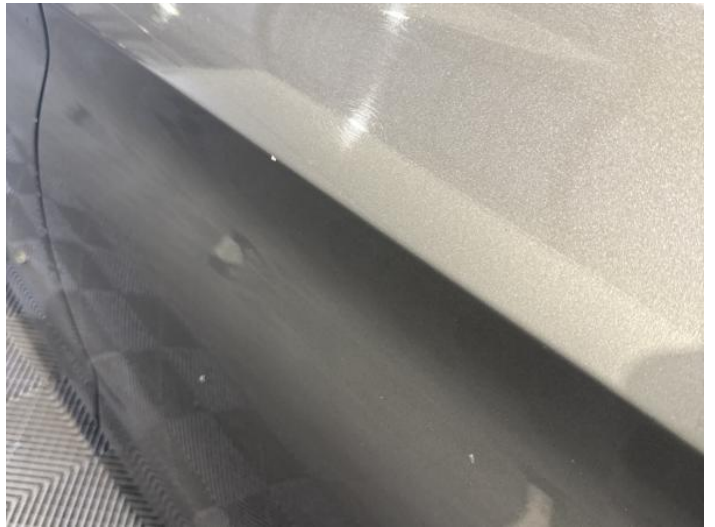
6: Door osr
Scratched
Over 25mm Thru Paint

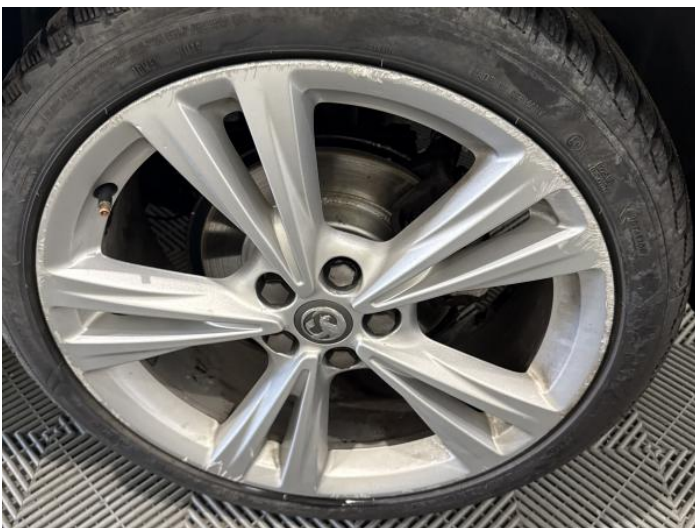
7: Wheel nsr
Scratched
Over 50mm

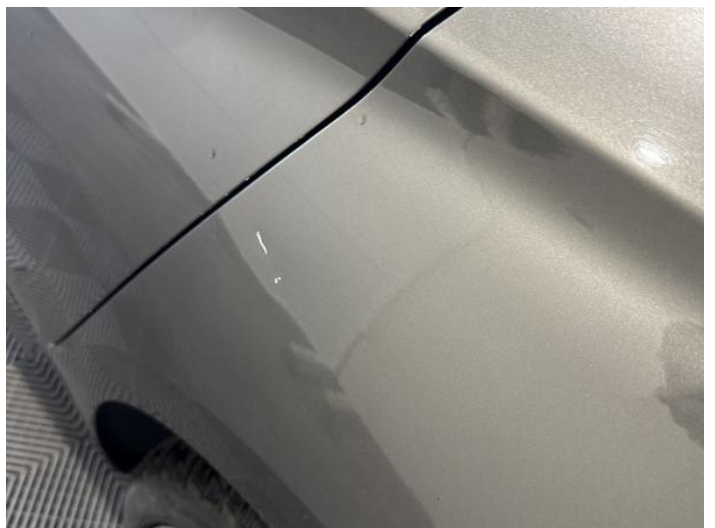
8: Qtr Panel nsr
Dented
With Paint Damage

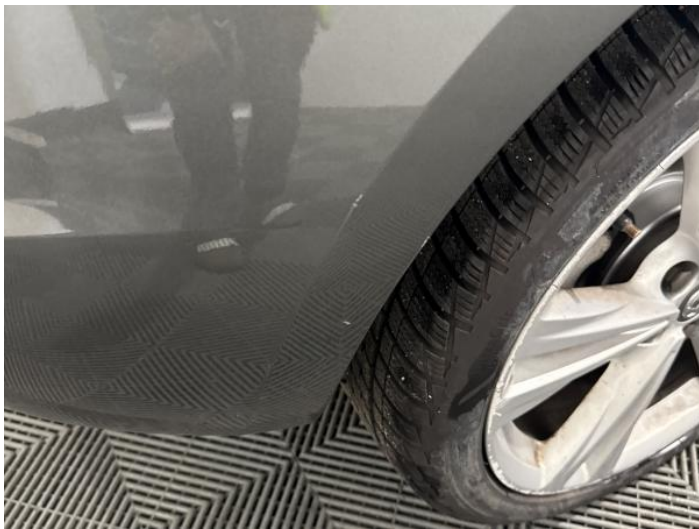
9: Bumper Rear
Scratched
25 to 100mm Thru Paint

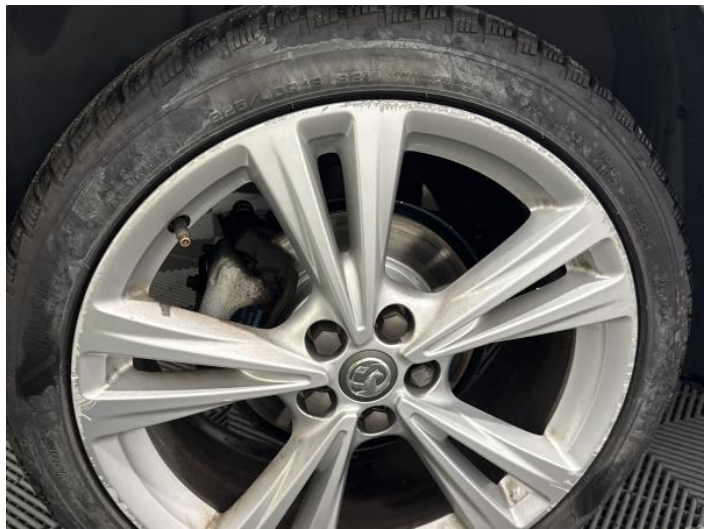
10: Wheel osr
Scratched
Over 50mm

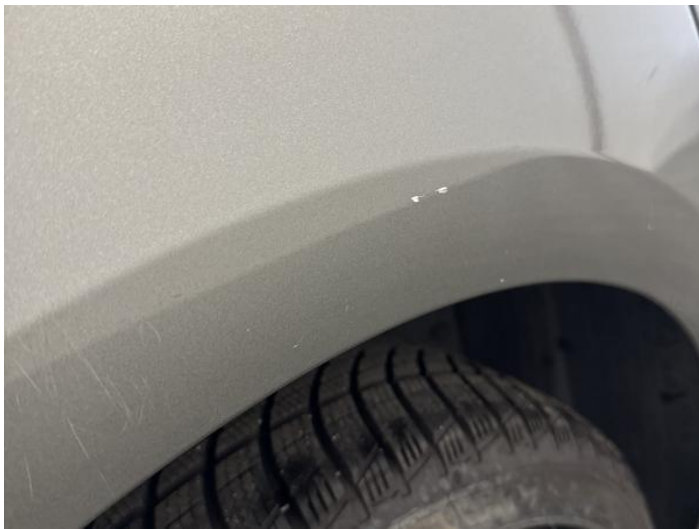
11: Qtr Panel osr
Dented
With Paint Damage

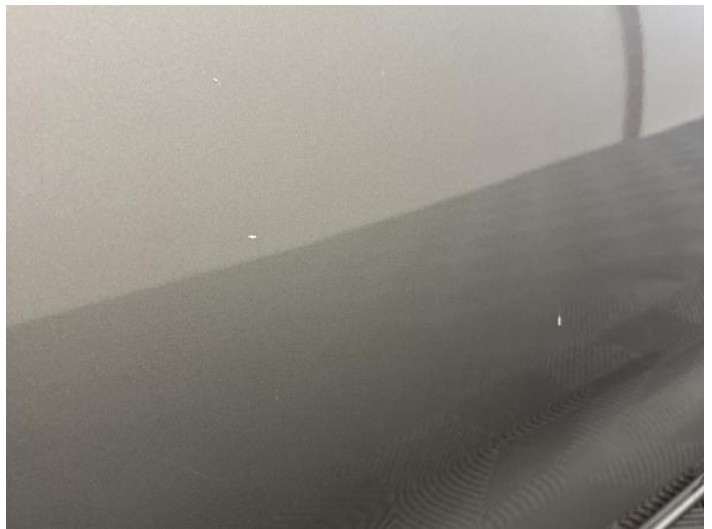
12: Door osr
Chipped
1 To 5

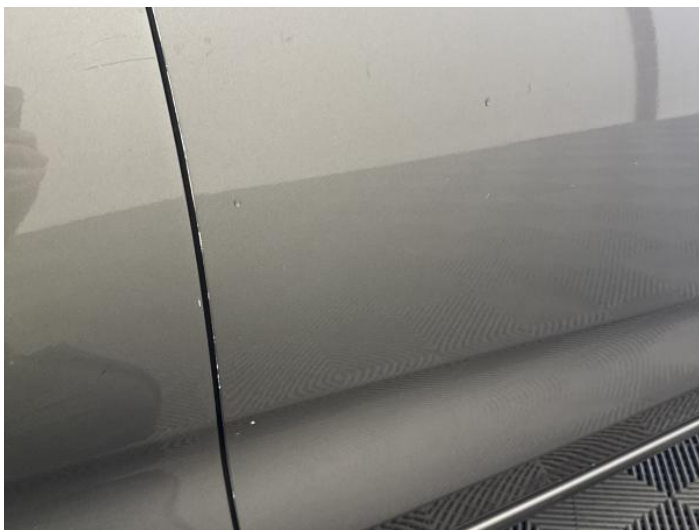
13: Door osf
Scratched
Over 25mm Thru Paint

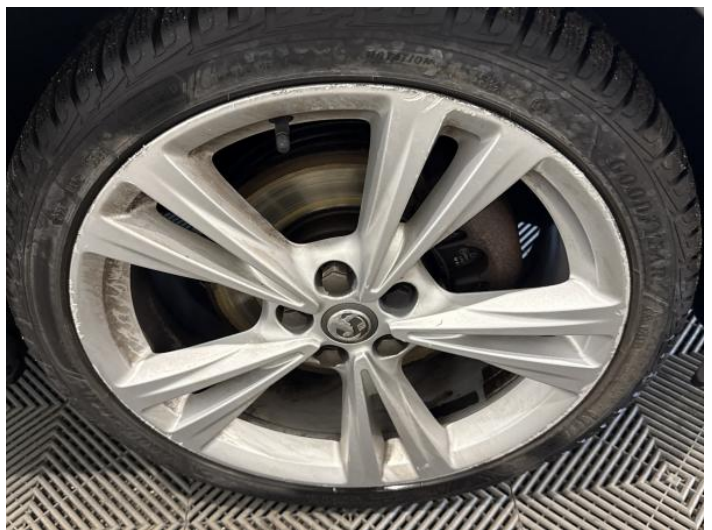
14: Wheel osf
Scratched
Over 50mm

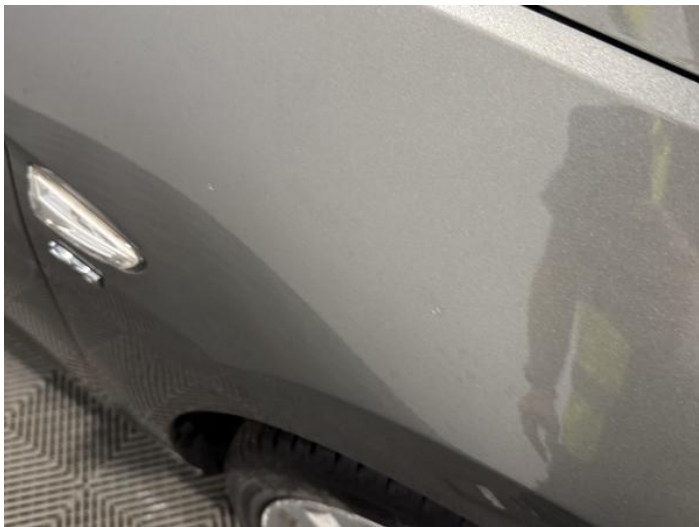
15: Wing osf
Chipped
1 To 5

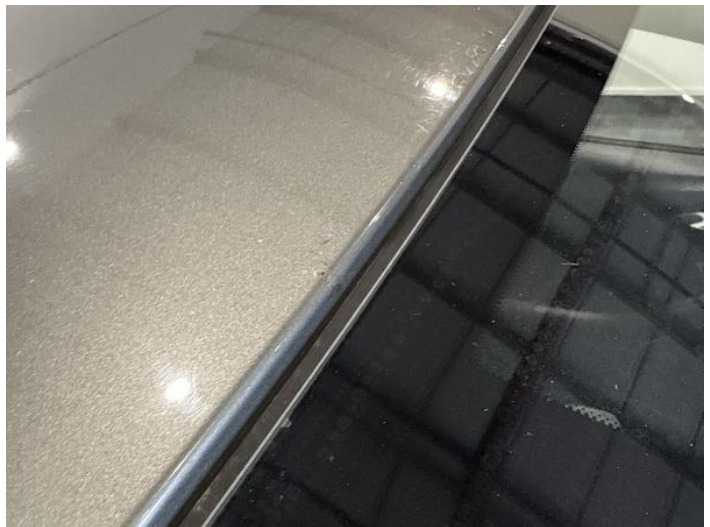
16: Roof
Chipped
Edge Chip

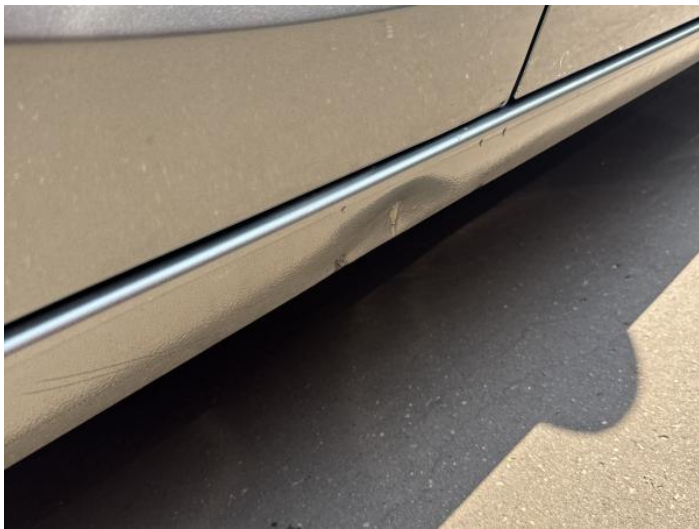
17: Sill os
Dented
Over 30mm
