# VEHICLE INSPECTION REPORT

**GF73EBK**

## Volkswagen Polo 1.0 TSI Life 5dr DSG

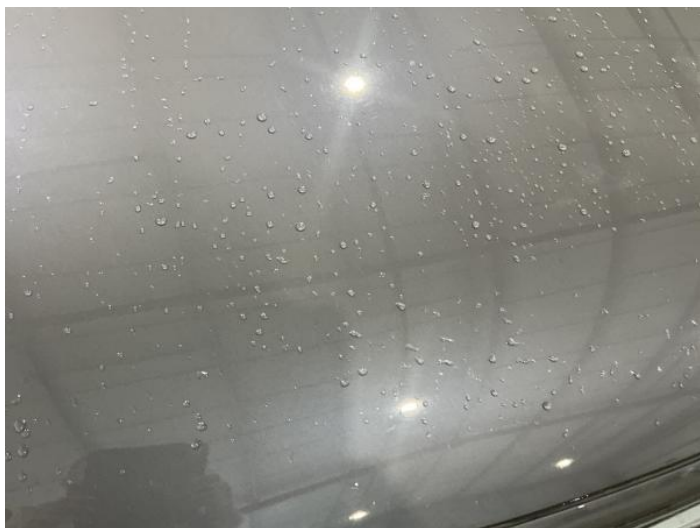
1: Bonnet  
Chipped  
1 To 5

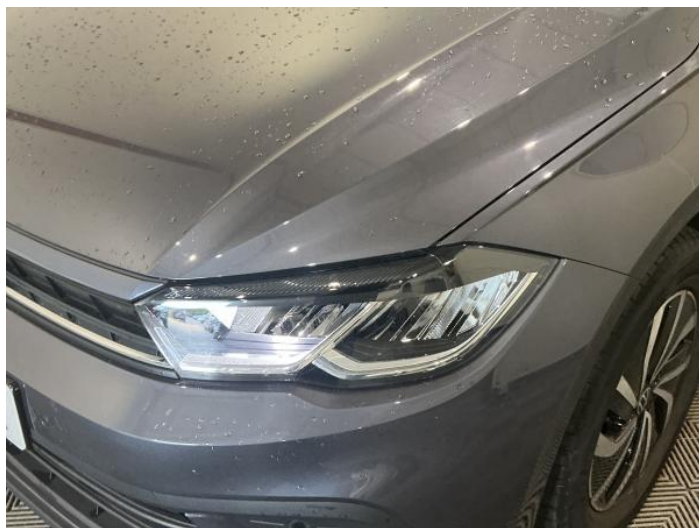
2: Bumper Front  
Chipped  
Multiple Chips

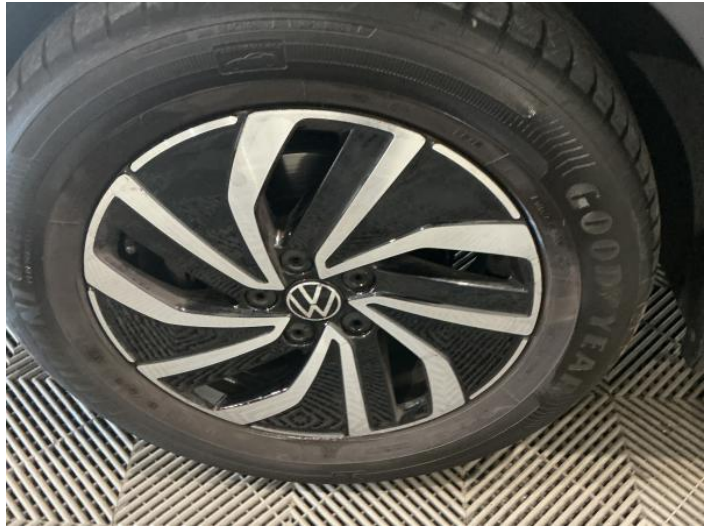
4: Wheel nsf  
Scratched  
Up To 50mm

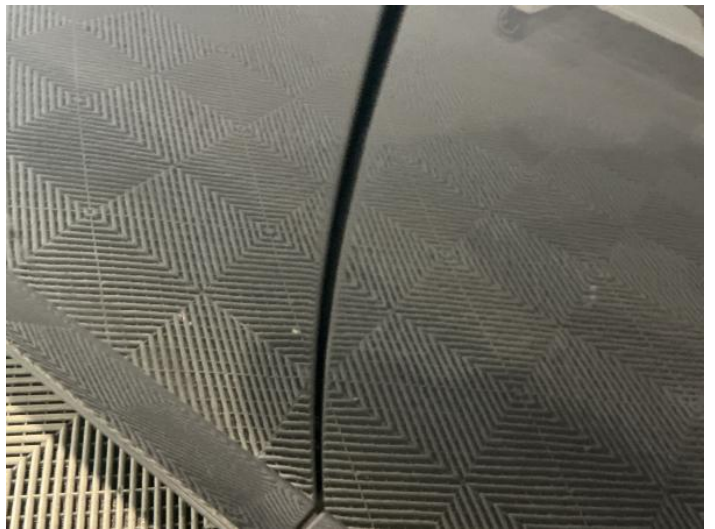
6: Door nsf  
Chipped  
1 To 5

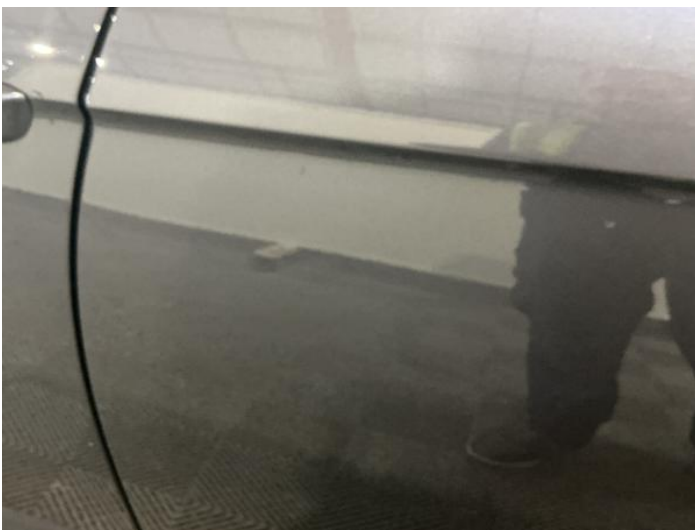
7: Door nsr  
Chipped  
1 To 5

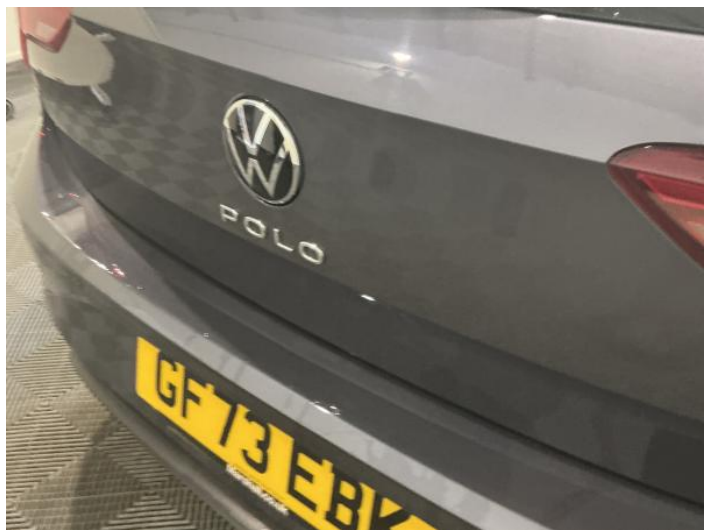
8: Bumper Rear  
Chipped  
Multiple Chips

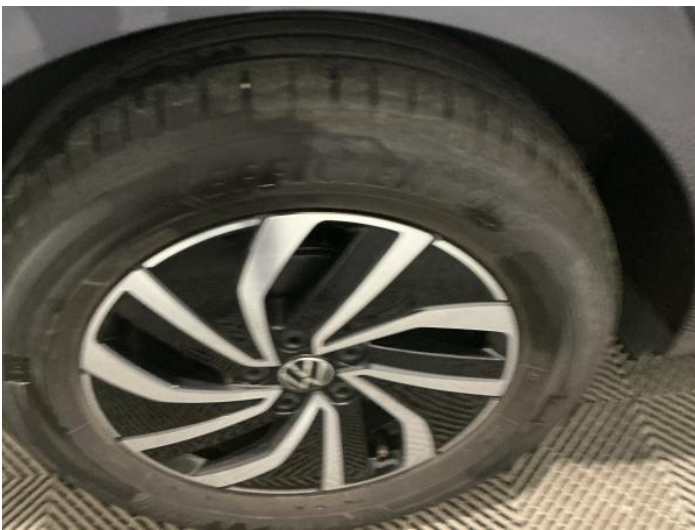
11: Wheel osr  
Scratched  
Up To 50mm

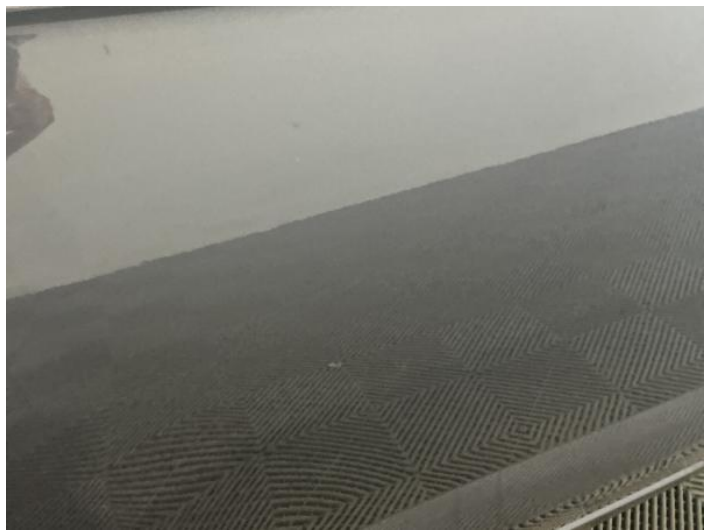
12: Door osr  
Chipped  
1 To 5

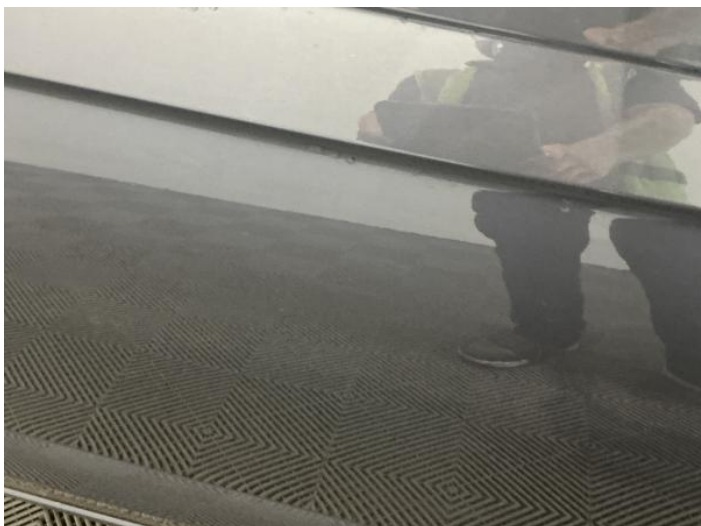
15: Door osf  
Chipped  
1 To 5
