VEHICLE INSPECTION REPORT

EX20SXR

Vauxhall Insignia 1.6 Turbo D ecoTec Tech Line Nav 5dr

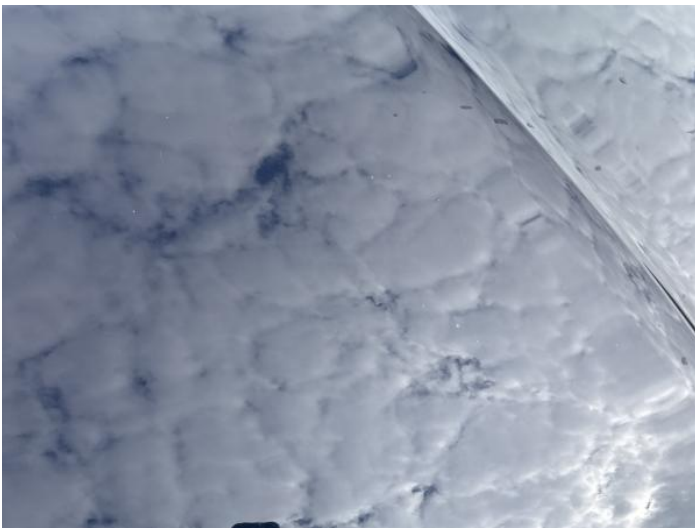
1: Bonnet
Chipped
Multiple Chips

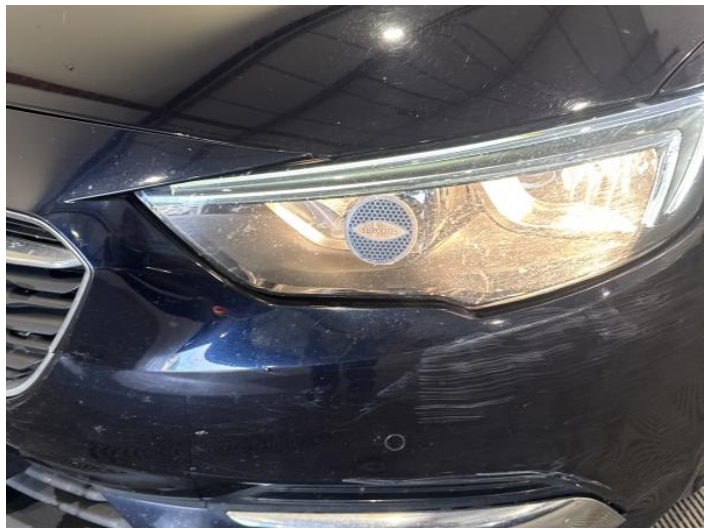
2: Bumper Front
Scratched
Over 100mm Thru Paint

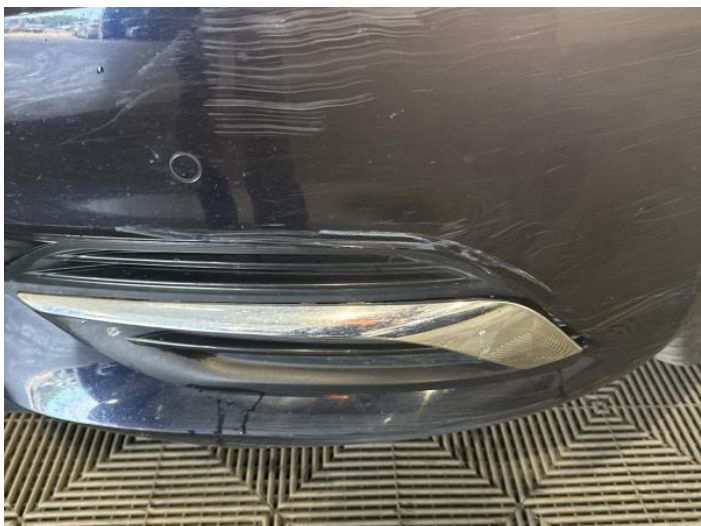
3: Bumper Front Moulding
Broken
Replace

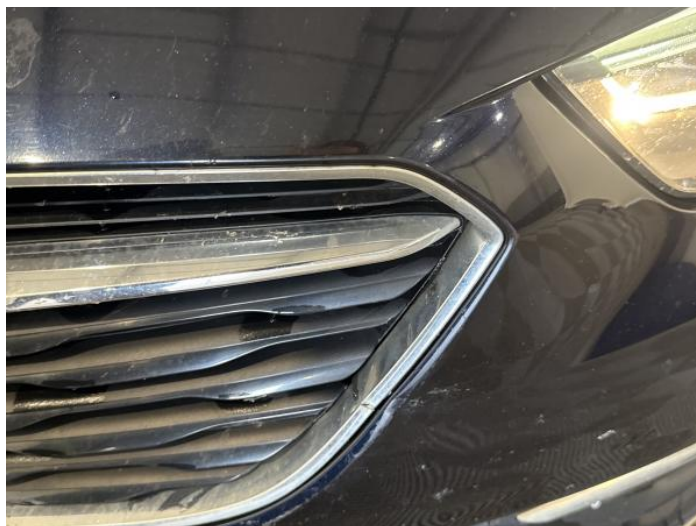
4: Bumper Front Grill
Broken
Replace

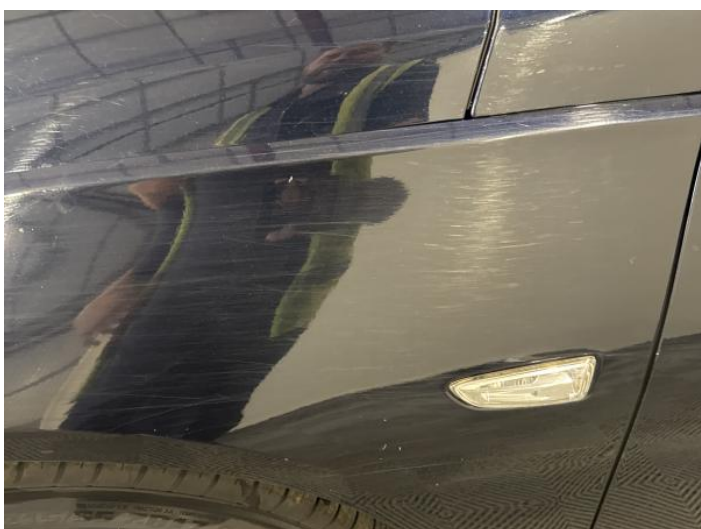
5: Wing nsf
Dented
With Paint Damage

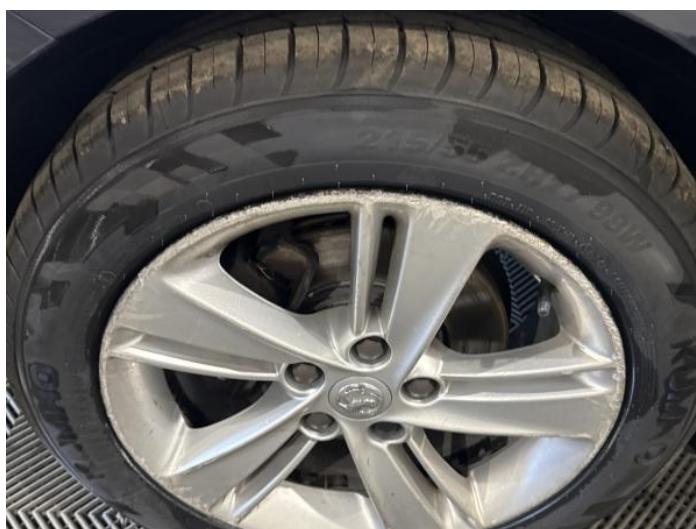
6: Wheel nsf
Scratched
Over 50mm

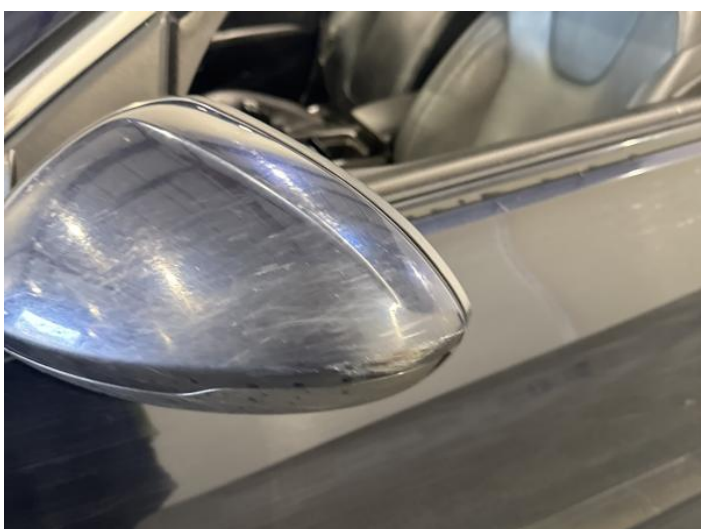
7: Door Mirror Assy nsf
Scratched (Painted)
Over 25mm Thru Paint

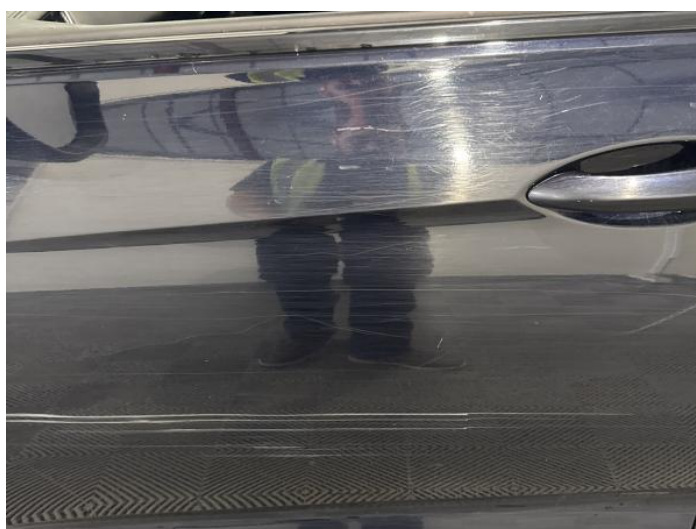
8: Door nsf
Dented
With Paint Damage

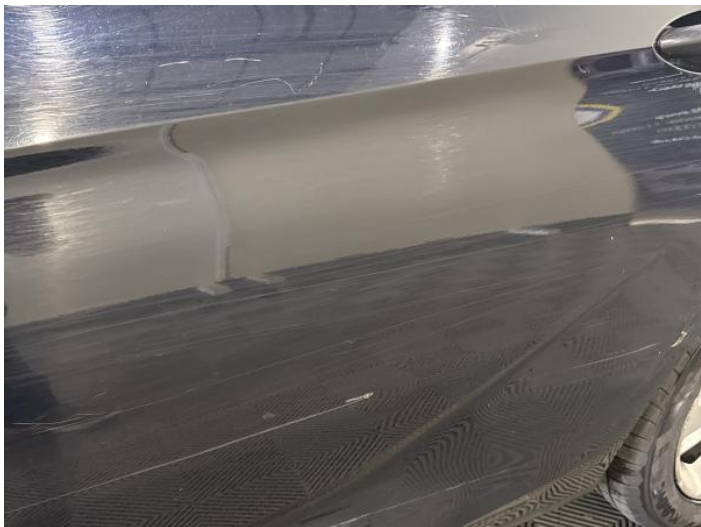
9: Door nsr
Dented
With Paint Damage

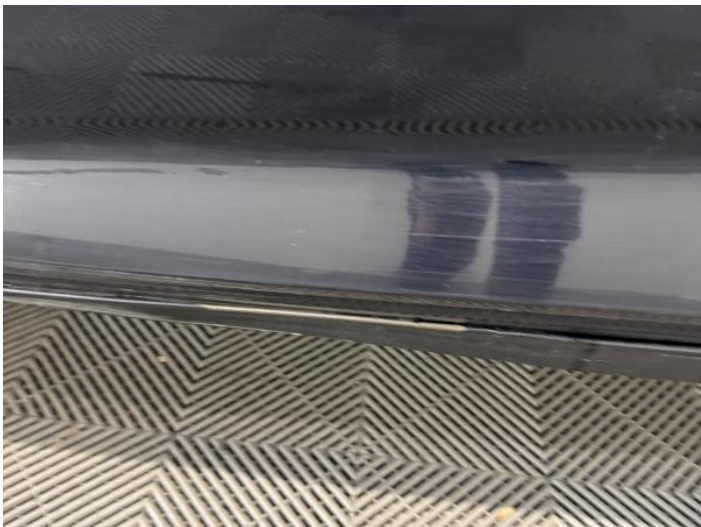
10: Sill ns
Scratched
Over 25mm Thru Paint

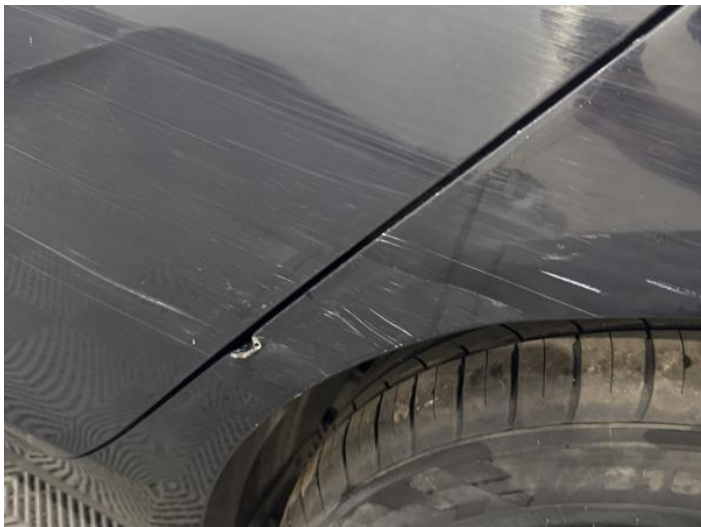
11: Qtr Panel nsr
Dented
With Paint Damage

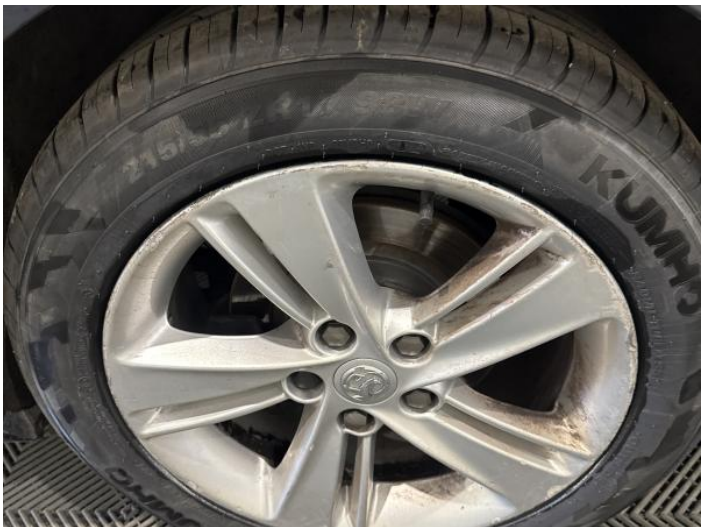
12: Wheel nsr
Scratched
Over 50mm

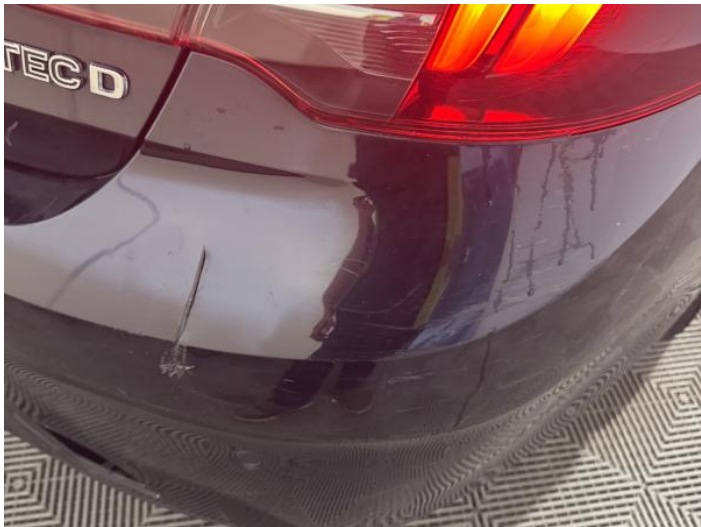
13: Bumper Rear
Cracked
Over 25mm

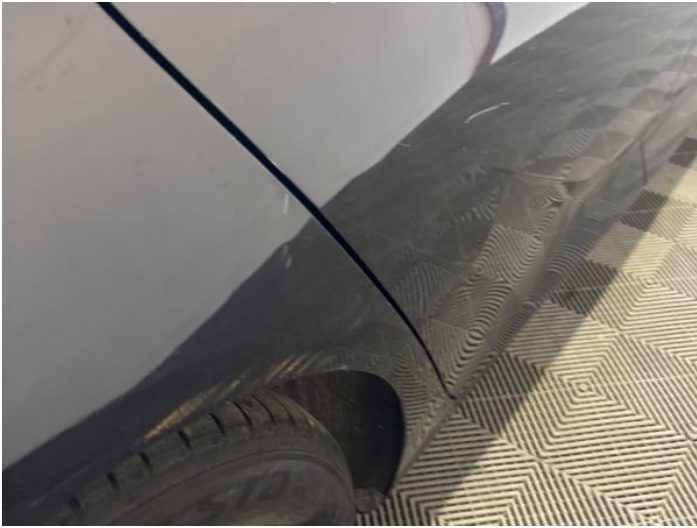
15: Qtr Panel osr
Dented
With Paint Damage

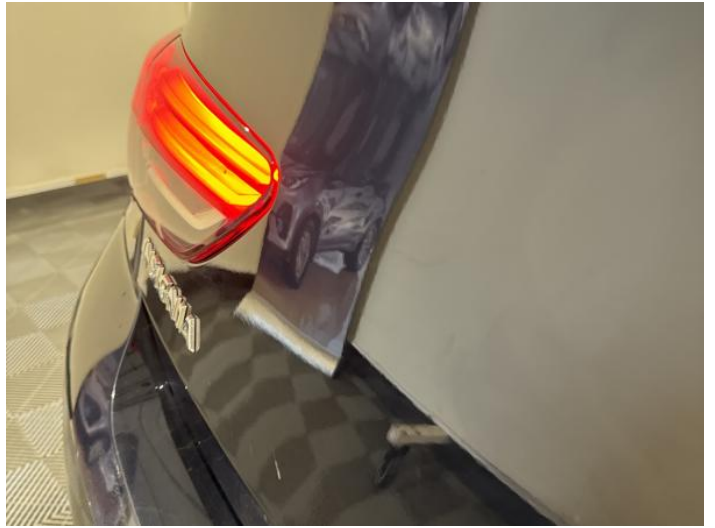
16: Boot Lid
Dented
Between 10mm + 30mm

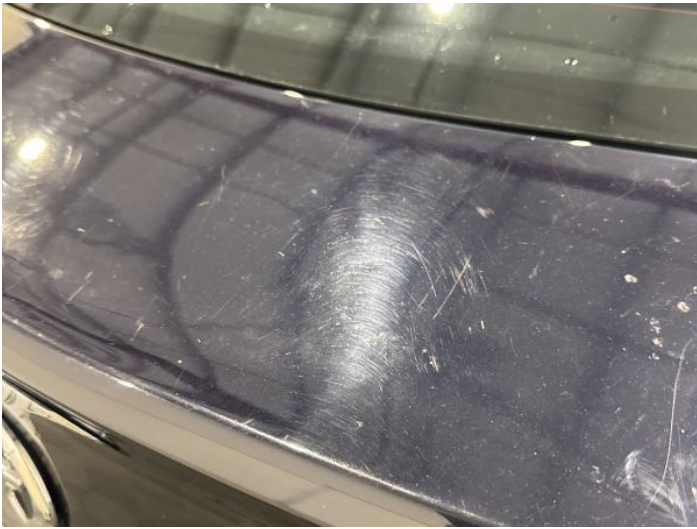
17: Boot Lid
Chipped
Multiple Chips

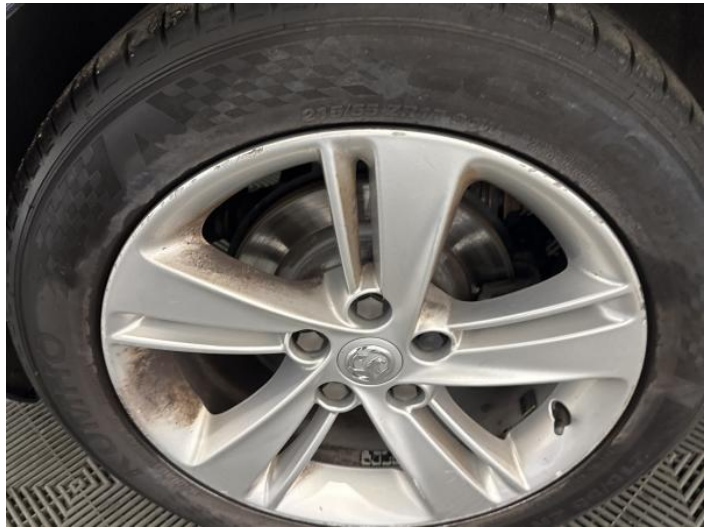
18: Wheel osr
Scratched
Over 50mm

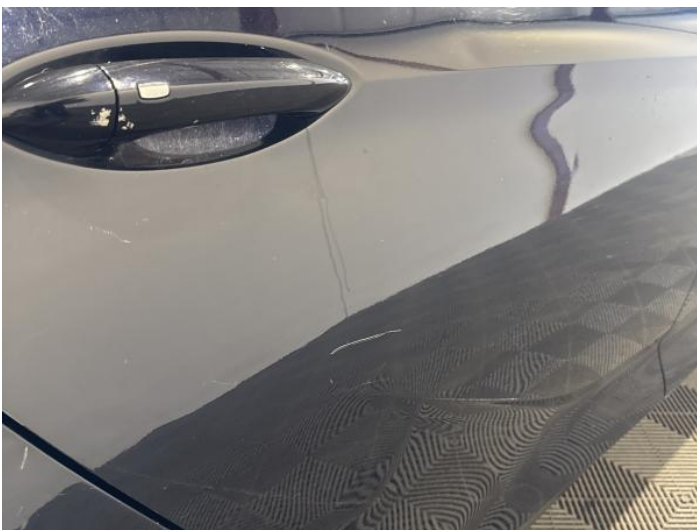
19: Door osf
Dented
With Paint Damage

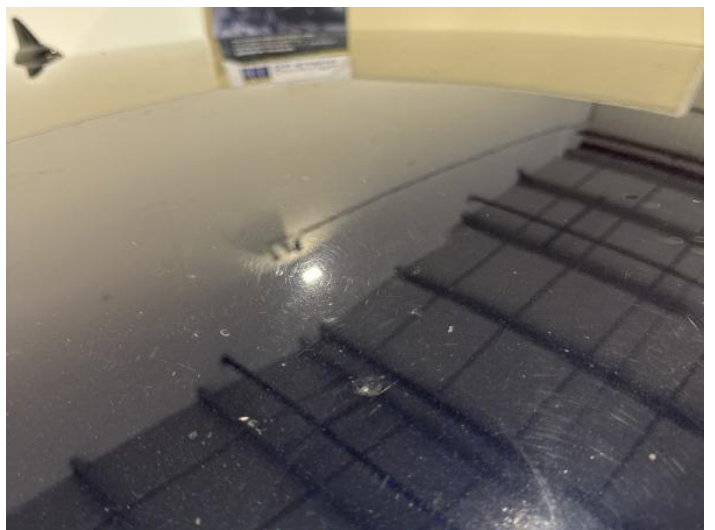
20: Roof
Dented
Between 10mm + 30mm

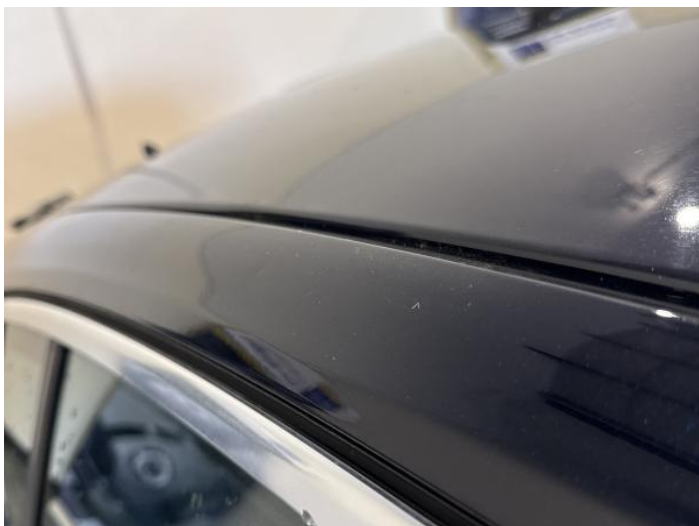
21: C Post os
Dented
2 Or Less UpTo 10mm

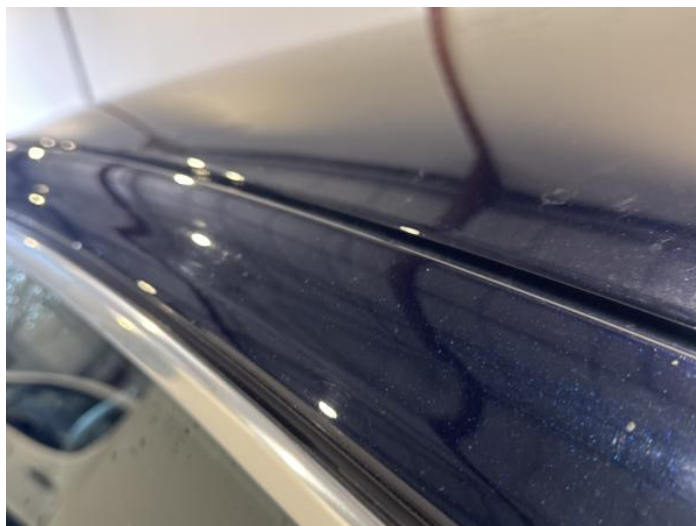
22: C Post ns
Dented
Between 10mm + 30mm

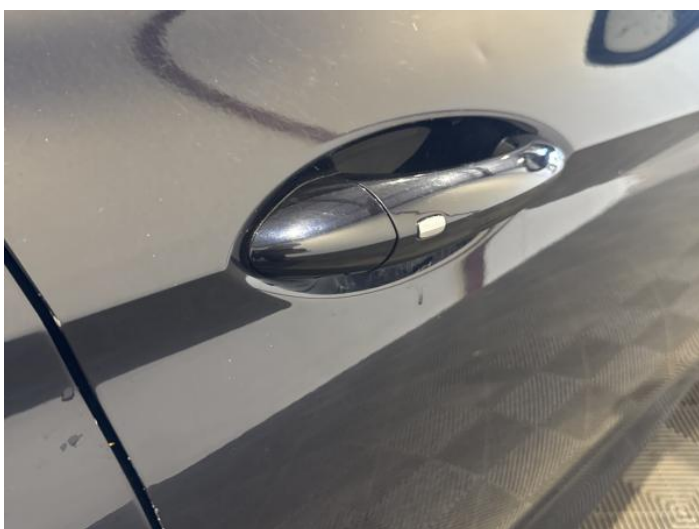
23: Door osr
Dented
With Paint Damage

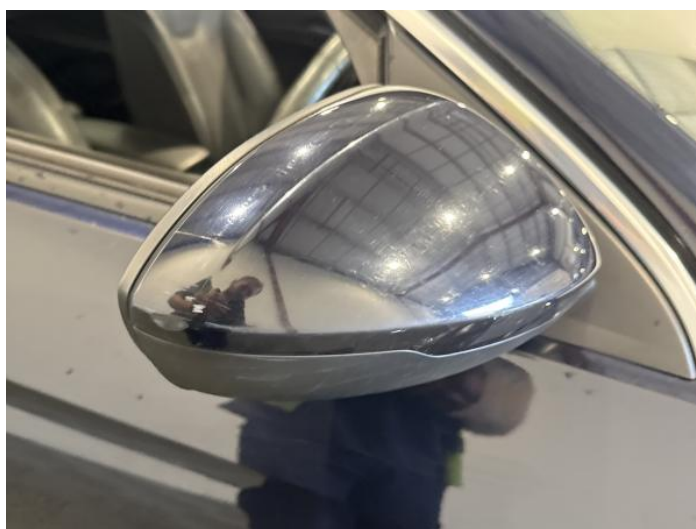
24: Door Mirror Assy osf
Scratched (Painted)
Over 25mm Thru Paint

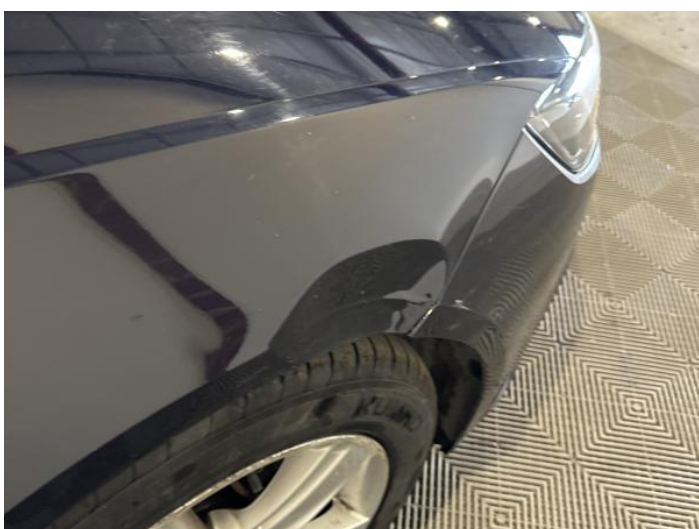
25: Wing osf
Dented
With Paint Damage

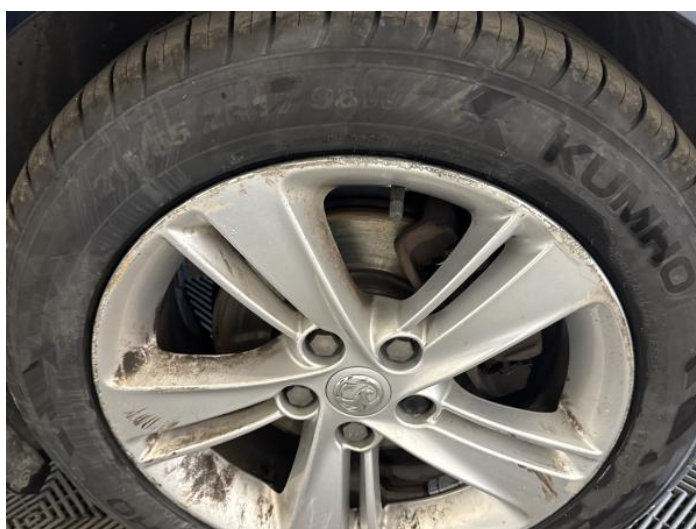
26: Wheel osf
Scratched
Over 50mm

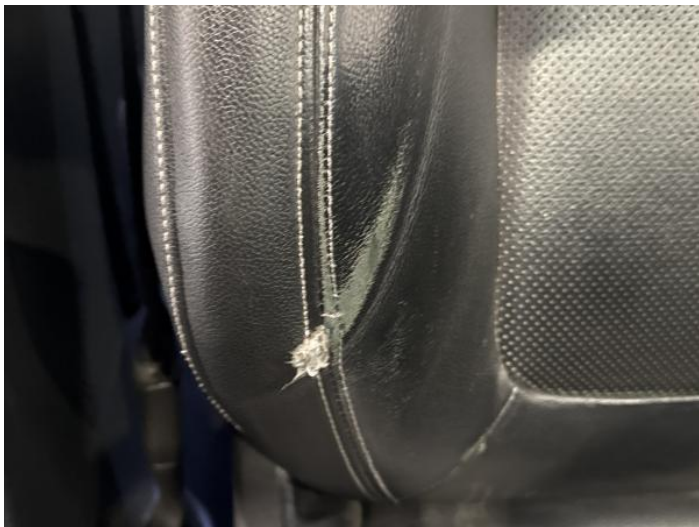
27: Seat Base Cover osf
Torn
Over 3mm
