VEHICLE INSPECTION REPORT

LB65LCG

Ford Focus 1.5 TDCi 120 Titanium 5dr

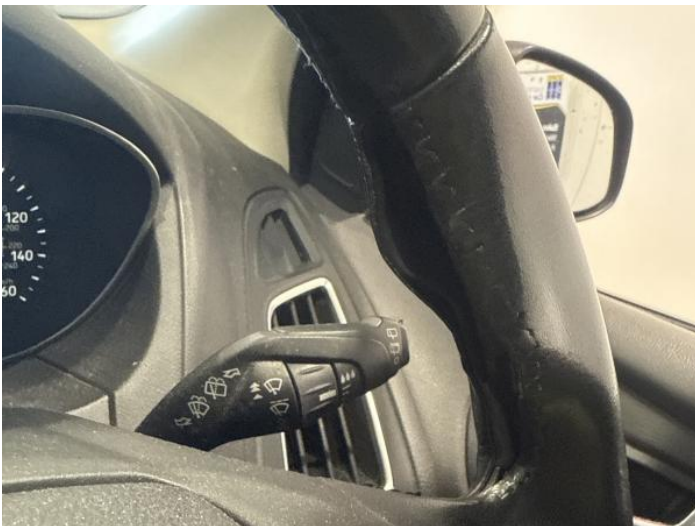
1: Steering Wheel
Damaged
Replace

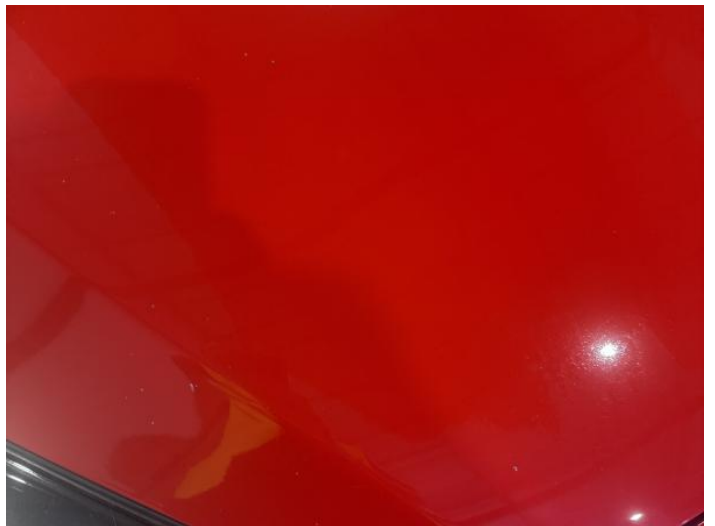
2: Bonnet
Chipped
Multiple Chips

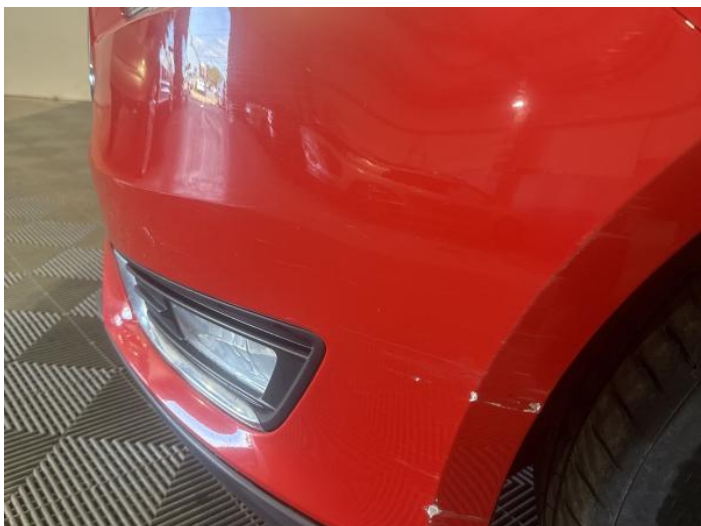
3: Bumper Front
Scratched
Over 100mm Thru Paint

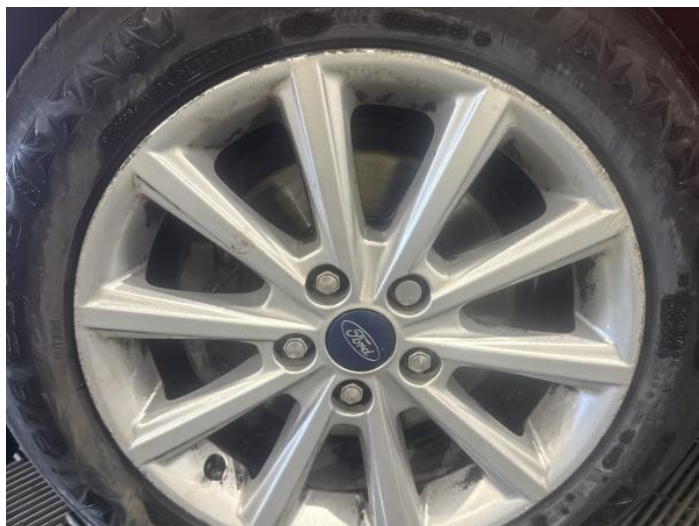
4: Wheel nsf
Scratched
Over 50mm

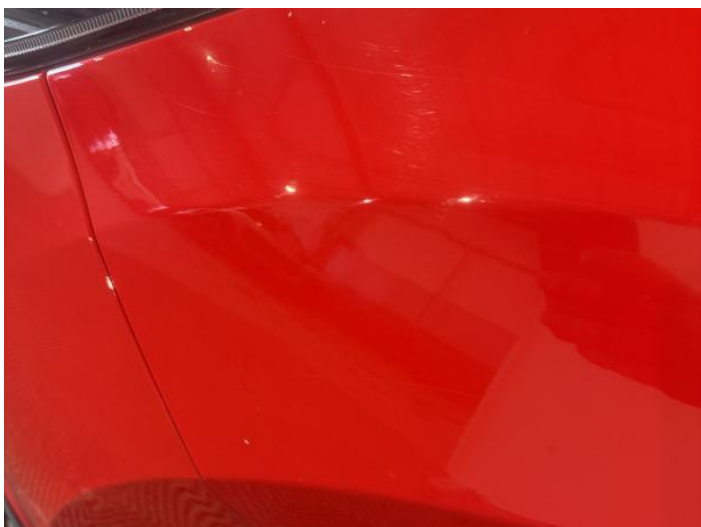
5: Wing nsf
Chipped
1 To 5

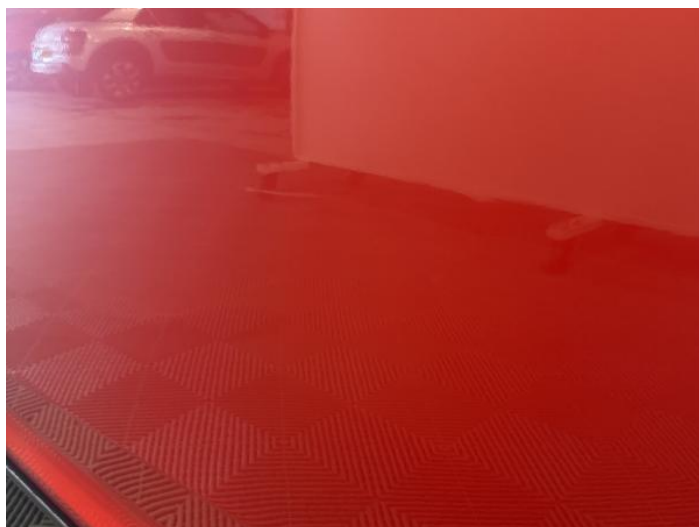
6: Door nsf
Scratched
Over 25mm Thru Paint

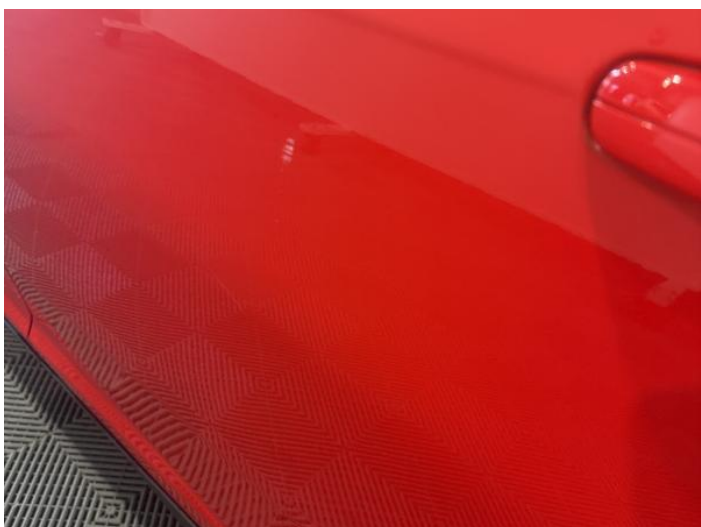
7: Door nsr
Scratched
Over 25mm Thru Paint

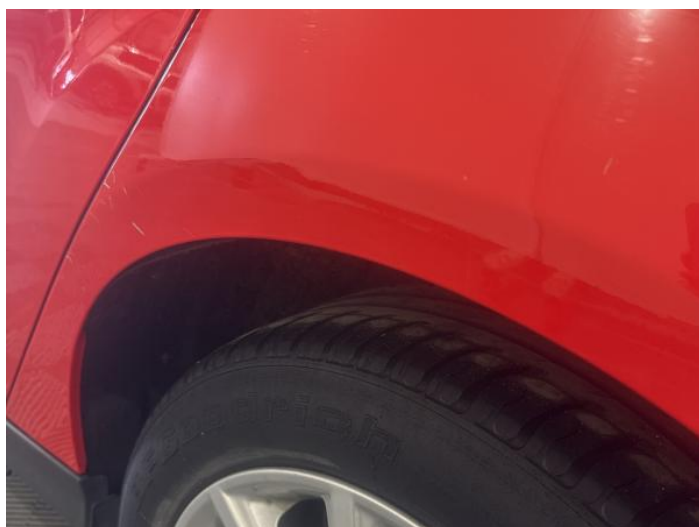
8: Qtr Panel nsr
Dented
With Paint Damage

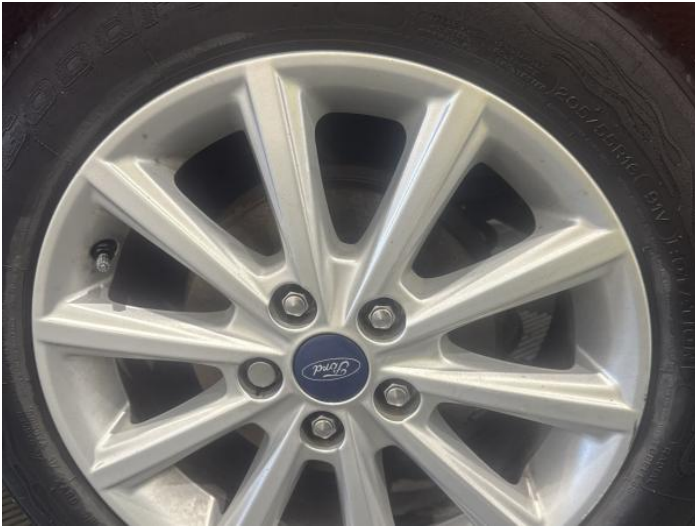
9: Wheel nsr
Scratched
Over 50mm

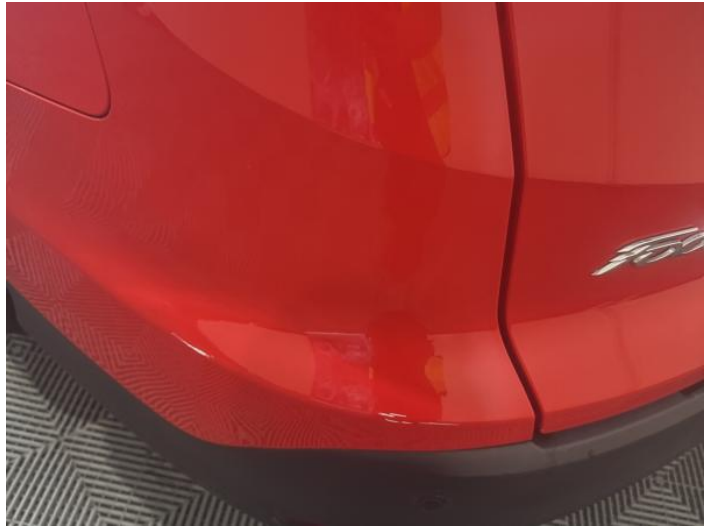
10: Bumper Rear
Scratched
Over 100mm Thru Paint

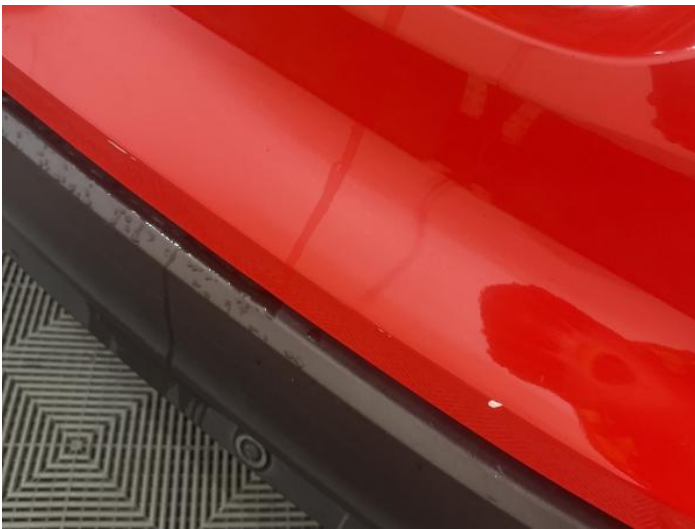
11: Tailgate
Scratched
Over 25mm Thru Paint

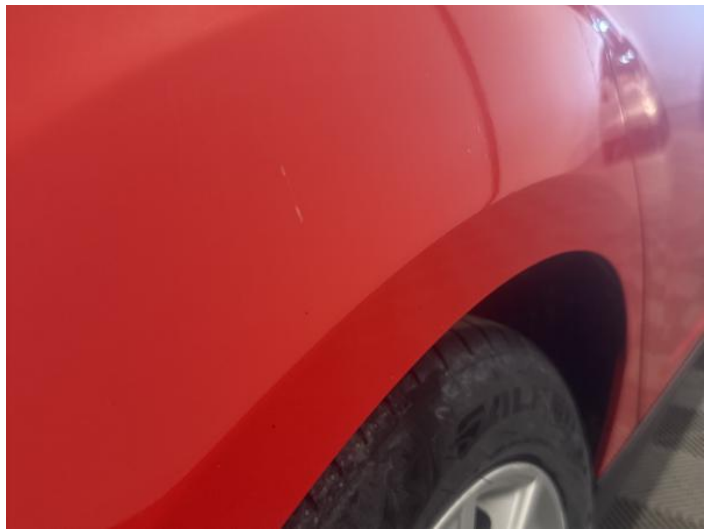
12: Qtr Panel osr
Dented
Over 2 UpTo 10mm

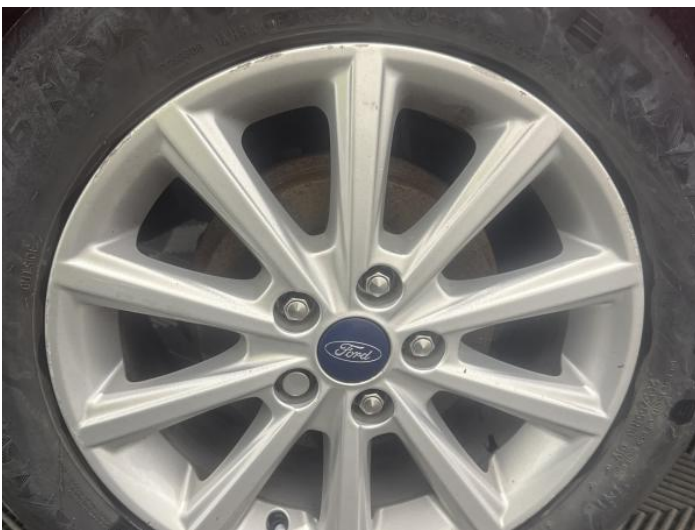
13: Wheel osr
Scratched
Over 50mm

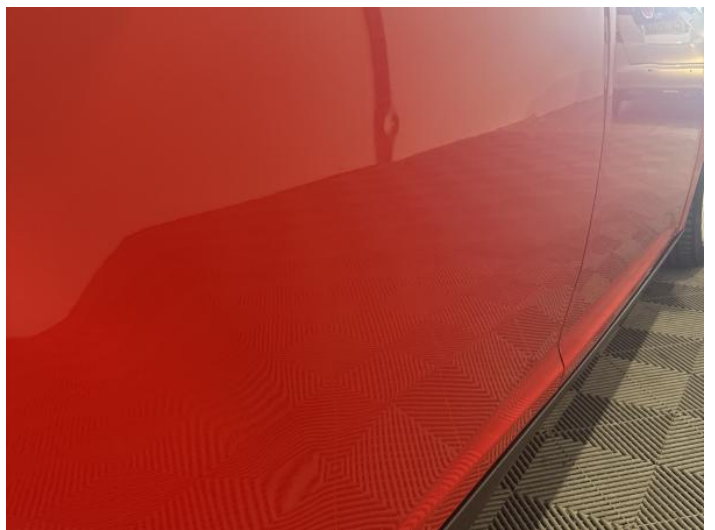
14: Door osr
Dented
Over 30mm

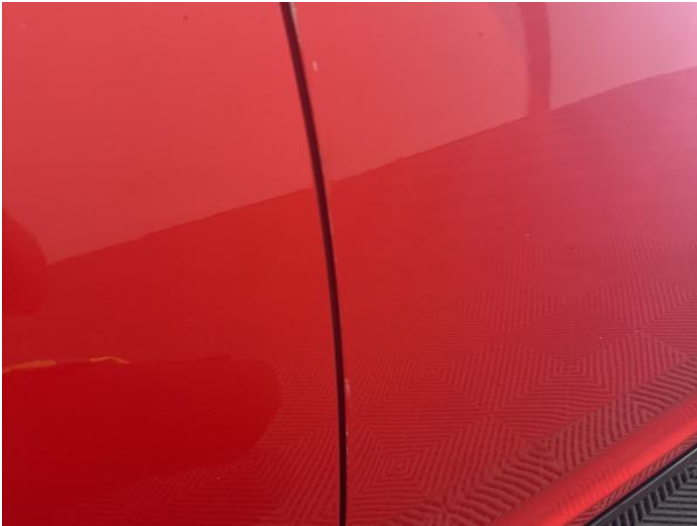
15: Door osf
 Scratched
 Over 25mm Thru Paint

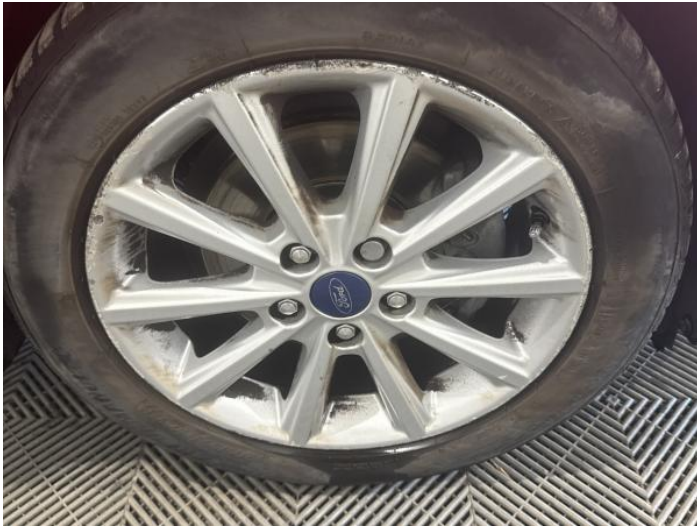
16: Wheel osf
 Scratched
 Over 50mm

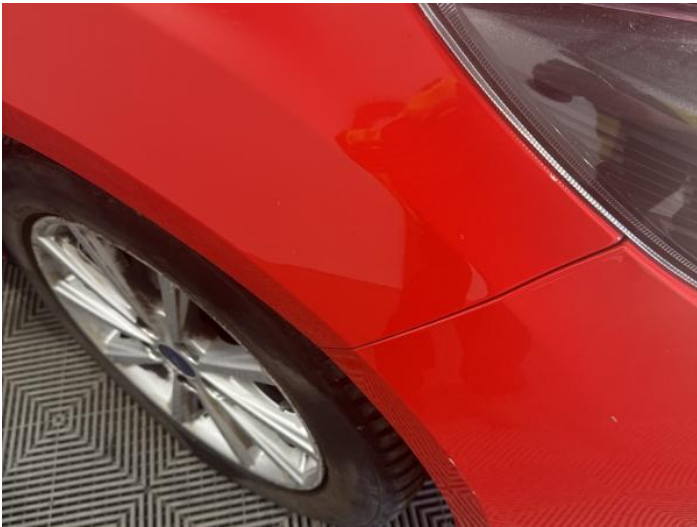
17: Wing osf
 Chipped
 1 To 5

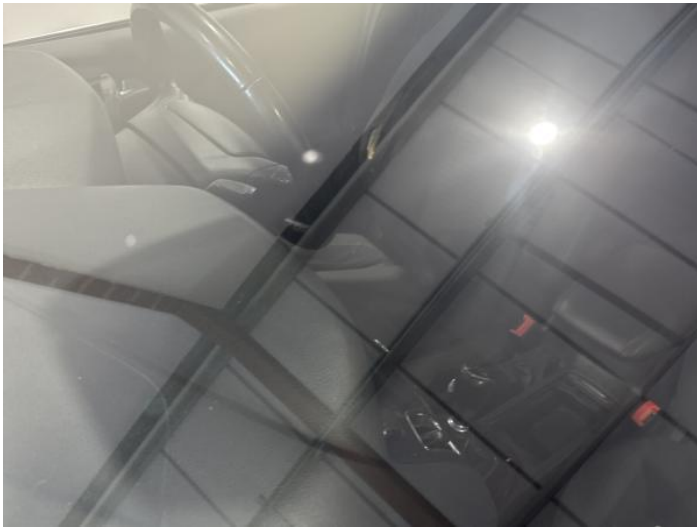
18: Screen Front
 Chipped
 UpTo 10mm
