# VEHICLE INSPECTION REPORT

**HR19LFB**

## Ford Mondeo 1.5 EcoBoost 165 Titanium Edition 5dr

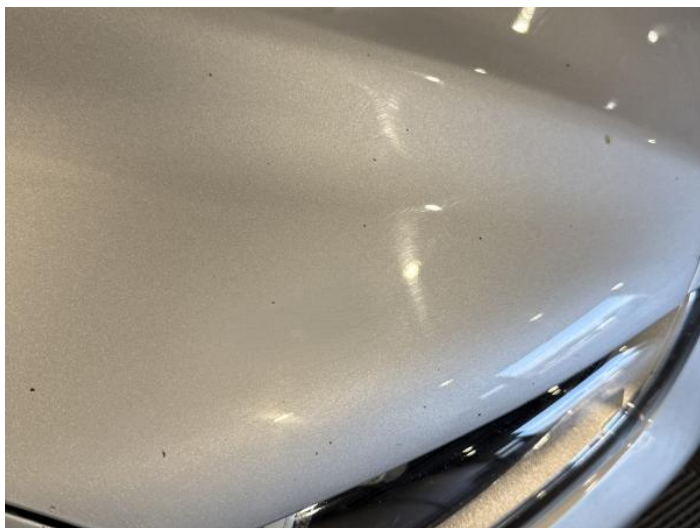
1: Bonnet  
Scratched  
Over 25mm Thru Paint

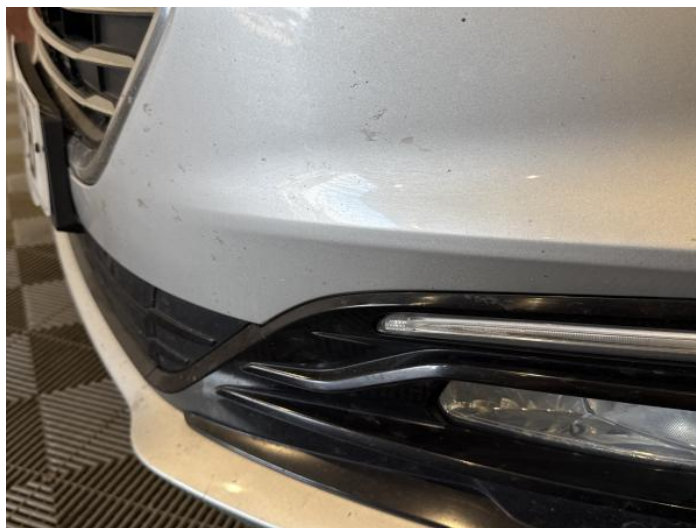
2: Bumper Front  
Chipped  
Multiple Chips

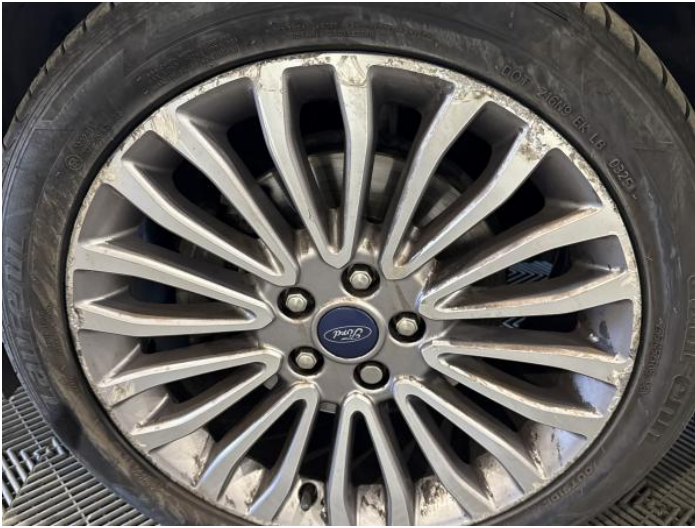
3: Wheel nsf  
Scratched  
Over 50mm

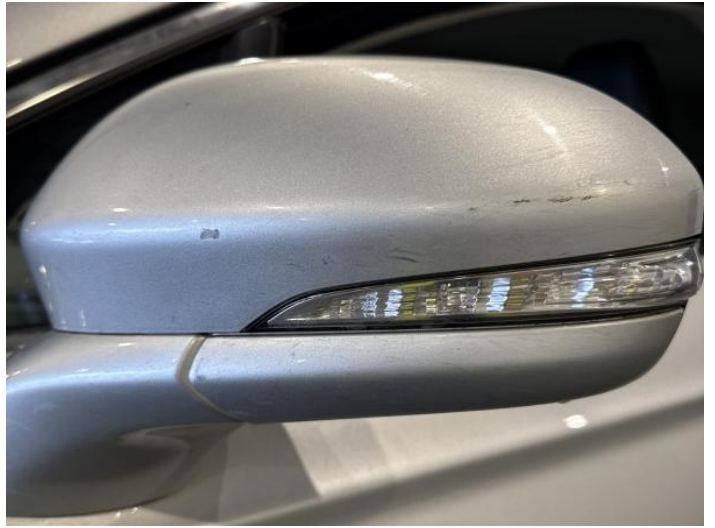
4: Door Mirror Assy nsf  
Scratched (Painted)  
UpTo 25mm Thru Paint

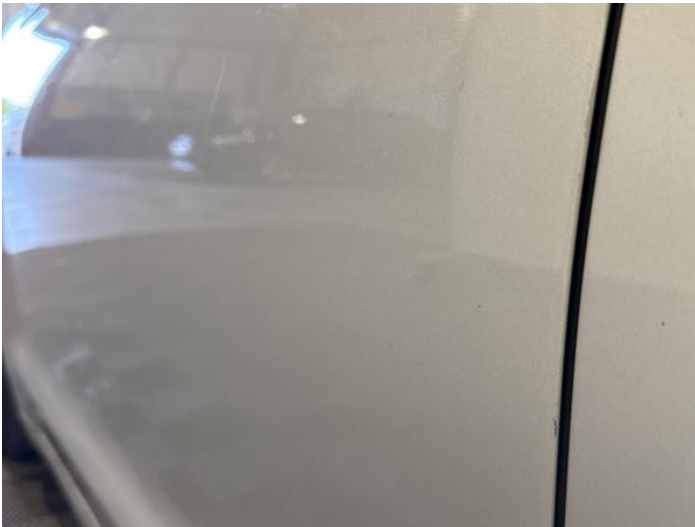
5: Door nsf  
Dented  
Between 10mm + 30mm

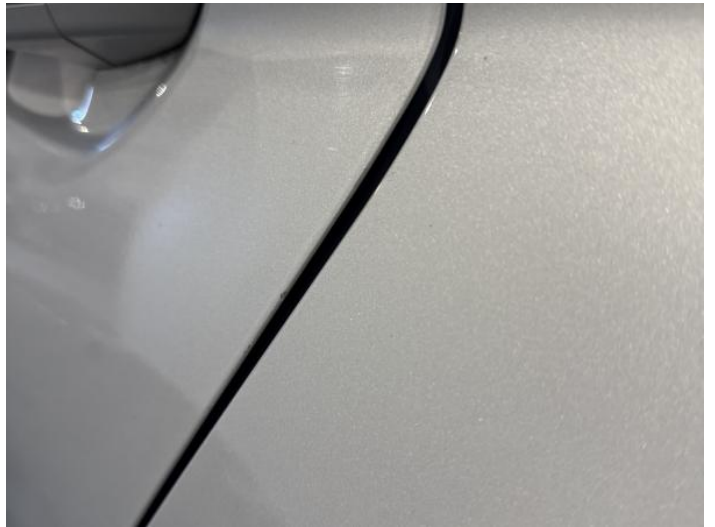
6: Door nsr  
Chipped  
Edge Chip

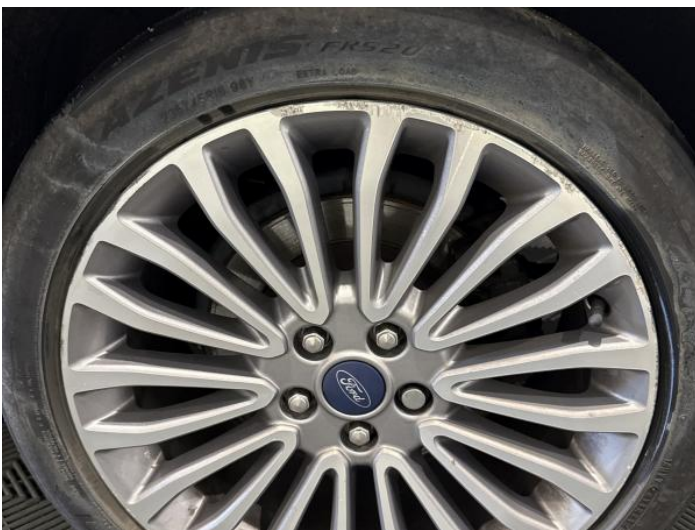
7: Wheel nsr  
Scratched  
Over 50mm

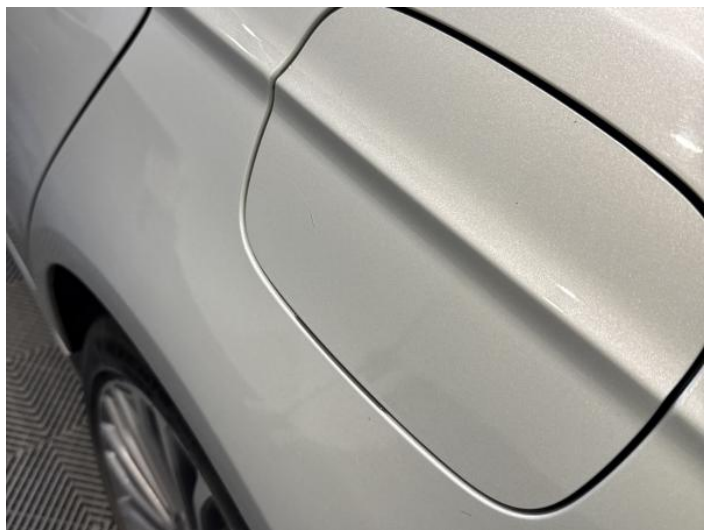
8: Qtr Panel nsr  
Scratched  
Over 25mm Thru Paint

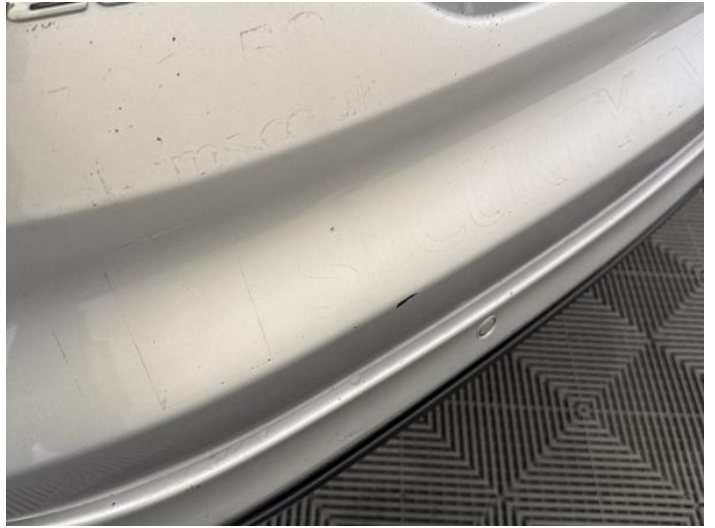
10: Tailgate  
Scratched  
Over 25mm Thru Paint

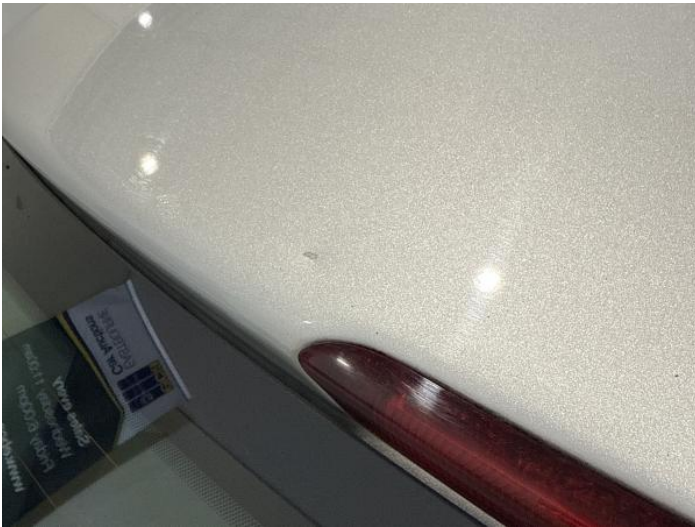
11: Roof  
Dented  
Between 10mm + 30mm

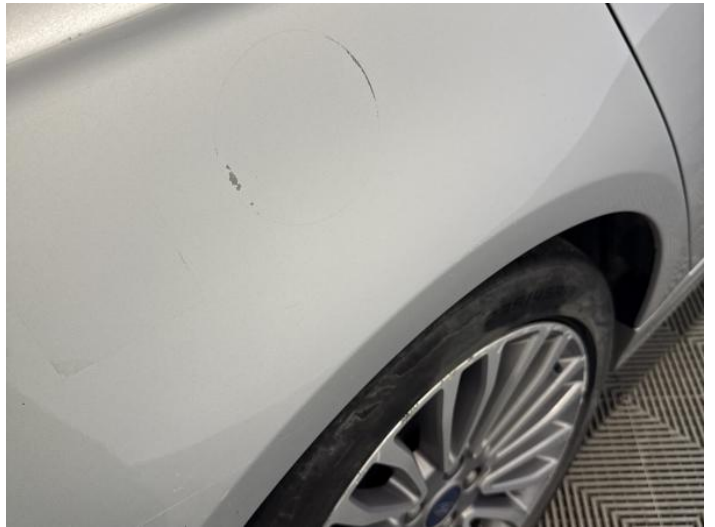
12: Qtr Panel osr  
Scratched  
Over 25mm Thru Paint

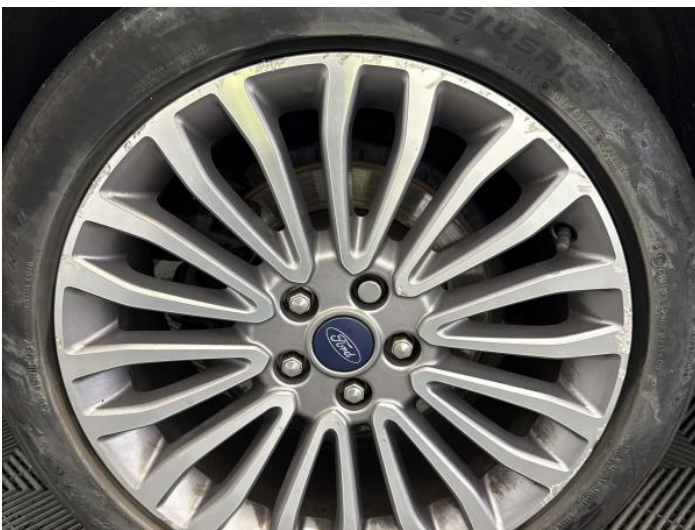
13: Wheel osr  
Scratched  
Over 50mm

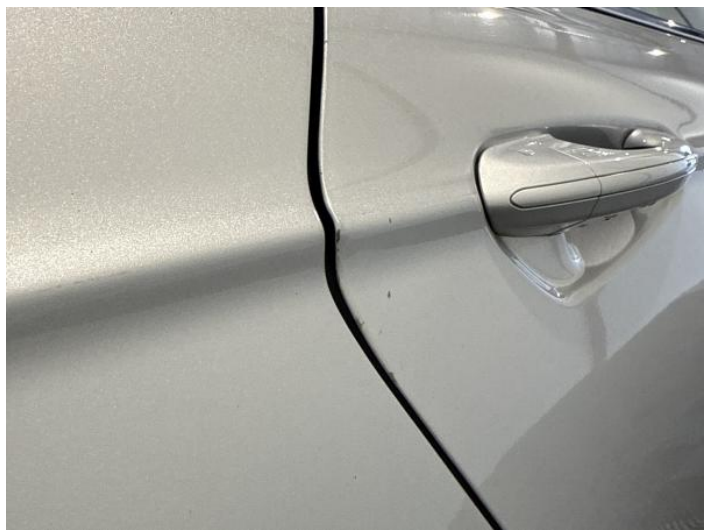
14: Door osr  
Chipped  
Edge Chip

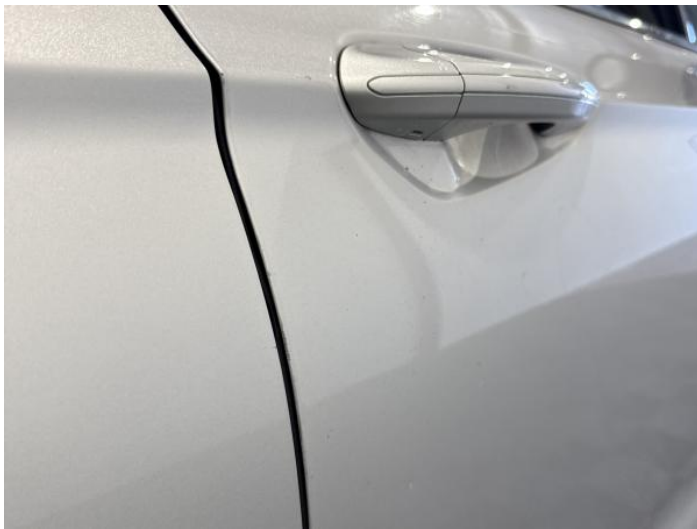
15: Door osf  
Chipped  
Edge Chip

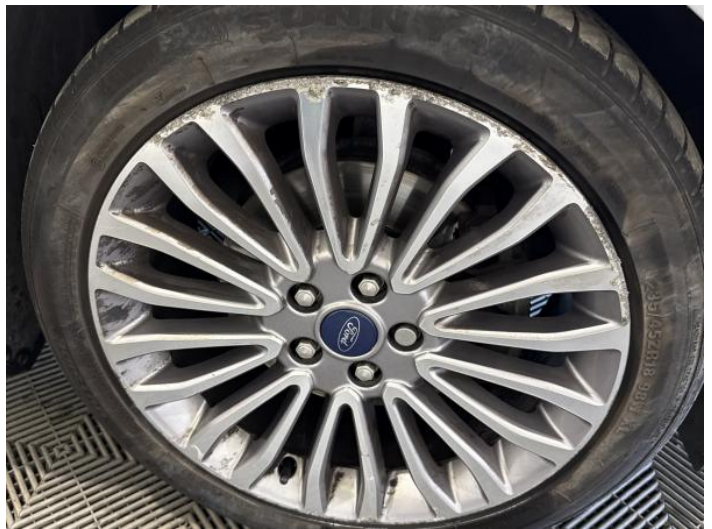
16: Wheel osf  
Scratched  
Over 50mm

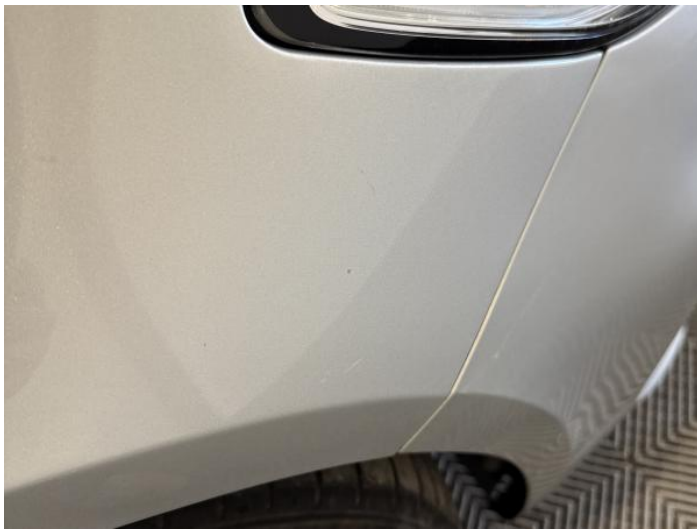
17: Wing osf  
Scratched  
UpTo 25mm Thru Paint
