VEHICLE INSPECTION REPORT

HN09VUG

Renault Megane 1.6 16V 110 Dynamique 5dr

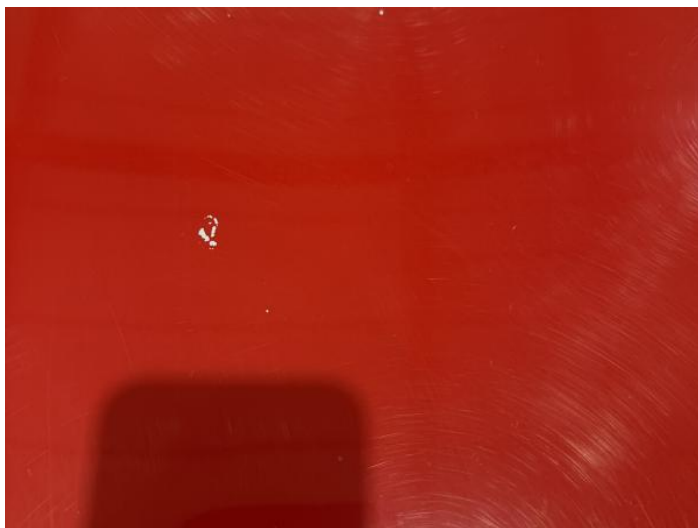
1: Bonnet
Chipped
Multiple Chips

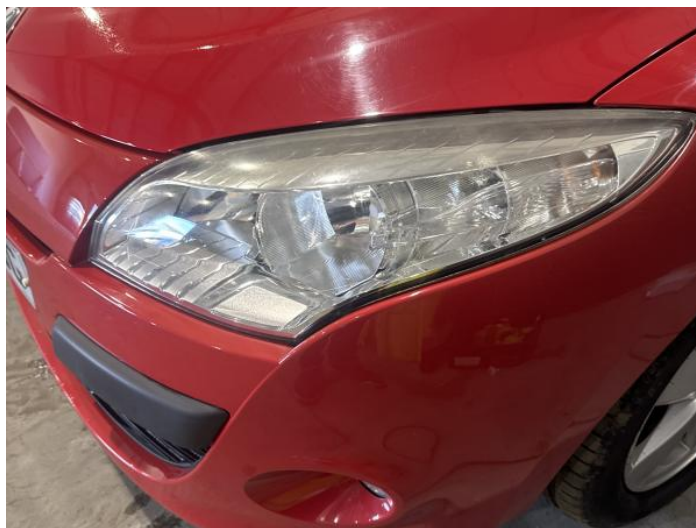
2: Bumper Front
Poor Previous Repair
Poor Colour

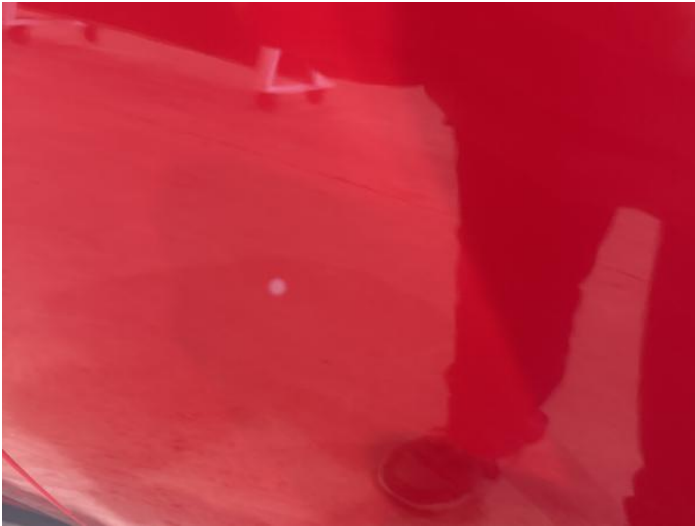
3: Wing osf
Chipped
1 To 5

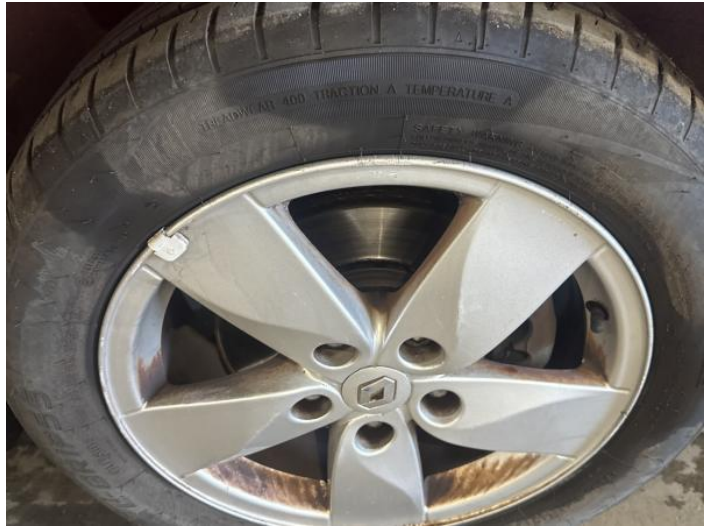
4: Wheel osf
Scratched
Over 50mm

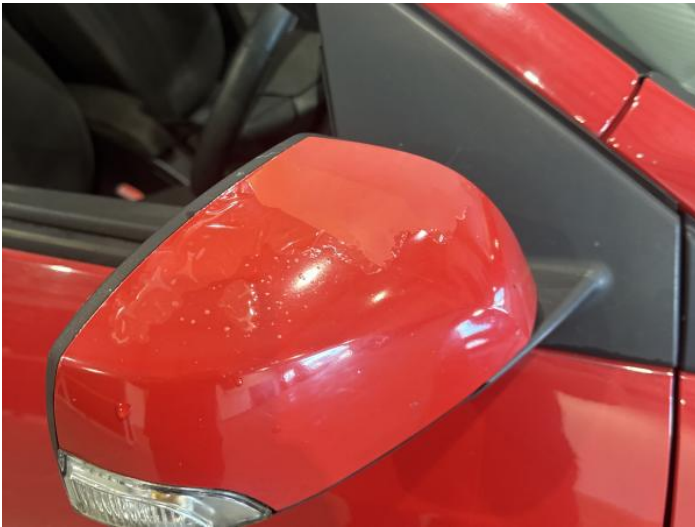
5: Door Mirror Assy osf
Scratched (Painted)
Over 25mm Thru Paint

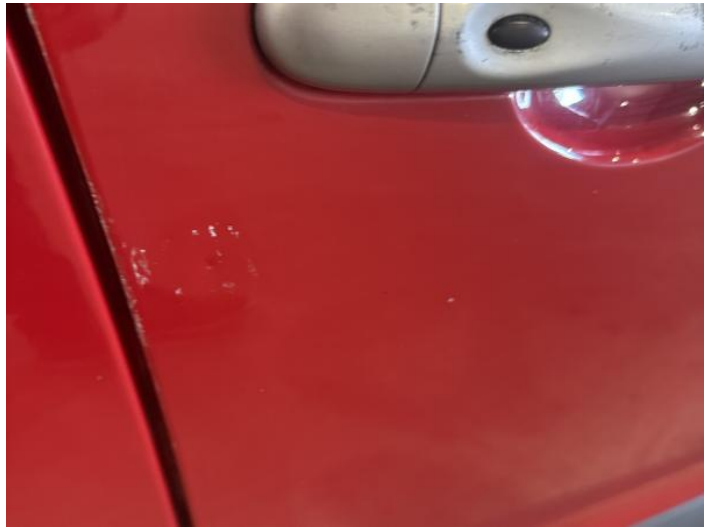
6: Door osf
Chipped
Multiple Chips

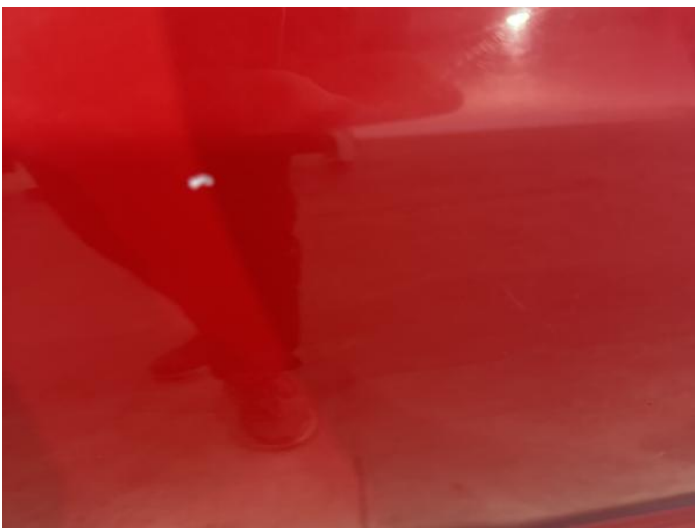
7: Door osr
Chipped
Multiple Chips

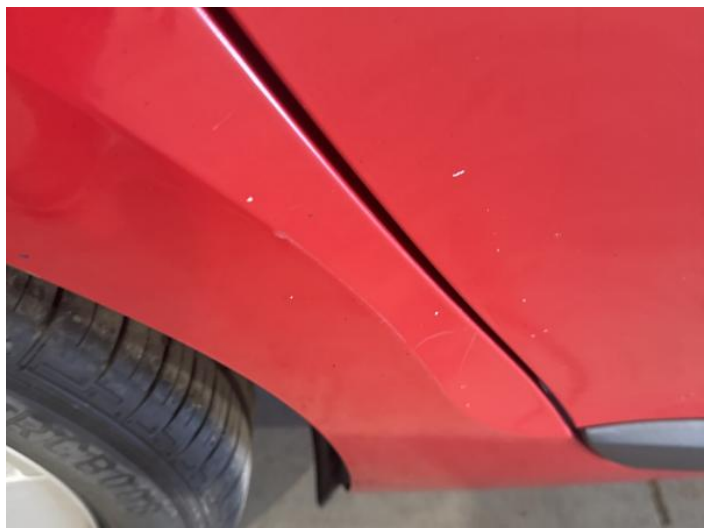
8: Qtr Panel osr
Chipped
1 To 5

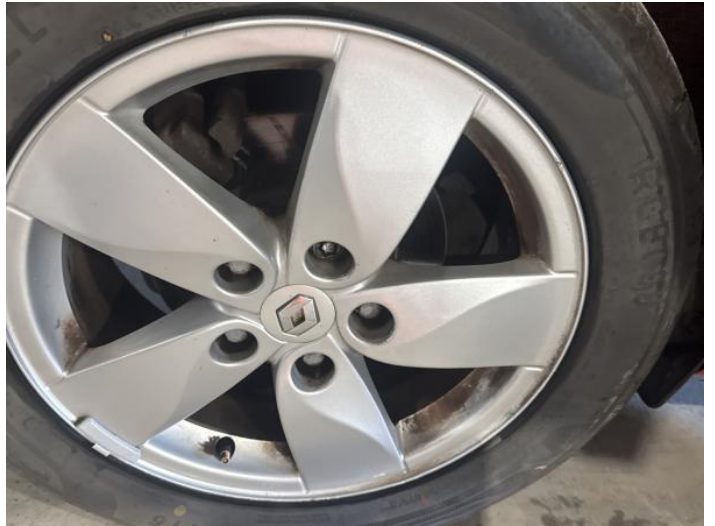
10: Wheel osr
Scratched
Over 50mm

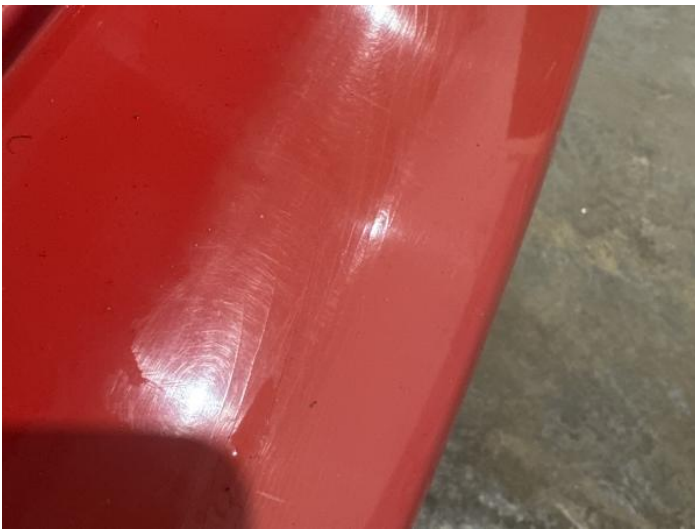
11: Bumper Rear
Poor Previous Repair
Rippled UpTo 30%

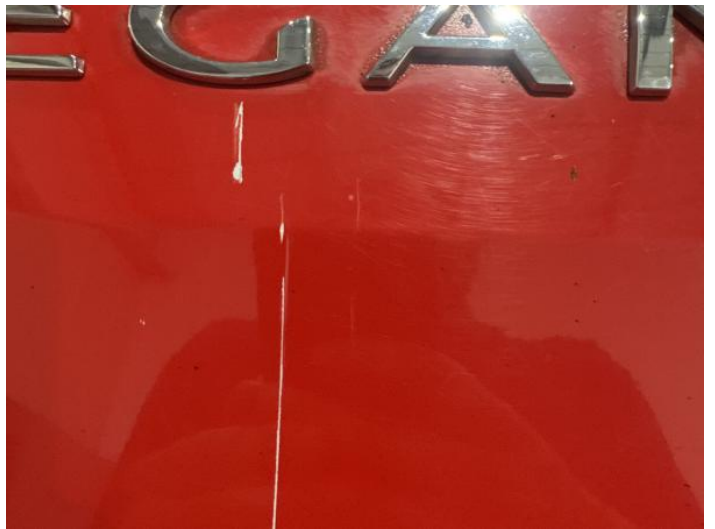
12: Boot Lid
Scratched
Over 25mm Thru Paint

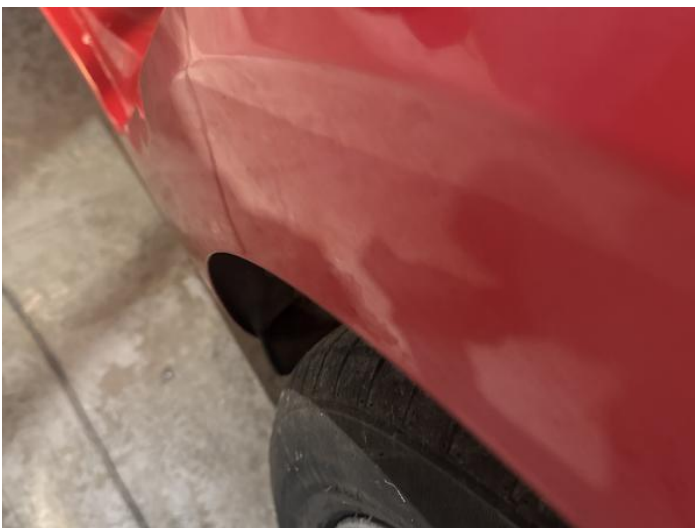
13: Qtr Panel nsr
Dented
Over 2 UpTo 10mm

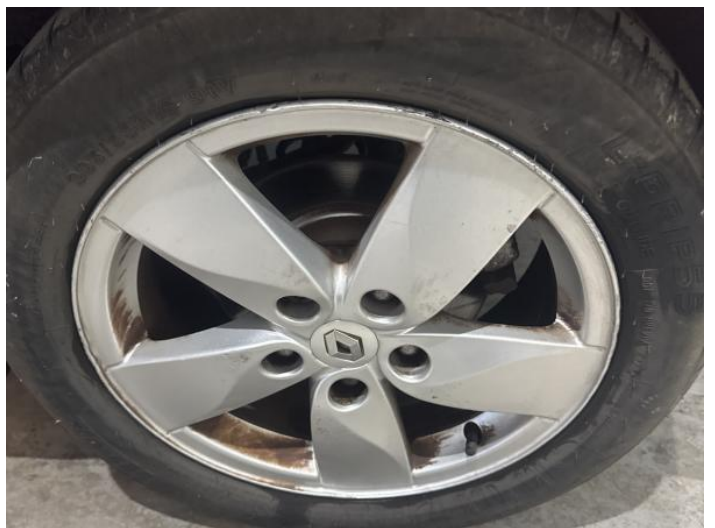
14: Wheel nsr
Scratched
Over 50mm

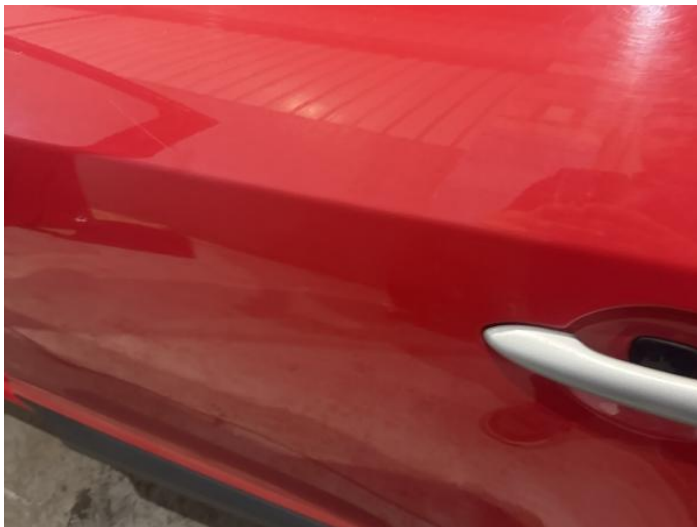
15: Door nsr
Scratched
Over 25mm Not Thru Paint

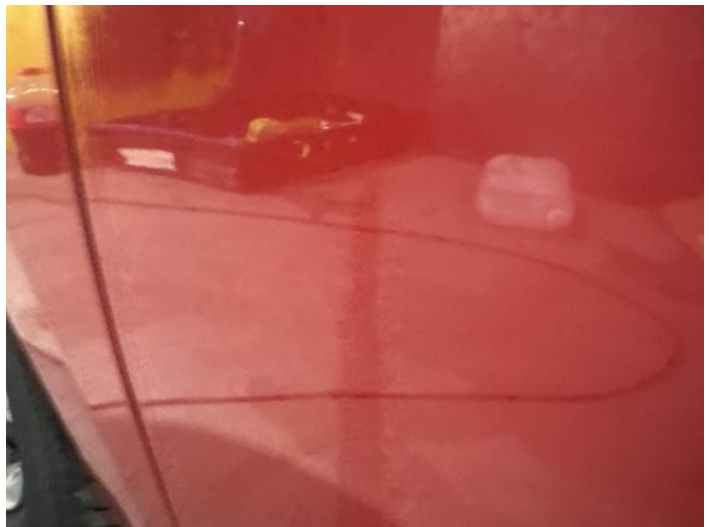
16: Door nsr
Scratched
Over 25mm Not Thru Paint

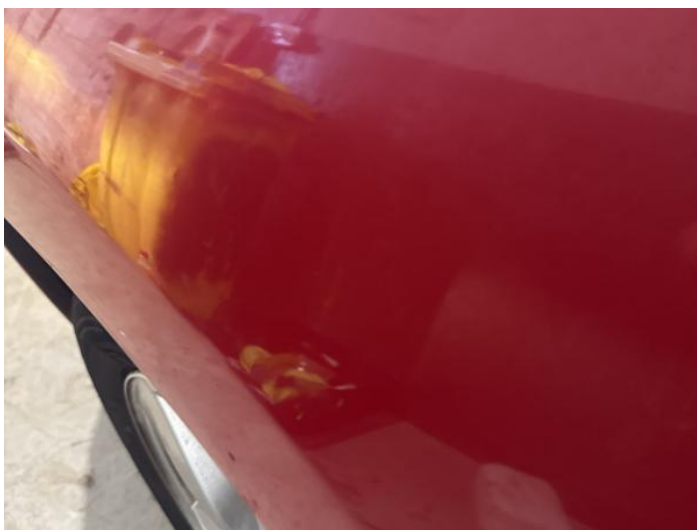
17: Wing nsf
Poor Previous Repair
Poor Paint

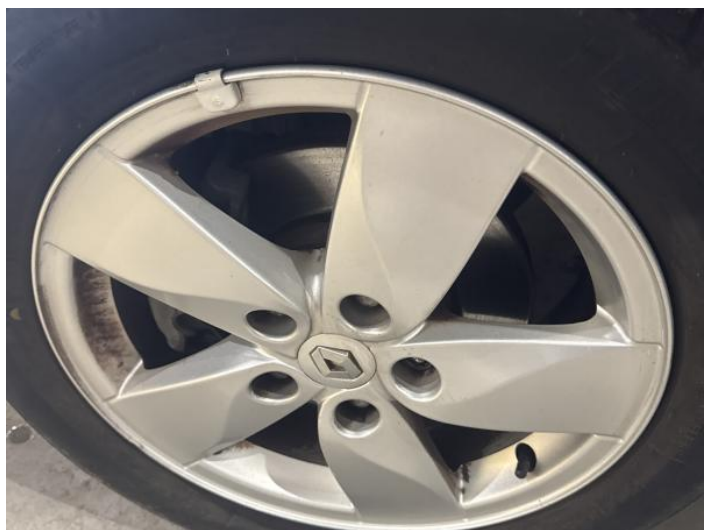
18: Wheel nsf
Scratched
Over 50mm
