# VEHICLE INSPECTION REPORT

**GY17AMO**

## Kia Sportage 1.7 CRDi ISG 3 5dr DCT Auto [Panoramic Roof]

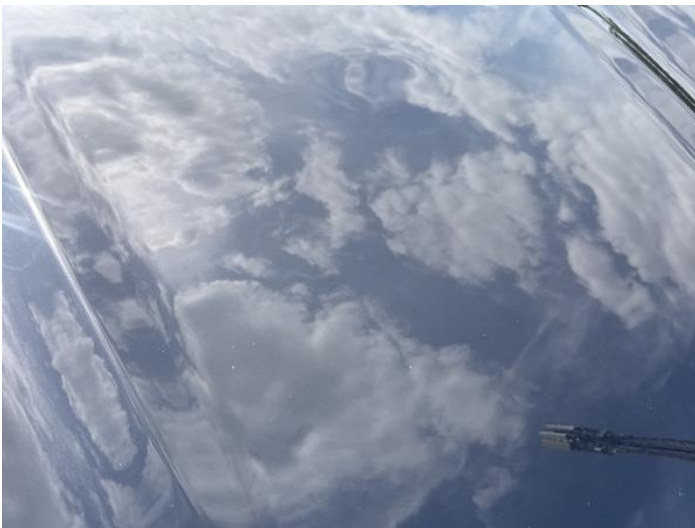
1: Bonnet  
Chipped  
Multiple Chips

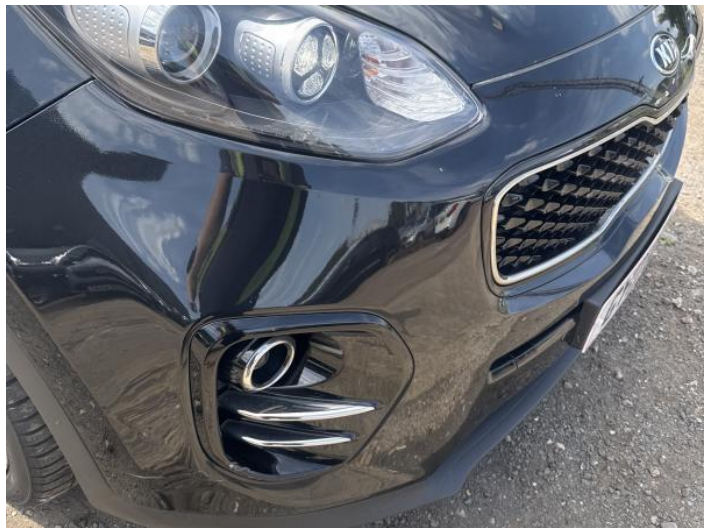
2: Bumper Front  
Poor Previous Repair  
Poor Paint

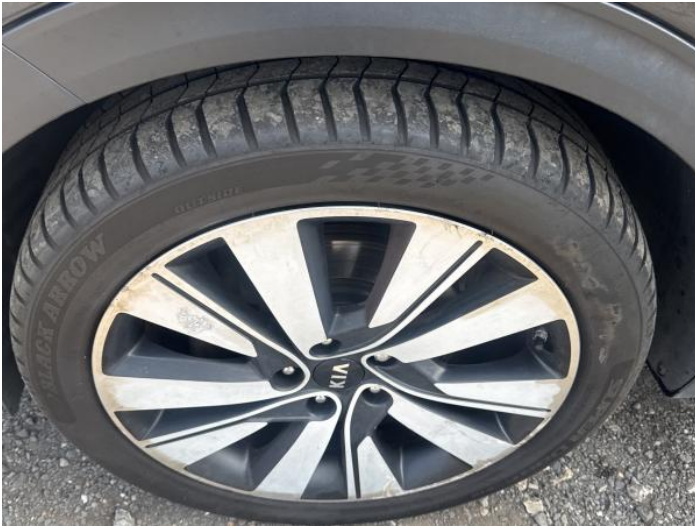
3: Wheel nsf  
Scratched  
Over 50mm

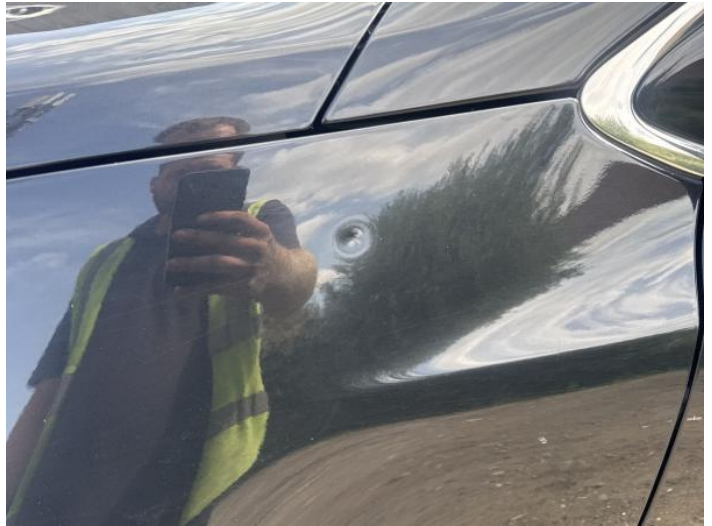
4: Wing nsf  
Dented  
Over 2 UpTo 10mm

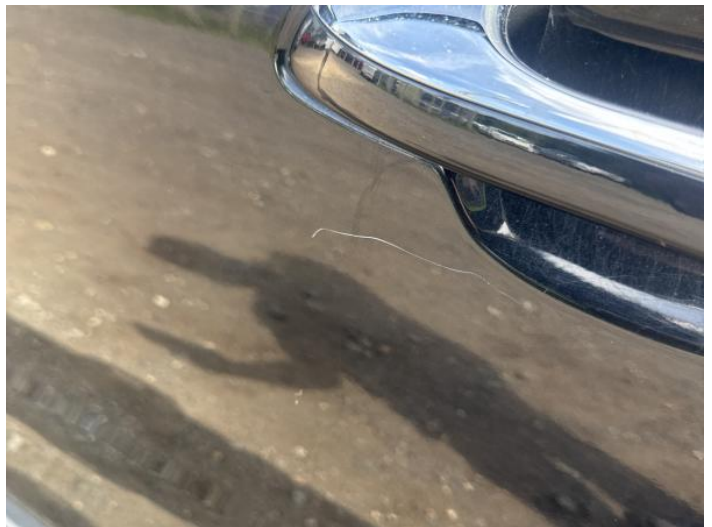
6: Door nsf  
Scratched  
Over 25mm Thru Paint

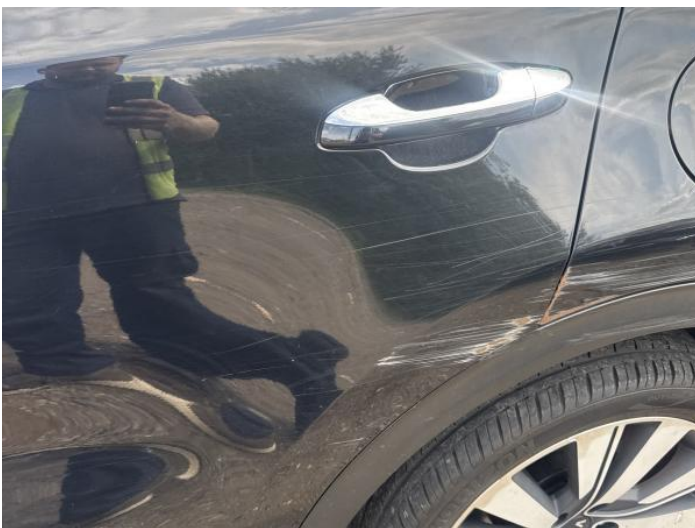
7: Door nsr  
Dented  
With Paint Damage

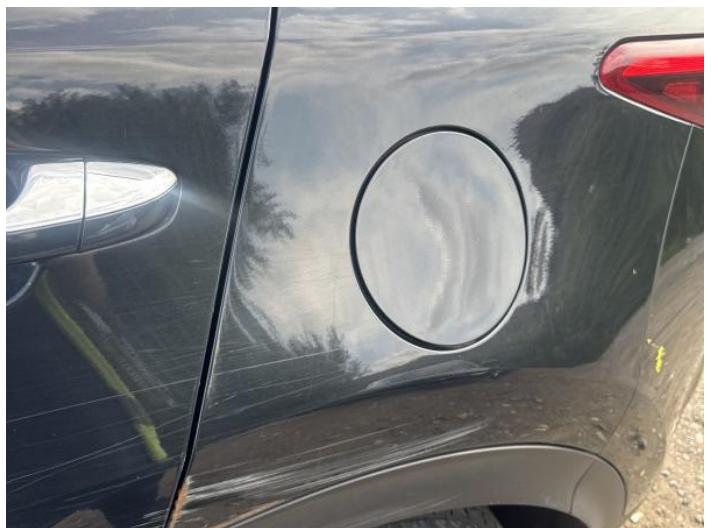
8: Qtr Panel nsr  
Dented  
With Paint Damage

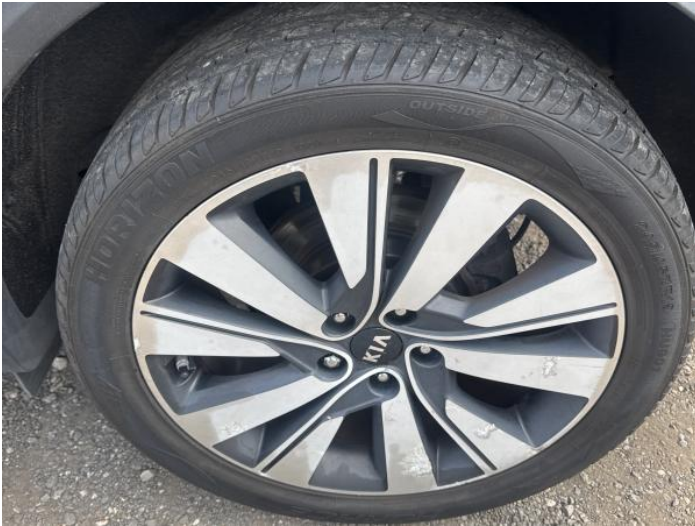
9: Wheel nsr  
Scratched  
Over 50mm

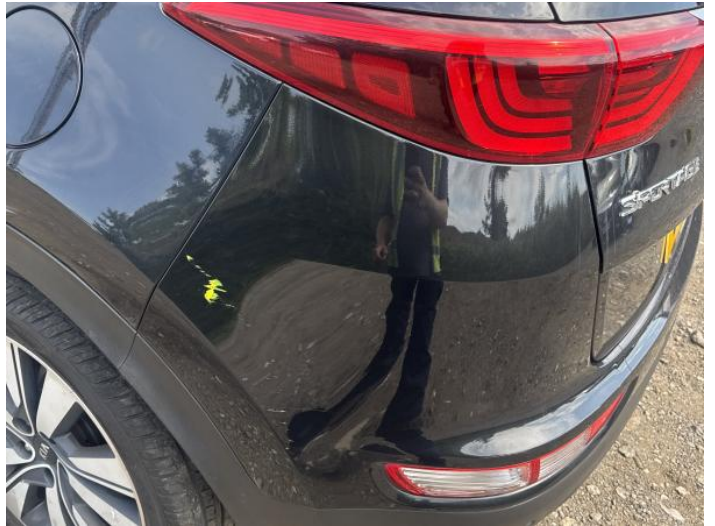
10: Bumper Rear  
Scratched  
Over 100mm Thru Paint

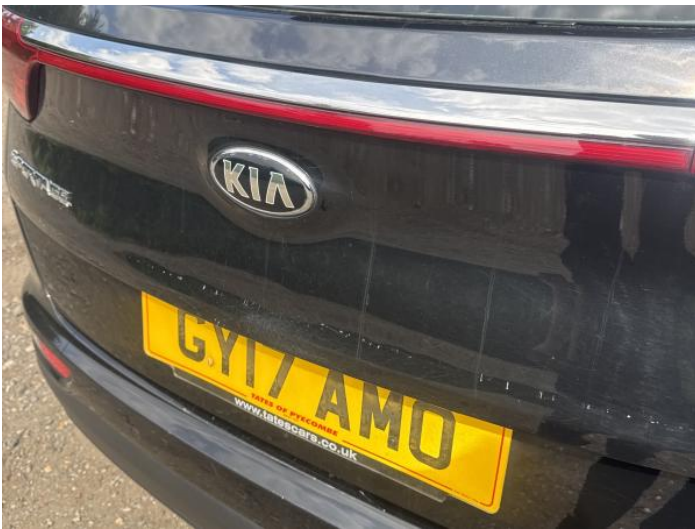
11: Boot Lid  
Scratched  
Over 25mm Thru Paint

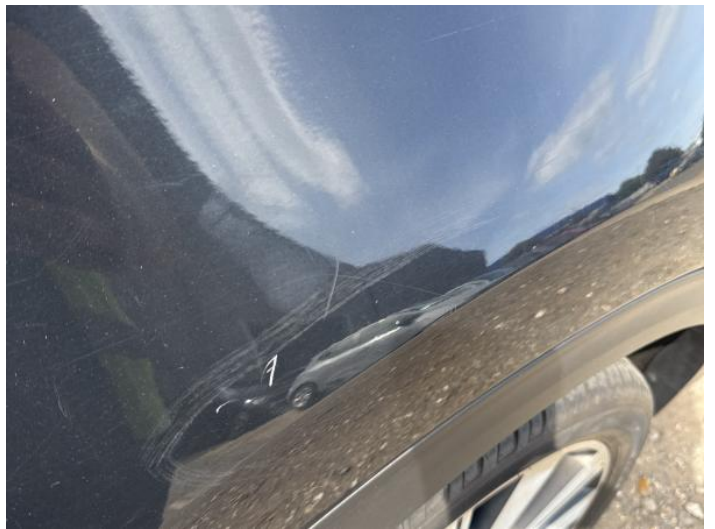
12: Qtr Panel osr  
Chipped  
1 To 5

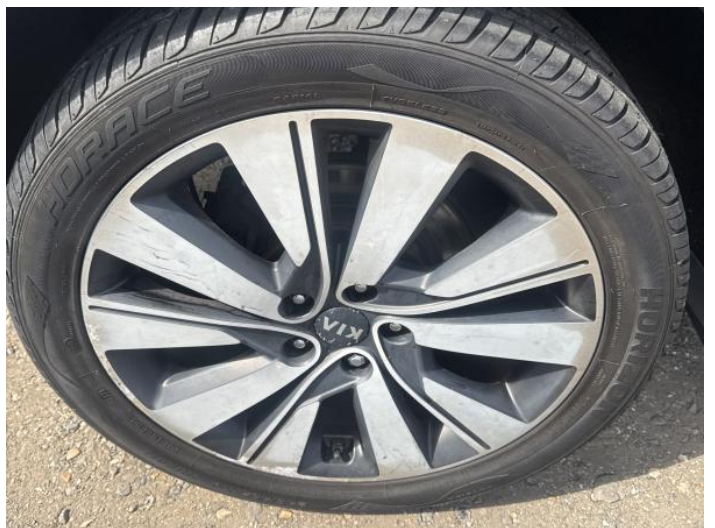
14: Wheel osr  
Scratched  
Over 50mm

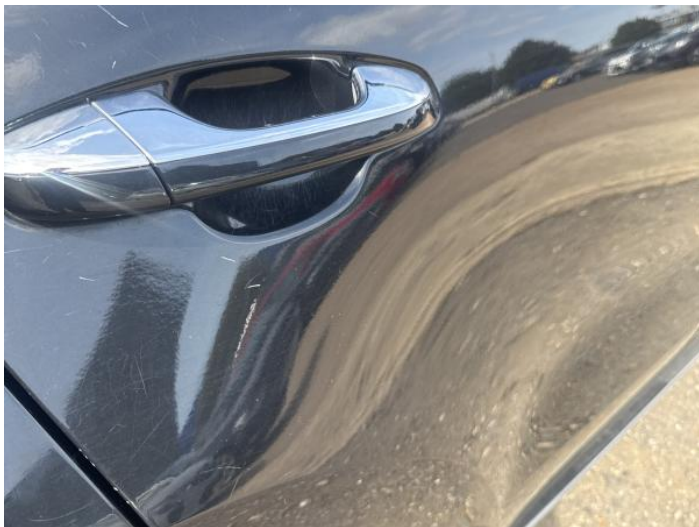
15: Door osr  
Dented  
With Paint Damage

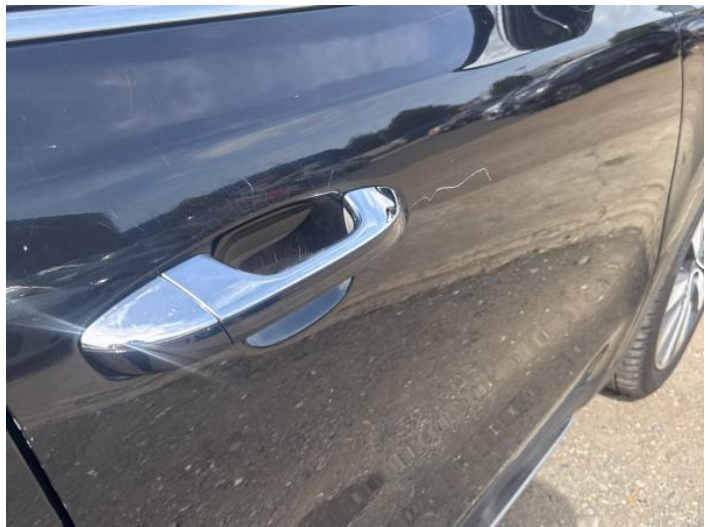
16: Door osf  
Scratched  
Over 25mm Thru Paint

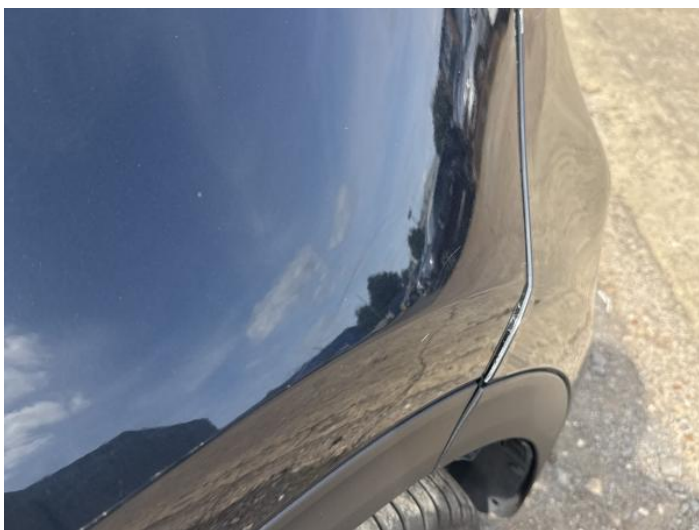
17: Wing osf  
Dented  
Over 2 UpTo 10mm

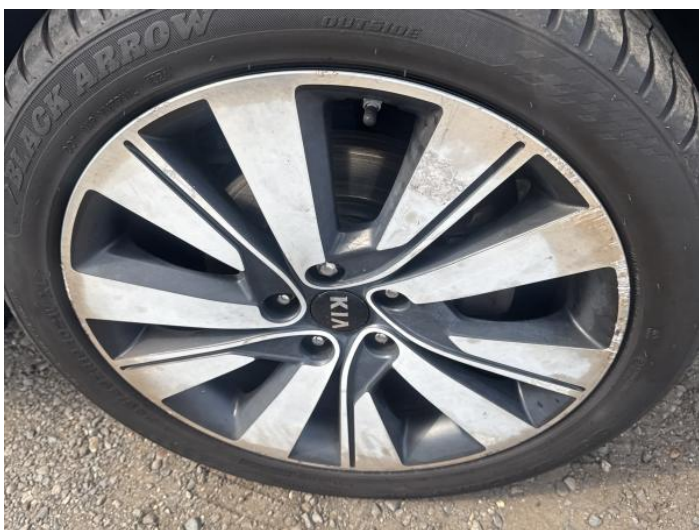
19: Wheel osf  
Scratched  
Over 50mm

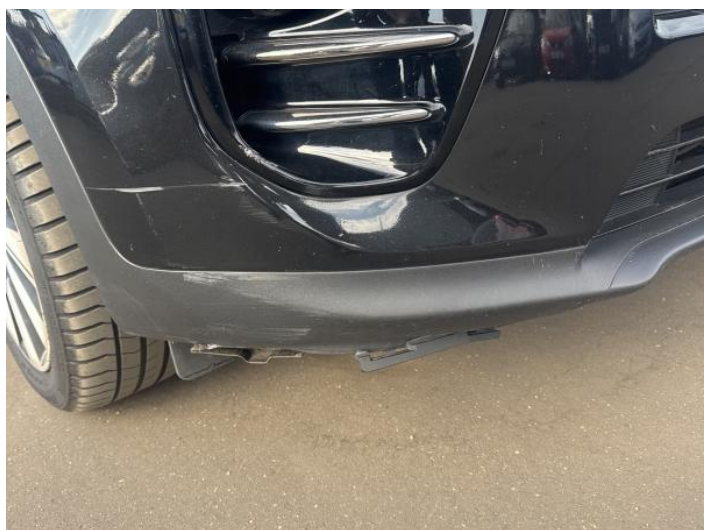
20: Bumper Front Moulding  
Broken  
Replace
