VEHICLE INSPECTION REPORT

PX12ZWN

Mini Hatchback 1.6 Cooper 3dr

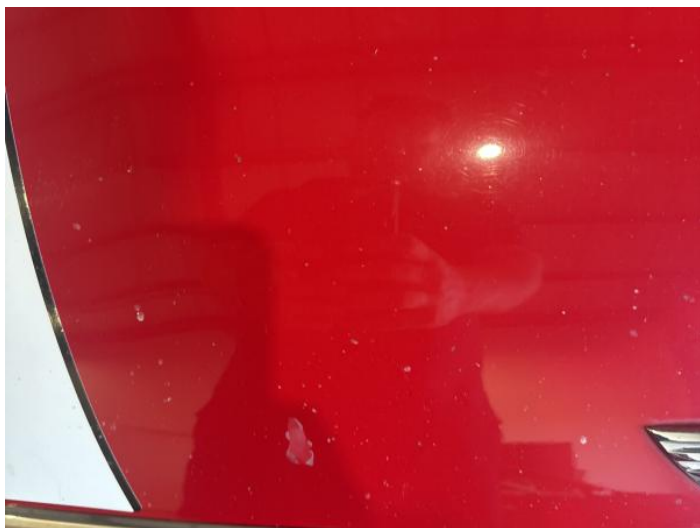
1: Bonnet
Poor Previous Repair
Paint Flake

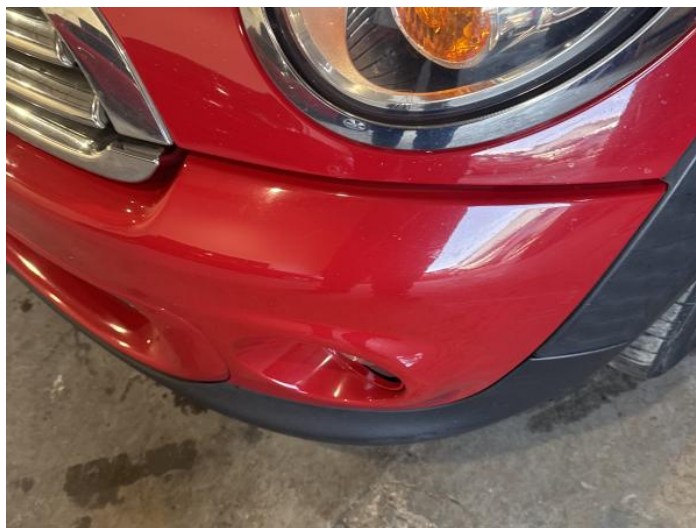
2: Bumper Front
Scratched
25 to 100mm Thru Paint

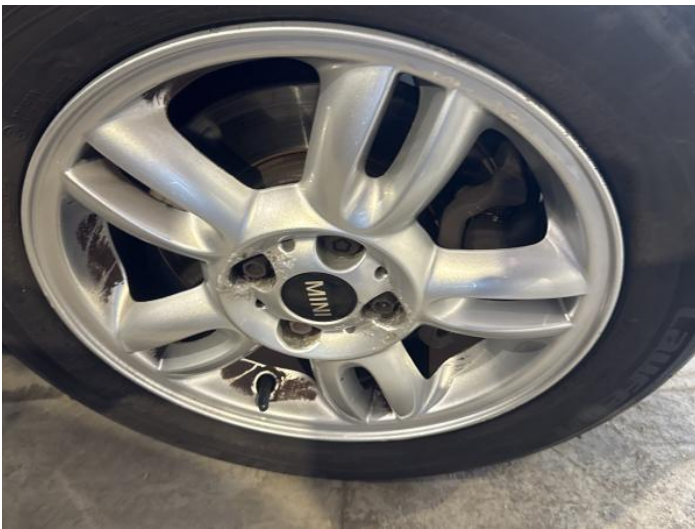
5: Wheel osf
Scratched
Over 50mm

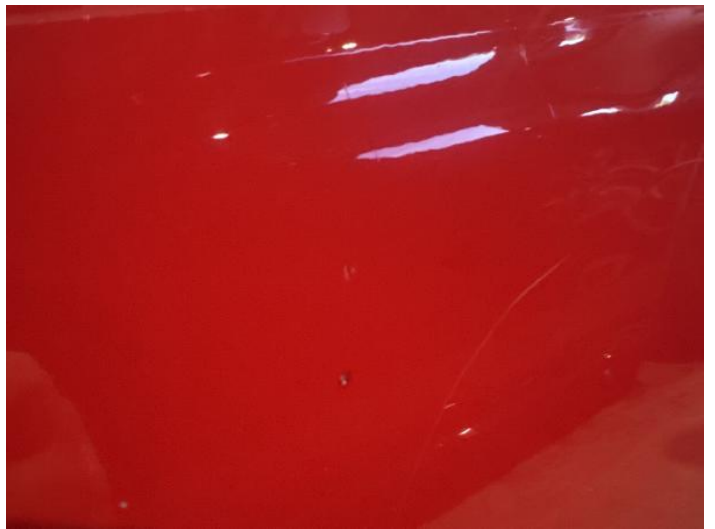
6: Door osf
Chipped
Multiple Chips

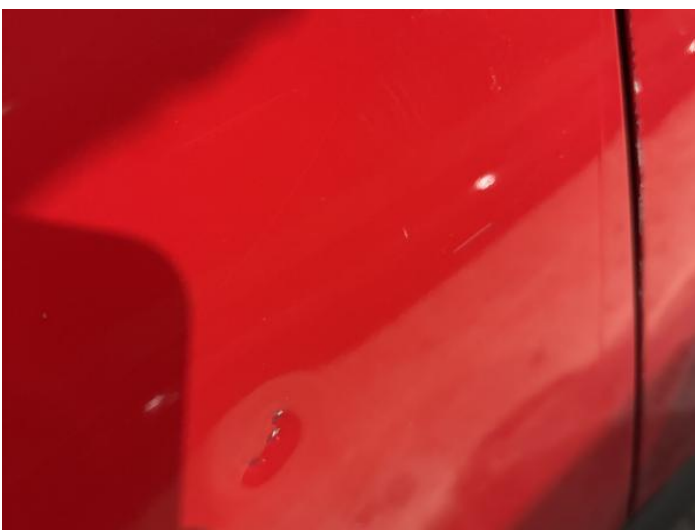
7: Qtr Panel osr
Dented
With Paint Damage

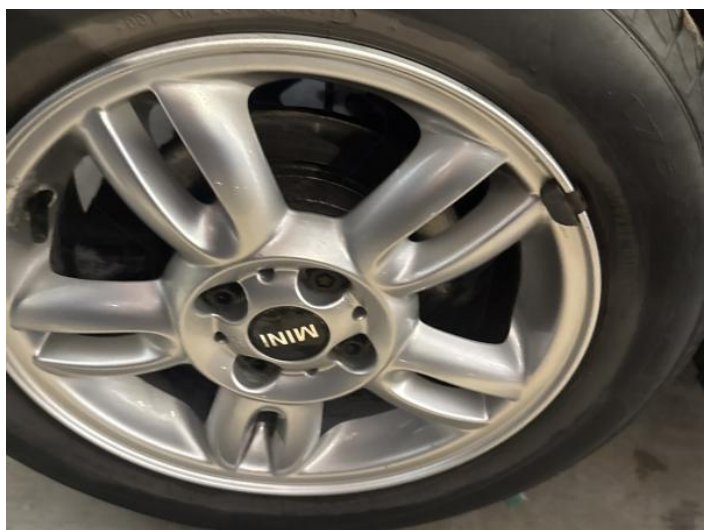
8: Wheel osr
Scratched
Over 50mm

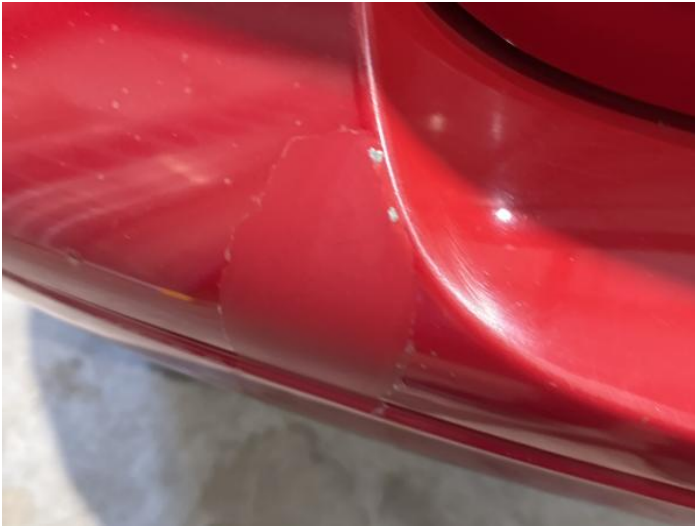
9: Bumper Rear
Poor Previous Repair
Paint Flake

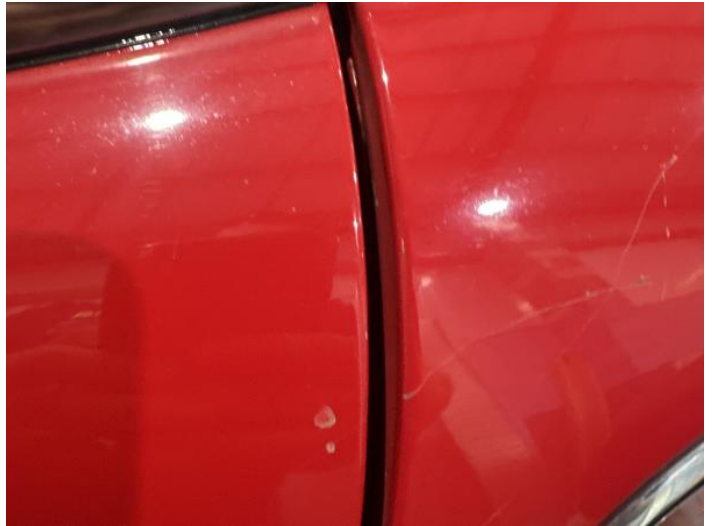
10: Boot Lid
Chipped
1 To 5

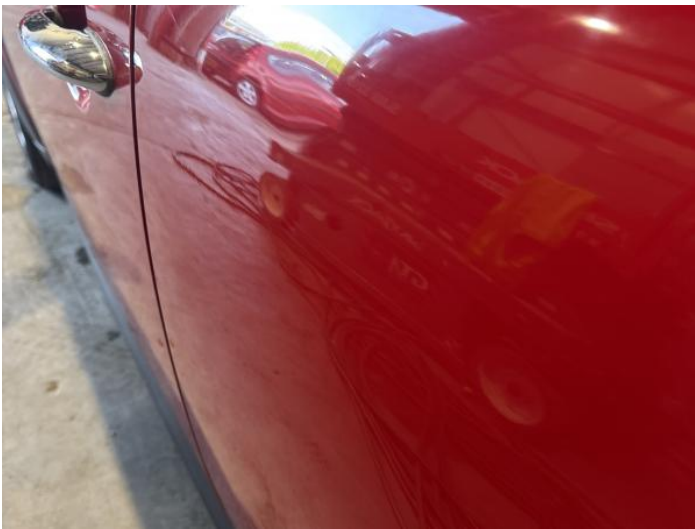
11: Qtr Panel nsr
Dented
Over 30mm

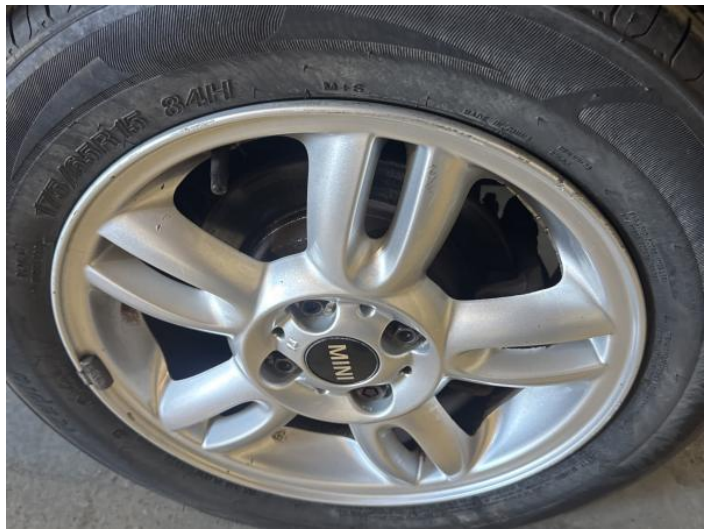
12: Wheel nsr
Scratched
Over 50mm

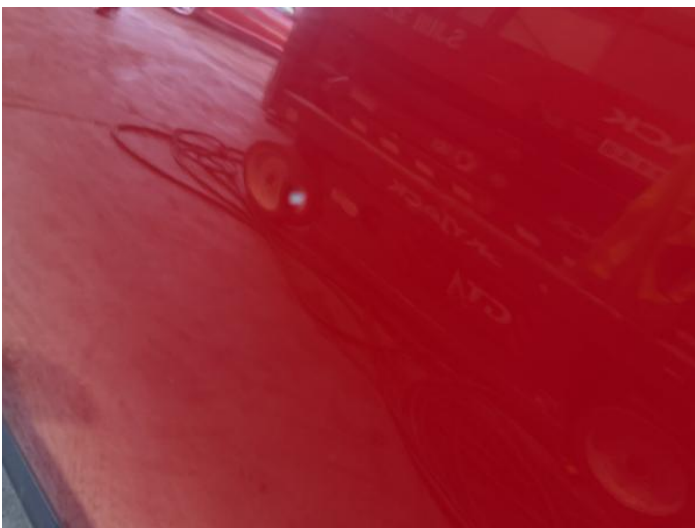
13: Door nsf
Dented
Over 2 UpTo 10mm

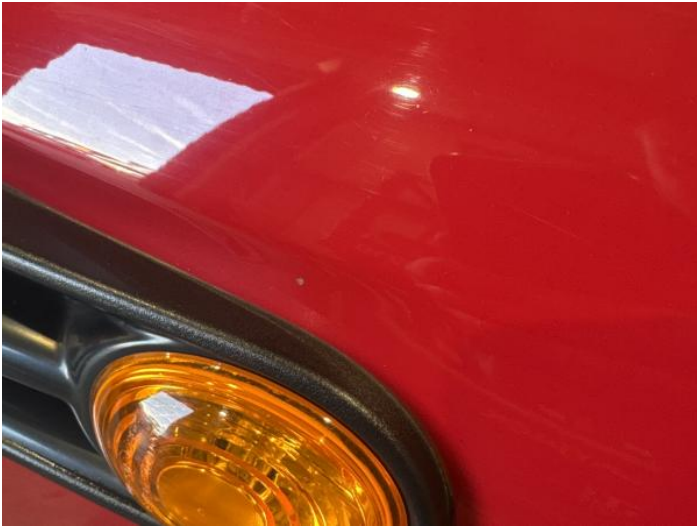
15: Wing nsf
Chipped
1 To 5

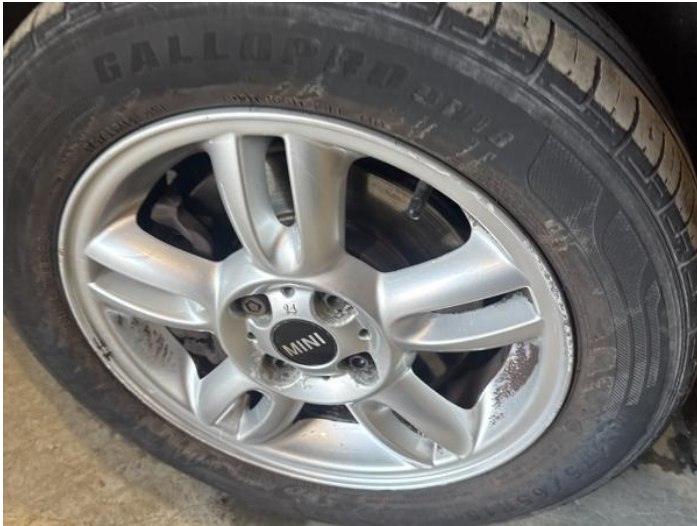
16: Wheel nsf
Scratched
Over 50mm
