## VEHICLE INSPECTION REPORT

**PY10FDZ**

### BMW X1 xDrive 20d SE 5dr

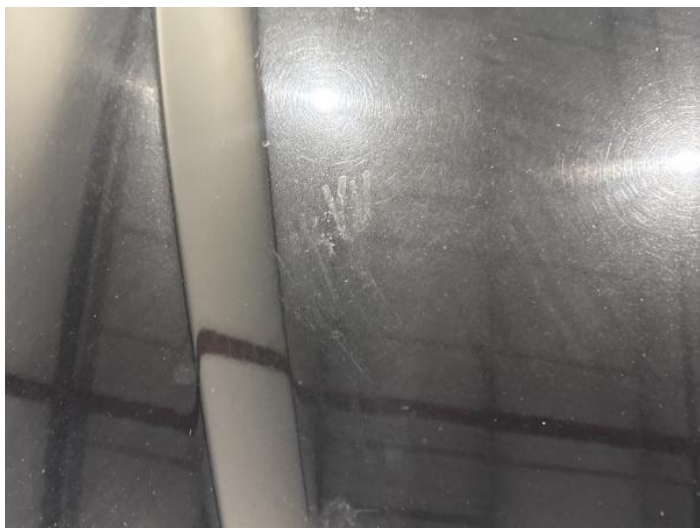
1: Bonnet  
Poor Previous Repair  
Poor Paint

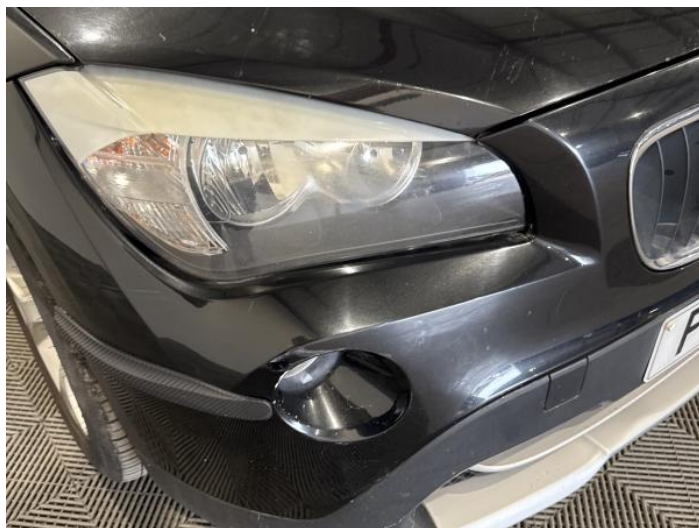
2: Bumper Front  
Scratched  
Over 100mm Thru Paint

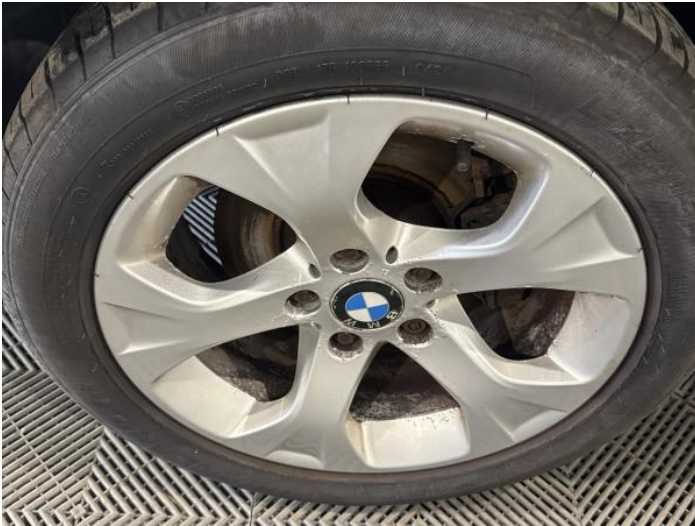
3: Wheel nsf  
Corroded  
Light

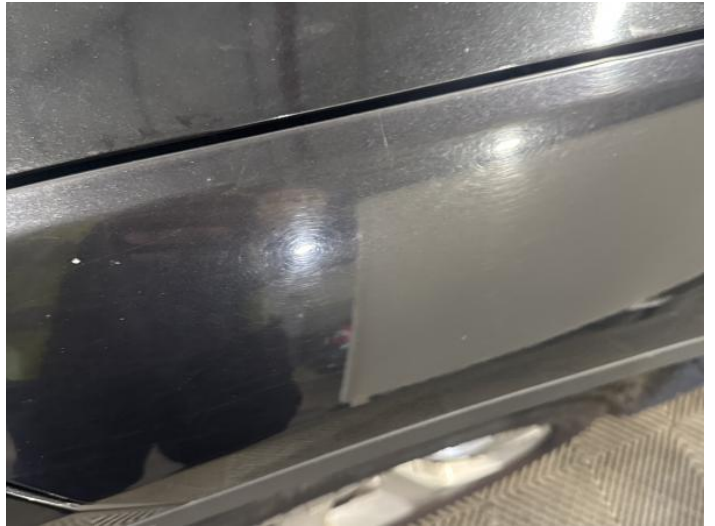
4: Wing nsf  
Chipped  
1 To 5

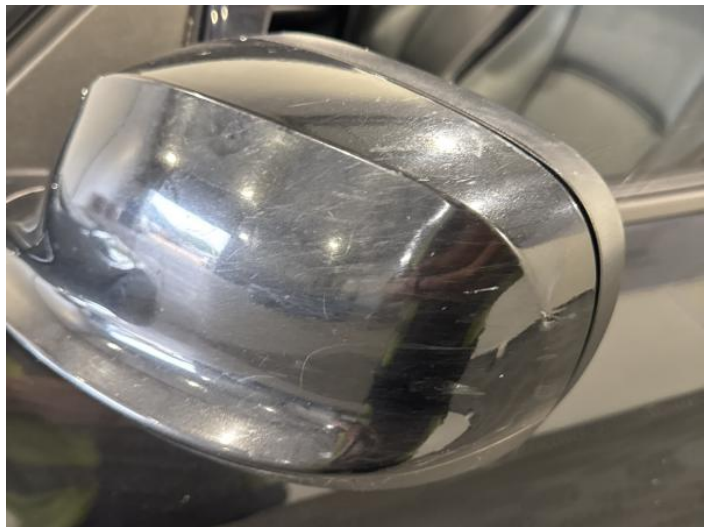
6: Door Mirror Assy nsf  
Scratched (Painted)  
Over 25mm Thru Paint

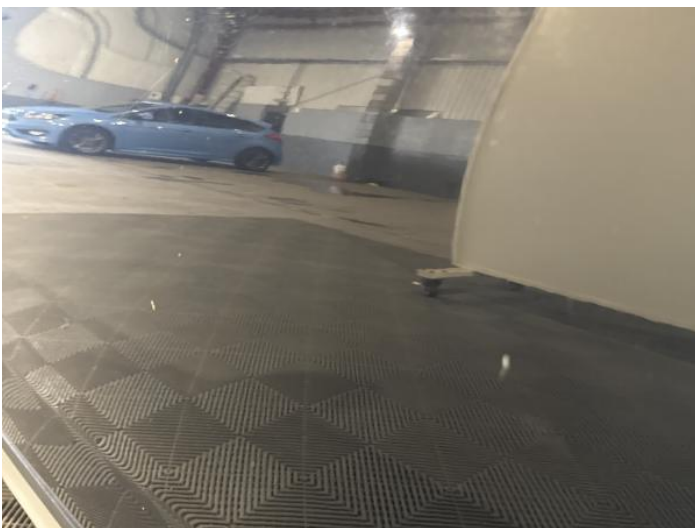
7: Door nsf  
Chipped  
Multiple Chips

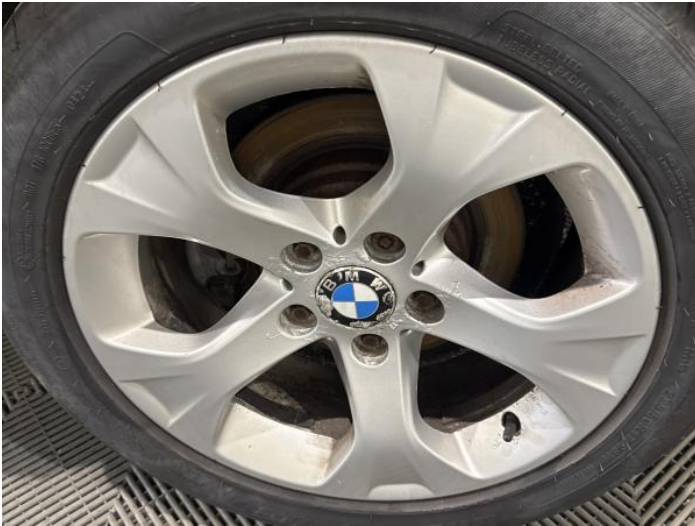
9: Wheel nsr  
Scratched  
Over 50mm

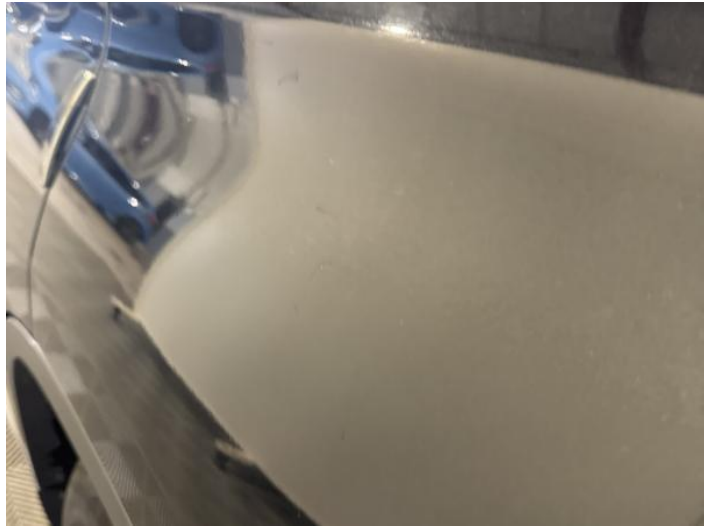
10: Qtr Panel nsr  
Dented  
Over 2 UpTo 10mm

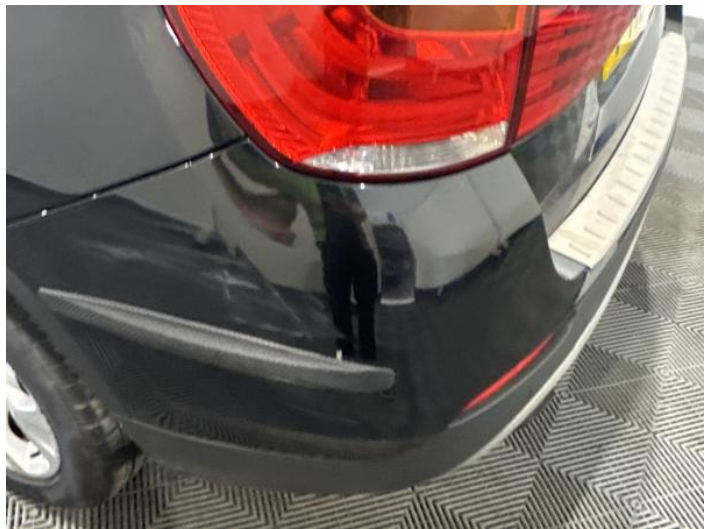
12: Bumper Rear  
Scratched  
Over 100mm Thru Paint

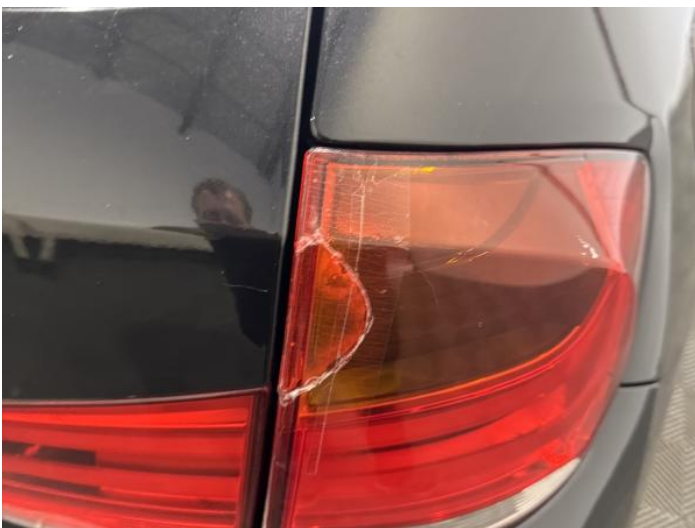
13: Lamp osr  
Broken  
Replace

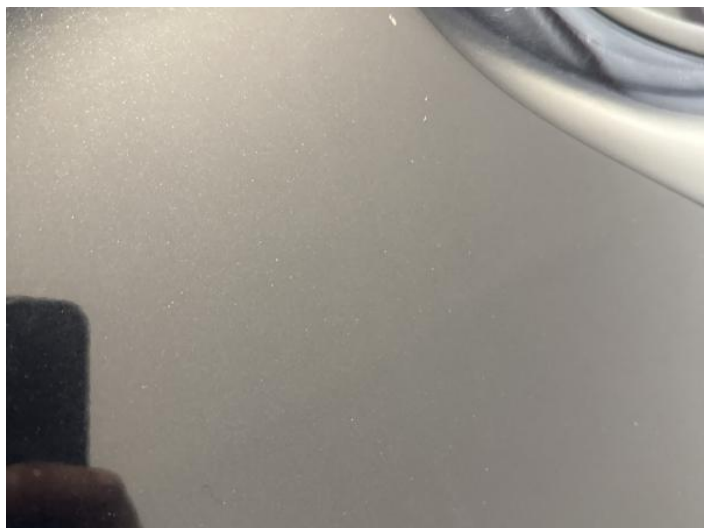
14: Qtr Panel osr  
Chipped  
1 To 5

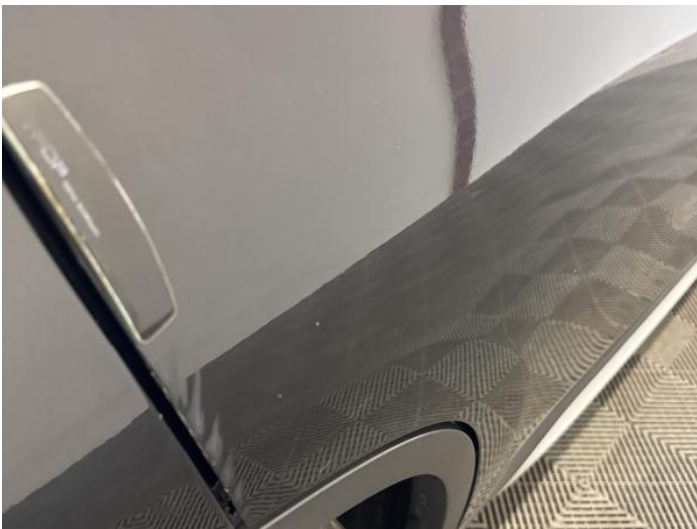
17: Door osr  
Poor Previous Repair  
Poor Paint

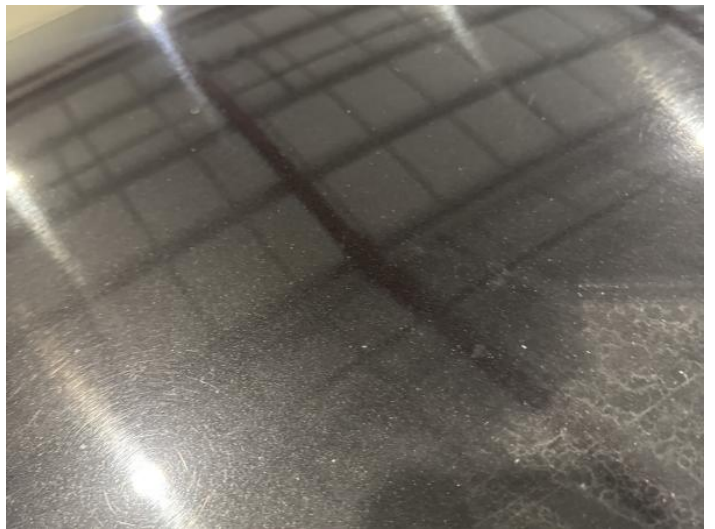
18: Roof  
Dented  
Between 10mm + 30mm

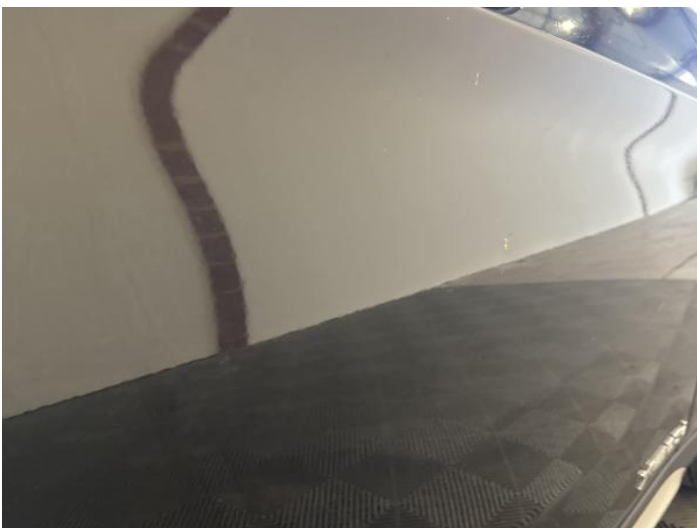
19: Door osf  
Chipped  
1 To 5

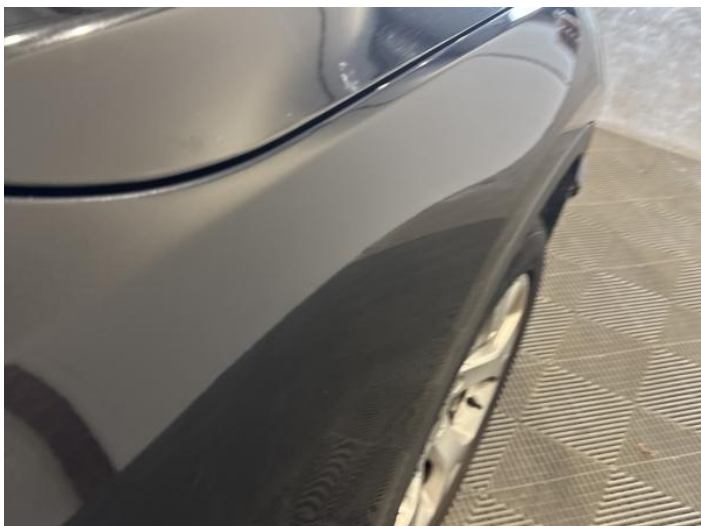
21: Wing osf  
Dented  
With Paint Damage

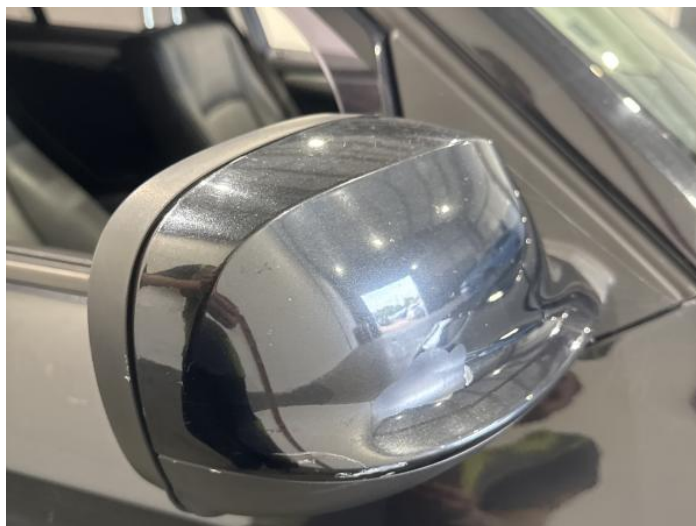
22: Door Mirror Assy osf  
Scratched (Painted)  
Over 25mm Thru Paint

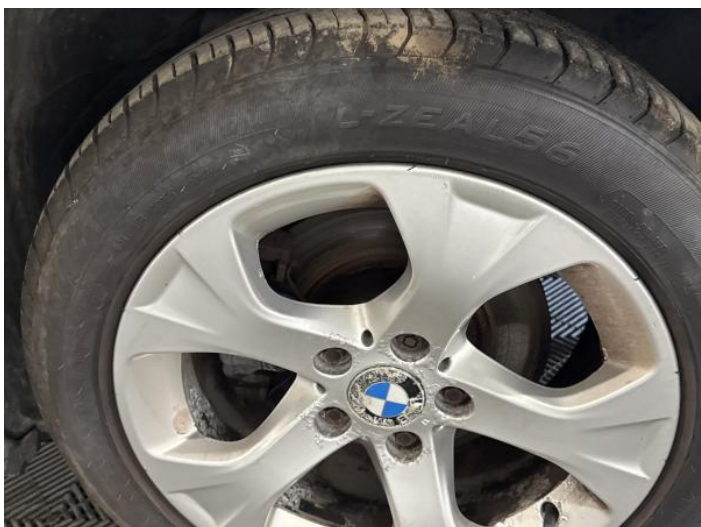
23: Wheel osf  
Scratched  
Up To 50mm

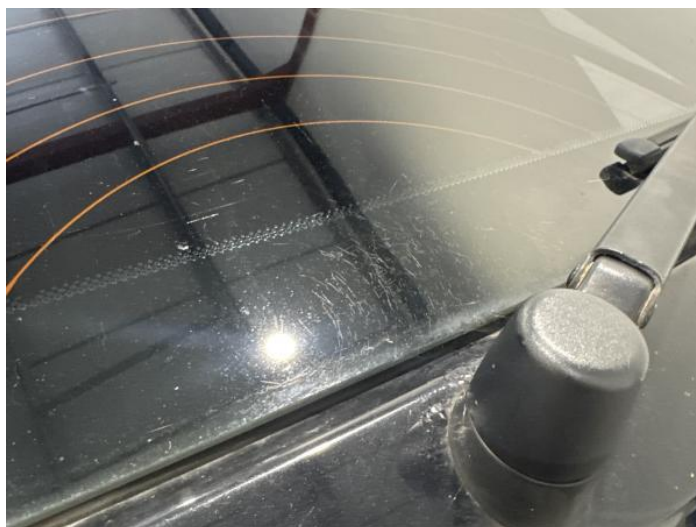
24: Boot Lid  
Rusted  
UpTo 5mm
