VEHICLE INSPECTION REPORT

HW71MUB

Land Rover Range Rover Velar 2.0 P400e S 5dr Auto

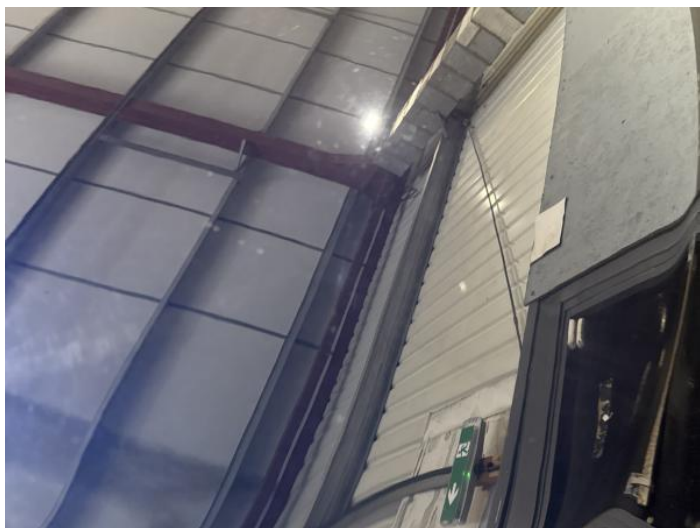
1: Bonnet
Chipped
1 To 5

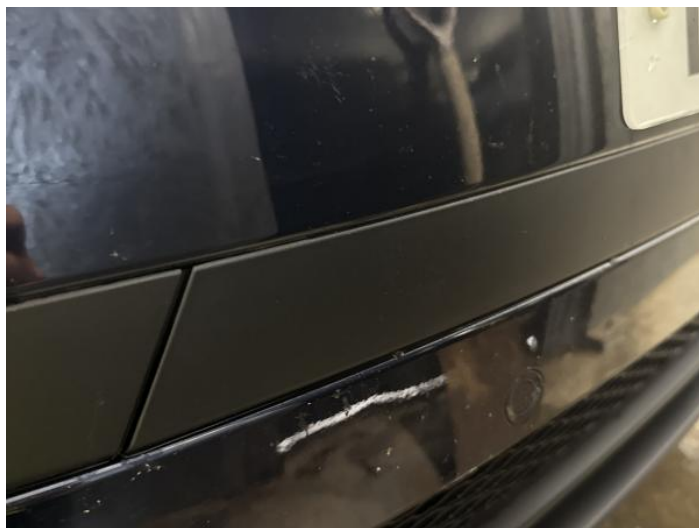
2: Bumper Front
Chipped
Multiple Chips

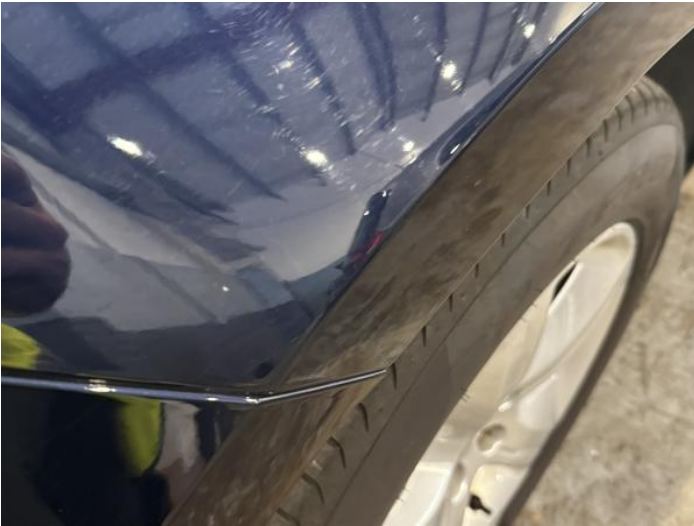
3: Wing nsf
Chipped
1 To 5

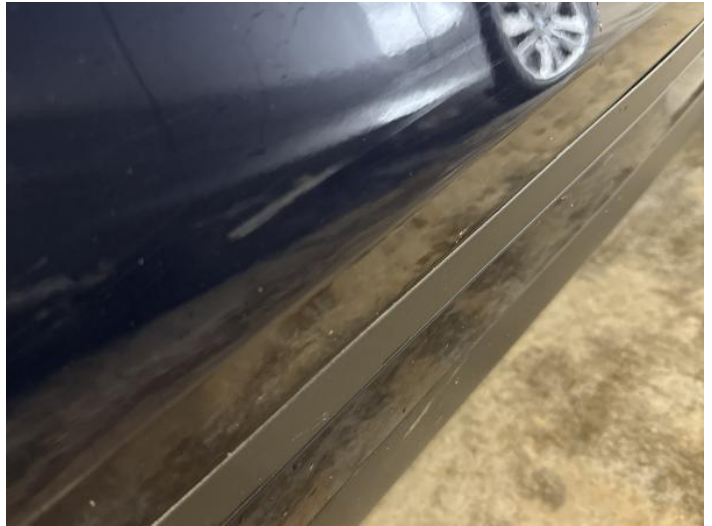
4: Door nsf
Scratched
Over 25mm Thru Paint

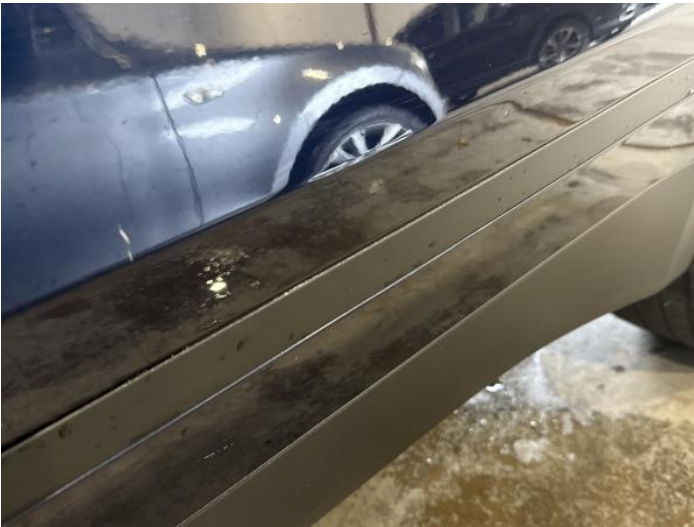
5: Door nsr
Dented
Between 10mm + 30mm

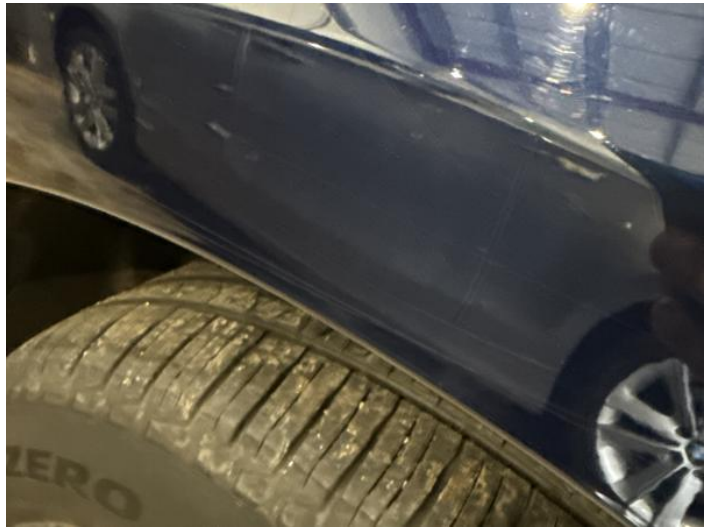
6: Qtr Panel nsr
Scratched
Over 25mm Thru Paint

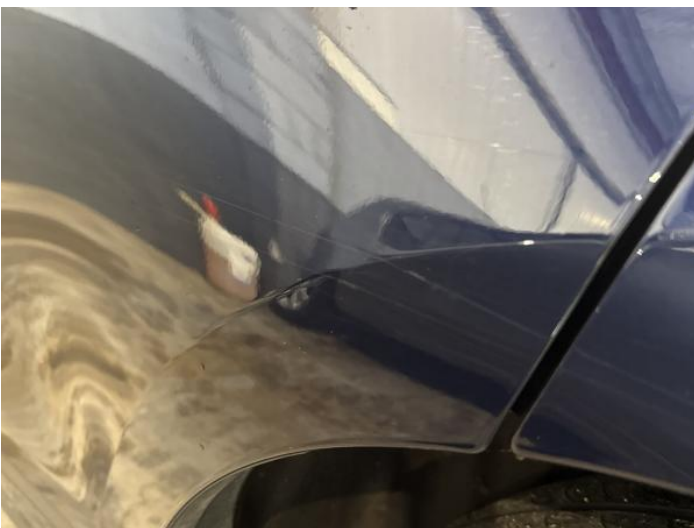
7: Door nsr
Scratched
Over 25mm Thru Paint

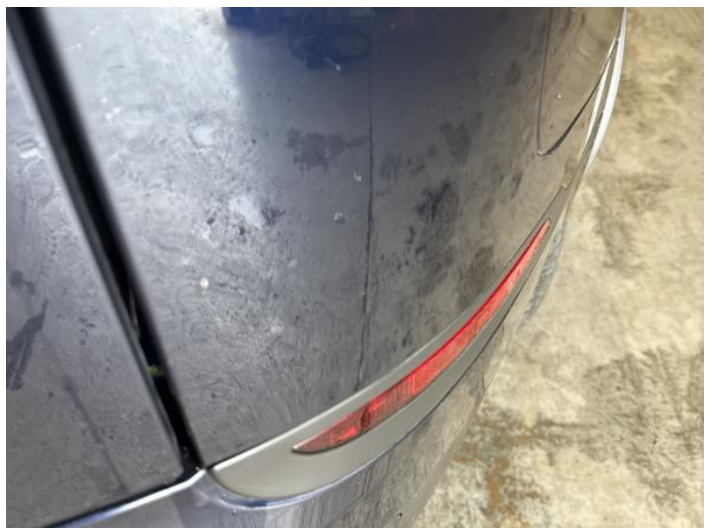
8: Bumper Rear
Scratched
Up To 25mm Thru Paint

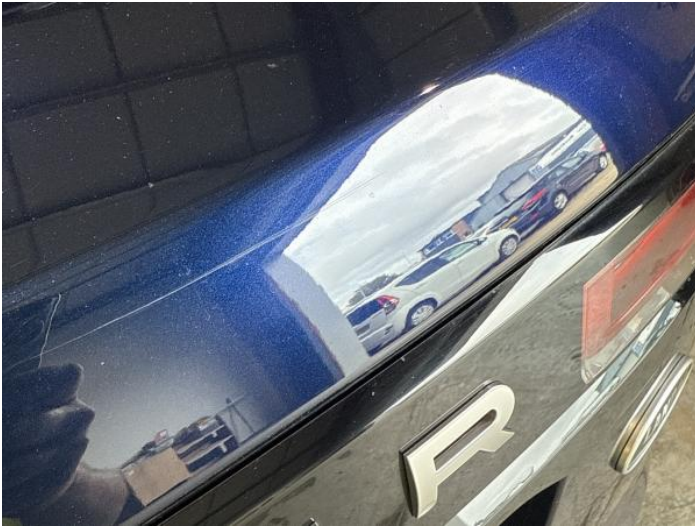
9: Tailgate
Scratched
Over 25mm Thru Paint

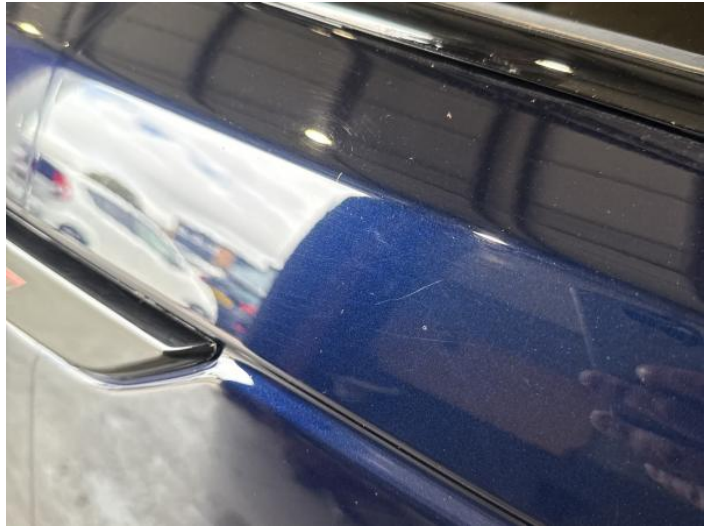
10: Qtr Panel osr
Scratched
UpTo 25mm Thru Paint

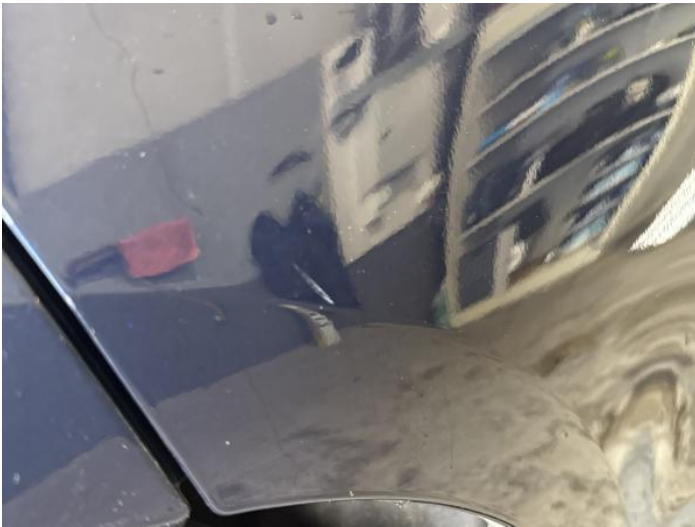
11: Door osr
Scratched
UpTo 25mm Thru Paint

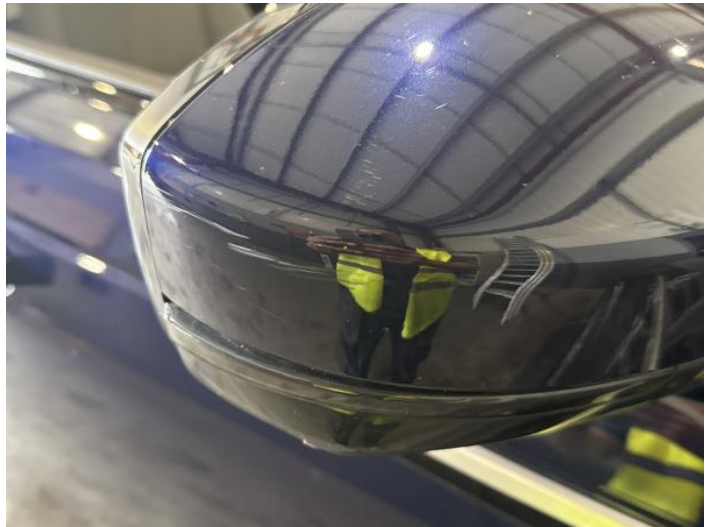
12: Door Mirror Assy osf
Scratched (Painted)
UpTo 25mm Thru Paint

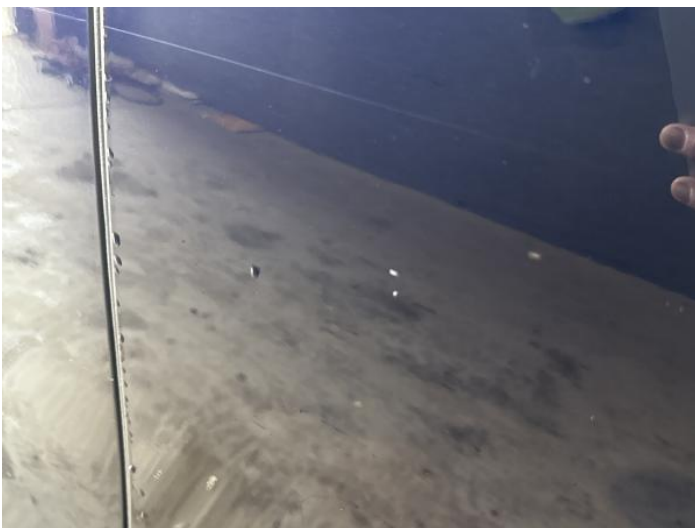
13: Door osf
Scratched
UpTo 25mm Thru Paint

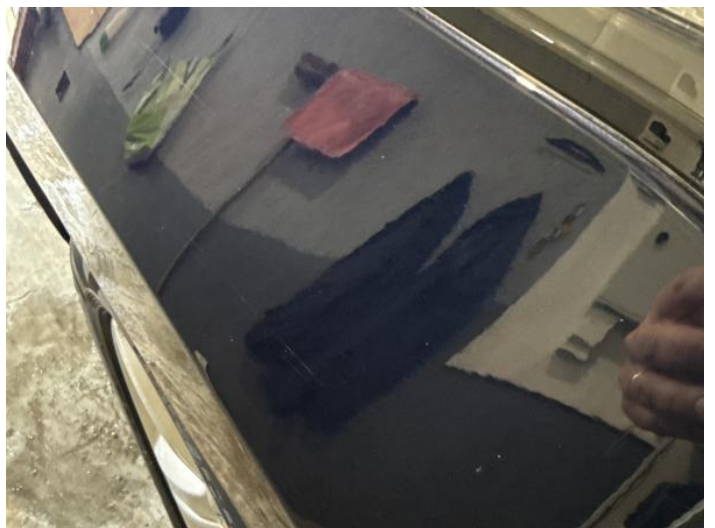
14: Wing osf
Scratched
Over 25mm Thru Paint
