### **VEHICLE INSPECTION REPORT**

**MJ67XLF**

### Vauxhall Astra 1.0T ecoTEC SRi 5dr

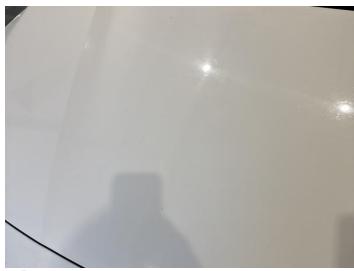
1: Bonnet Chipped 1 To 5

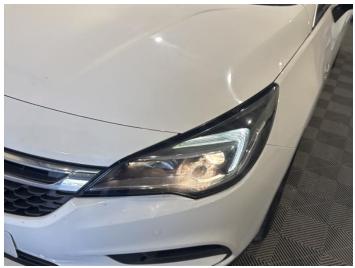
2: Bumper Front Chipped Multiple Chips

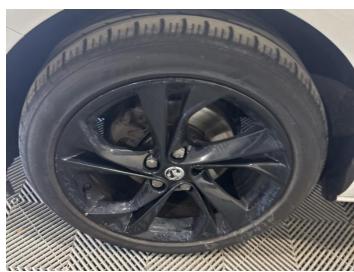
4: Wheel nsf Scratched Over 50mm

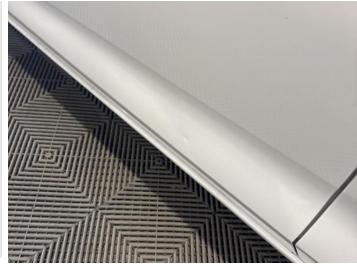
6: Door nsf Dented Over 2 UpTo 10mm

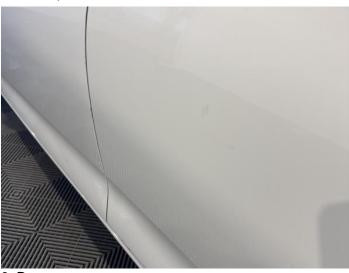
8: Door nsr Dented Between 10mm + 30mm

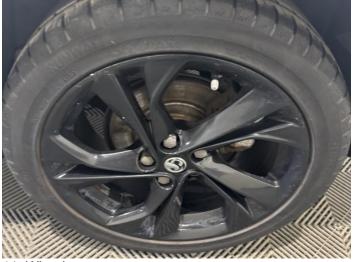
11: Wheel nsr Scratched Over 50mm

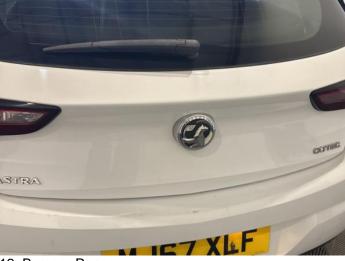
12: Bumper Rear Scratched 25 to 100mm Thru Paint

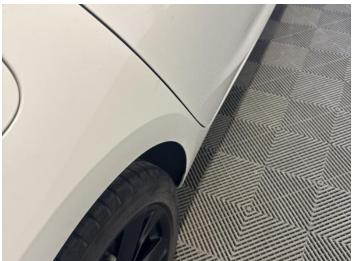
15: Qtr Panel osr Scratched Over 25mm Thru Paint

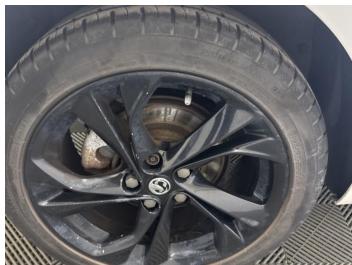
16: Wheel osr Scratched Over 50mm

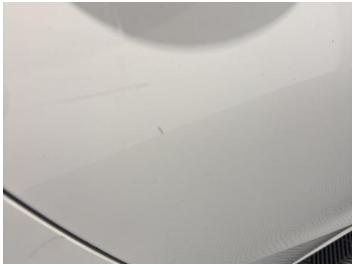
17: Door osr Scratched UpTo 25mm Thru Paint

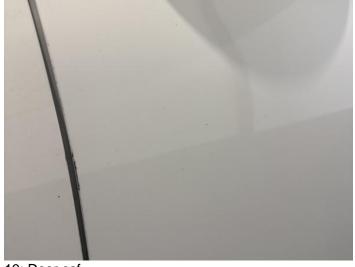
19: Door osf Chipped 1 To 5

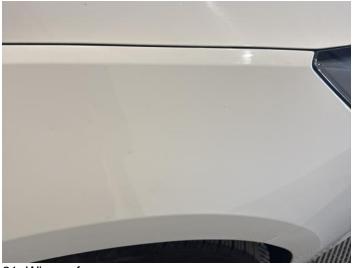
21: Wing osf Chipped 1 To 5

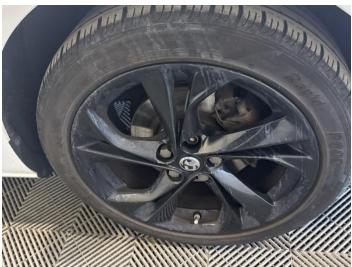
22: Wheel osf Scratched Over 50mm
