VEHICLE INSPECTION REPORT

GJ14YJP

Audi A3 1.4 TFSI S Line 5dr

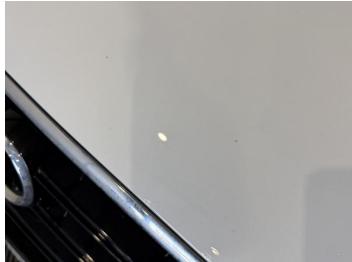
1: Bonnet Chipped 1 To 5

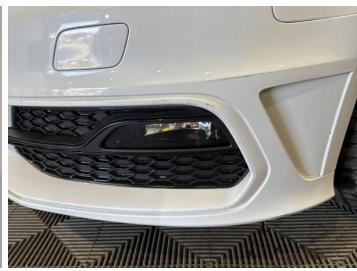
2: Bumper Front Scratched Over 100mm Thru Paint

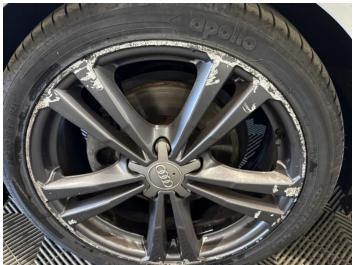
3: Wheel nsf Scratched Over 50mm

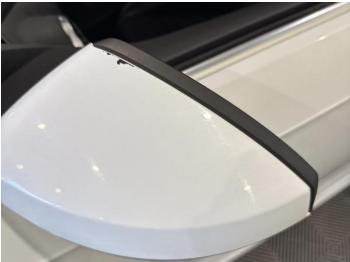
4: Door Mirror Assy nsf Scratched (Painted) UpTo 25mm Thru Paint

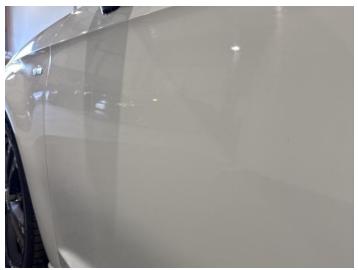
5: Door nsf Dented Over 30mm

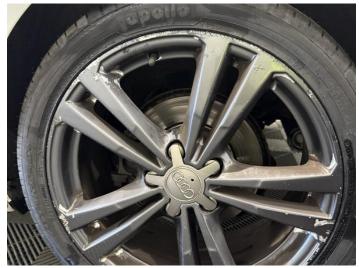
7: Wheel nsr Scratched Over 50mm

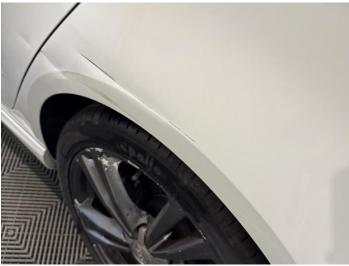
8: Qtr Panel nsr Dented With Paint Damage

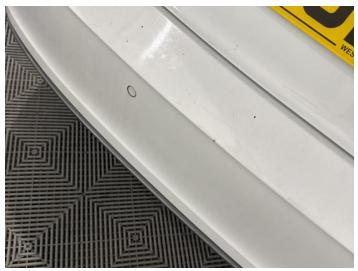
9: Bumper RearScratched25 to 100mm Thru Paint

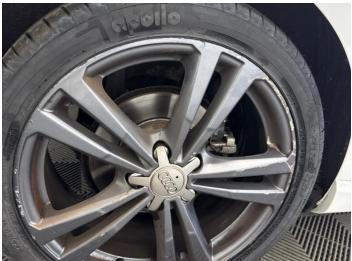
10: Wheel osr Scratched Over 50mm

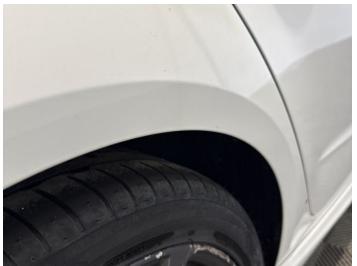
11: Qtr Panel osr Dented 2 Or Less UpTo 10mm

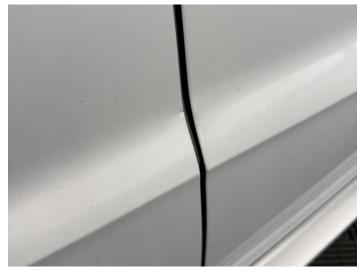
13: Door osr Dented 2 Or Less UpTo 10mm

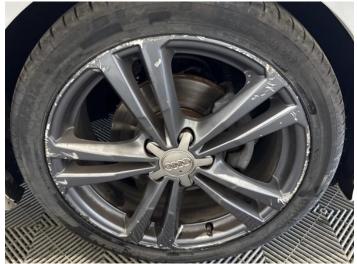
14: Wheel osf Scratched Over 50mm

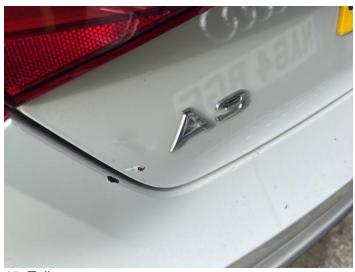
15: Tailgate Dented With Paint Damage
